Wetland Functionality Assessment & Rehabilitation Plan for the Constructed Montrose Farming Trust Dam on Persberg Farm Near Helpmekaar in KwaZulu-Natal.

Report name	Wetland Functionality Assessment & Rehabilitation Plan for the Constructed Montrose Farming Trust Dam on Persberg Farm Near Helpmekeer in KwaZulu-Natal.	
Reference code	AFZ-1607-09	
Submitted to	Andrew Batho at Afzelia	
Report writer 1	Wayne Jackson	25th September 2016

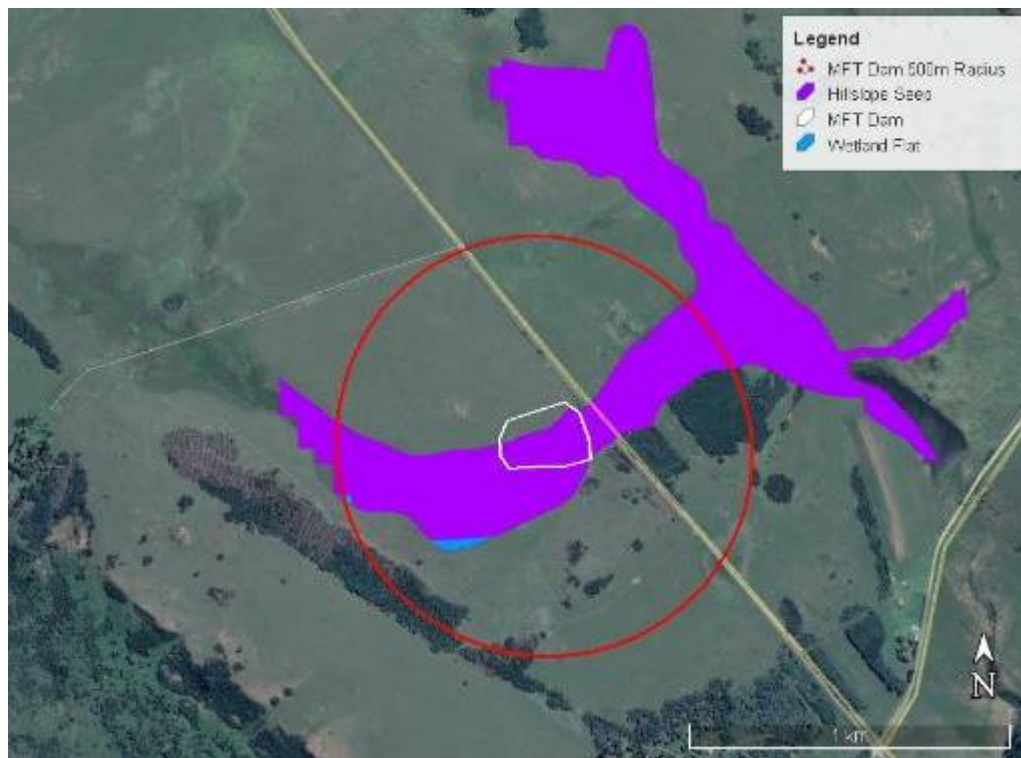
Plan 2: The NFEPA wetlands located within 500m of the MFT Dam.

The FEPA wetlands were classified as a bench (flat) wetland and a Hillslope Seep wetland. The Wetland condition and rankings for both these FEPA wetlands were A/B ($\geq 75\%$ Natural

vegetation) and rank four (4) (wetlands with A/B condition and associated with at least three other wetlands). These sites were classified as predominantly natural. The NFEPA wetland information is a coarse data set and must be ground truthed.

From the field assessment undertaken and Google Earth historical imagery it is concluded that the wetlands were not Bench Flats and Hillslope Seeps, but rather Unchannelled valley bottom wetland systems. There was an existing dam in 2012 (as far as Google Earth history goes) as well as evidence of cattle paths which indicate grazing activities within the wetland. These activities will alter the Present Ecological Category (PES) or wetland condition to a lower level of what can only be assumed a C (Moderately Modified) State. This can only be assumed as the wetland assessment was only conducted post-construction of the new MFT Dam wall.

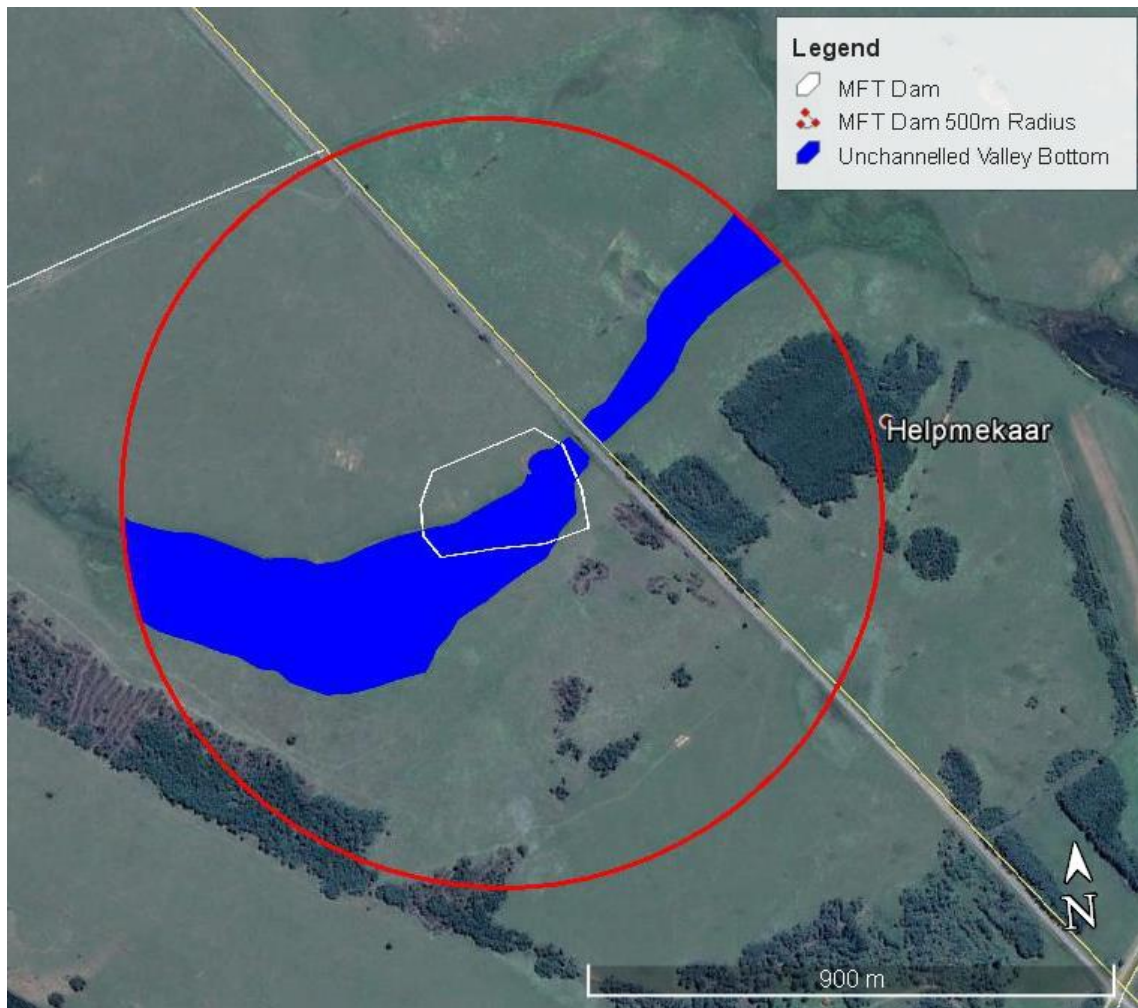
Plan 3: MFT Dam wetland delineation with the 500m assessment buffer.

The wetland delineation is shown in Plan 3 and the HGM units in Plan 4 with the wetland classification as per SANBI guidelines (Ollis, et al., 2013) in Table 4-2.

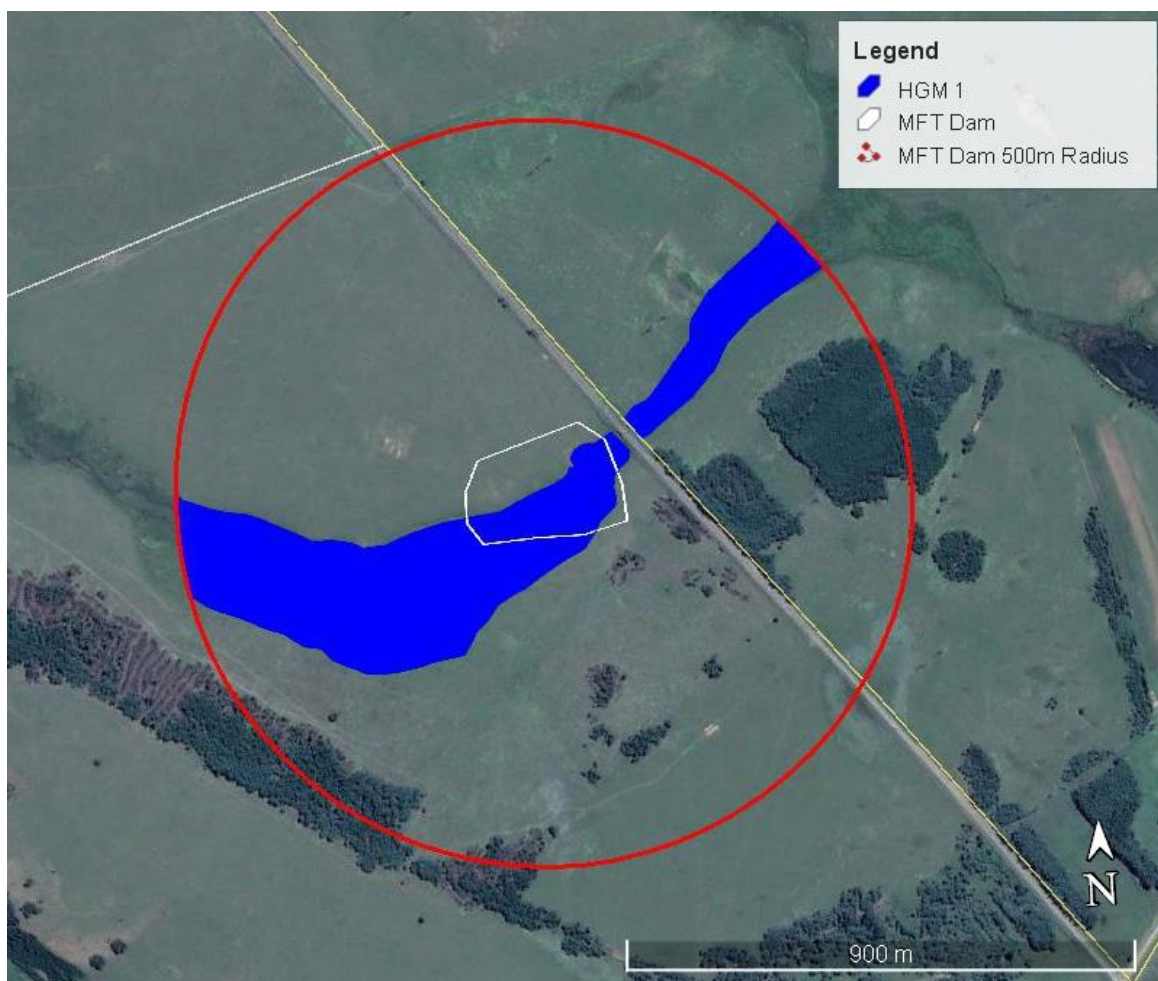
Plan 4: MFT Dam HGM unit.

Dam location. The wetland then drains into a culvert under the R33 road and continues draining north east. The unchannelled valley bottom then links up with another unchannelled valley bottom system and drains south west down the mountain feeding the larger catchment.

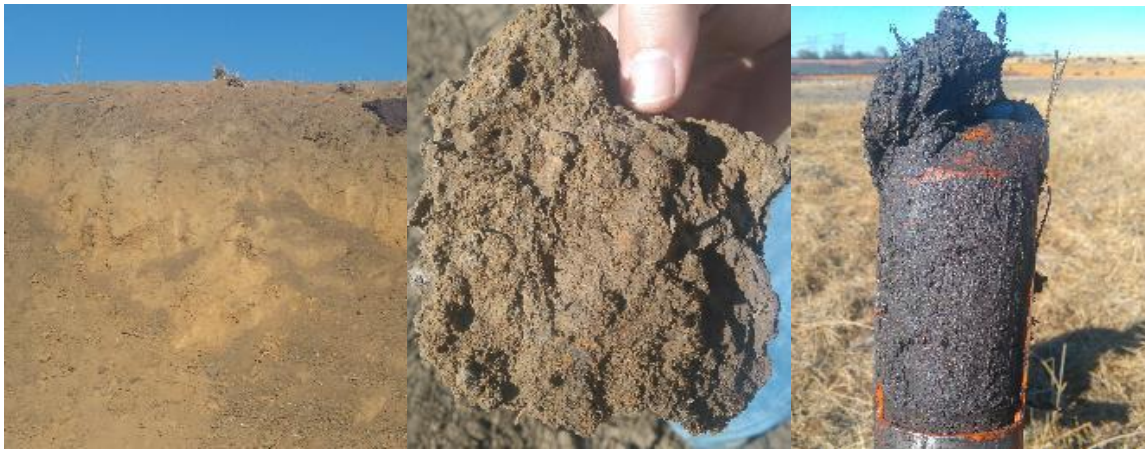
The soils are shallow Mispah soils on the northern banks with slopes in excess of 10%. The southern bank is flatter in slope and the soils are deeper with Clovelly and Hutton soils dominating the midslope positions in the land scape. The valley bottom shows a transition from Clovelly soils (midslope), to Westleigh soils (footslope), to Katspruit soils (valley bottom) (Figure 4-1).

Figure 4-1: The soils present from left to right; Clovelly, Westleigh, and Katspruit.

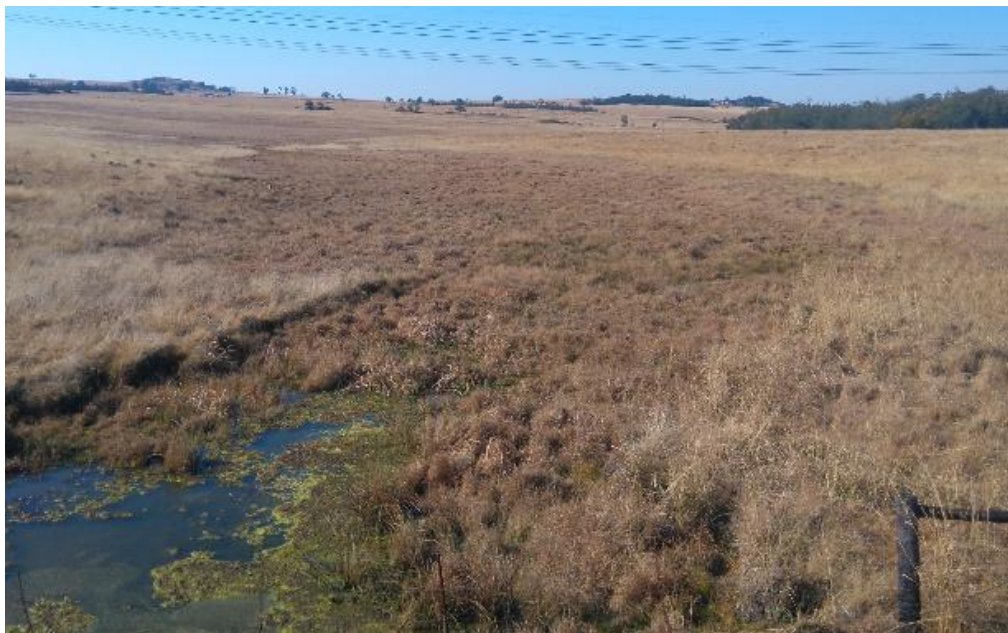
Figure 4-2: The unchannelled valley bottom.
