## SURVEY OF CULTURAL HERITAGE RESOURCES ON THE FARM RIETFONTEIN 375 JR PRETORIA DISTRICT

# AFRICAN HERITAGE CONSULTANTS CC

OCTOBER 2003

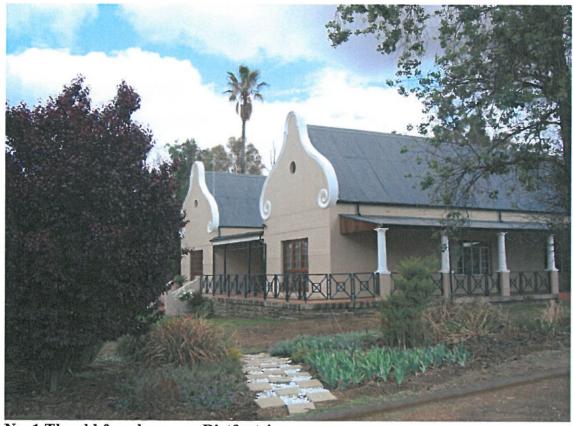
According to the present owner, Mr Gerhard Bredenkamp the original house and outbuildings had been built in 1899. As the Anglo-Boer War broke out the buildings were only completed after the war. The main house was extended several times and today mainly represents the 1930/40 building style. The *waenhuis* is largely in its original state and an excellent example of a Boer farm outbuilding. It has a loft (solder) for storing food for animals during the winter (see photograph 1 & 2).

No. 1 The old farmhouse on Rietfontein

The original farmhouse and outbuildings are older than sixty years and fall under the National Heritage Resources Act, Act 25 of 1999. According to Mr Gerhard Bredenkamp these buildings and an area of forty hectares are not part of the new development and not in danger of destruction.

The original farmhouse and outbuildings, the graveyard and the large cattle kraal are truly worth preserving. If this area falls outside the new proposed development the structures will at least in the short and medium term be save.

That the original farm settlement as well as the archaeological site be preserved and excluded from development.

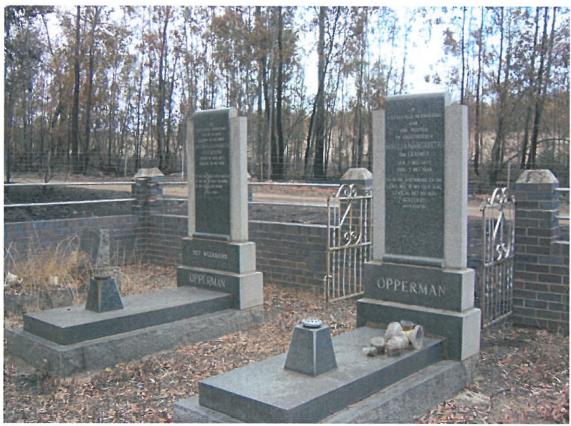
There are three graves in a small graveyard located at S25°50'59.5" and E28°20'37.5". Two of the graves are those of the original owners of the farm. The details are as follows:

Jacobus Gerhardus Opperman 18/4/1877 – 25/5/1945 and Sibella Margaretha Geb Erasmus 7/5/1877 – 7/5/1958 (see photograph 3)

No. 3 The Opperman graveyard

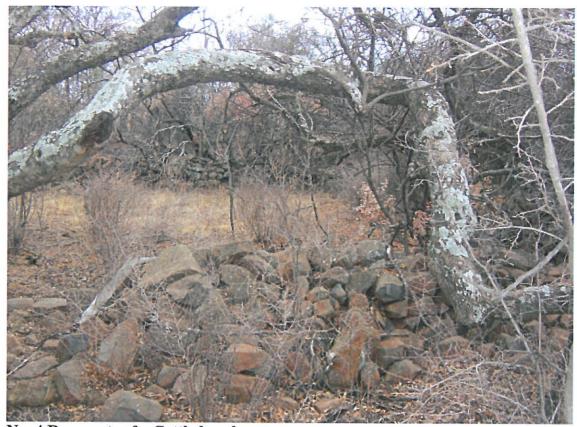
A square cattle kraal located at S25°50'56.6" and E28°20'50.8", is built with local stone without mortar. It is typical of early kraals on Boer farms (see photograph 4).

No. 4 Remnants of a Cattle kraal

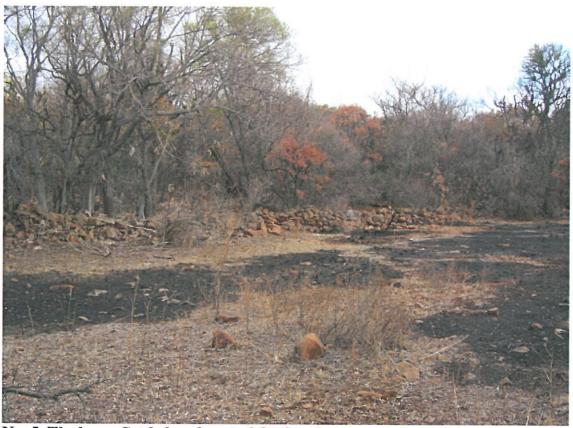
A very large cattle kraal approximately 25 X 45 metres found at S25°50'47.2" and E28°20'46.2". This kraal is approximately 25 X 45 metres. It is constructed of dry stonewalling. It is part of the original farm settlement and lies just east of the farmhouse (see photograph 6).

No. 5 The large Cattle kraal east of the farmhouse

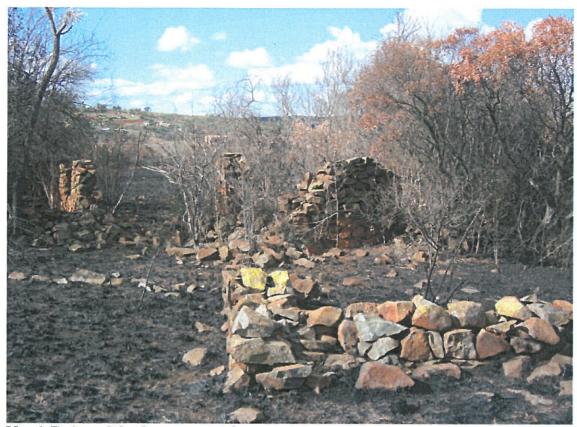
At S25°50'53.5" and E28°20'55.2" several stone ruins occur. Most of them are square walls built with stone and clay.

According to Mr Gerhard Bredenkamp this site and the cattle kraal were part of a *bywoner* settlement. After the Anglo-Boer War poor whites were allowed to settle on the farms of rich land owners (see photograph 5).

No. 6 Ruins of the *bywoners* settlement. The walls of the house can be seen in the background. The wall in front most probably was the garden wall.

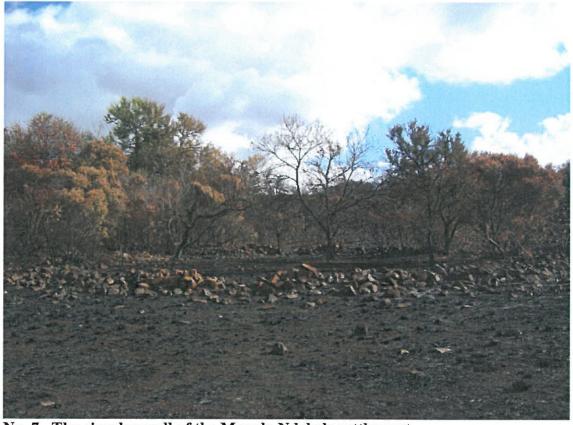
Only one archaeological site could be found on the farm. The site is located at S25°51'13.4" and E28°21'16.0". The site consists of a large stone circle of 25 metres in diameter and two smaller circles. This is a typical Late Iron Age settlement. From archaeological and historical sources we know that it most probably formed part of the Manala Ndebele settlements with the main concentration along the Bromberg. The Manala Ndebele were concord by Mzilekazi in the 1820's (see photograph 7).

No. 7 The circular wall of the Manala Ndebele settlement

The archaeological site and at least 50 metres around it should be save guarded from development. The stonewalls formed the central part of the settlement. The houses were outside the walled area. For this reason a area of at least 50 metres around the stonewalls should be kept as a save area with no development.
