**PHASE 1 HERITAGE IMPACT ASSESSMENT:
CATO RIDGE DEVELOPMENT,
ETHEKWINI MUNICIPALITY, KWAZULU-NATAL**

November 2021

**FOR: Zutari (Pty) Ltd
Jeanne-Louise Wiese**

**AUTHOR: JLB Consulting
Jean Beater**

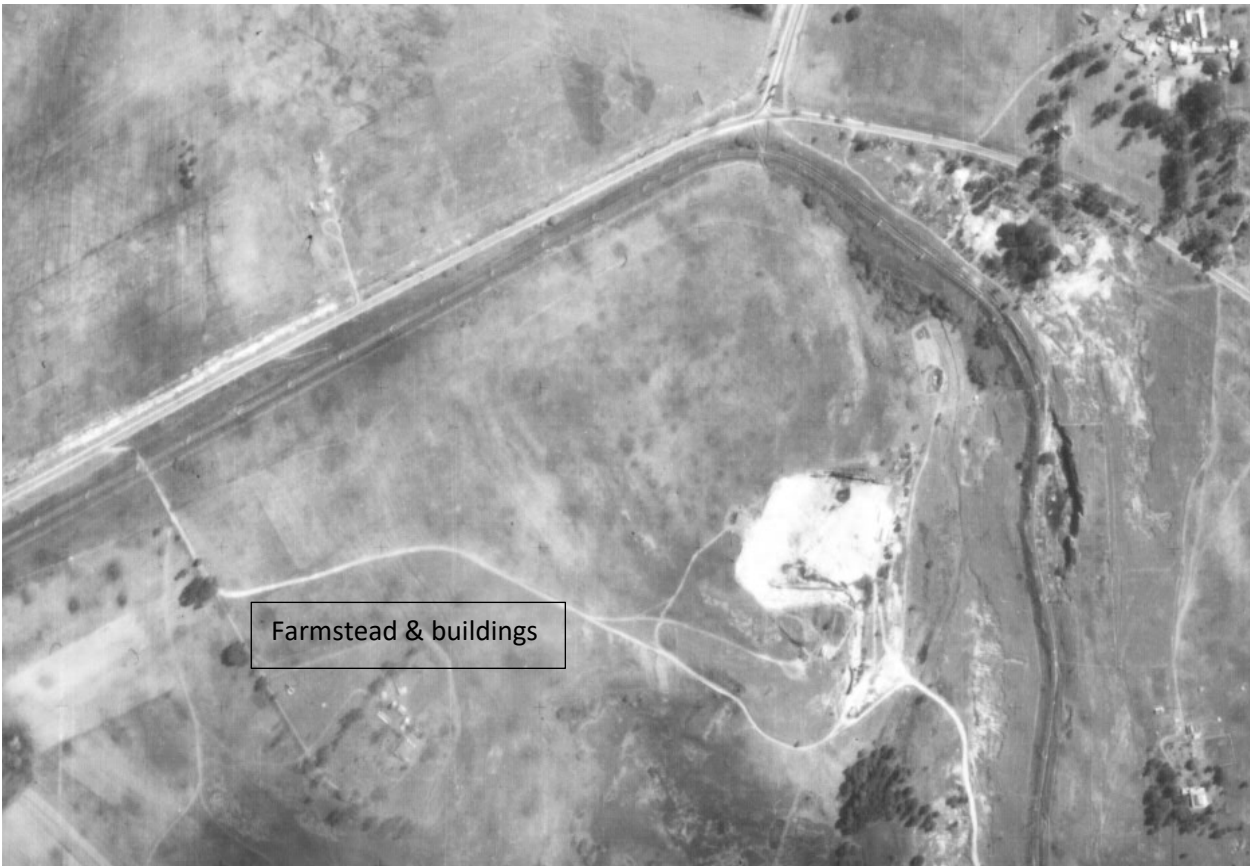
Figure 6: 1968 photograph of Development Area 1

The area was inspected on foot. There is a large quarry located just below the structures and near the railway line which is visible in the image above. The 1937 aerial image (**Figure 5**) shows the area as largely undeveloped apart from the railway line that still runs around it; however, between 1937 and 1968, a farmstead with several out-buildings was constructed that can be seen

in **Figure 5** and **Figure 6**. The large quarry is also visible by 1968. The farmstead is located outside Proposed Development Area 1.

The site of the farmstead depicted in **Figure 6** was inspected. It is situated amongst trees and bushes. It is no longer in use and has fallen into disrepair. The remains of several structures were found as well as an intact silo/tower (see **Figures 7 - 9**). An inspection of the surrounding area was undertaken and no graves or other heritage resources were found.

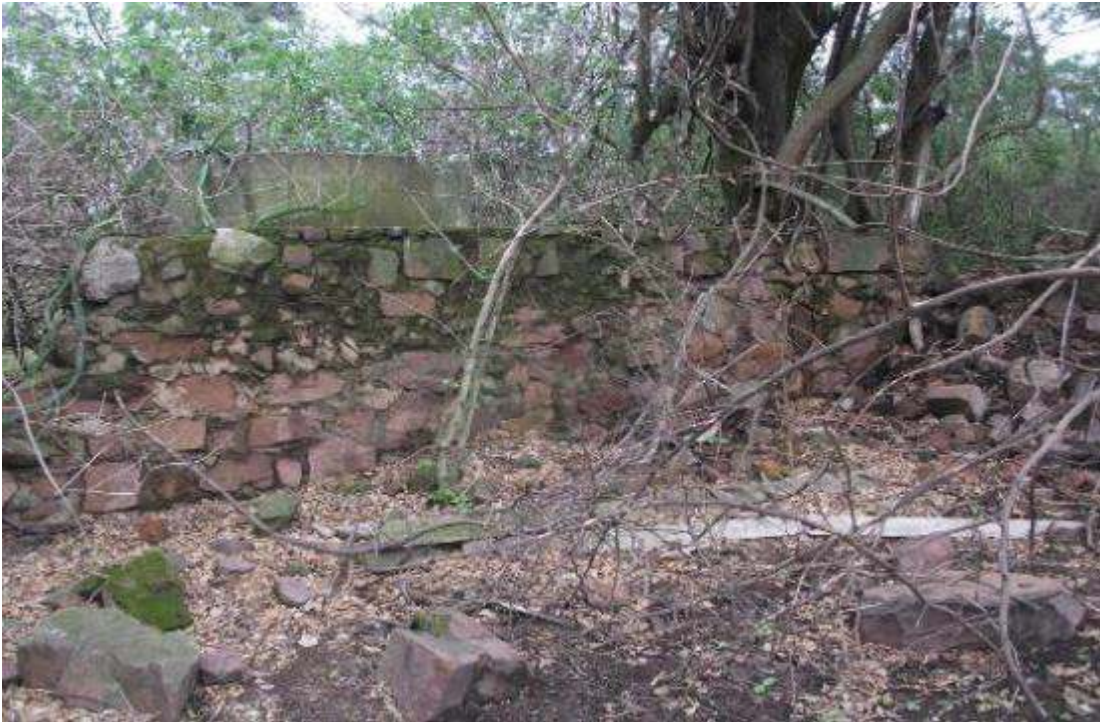
Figure 7: Remains of wall with concrete water tank behind wall

It is therefore recommended that either a built heritage specialist be consulted regarding the age of the remains of the structures and the silo or that an application is made to the Institute for permission to demolish and remove the structures on the presumption that the remains of the structures are older than 60 years. The application process for the demolition, alteration or addition to a structure which is, or which may reasonably be expected to be older than 60 years must follow the process as described in section 3 of the draft KwaZulu-Natal & Research Institute Regulations, 2021 or section 2 of the KwaZulu-Natal Heritage Regulations 2012 if the 2021 regulations have not been officially promulgated by the time an application is made.

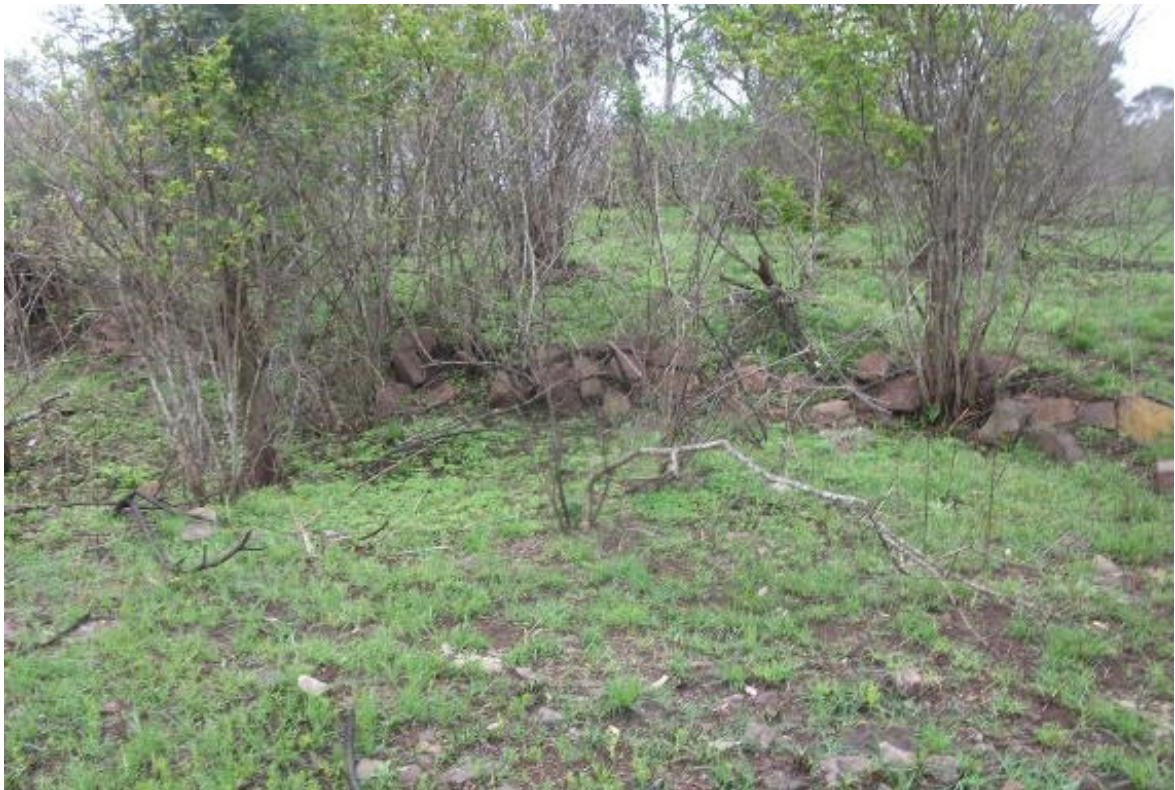
Figure 8: Low stone walling within remains of farmstead complex

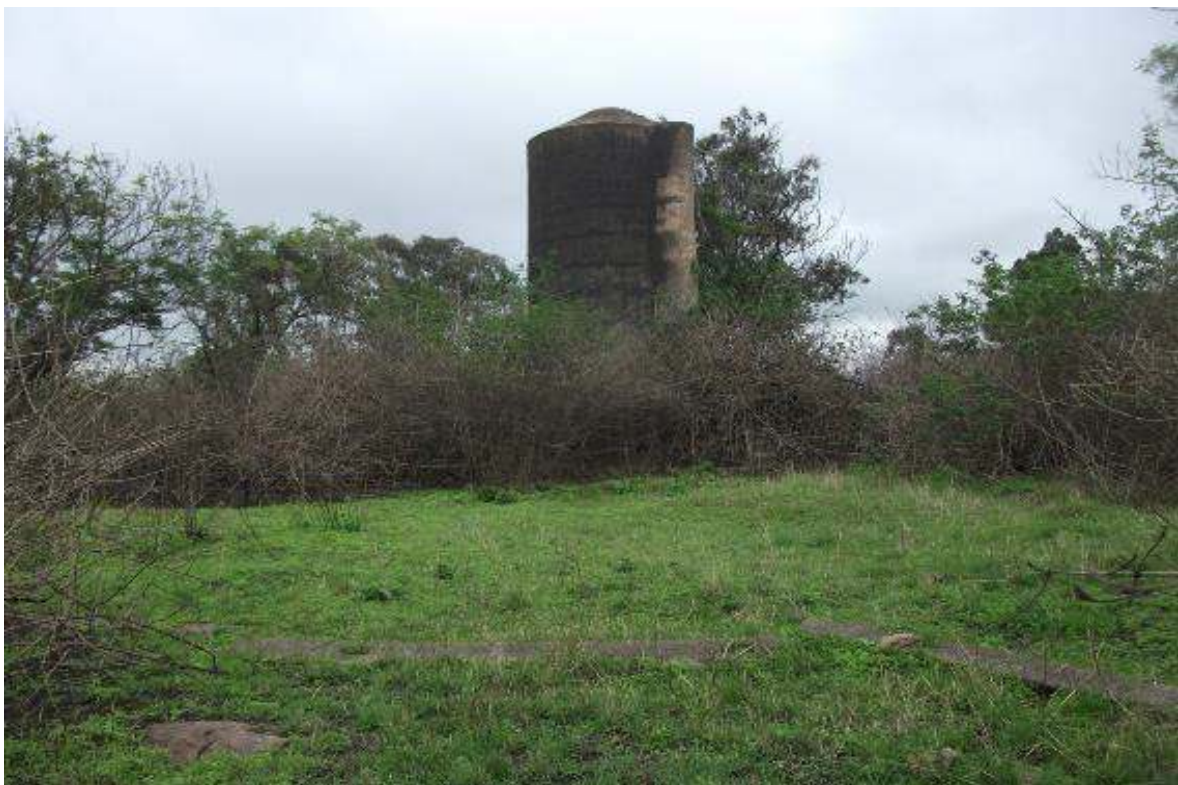
Figure 9: Intact silo

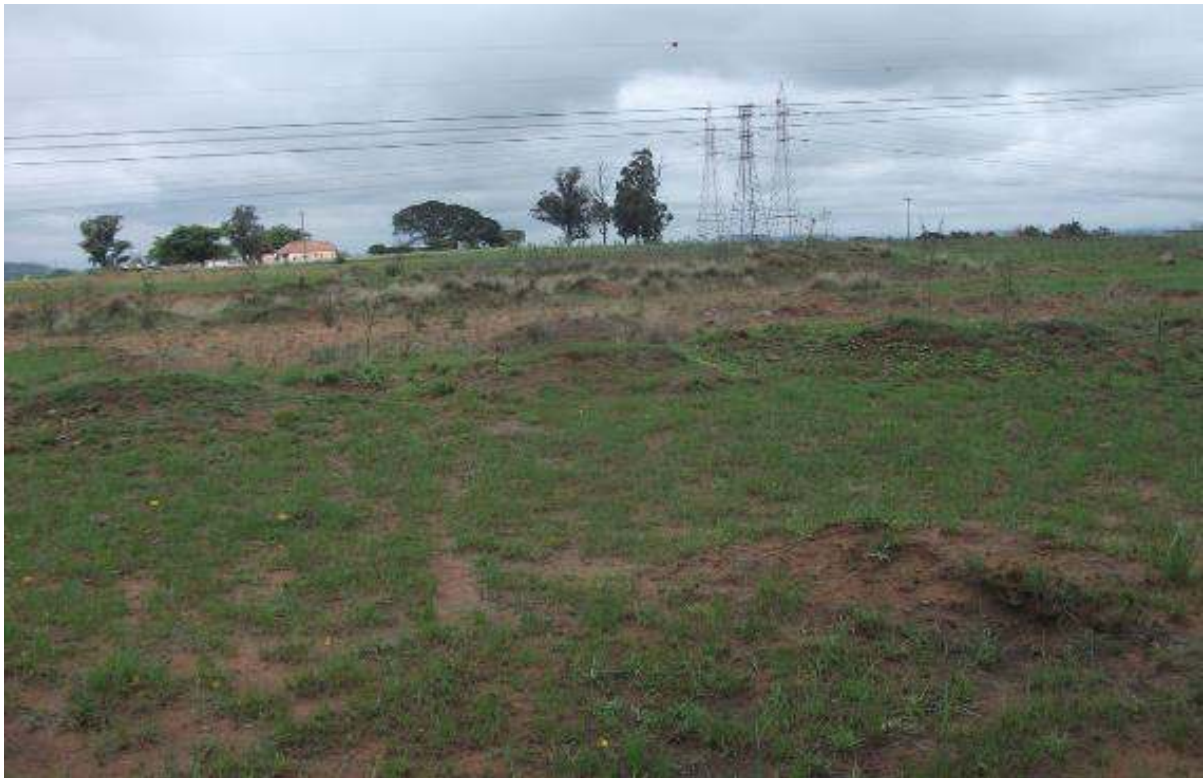
The remainder of Development Area 1 was inspected. An individual walking across the area was asked if he was aware of any graves or other heritage sites on the site. He said that he had not heard of graves on the site but was not from the immediate area. No heritage sites were found during the inspection. The area west of the farmstead complex within Development Area 1 is disturbed by sand mining activities and dumping (see **Figure 10**).

Figure 10: Mounds of soil due to sand mining

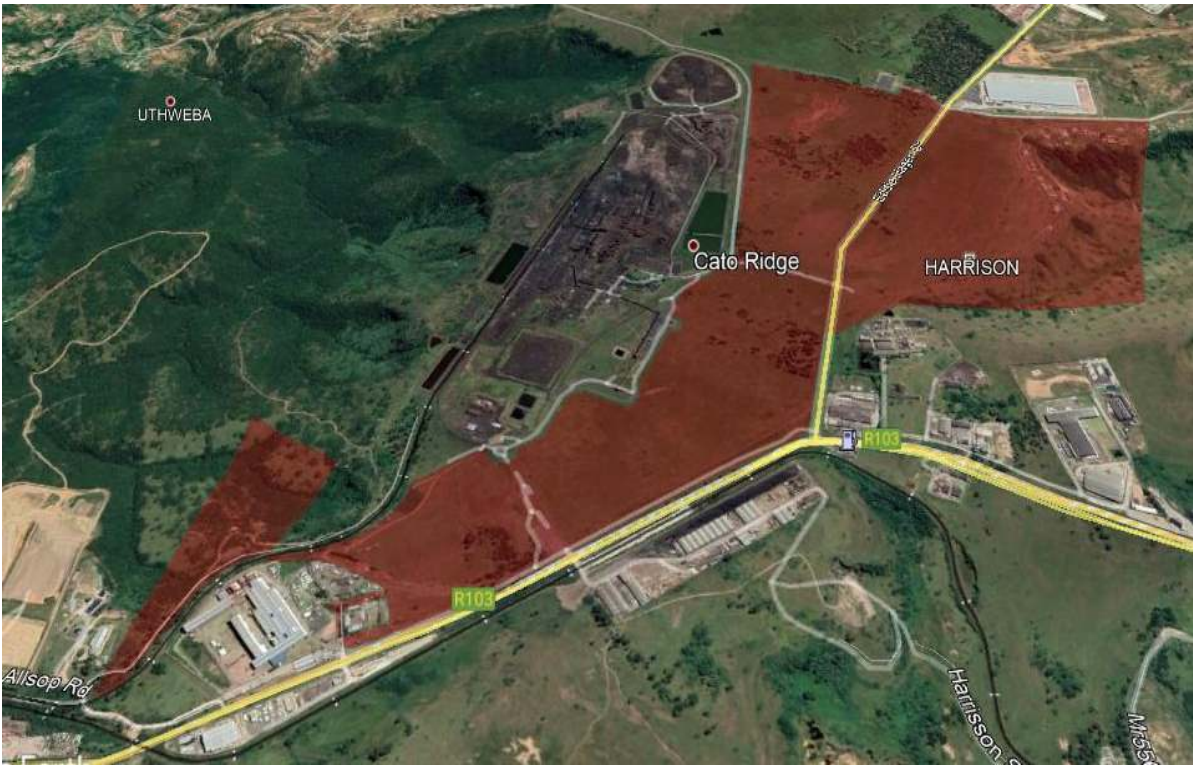
Figure 13: Proposed Development Area 2

The various areas making up Proposed Development Area 2 (**Figure 13**) were inspected on foot. In the 1937 aerial photograph (**Figure 14**) of the northern section of Proposed Development Area 2, there are two farmsteads visible located on either side of Eddie Hagan Drive as well as rows of trees and large tracts of cultivated land. Farmstead 1 was located west of Eddie Hagan Drive and Farmstead 2 was located east of Eddie Hagan Drive.

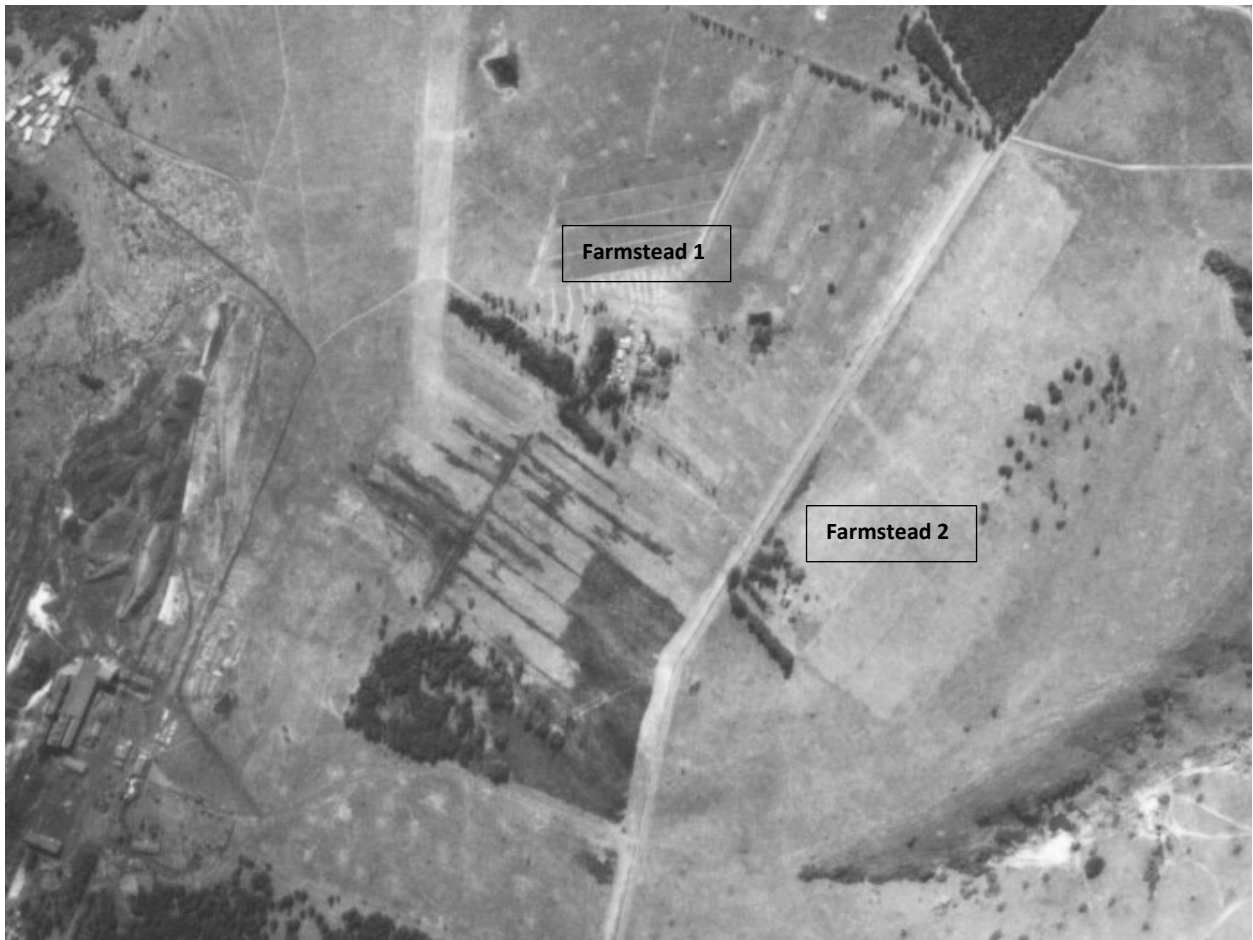
Figure 15: 1967 aerial image

The 1967 aerial photograph (**Figure 15**) still shows the two farmsteads as well as the Assmang Cato Ridge Works on the western boundary of the image and the airstrip between Farmstead 1 and Cato Ridge Works. By 1978, only a few remains of Farmstead 2 on the eastern side of Eddie Hagan Drive are visible whereas structures associated with Farmstead 1 are still intact.

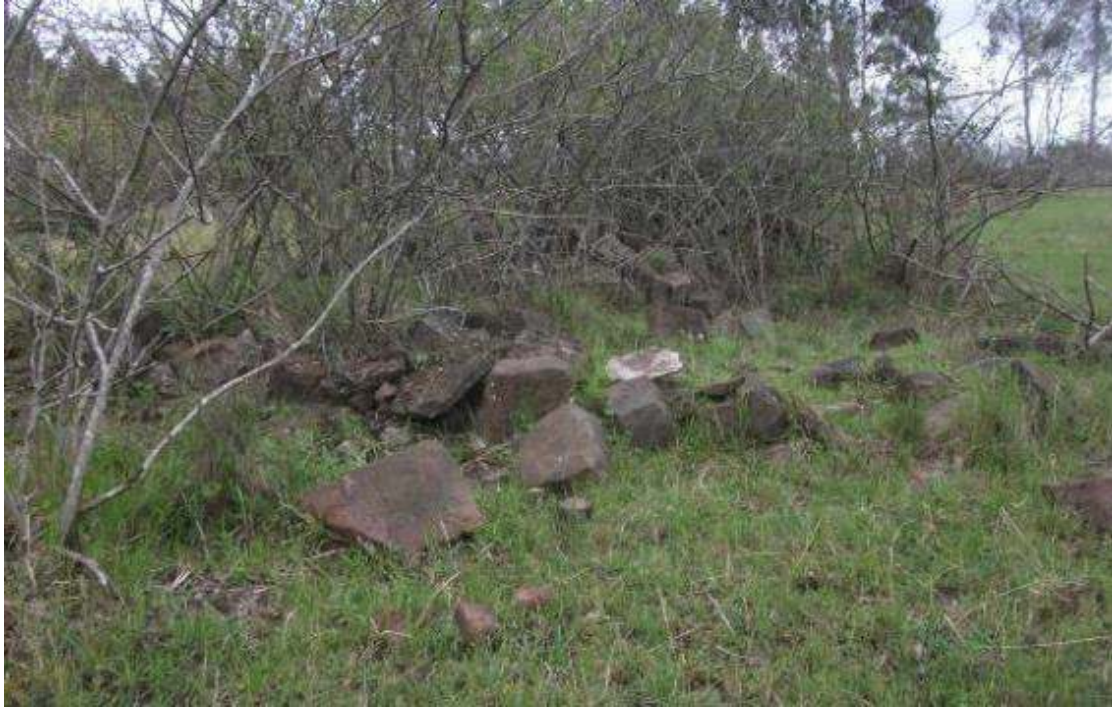
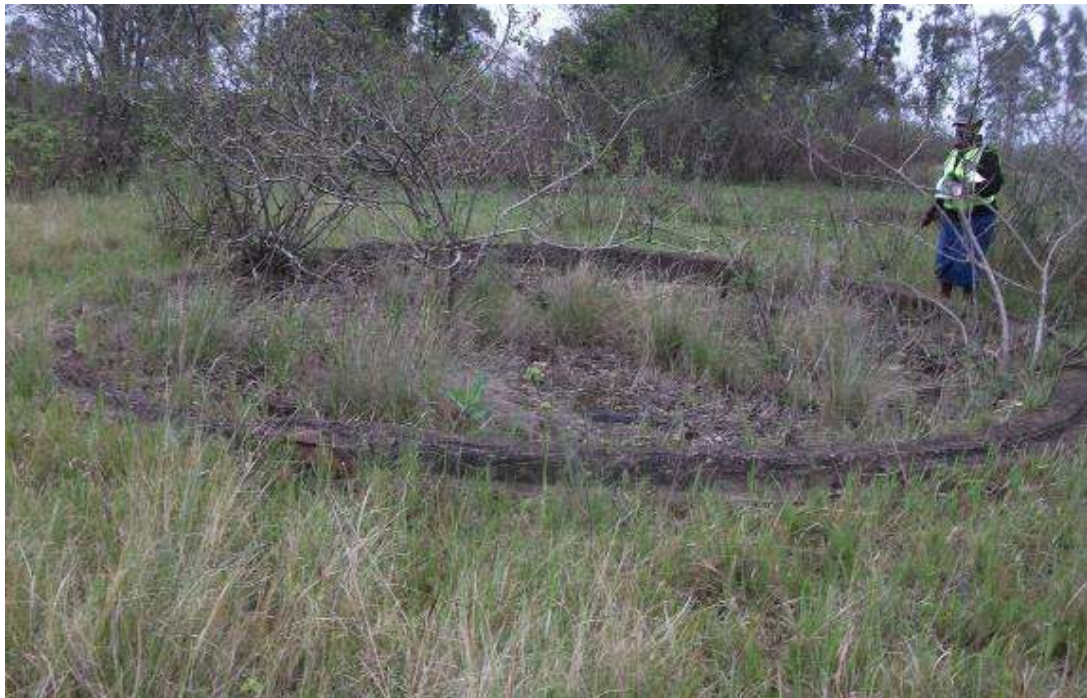
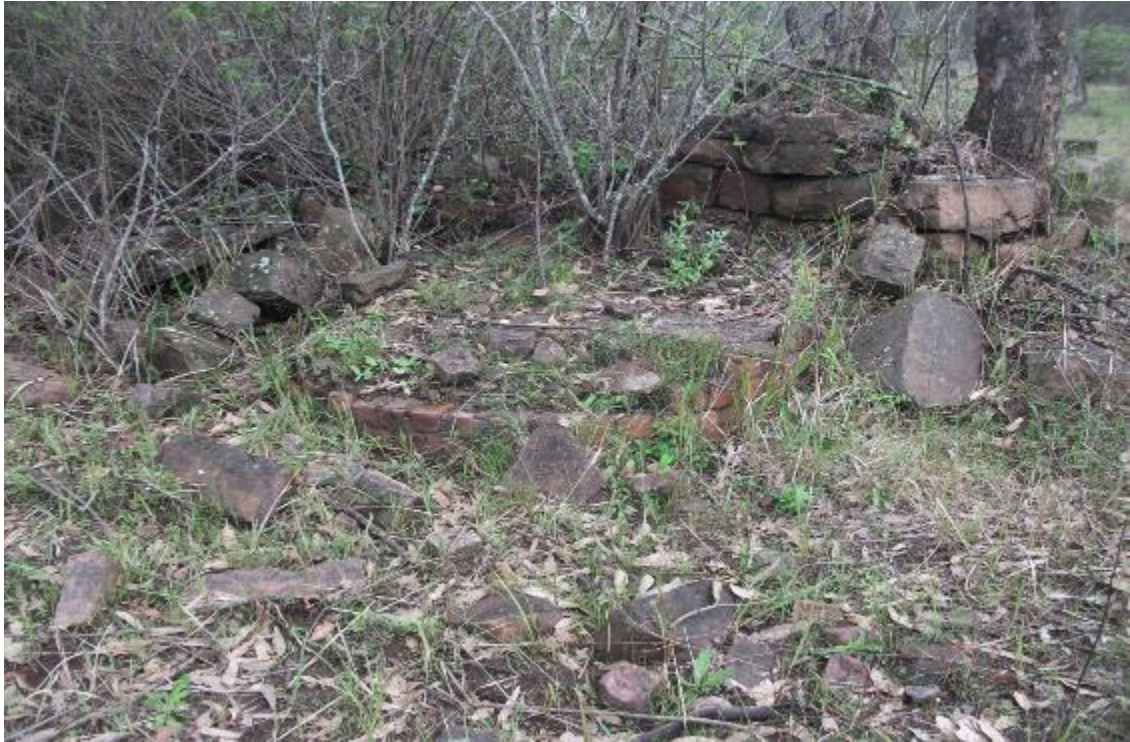
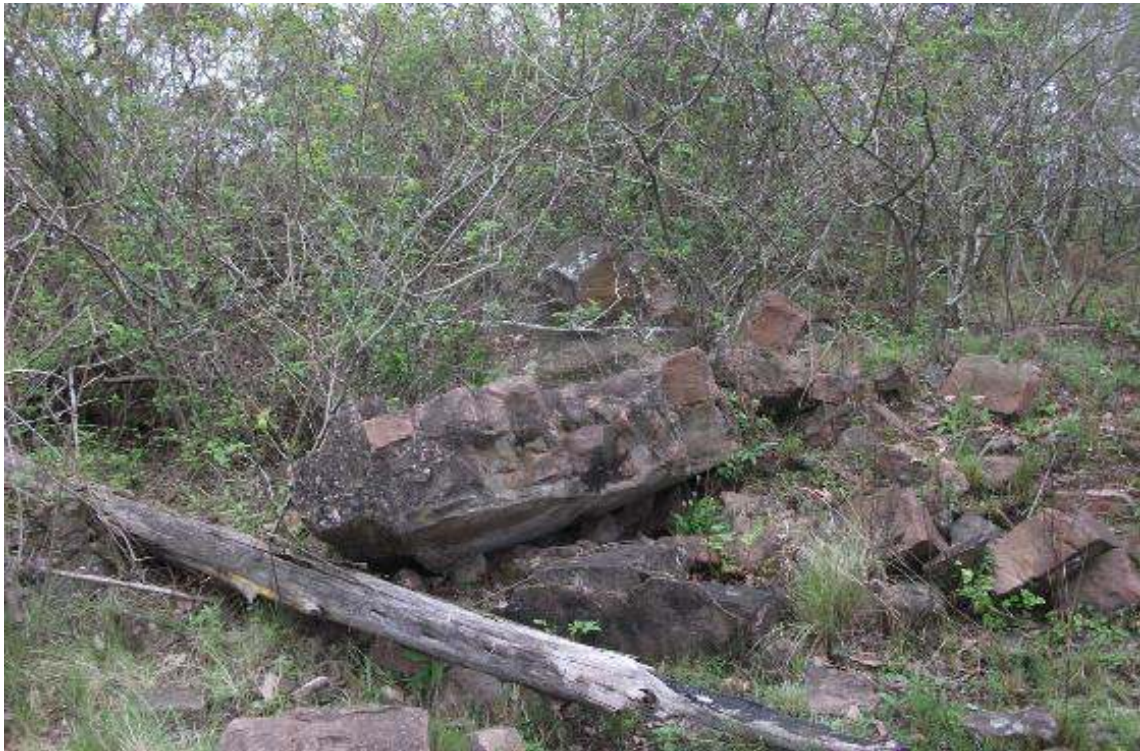
No graves were found on the western side of Eddie Hagan Drive during the inspection. Only extensive remains of several structures making up Farmstead 1 were found which can be seen in **Figures 16 - 19**.

Figure 16: Farmstead 1: Remains of structure made from stone

Figure 17: Farmstead 1: Remains of circular structure

Figure 18: Farmstead 1: Remains of structures

Figure 19: Farmstead 1: Remains of structure

An application must be made to the Institute for the for the alteration or demolition of structures older than 60 years if this area is to be impacted. In terms of the structures where the age could not be clearly determined, it is recommended that either a built heritage specialist be

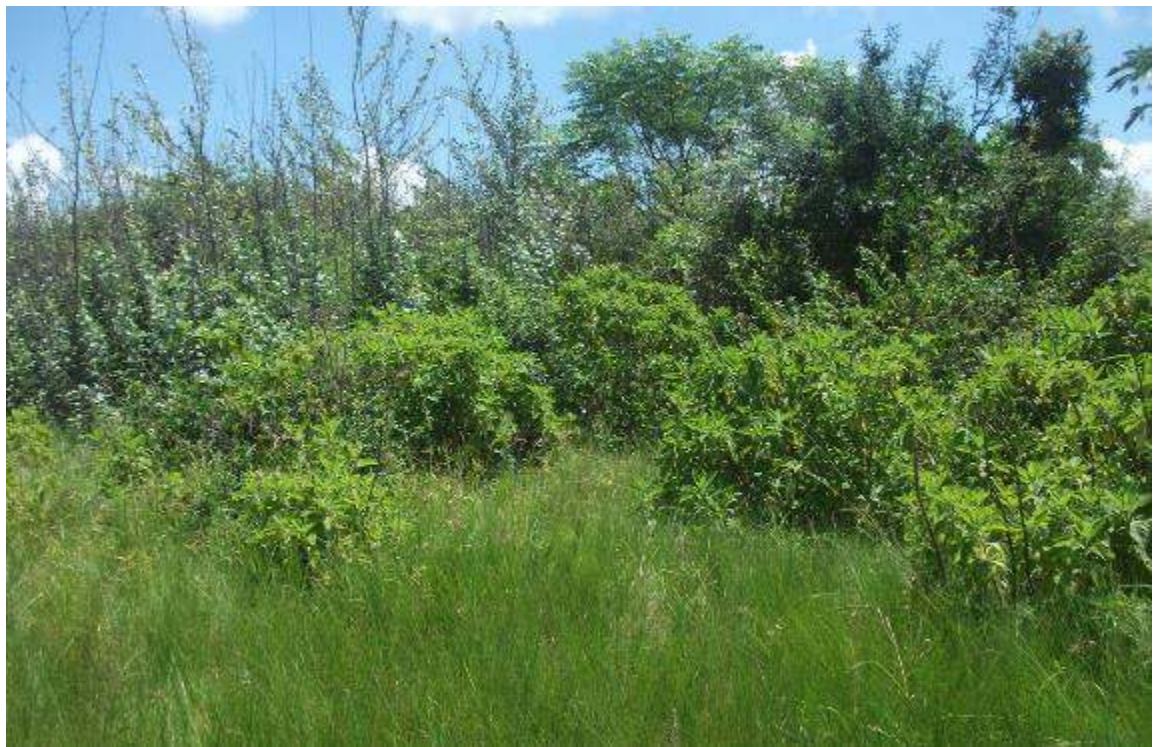
Figure 20: Location of Farmstead 2 east of Eddie Hagan Drive

In contrast, there are few remains of Farmstead 2 located on the eastern side of Eddie Hagan Drive (**Figure 20**). The site is thickly overgrown with bush with some rubble found within the bush. The outline of what could be a pathway marked out in stone is still visible (**Figure 21**).

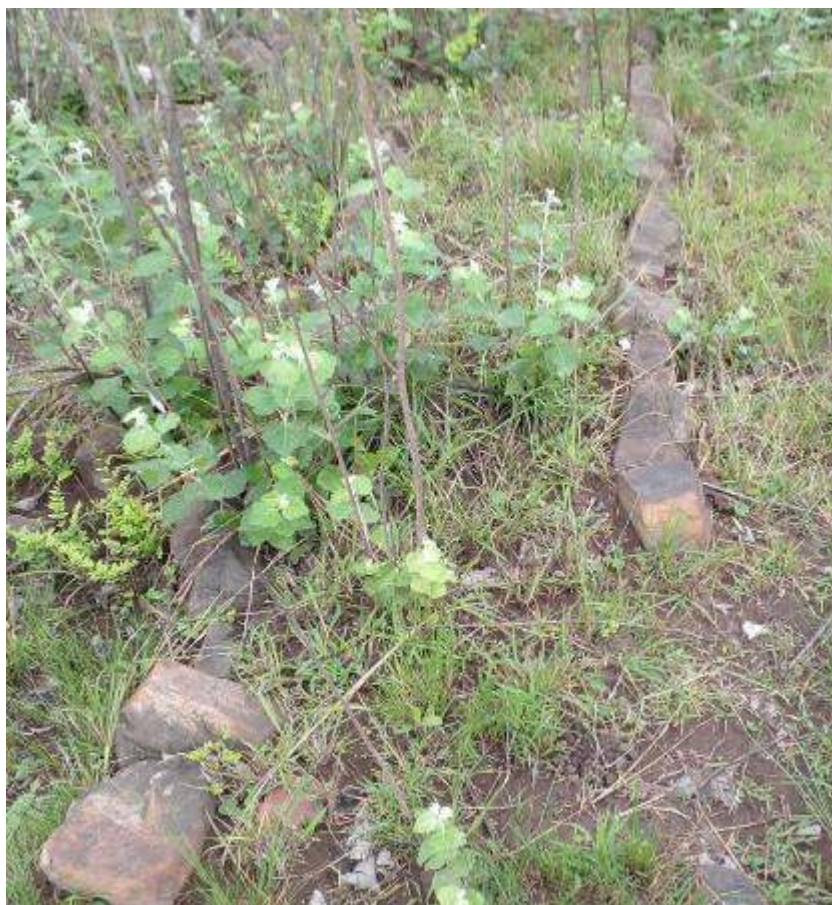
Figure 21: Farmstead 2: Remains of stone-lined pathway

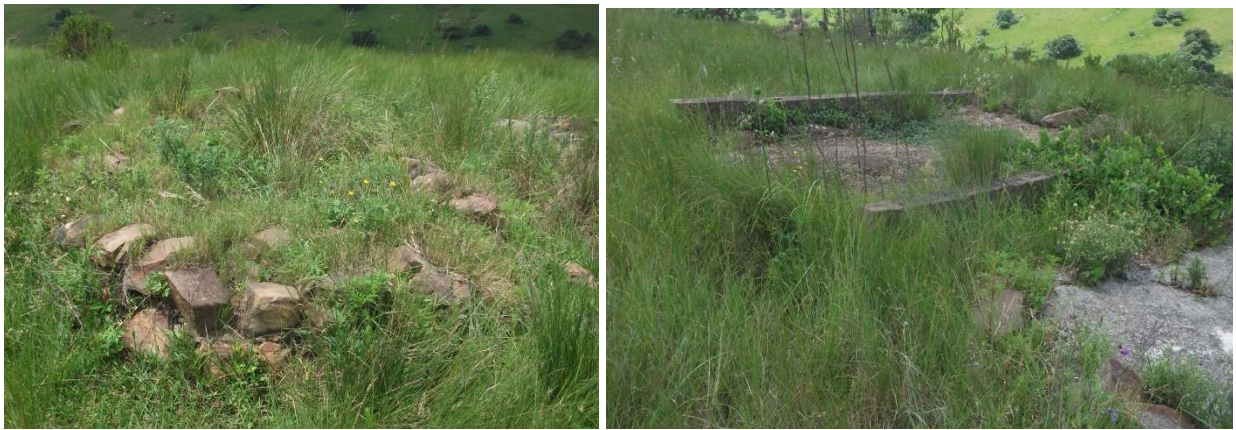
During the heritage baseline and sensitivity screening exercise that was undertaken in February 2021, several graves were found on the eastern boundary of Proposed Development Area 2 (**Figure 22**). It was recommended in the screening report that the area east of the old road or railway track be designated a 'no-go' area due to the high heritage sensitivity of graves. This recommendation still stands for this report. This area has been excluded from the development footprint.

Figure 22: Graves found during screening exercise

It is recommended that because graves are highly significant to people and there are many traditional, cultural and personal sensitivities concerning the relocation of graves, the removal of graves is not advised. If it is decided to remove any of the graves identified, then the procedure provided in section 5 of the draft KwaZulu-Natal & Research Institute Regulations, 2021 must be followed or the process in section 4 of the KwaZulu-Natal Heritage Regulations 2012 if the 2021 regulations have not been officially promulgated by the time an application is made. The grave sites and recommended buffers around them as described in this report have been excluded from the development footprint. Prior to construction and during construction, if there are any chance finds of graves, then work will need to stop in the area of the find and a heritage specialist called to site to ascertain the way forward.

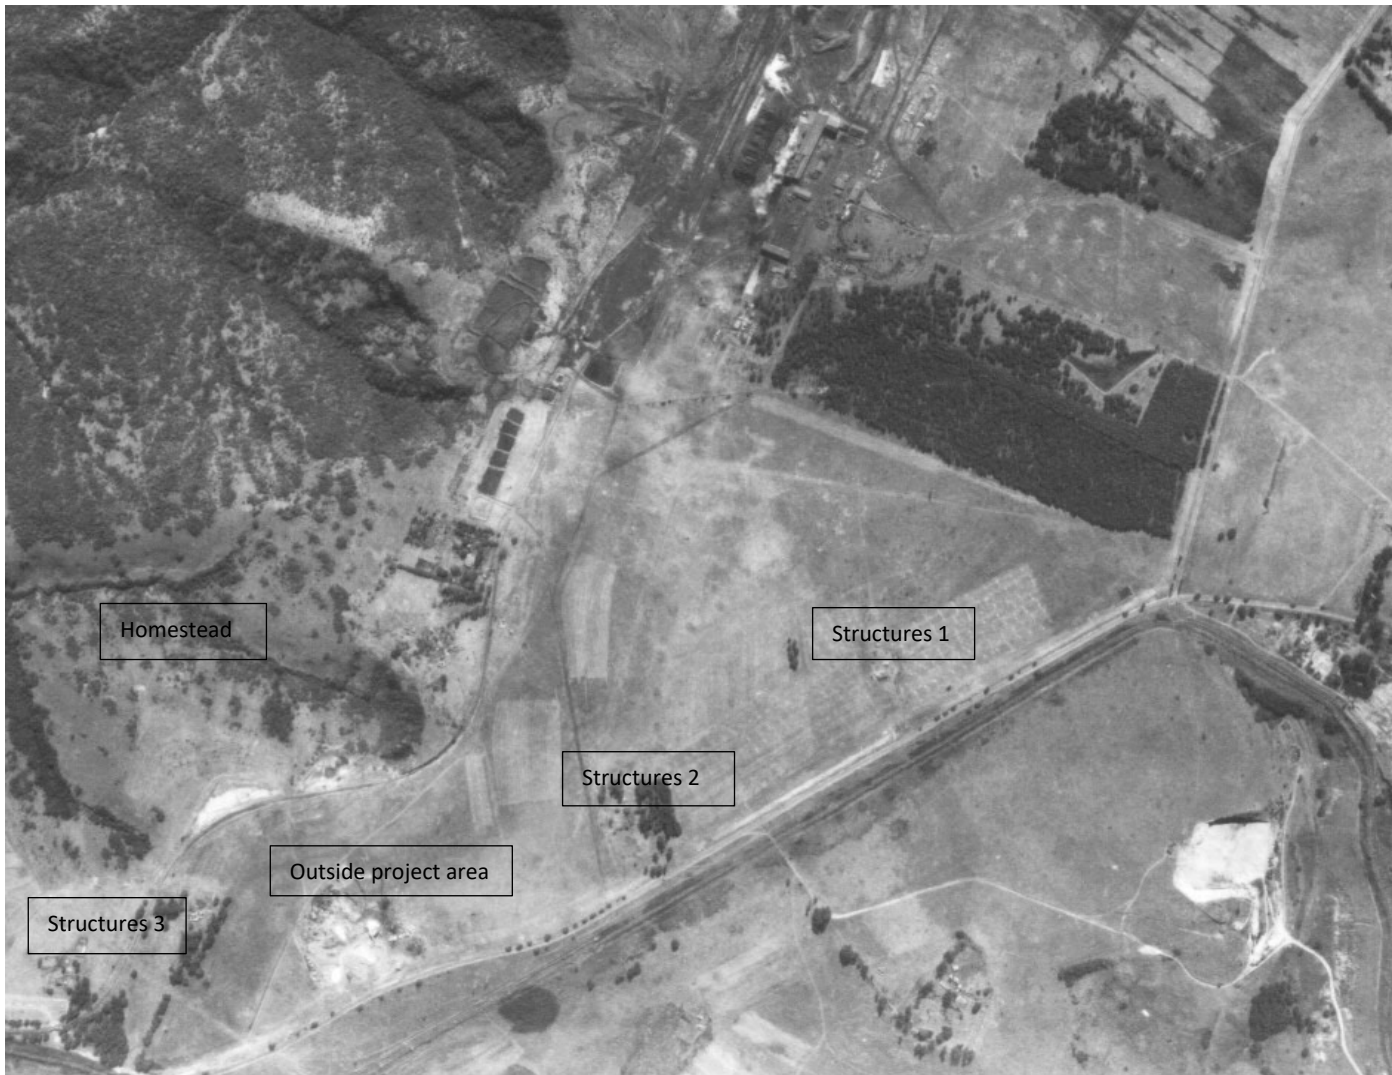
Figure 23: 1967 aerial photograph

The southern-western half of Proposed Development Area 2 was also inspected on foot accompanied by a member of Assmang security. The area between the R103 road and the Assmang Cato Ridge Works was accessed from the delivery entrance to Assmang. The 1967 aerial photograph below indicates structures and cultivated lands alongside the R103 road.

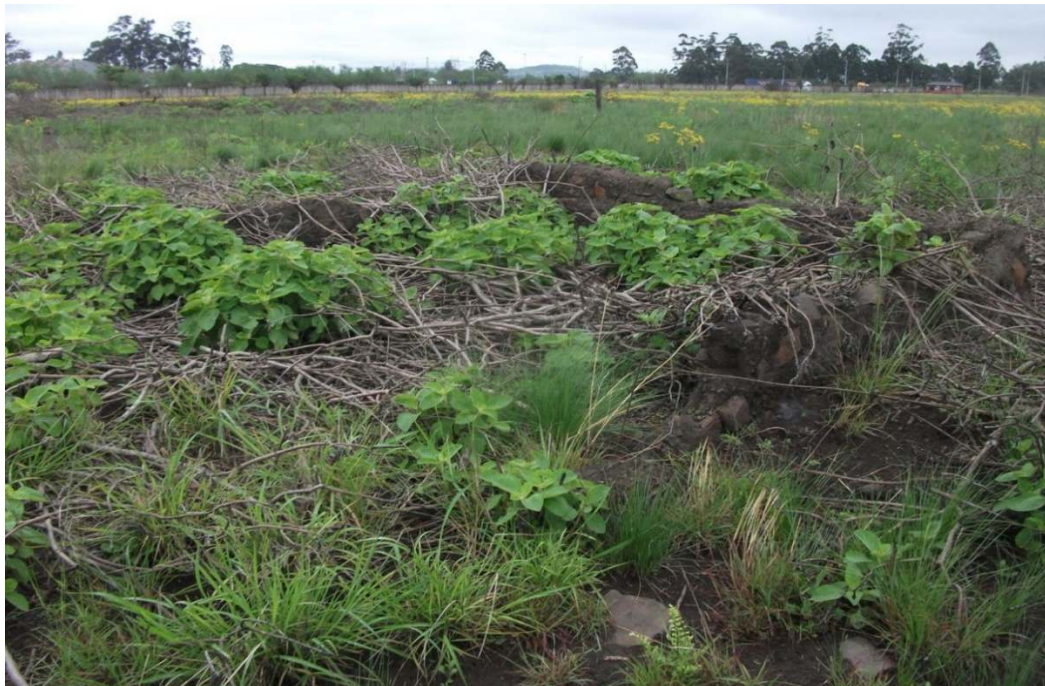
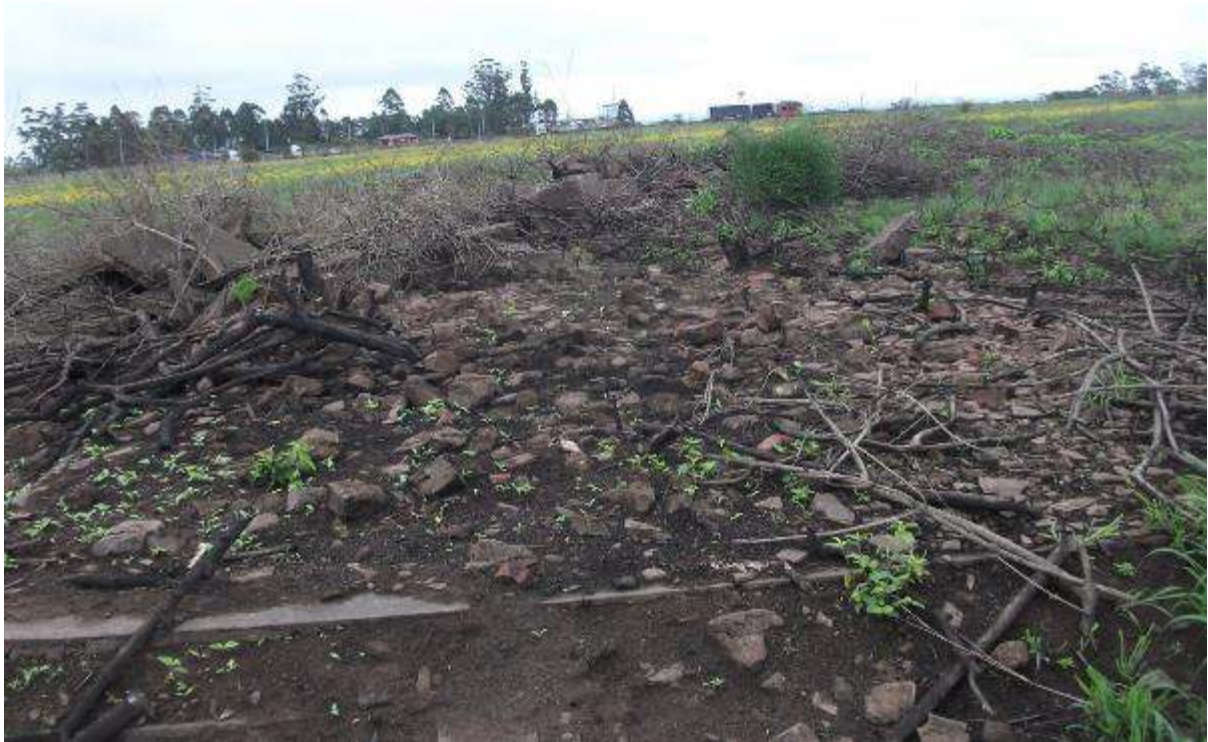
By 1983, much of the area is under cultivation. Only the remains of a few structures making up structures 1 are still visible as indicated in **Figures 25-26**.

Figure 25: Remains of square structure

Figure 26: Remains of structure looking towards Assmang delivery entrance

Single grave within homestead complex	29°42'49.6" S 30°37'47.6" E	High heritage significance	Leave graves <i>in situ</i> ; recommended no-go area to protect grave
Remains of structures 1 (Figures 25 - 26)	29°43'27.5" S 30°36'50.8" E	Low heritage significance; possibly protected by section 37 (1)(a)	Age of structure could not be determined; if area is to be developed then age of remains needs to be determined; if > 60 years then relevant permit is required prior to removal of remains
Remains of buildings associated with structures 2 (Figures 28-30)	29°43'35.2" S 30°36'33.5" E	Low heritage significance; protected by section 37 (1)(a)	> 60 years; can be demolished once relevant permit has been received from the Institute
Cattle dip (Figure 31)	29°43'41.0" S 30°36'02.5" E	Low heritage significance; possibly protected by section 37 (1)(a)	Age of structure could not be determined; if area is to be developed then a built heritage specialist must be consulted to determine age & if permit is required to demolish structure

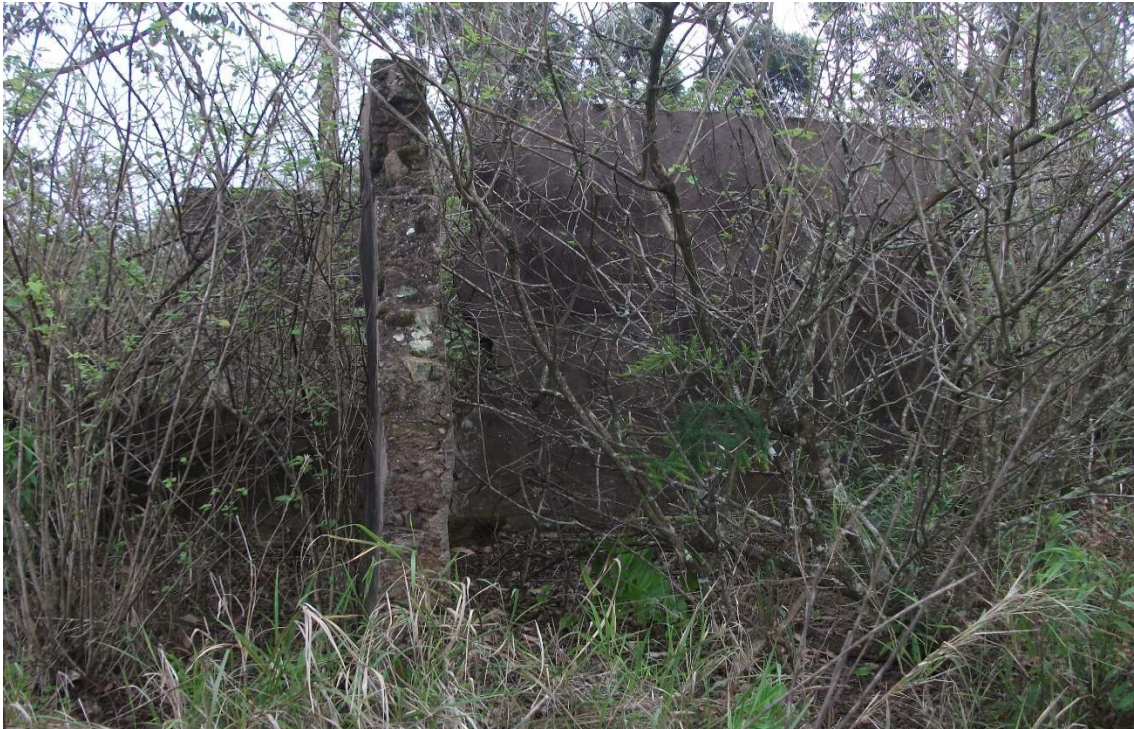
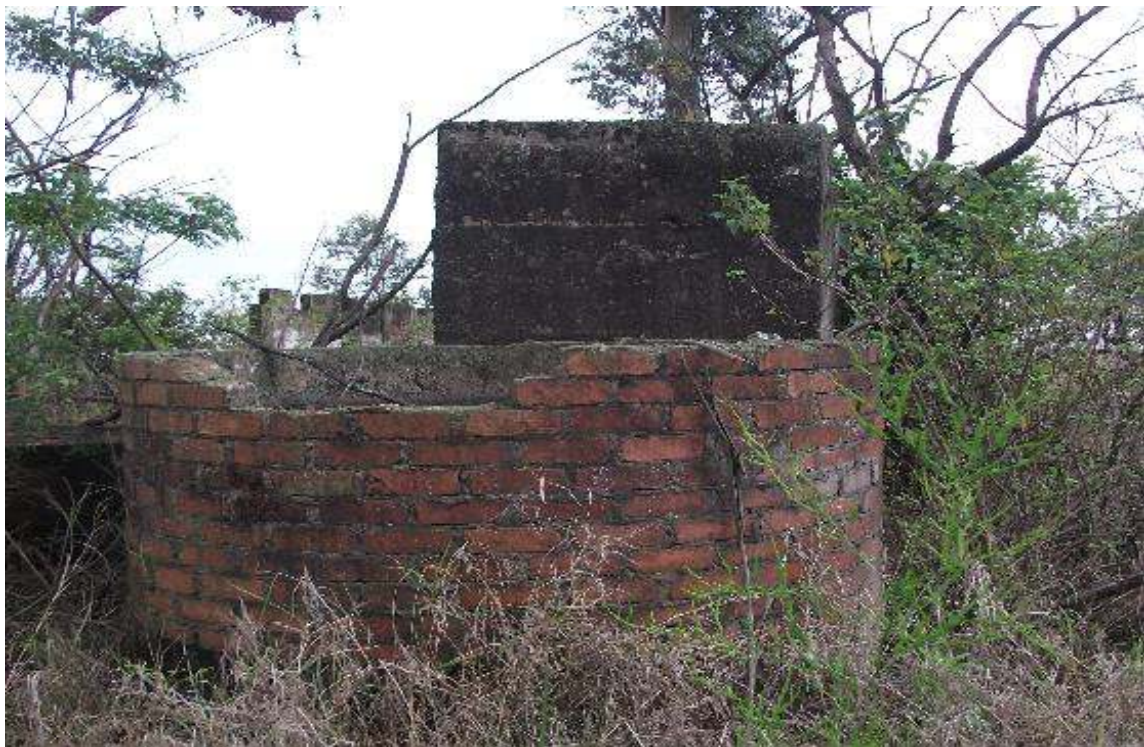
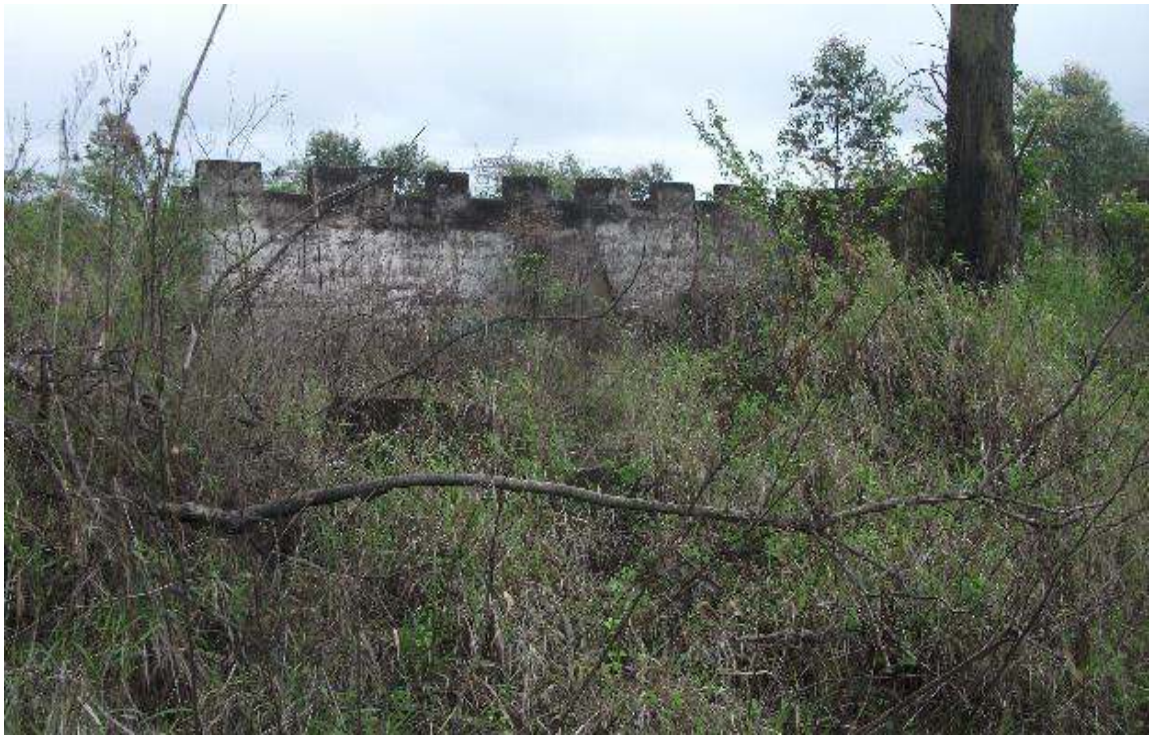
The ruins or structures (structures 2) indicated in **Figure 24** were investigated. Apart from the remains of walls, a round brick water tank/reservoir and the remains of a structure used for holding

animals (**Figures 28-30**), no other heritage resources were found. The area is overgrown with vegetation.

Figure 28: Remains of walls

Figure 29: Round brick structure with wall behind it

Figure 30: Structure for holding animals

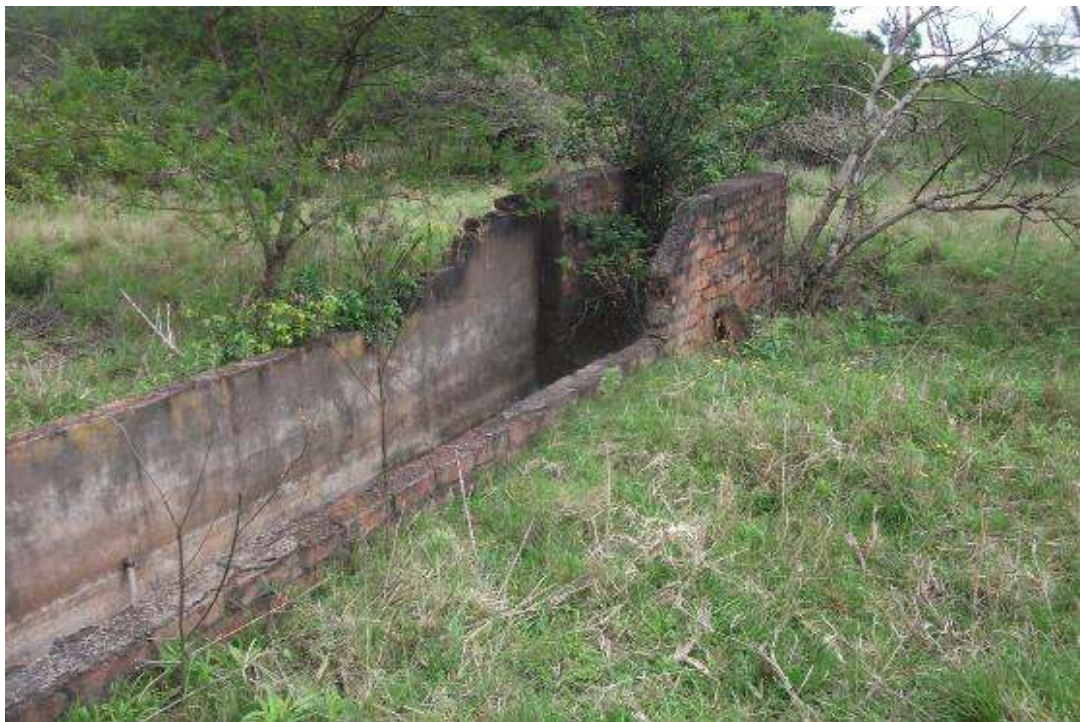
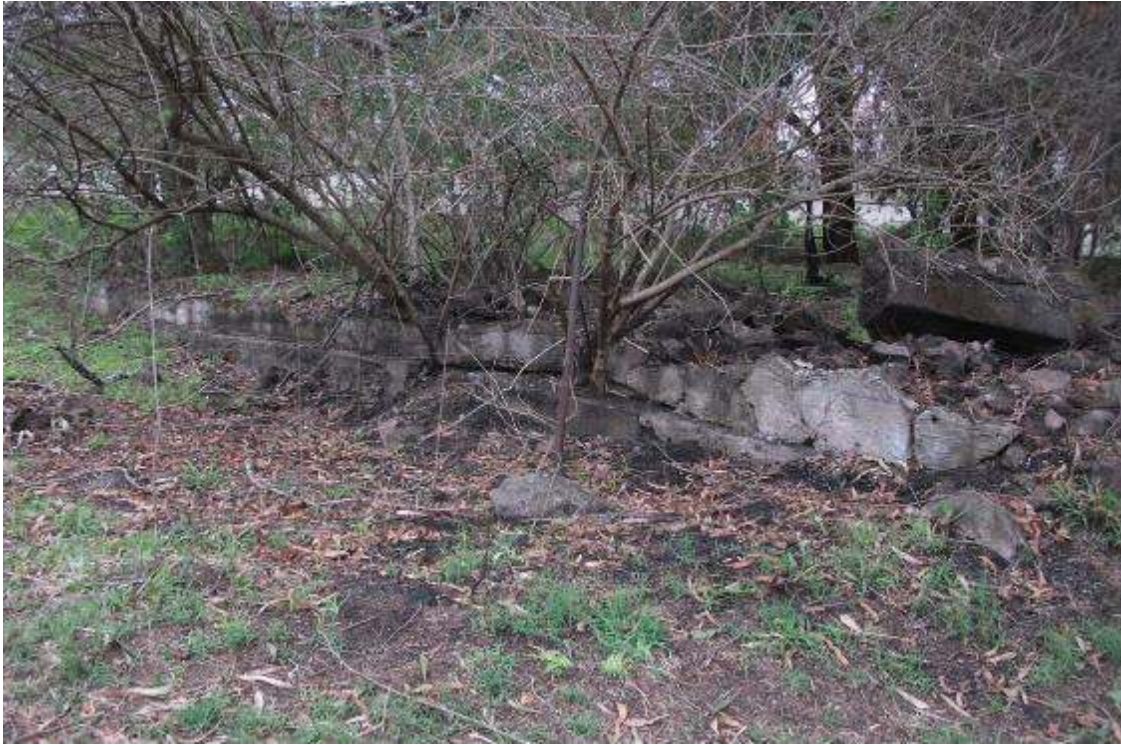
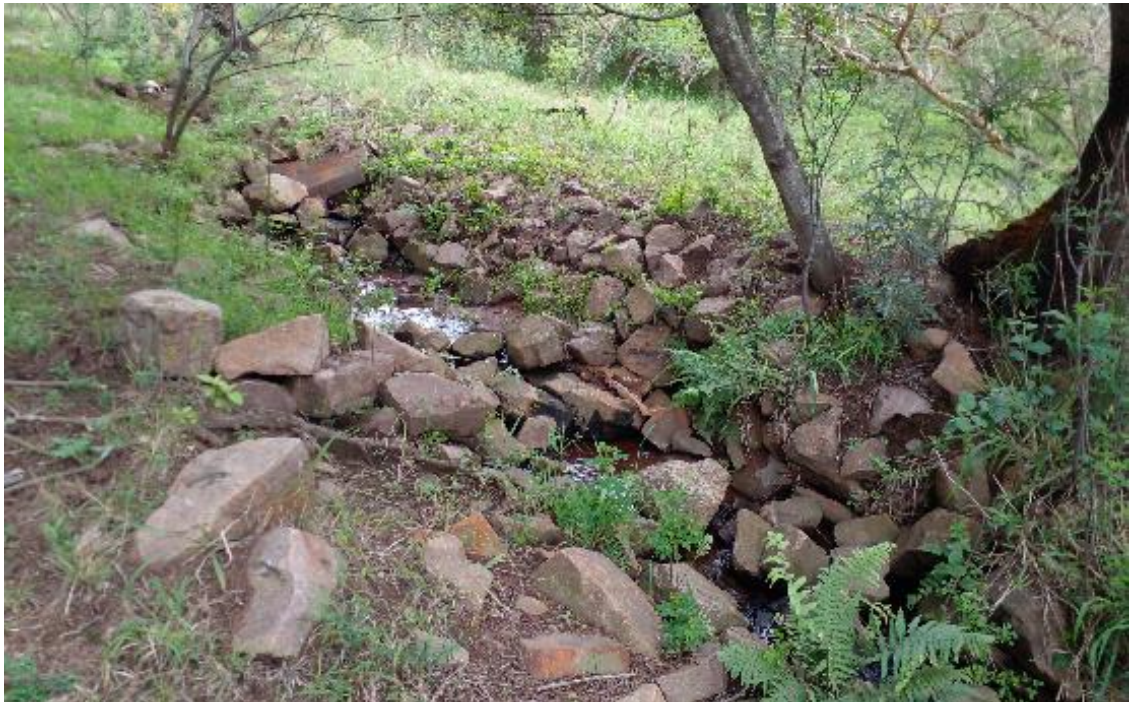
The area west of the railway line that falls within Proposed Development Area 2 (structures 2) were inspected on foot. The topography was steep in places. The remains of structures were found including an intact cattle dip and a stone-lined water canal. The specialist could not find earlier images than 1967 of this specific area hence the age of the structures could not be determined.

Figure 31: Cattle dip

Figure 32: Foundation of demolished structure

Figure 33: Water canal
