**PHASE 1 HERITAGE IMPACT ASSESSMENT:
CATO RIDGE DEVELOPMENT,
ETHEKWINI MUNICIPALITY, KWAZULU-NATAL**

November 2021

**FOR: Zutari (Pty) Ltd
Jeanne-Louise Wiese**

**AUTHOR: JLB Consulting
Jean Beater**

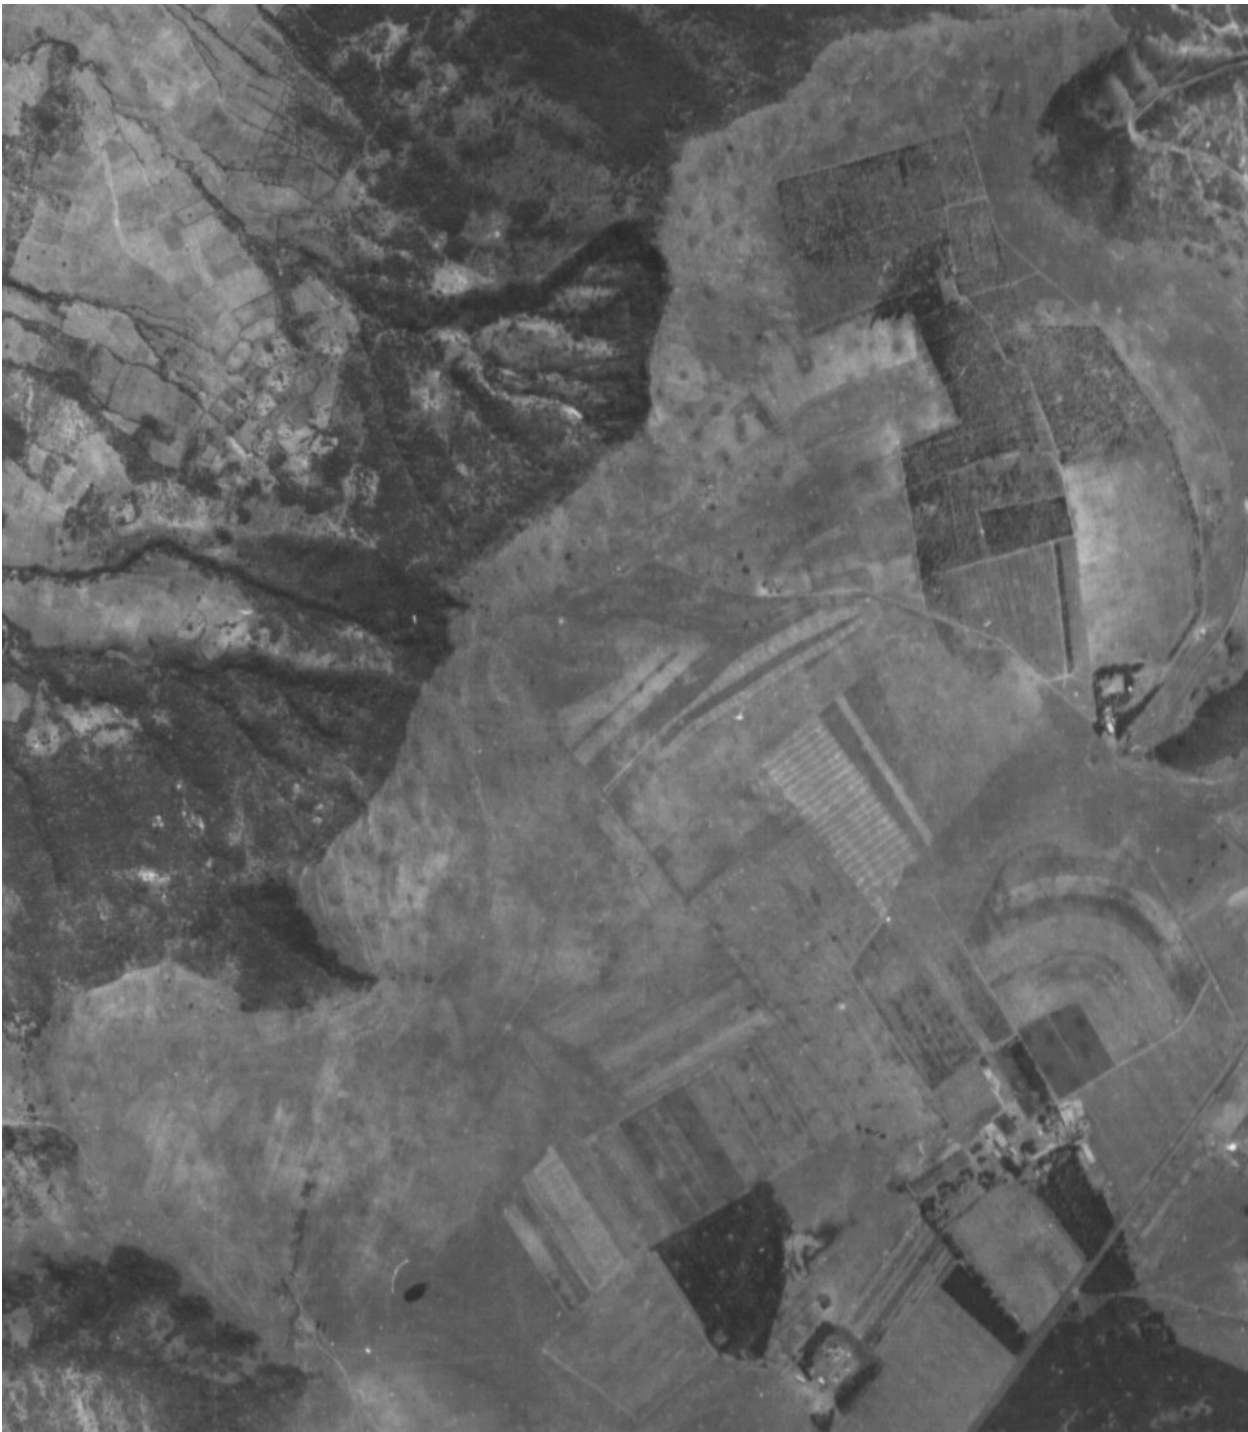
Figure 37: 1953 image of Proposed Development Area 3

The 1937 aerial photograph of Proposed Development Area 3 (**Figure 36**) shows several farmsteads as well as homesteads, the remains of a trading store and large areas under cultivation. The 1953 image (**Figure 37**) shows the same farmsteads, the trading store and more areas under cultivation. Homesteads are not visible apart from their outline. By 1973, the airstrip is visible on the aerial photograph and the buildings associated with farmstead 1 have almost completely disappeared.

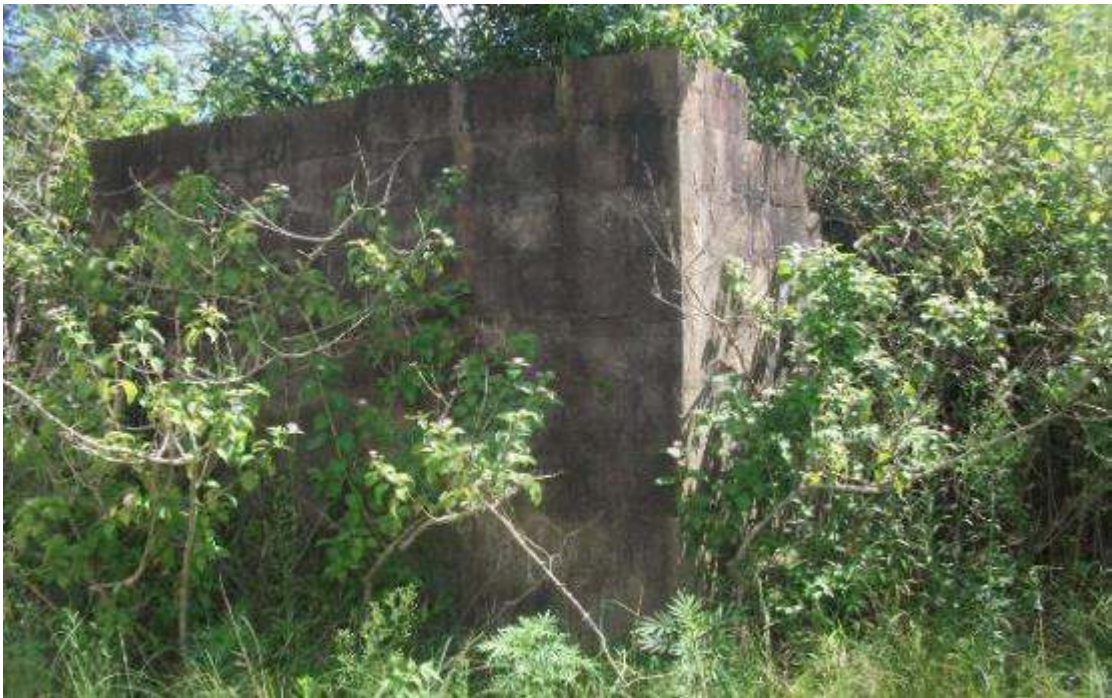
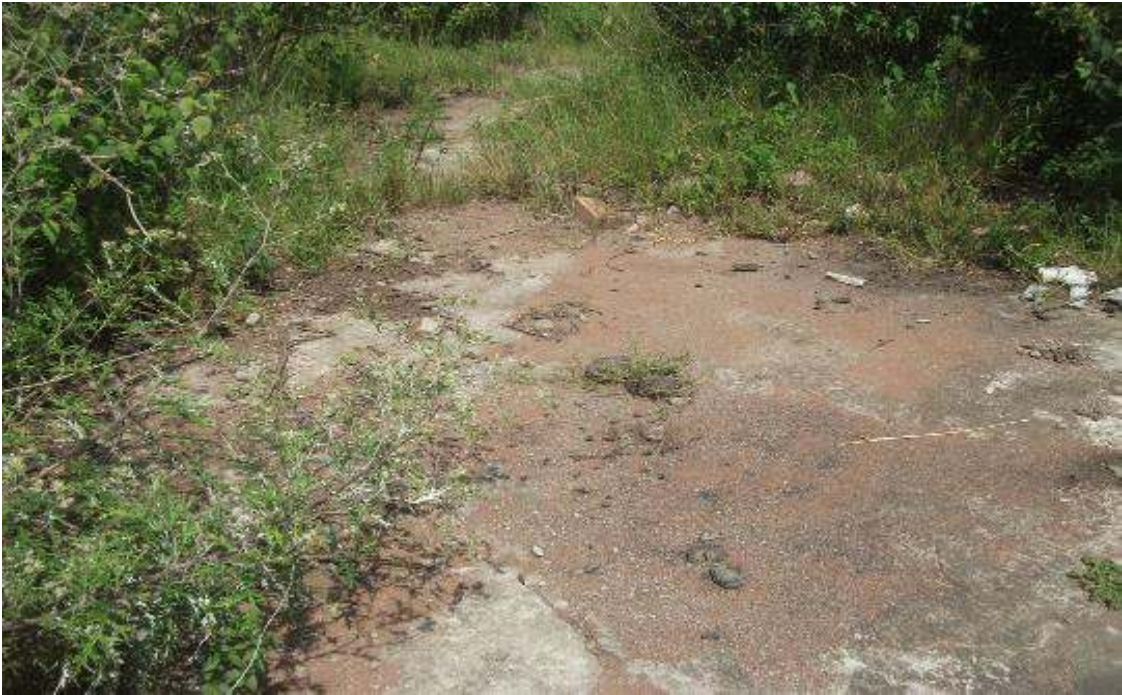
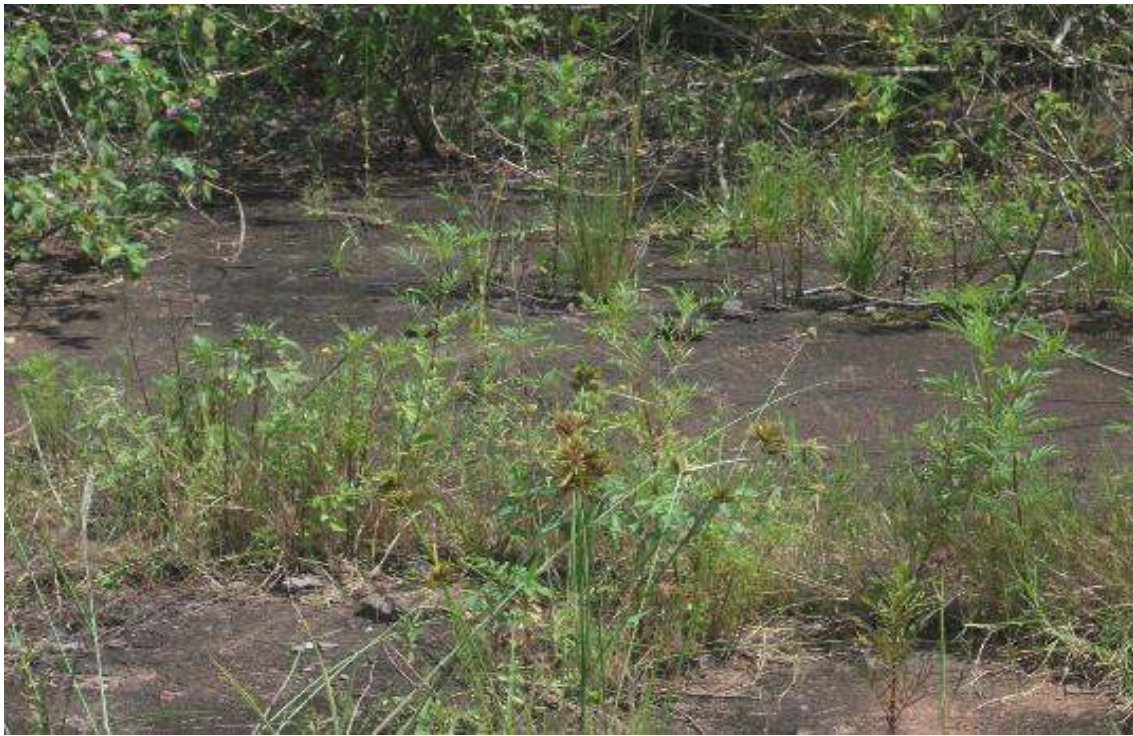
The site of farmstead 1 towards the bottom of **Figure 36** was inspected. Only the remains of a wall and the floors of the structures are still visible as well as the remains of a round concrete sunken structure (**Figures 38, 39 and 40**).

Figure 38: Remains of walls of structure

Figure 39: Concrete floor

Figure 40: Floor of round structure

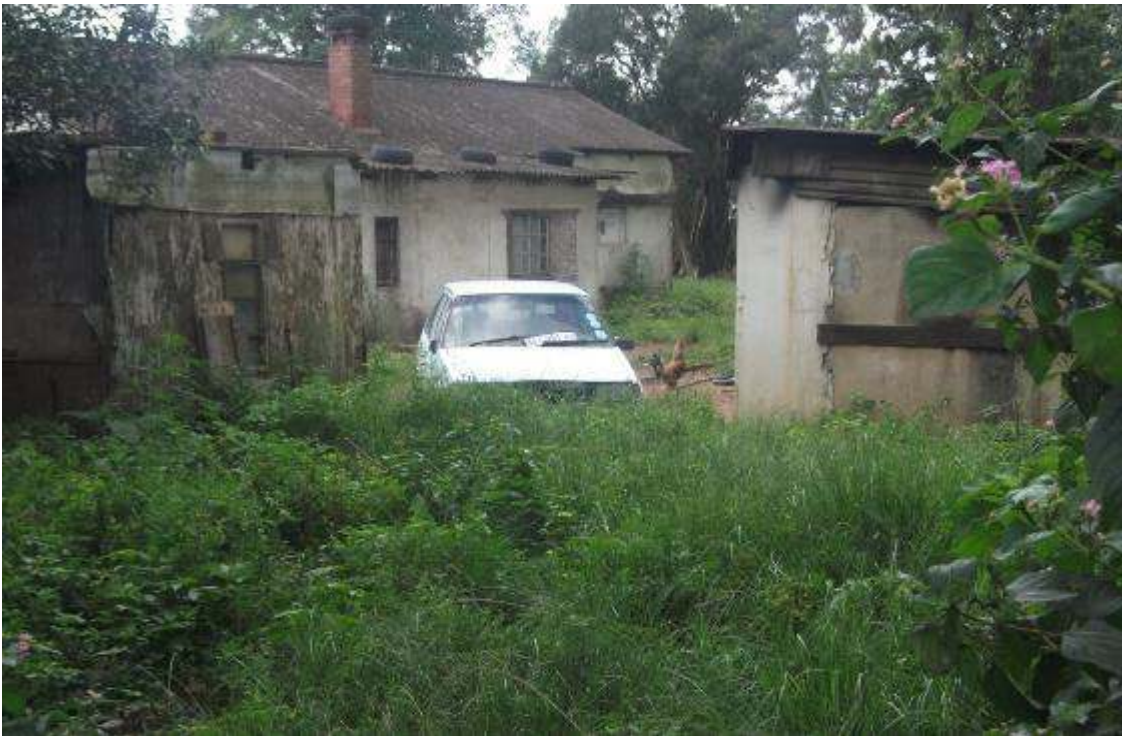
Several buildings making up farmstead 2 are still intact and inhabited whilst others have been reduced to rubble. The buildings, although inhabited, are in poor condition (**Figure 41**). Those living in the buildings were not at home during the time of the site inspection. According to a HIA report compiled in 2007 (eThembeni Cultural Heritage, 2007), at least three graves are associated with the buildings with the likelihood that more could be found. These graves were not visible during the site inspection due to the thick undergrowth.

Figure 41: Inhabited structure and associated buildings

There is one farmstead complex (farmstead 2) which has intact structures. The assessment of impacts indicated that the consequence of impacts pre-mitigation would be extremely detrimental and post-mitigation would be highly detrimental because the structures are inhabited and there are graves associated with structures. The significance rating, post-mitigation, is a minor negative rating due to the mitigation measures recommended.

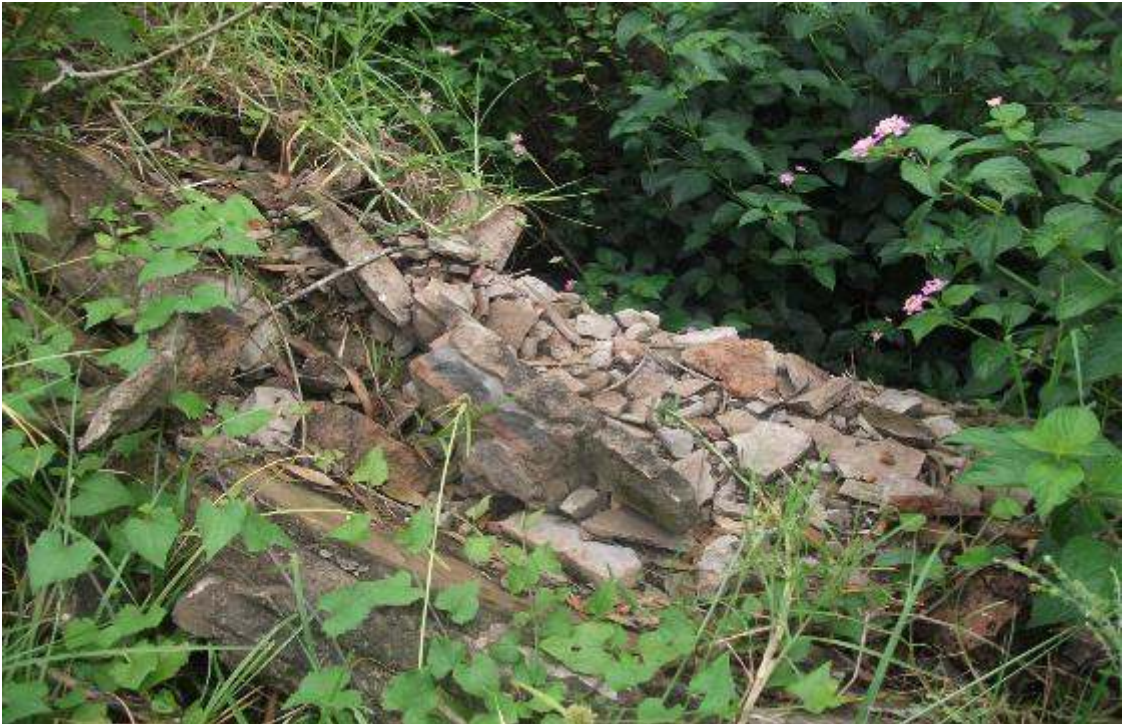
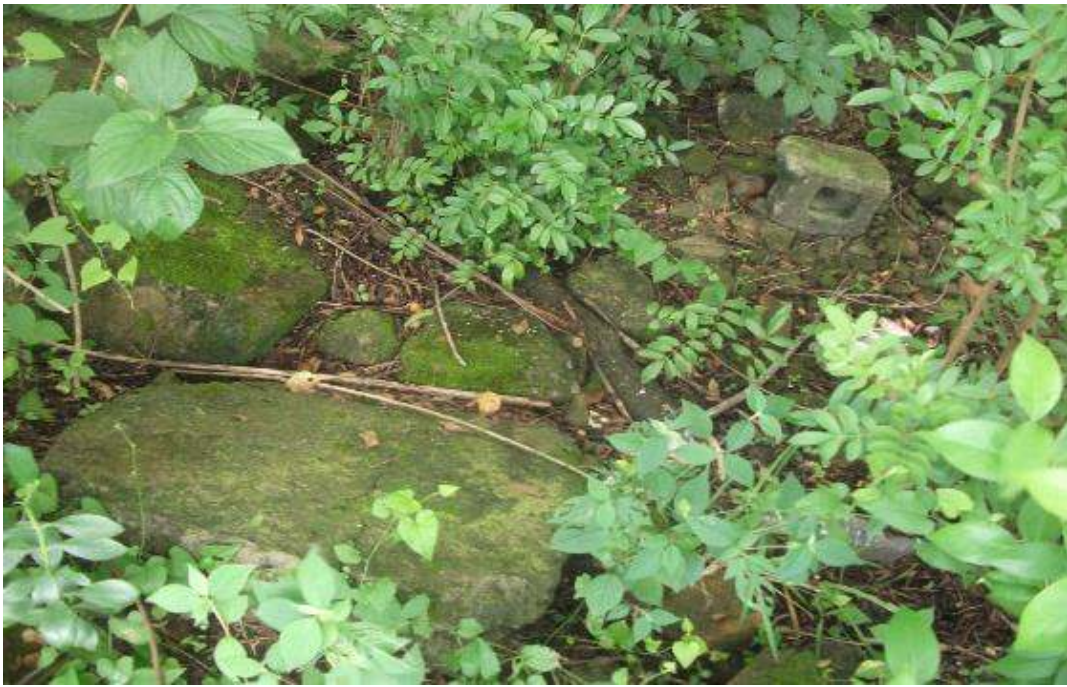
The remains of several structures were found close to the intact structures (**Figure 42** and **Figure 43**) which included a round silo or reservoir. The area is overgrown with vegetation but apart from the intact structures and possibility of graves mentioned above, no other heritage sites were found.

Figure 42: Remains of a reservoir

Figure 43: Remains of structure beneath larger tree

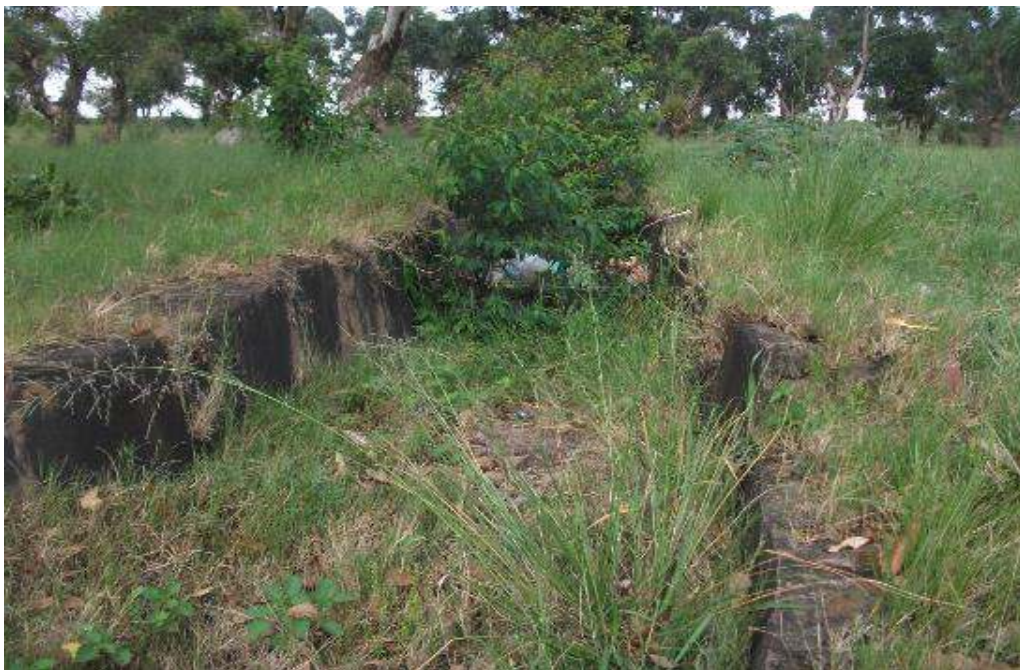
A cattle dip was discovered in the northern section of Proposed Development Area 3. It is filled with rubble and vegetation. According to the 2007 HIA report (eThembeni Cultural Heritage, 2007), a grave is located near the cattle dip. During the 2007 site inspection, no grave was found. During the 2021 inspection, the immediate and larger surrounding area was inspected but the grave could not be found. The area around the cattle dip and in the eucalyptus tree plantation has been extensively disturbed by sand mining activities which may have led to the destruction of the grave.

Figure 44: Unused cattle dip

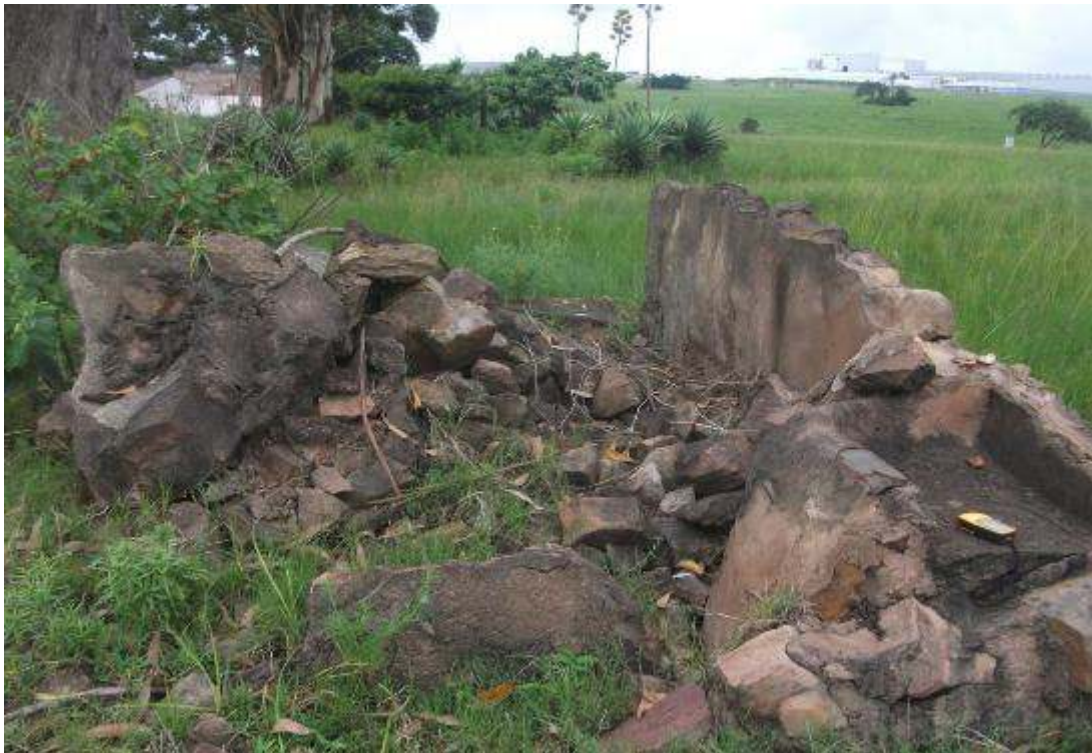
The ruins of two structures were found situated about 100m north-west of the trading store. These structures could be associated with the trading store and therefore likely to be over 60 years. Their use could not be established.

Figure 46: Remains of structure with trading store in background

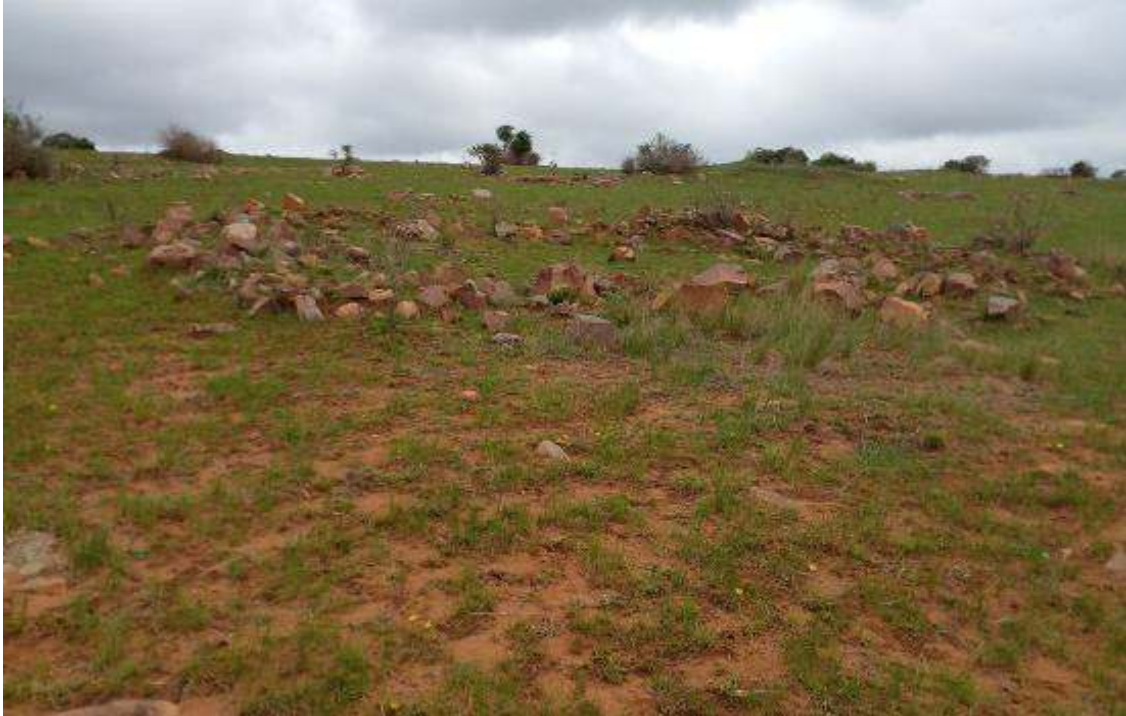
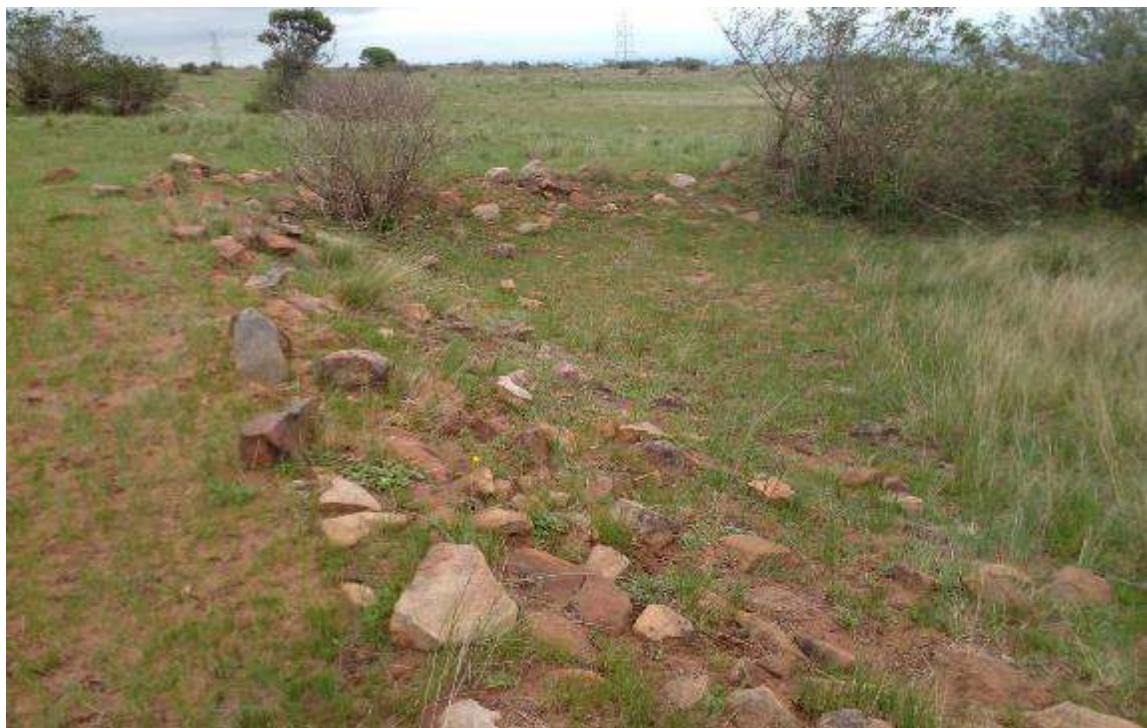
During the 2007 HIA study (eThembeni Cultural Heritage, 2007), four archaeological sites were found which were made up of three cattle byres/enclosures and the outline of foundations of two rectangular and two circular dwellings where there is possibly an unmarked grave. An inspection of these sites was also undertaken for this Phase 1 HIA. The sites were inspected for graves but no evidence could be found which could be due to 'wear and tear' over the years.

Figure 47: Cattle enclosure

Figure 48: Outline of rectangular structure

Circular stock byre, 3 – 4m in diameter	29°41'22.7" S 30°37'31.3" E	Low heritage significance; protected by section 40 (1)	Leave in-situ with a 15m buffer to avoid impacts; however, if necessary, the site may be altered or demolished with relevant permit from the Institute
Homestead foundation imprints of 2 rectangular & 2 circular dwellings. Former home of Gumede family with possible unmarked ancestral graves present (Figure 47)	29°41'26.1" S 30°37'18.0" E	High heritage significance because of possible presence of graves; protected by sections 39(1)(b) and 40(1)	Leave site in-situ; if development is to take place, then buffer of 30m around site where no construction activity may take place
