**Cultural Heritage Assessment for the Proposed Skoenmakers River
Rehabilitation and Bridge Restoration, Blue Crane Route Local
Municipality, Cacadu District Municipality, Eastern Cape**

Date:	September 2015
Version:	1 (Final Draft)

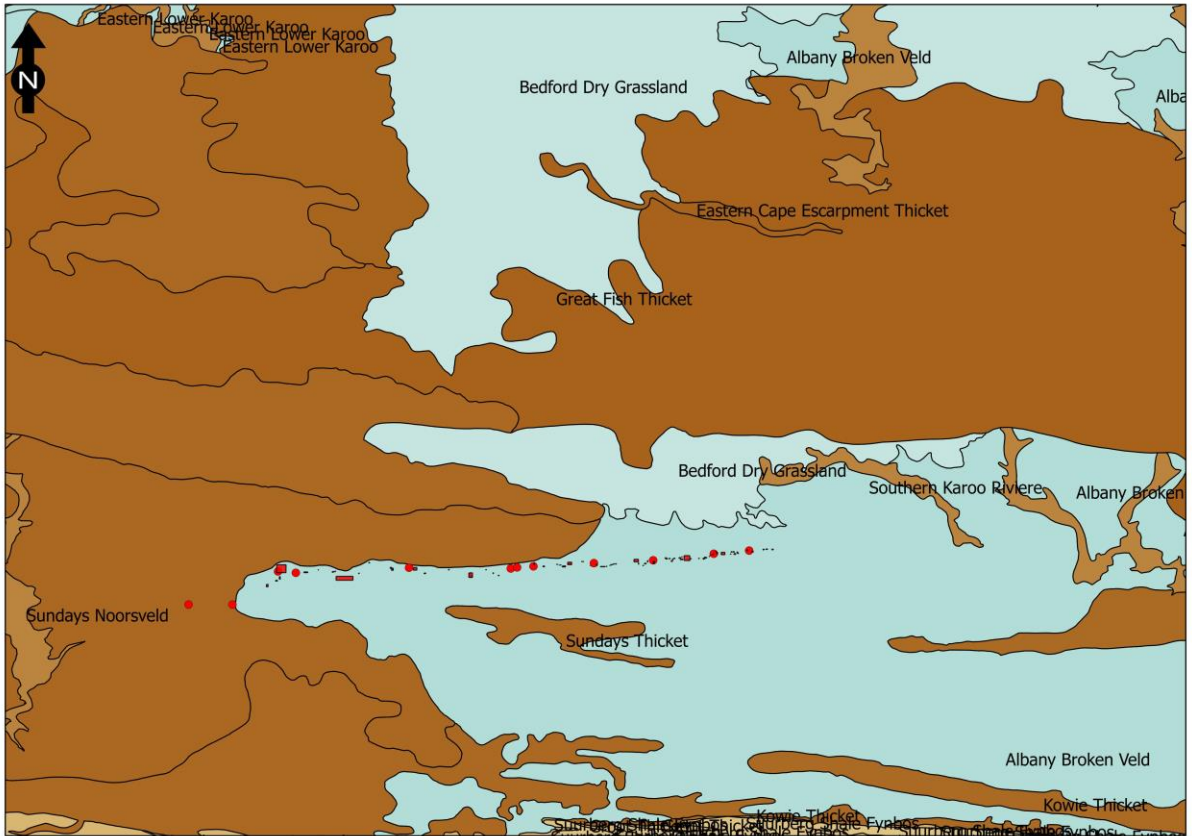
Figure 7: Erosion (rehabilitation) areas in the Skoenmakers River

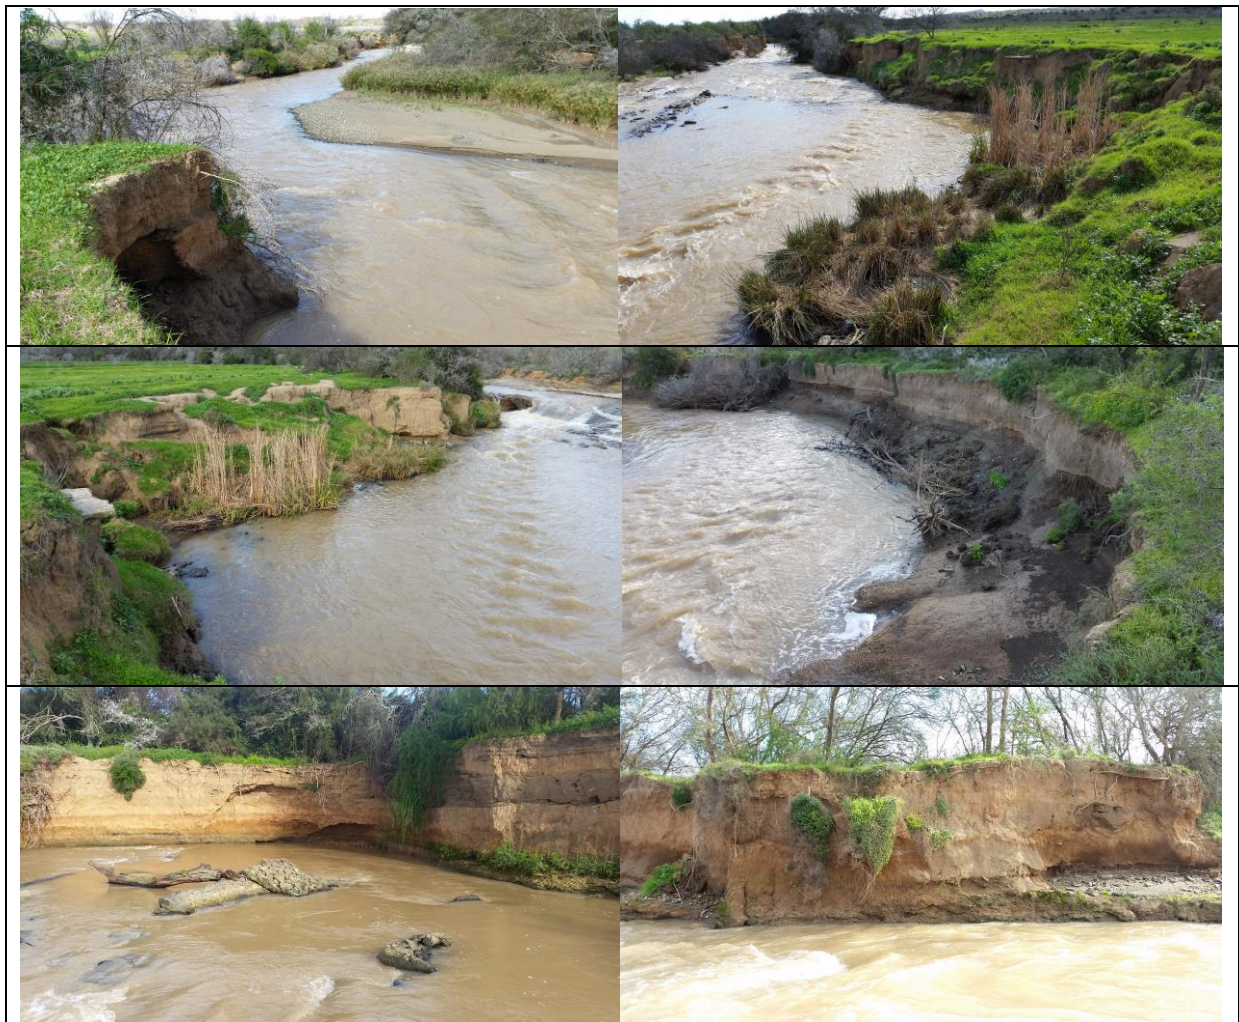
Over 100 sections of various sizes (ranging from under a hectare to a few hectares) have been identified for rehabilitation. Details relating to the earthworks required for the rehabilitation of the river banks are not yet available but will include construction and placement of measures to prevent further degradation of the river banks.

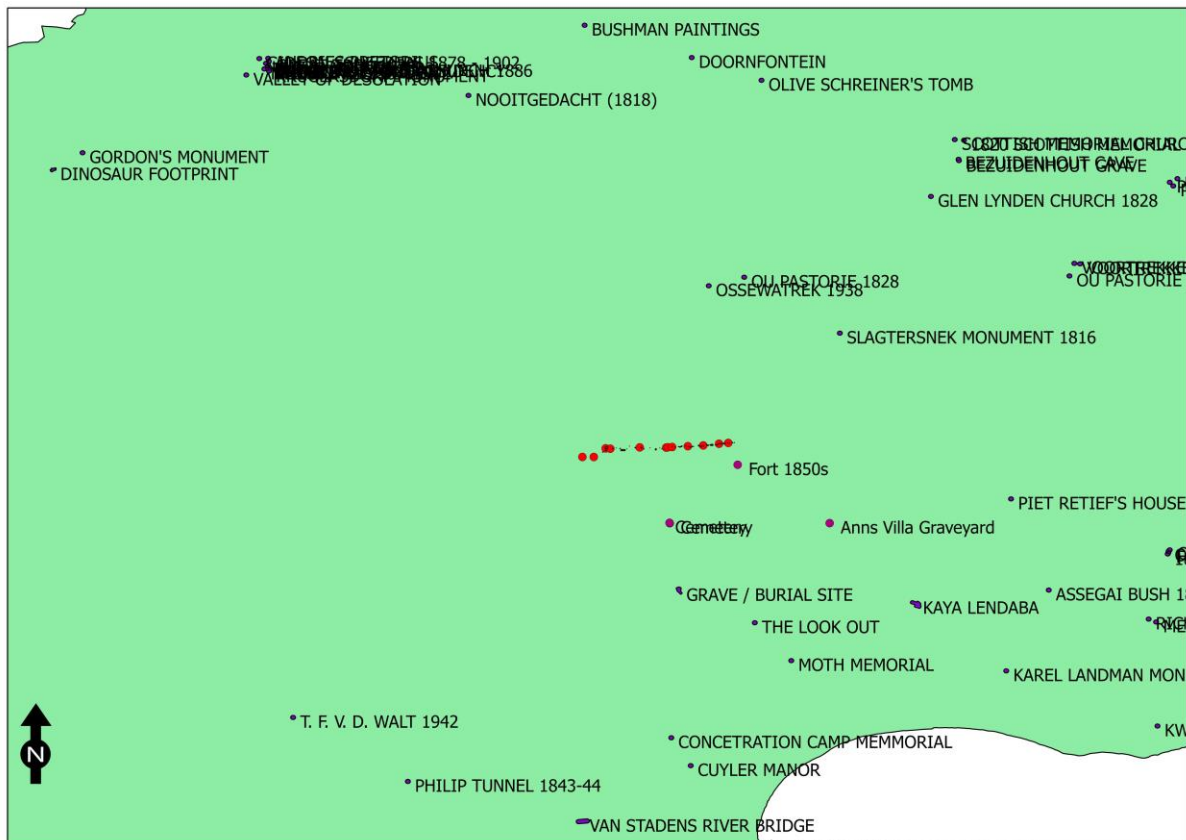
Figure 21: The locations of known cultural heritage sites in the region (Webley 2002, Bennie 2014 and various other sources)

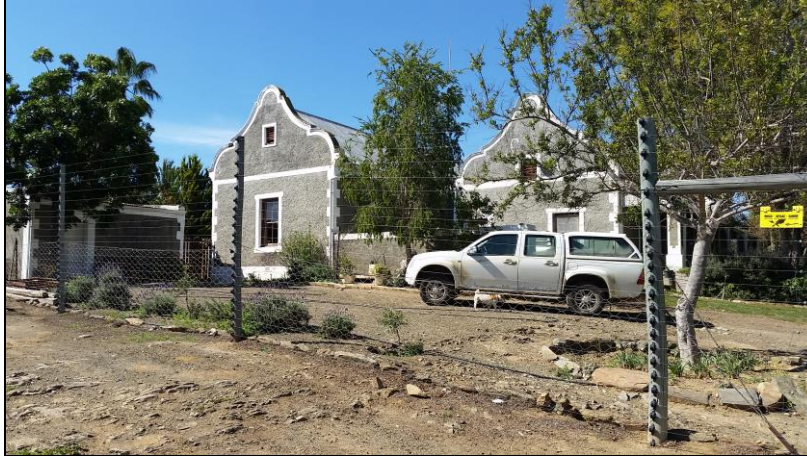
Figure 22: The farmhouse on the farm Geelhoutboom 247 was built in 1853 (later additions were also made to the farmhouse complex)

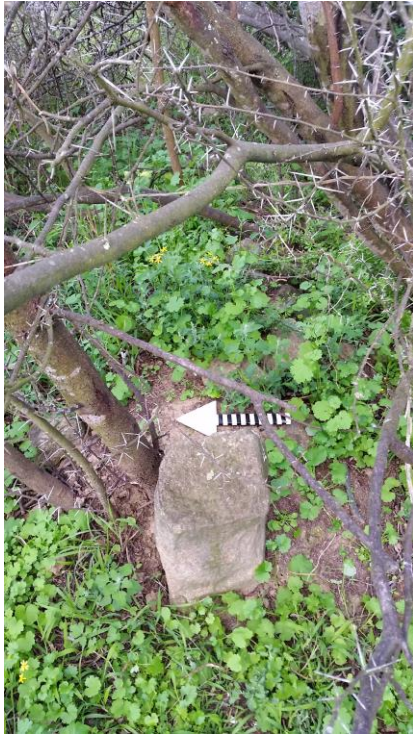
<p>Figure 28: General view of the headstone of the grave</p>

F. RATING OF POTENTIAL IMPACT OF DEVELOPMENT	
None	
Peripheral	√
Destruction	
Uncertain	
G. RECOMMENDED MITIGATION	
<ul style="list-style-type: none"> • The grave should be fenced off with an access gate installed • If the graves are to be exhumed and reburied it will entail a Phase 2 investigation with a social consultation process and the application of the required permits.

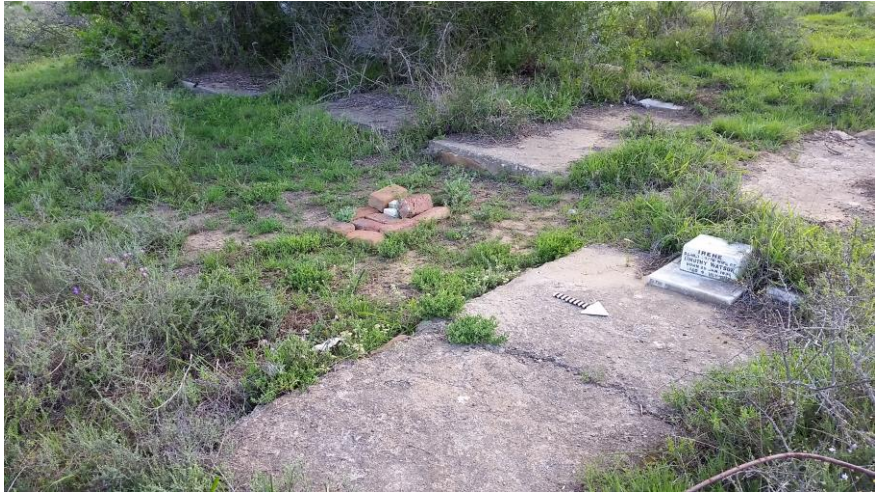
A. GENERAL SITE DESCRIPTION				
<p>The site comprises a family graveyard which consists of at least 7 graves of the Watson family. The graves have an east-west orientation with the headstones on the western side. All the graves are demarcated with cement bases and marble headstones (some of which were damaged). The following inscriptions could be recorded:</p> <ul style="list-style-type: none"> • Thomas Watson (Born: 16/09/1844; Died: 16/06/1924) • Richard Christopher Watson (Died: 2/12/1903 (23 years, 2 months and 14 days old) • Watson (Wife of T. Watson) (Born: 1/06/1853; Died: 23/06/1899) • Robert Albert Watson (?) • Irene Watson (Born: 29/01/1890; Died: 4/07/1918)

<p>Figure 29: General view of the graveyard</p>

E. GENERAL STATEMENT OF SITE SIGNIFICANCE	
Low	
Medium	
High	√
F. RATING OF POTENTIAL IMPACT OF DEVELOPMENT	
None	
Peripheral	
Destruction	
Uncertain	√
G. RECOMMENDED MITIGATION	
<ul style="list-style-type: none"> • The grave should be fenced off with an access gate installed • If the graves are to be exhumed and reburied it will entail a Phase 2 investigation with a social consultation process and the application of the required permits.

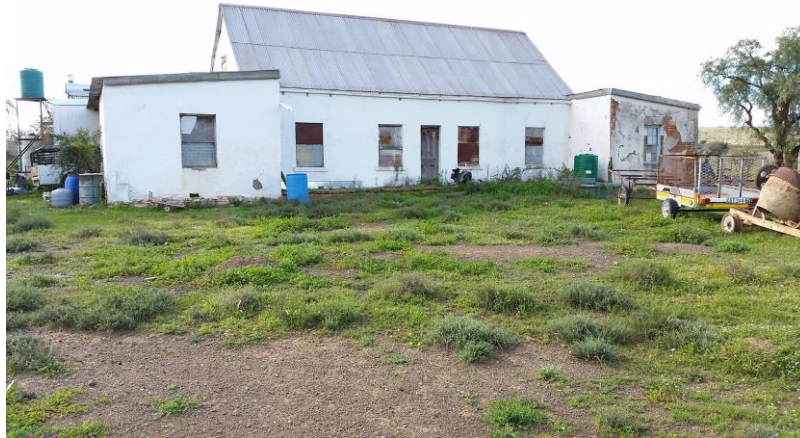
The site comprises a historic farmhouse complex that were probably built and later occupied by the Watson family in the 1800s. The house consists of multi-room stone and brick house with a corrugated iron roof. Several farm worker houses and other smaller structures were noted at the site. Several additions and changes have been made to the original house. The house has also been modernised with a solar geyser.

Figure 30: The farmhouse complex of the Watson family dating to the 1800s

G. RECOMMENDED MITIGATION			
<ul style="list-style-type: none"> The farmhouse is older than 60 years and therefore generally protected

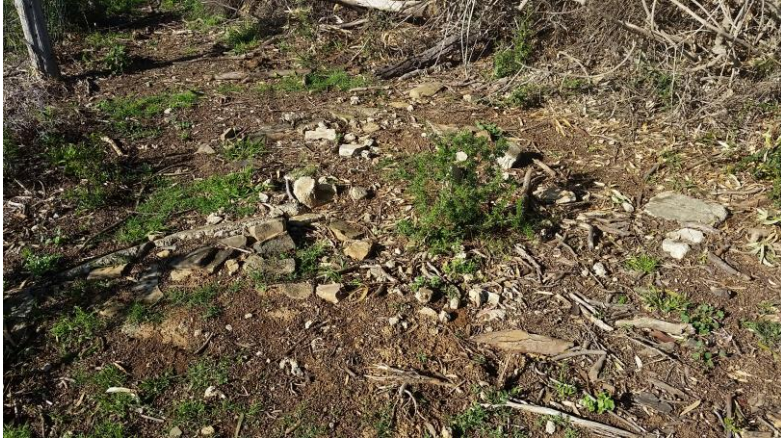
The site comprises a graveyard containing at least two graves demarcated by cements bases which have recently been extensively damaged. The graves are located near a cluster of Bluegum (*Eucalyptus sp.*) trees, adjacent to a

camp fence. It seems that both graves have an east-west orientation with the headstones on the western side. No recent grave offerings were noted. According to oral testimony the two graves were identified as a couple. The husband was known as Barn Bouer and his wife's name is unknown.

<p>Figure 31: The damaged remains of the two graves</p>

High	√
F. RATING OF POTENTIAL IMPACT OF DEVELOPMENT	
None	√
Peripheral	
Destruction	
Uncertain	
G. RECOMMENDED MITIGATION	
<ul style="list-style-type: none"> • The graves should be fenced off with an access gate installed • If the graves are to be exhumed and reburied it will entail a Phase 2 investigation with a social consultation process and the application of the required permits. 	
H. APPLICABLE LEGISLATION AND LEGAL REQUIREMENTS	
<ul style="list-style-type: none"> • National Heritage Resources Act (Act no. 25 of 1999) • Permit from SAHRA for exhumation and reburial • Human Tissue Act (Act 65 of 1983 as amended). • Removal of Graves and Dead Bodies Ordinance (Ordinance no. 7 of 1925) • Ordinance on Excavations (Ordinance no. 12 of 1980) • Local and provincial provisions, laws and by-laws 	
I. PHOTOGRAPH

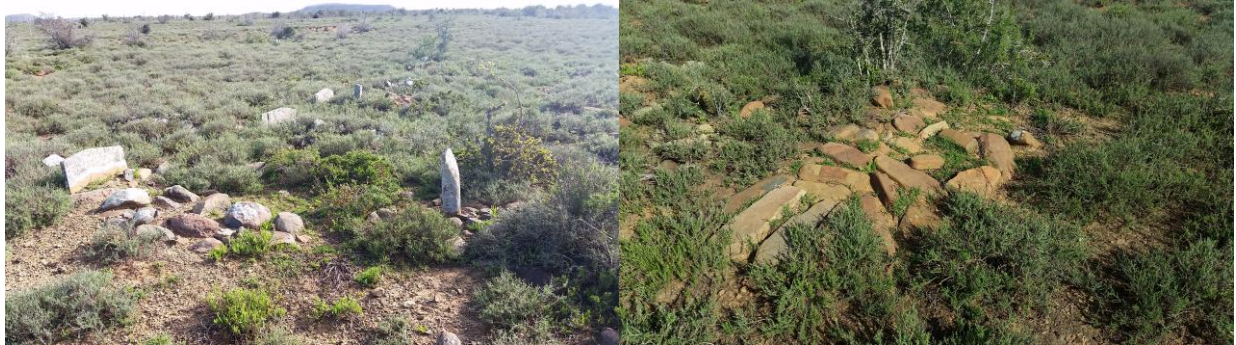
A. GENERAL SITE DESCRIPTION		
<p>The site comprises a graveyard containing at least 22 graves demarcated by semi-circular stone bases. The graves are located on the north end of an agricultural field. It seems that all the graves have an east-west orientation with the headstones on the western side. No recent grave offerings were noted. Oral testimony indicates that the graveyard is associated with the Latolla family.</p> <p>However, the graves are without inscriptions which imply they are, by default, regarded as older than 60 years and therefore fall under the protection of the NHRA (Act no 25 of 1999).</p>

Figure 32: Stone bases were constructed to demarcate the graves

G. RECOMMENDED MITIGATION		
<ul style="list-style-type: none"> The graves should be fenced off with an access gate installed If the graves are to be exhumed and reburied it will entail a Phase 2 investigation with a social consultation process and the application of the required permits.

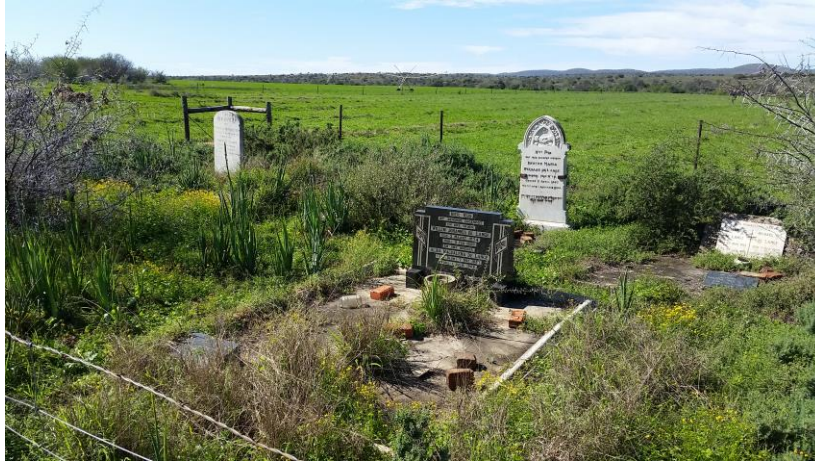
The site comprises a fenced graveyard containing at least 10 graves demarcated by cements bases and marble and granite headstones. It seems that all the graves have a north-south orientation with the headstones on the southern side. This is very unusual and it might be linked to religious beliefs and practices. No recent grave offerings were noted. The following inscriptions were noted:

Figure 33: The fenced family graveyard

G. RECOMMENDED MITIGATION			
<ul style="list-style-type: none"> No impact is foreseen at the graveyard If the graves are to be exhumed and reburied it will entail a Phase 2 investigation with a social consultation process and the application of the required permits.

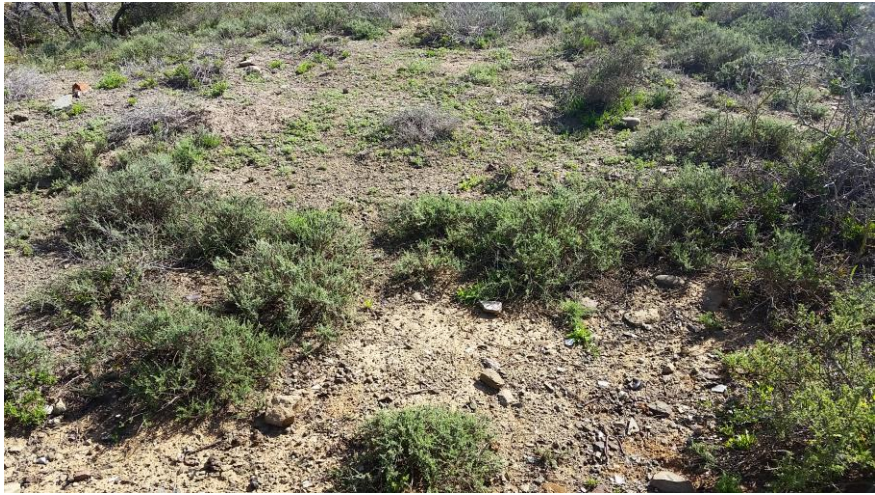
Other similar sites in the regional landscape.		√	
B3. CONDITION OF SITE			
Integrity of deposits/structures.		Stable, but exposed	
C. SPHERE OF SIGNIFICANCE	High	Medium	Low
International			√
National			√
Provincial			√
Local		√	
Specific community		√

<p>Figure 34: An extensive historical midden with large quantities of broken glass and ceramics on the surface</p>

G. RECOMMENDED MITIGATION			
<ul style="list-style-type: none"> No impact is foreseen on the midden 			
H. APPLICABLE LEGISLATION AND LEGAL REQUIREMENTS			
<ul style="list-style-type: none"> National Heritage Resources Act (Act no. 25 of 1999, Section 34)

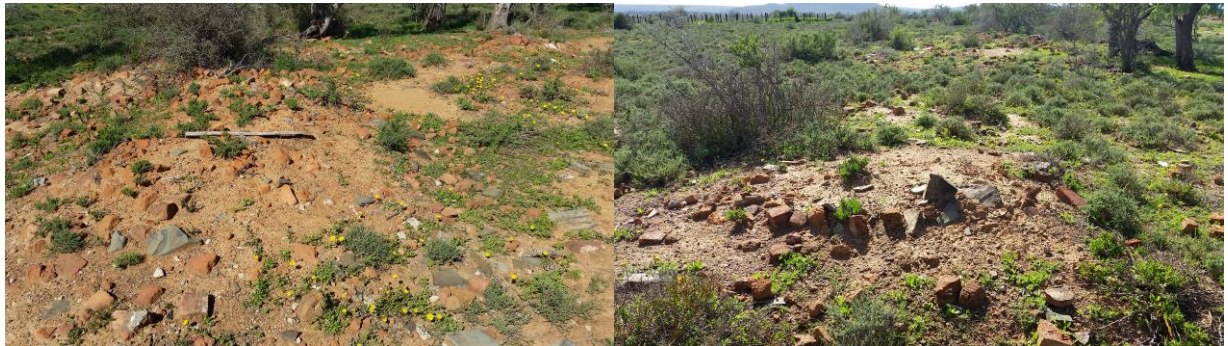
A. GENERAL SITE DESCRIPTION				
This site comprises the previous Middlewater Police Station which consists mainly of the foundations of the structures. The dressed stone foundations and sun-baked bricks can still be seen on the surface. At least two multi-room structures could be identified. According to oral testimony of Rocco Gouws the station was probably operational in the mid-1800s. A primary midden (Site 8) and a secondary midden to the east of the site were identified in association with the main structures.

<p>Figure 35: The stone foundations and bricks of the old the Police Station</p>

E. GENERAL STATEMENT OF SITE SIGNIFICANCE	
Low	
Medium	√
High	
F. RATING OF POTENTIAL IMPACT OF DEVELOPMENT	
None	√
Peripheral	
Destruction	
Uncertain	
G. RECOMMENDED MITIGATION	
<ul style="list-style-type: none"> No impact is foreseen at the site 	
H. APPLICABLE LEGISLATION AND LEGAL REQUIREMENTS	
<ul style="list-style-type: none"> National Heritage Resources Act (Act no. 25 of 1999, Section 34) 	
I. PHOTOGRAPH

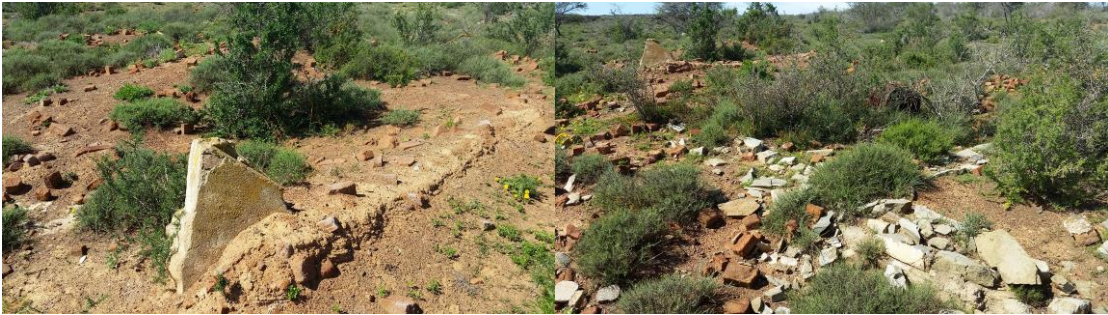
A. GENERAL SITE DESCRIPTION		
<p>This site comprises the foundations of a farmhouse complex. The main structure was a multi-room stone and brick house, probably with a corrugated iron roof. The house has however completely collapsed and all the door and window frames and other wooden or steel fittings have been removed. An extensive midden was also recorded to the east of the main house remains. Pieces of glass, ceramics, metal, bone and even complete bottles were noted. The farmhouse probably dates to the mid-1800s.</p>

Figure 36: Foundations of the dilapidated multi-room farmhouse

G. RECOMMENDED MITIGATION			
<ul style="list-style-type: none"> No impact is foreseen at the site 			
H. APPLICABLE LEGISLATION AND LEGAL REQUIREMENTS			
<ul style="list-style-type: none"> National Heritage Resources Act (Act no. 25 of 1999, Section 34)

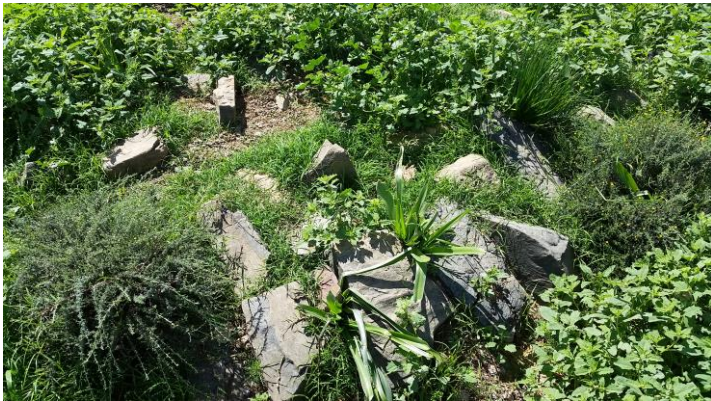
A. GENERAL SITE DESCRIPTION				
The site comprises a fenced graveyard containing at least 50 graves demarcated by stone bases. It seems that all the graves have an east-west orientation with the headstones on the western side. No grave offerings were noted.				
However, the graves are without inscriptions which mean they are, by default, regarded as older than 60 years and therefore fall under the protection of the NHRA (Act no 25 of 1999).

<p>Figure 37: Stone base demarcating a grave</p>

F. RATING OF POTENTIAL IMPACT OF DEVELOPMENT	
None	√
Peripheral	
Destruction	
Uncertain	
G. RECOMMENDED MITIGATION	
<ul style="list-style-type: none"> No impact is foreseen at the graveyard If the graves are to be exhumed and reburied it will entail a Phase 2 investigation with a social consultation process and the application of the required permits.

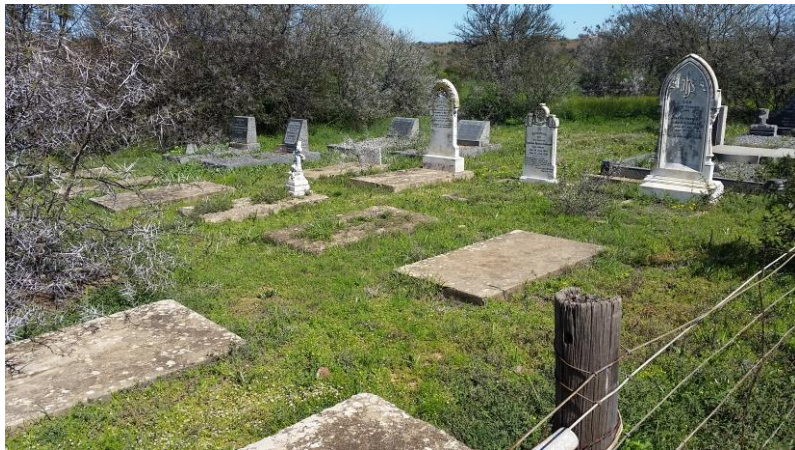
The site comprises a fenced graveyard containing at least 27 graves demarcated by cement bases and marble headstones. It seems that all the graves have an east-west orientation with the headstones on the western side. No grave offerings were noted. The following inscriptions were noted:

<p>Figure 38: The family graveyard is fenced</p>

Peripheral	
Destruction	
Uncertain	
G. RECOMMENDED MITIGATION	
<ul style="list-style-type: none"> No impact is foreseen at the graveyard If the graves are to be exhumed and reburied it will entail a Phase 2 investigation with a social consultation process and the application of the required permits. 	
H. APPLICABLE LEGISLATION AND LEGAL REQUIREMENTS	
<ul style="list-style-type: none"> National Heritage Resources Act (Act no. 25 of 1999) Permit from SAHRA for exhumation and reburial Human Tissue Act (Act 65 of 1983 as amended). Removal of Graves and Dead Bodies Ordinance (Ordinance no. 7 of 1925) Ordinance on Excavations (Ordinance no. 12 of 1980) Local and provincial provisions, laws and by-laws 	
I. PHOTOGRAPH

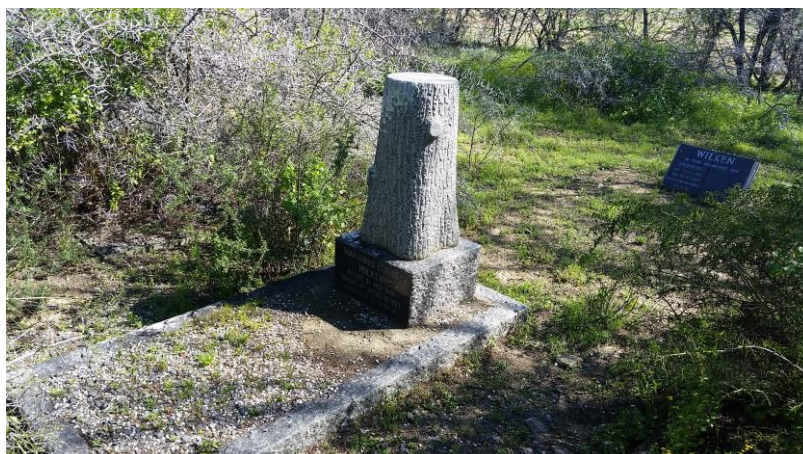
A. GENERAL SITE DESCRIPTION		
<p>The site comprises a fenced graveyard containing at least 12 graves demarcated by cement and granite bases and granite headstones. Several graves only have bases with rocks. It seems that all the graves have an east-west orientation with the headstones on the western side. No grave offerings were noted. The following inscriptions were noted:</p> <ul style="list-style-type: none"> Herwin Wilken (Born: 7/04/1926; Died: 19/11/1987) Marthinus Esaias Wilken (Born: 9/05/1892; Died: 4/08/1957) ? Stuart (Born: 20/02/1915; Died: 26/10/1960) <p>However, some graves are without inscriptions which mean they are, by default, regarded as older than 60 years and therefore fall under the protection of the NHRA (Act no 25 of 1999).</p>

Figure 39: Some of the graves are demarcated by granite bases and headstones

G. RECOMMENDED MITIGATION			
<ul style="list-style-type: none"> No impact is foreseen at the graveyard If the graves are to be exhumed and reburied it will entail a Phase 2 investigation with a social consultation process and the application of the required permits.

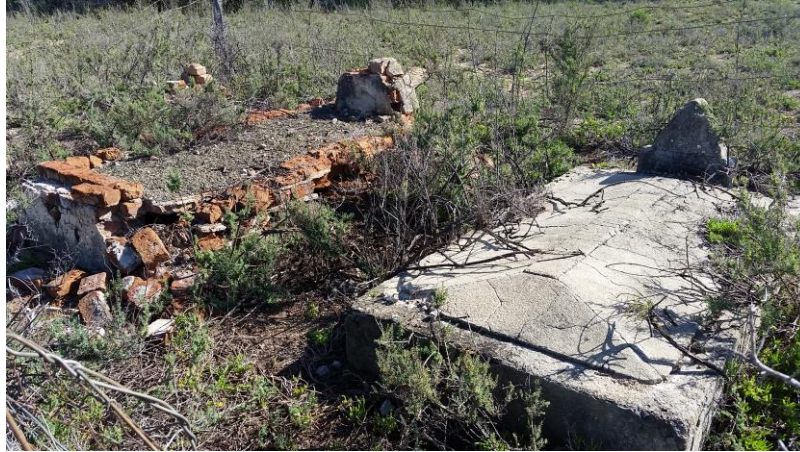
Figure 40: Graves demarcated by brick and cement bases

G. RECOMMENDED MITIGATION			
<ul style="list-style-type: none"> No impact is foreseen at the graveyard If the graves are to be exhumed and reburied it will entail a Phase 2 investigation with a social consultation process and the application of the required permits.
