## 7.4 ENVIRONMENTAL BASE LINE – TYPE OF ENVIRONMENT AFFECTED

***Socio-Economic Impact Assessment Report for the HERNIC Ferrochrome Plant, Morula Operations, January 2017. An Kritzinger (Economic Specialist) and Johan Oosthuizen (Social Specialist).*** The Report addresses both Socio-Cultural and Socio-Economic Aspects and is attached as **APPENDIX 7(B)**.

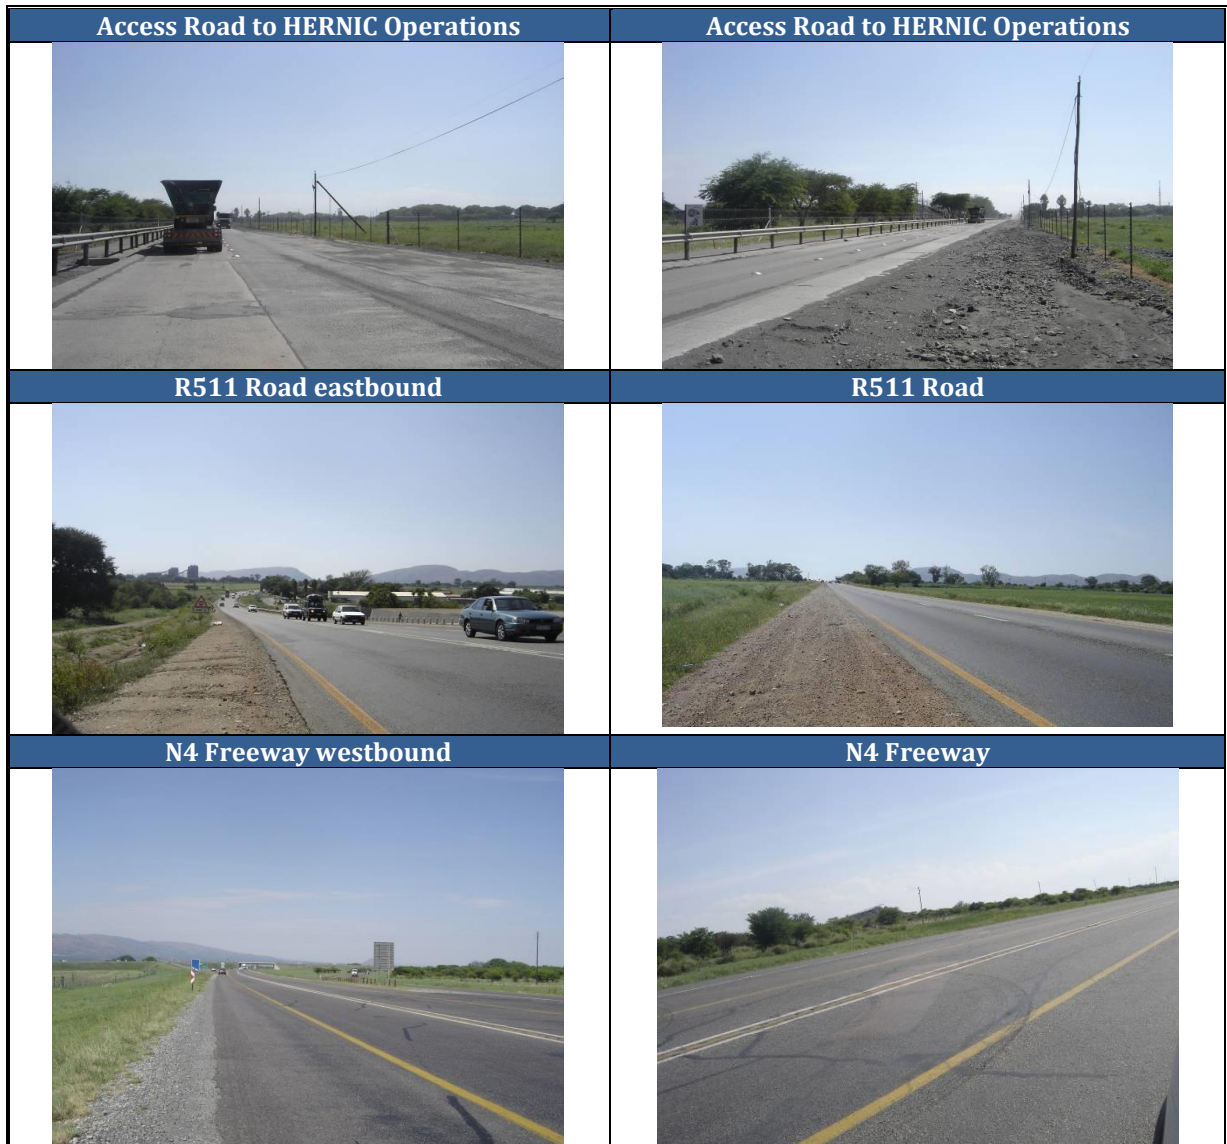
**Figure 7.4.5(b): Photo Collage of Main Access Roads showing current Road Condition**

Both these main access roads (R 511 and R 566) are in acceptable condition with minor maintenance requirements.

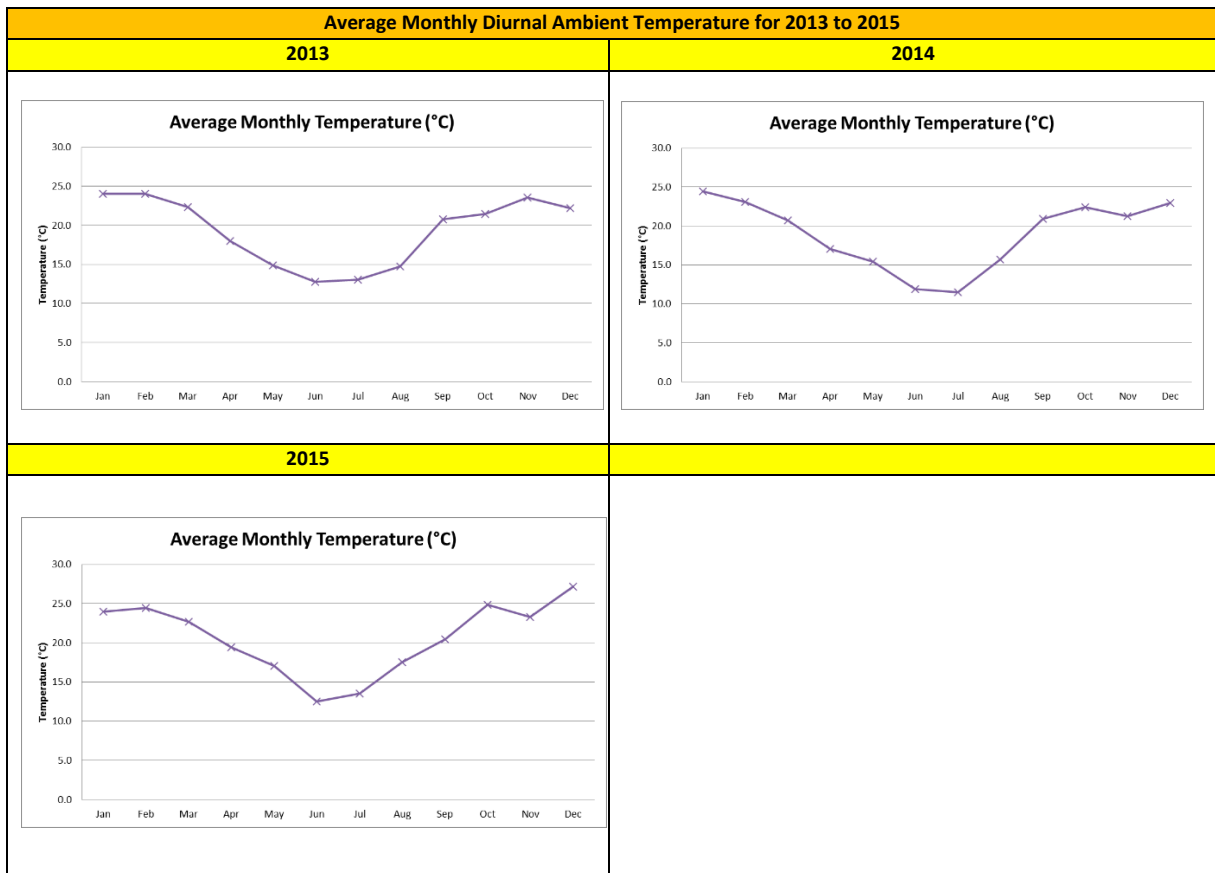
Figure 7.4.8.1(a): Average Monthly Diurnal Ambient Temperature for 2013 to 2015

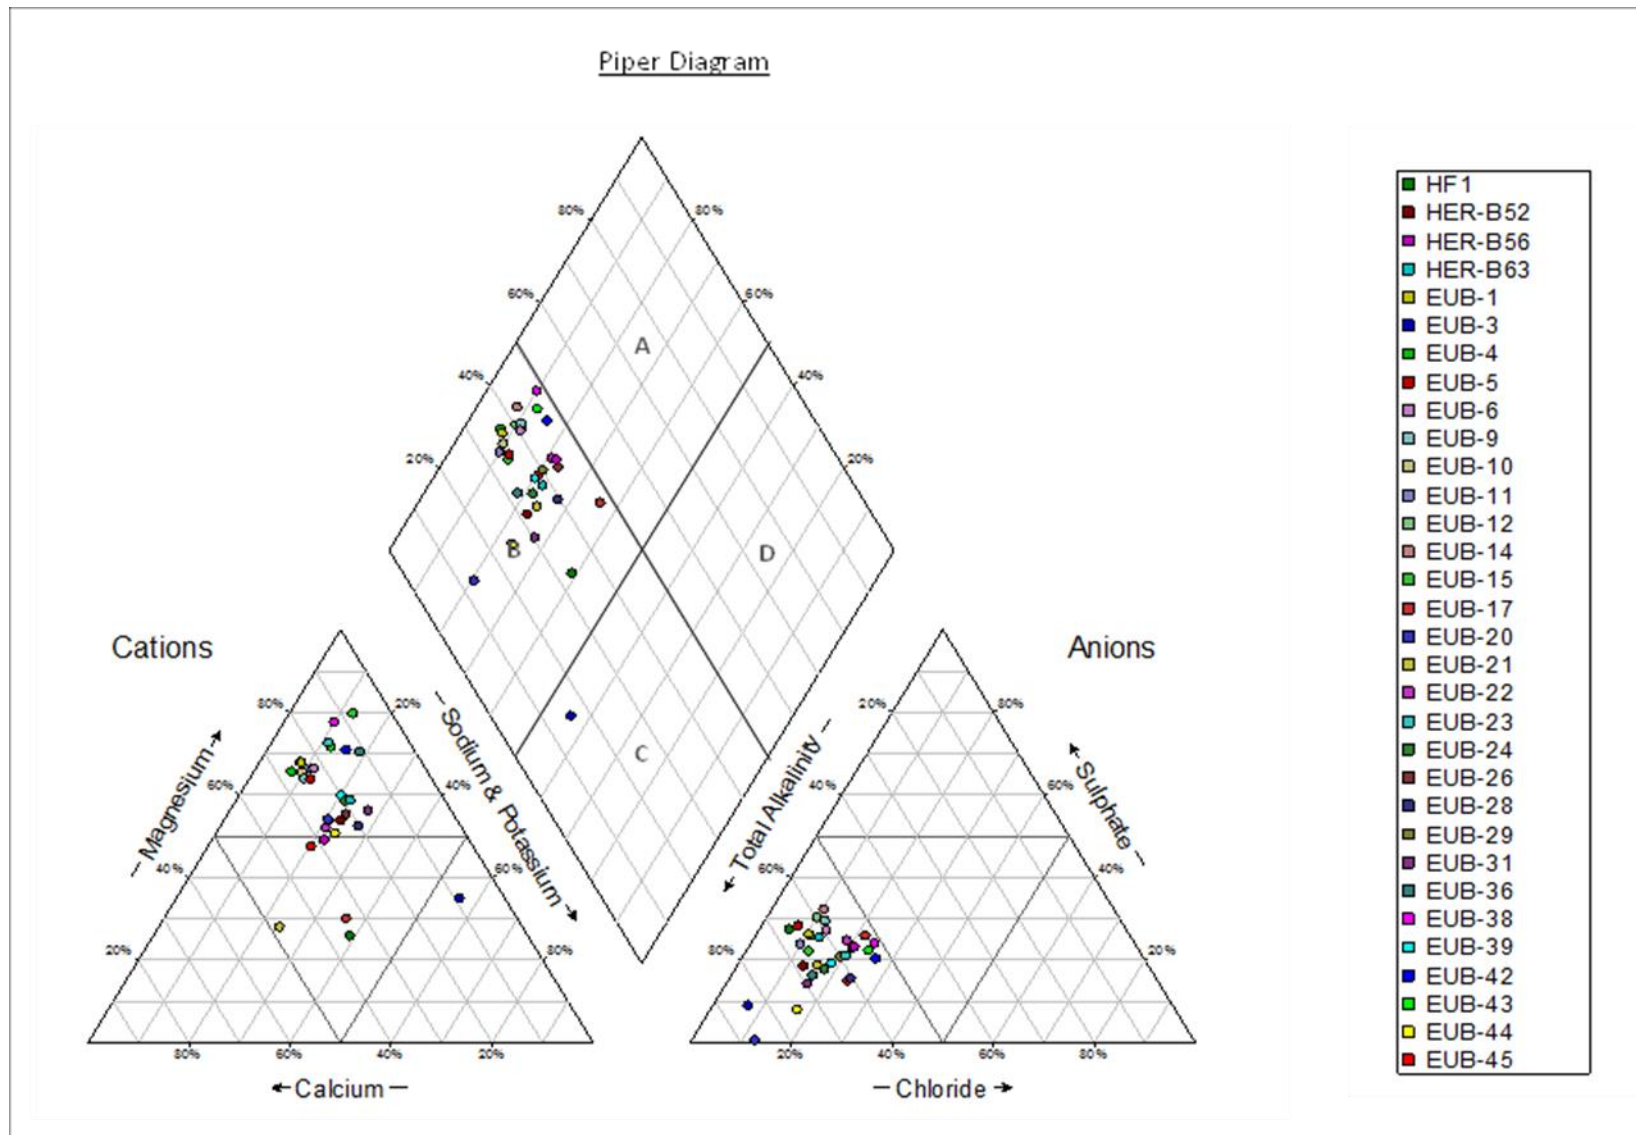
**Figure 7.4.12.3(j): Background Groundwater Quality - Piper Diagram**

The groundwater sampled from borehole EUB-3 has more Na<sup>+</sup> & K<sup>+</sup> and less Ca<sup>2+</sup> and Mg<sup>2+</sup> equivalent cations, with almost no Cl<sup>-</sup>(12%) than the rest of the background groundwater samples. The groundwater sample collected from borehole EUB-3 is subsequently classified as having a Type-C hydrochemical signature.

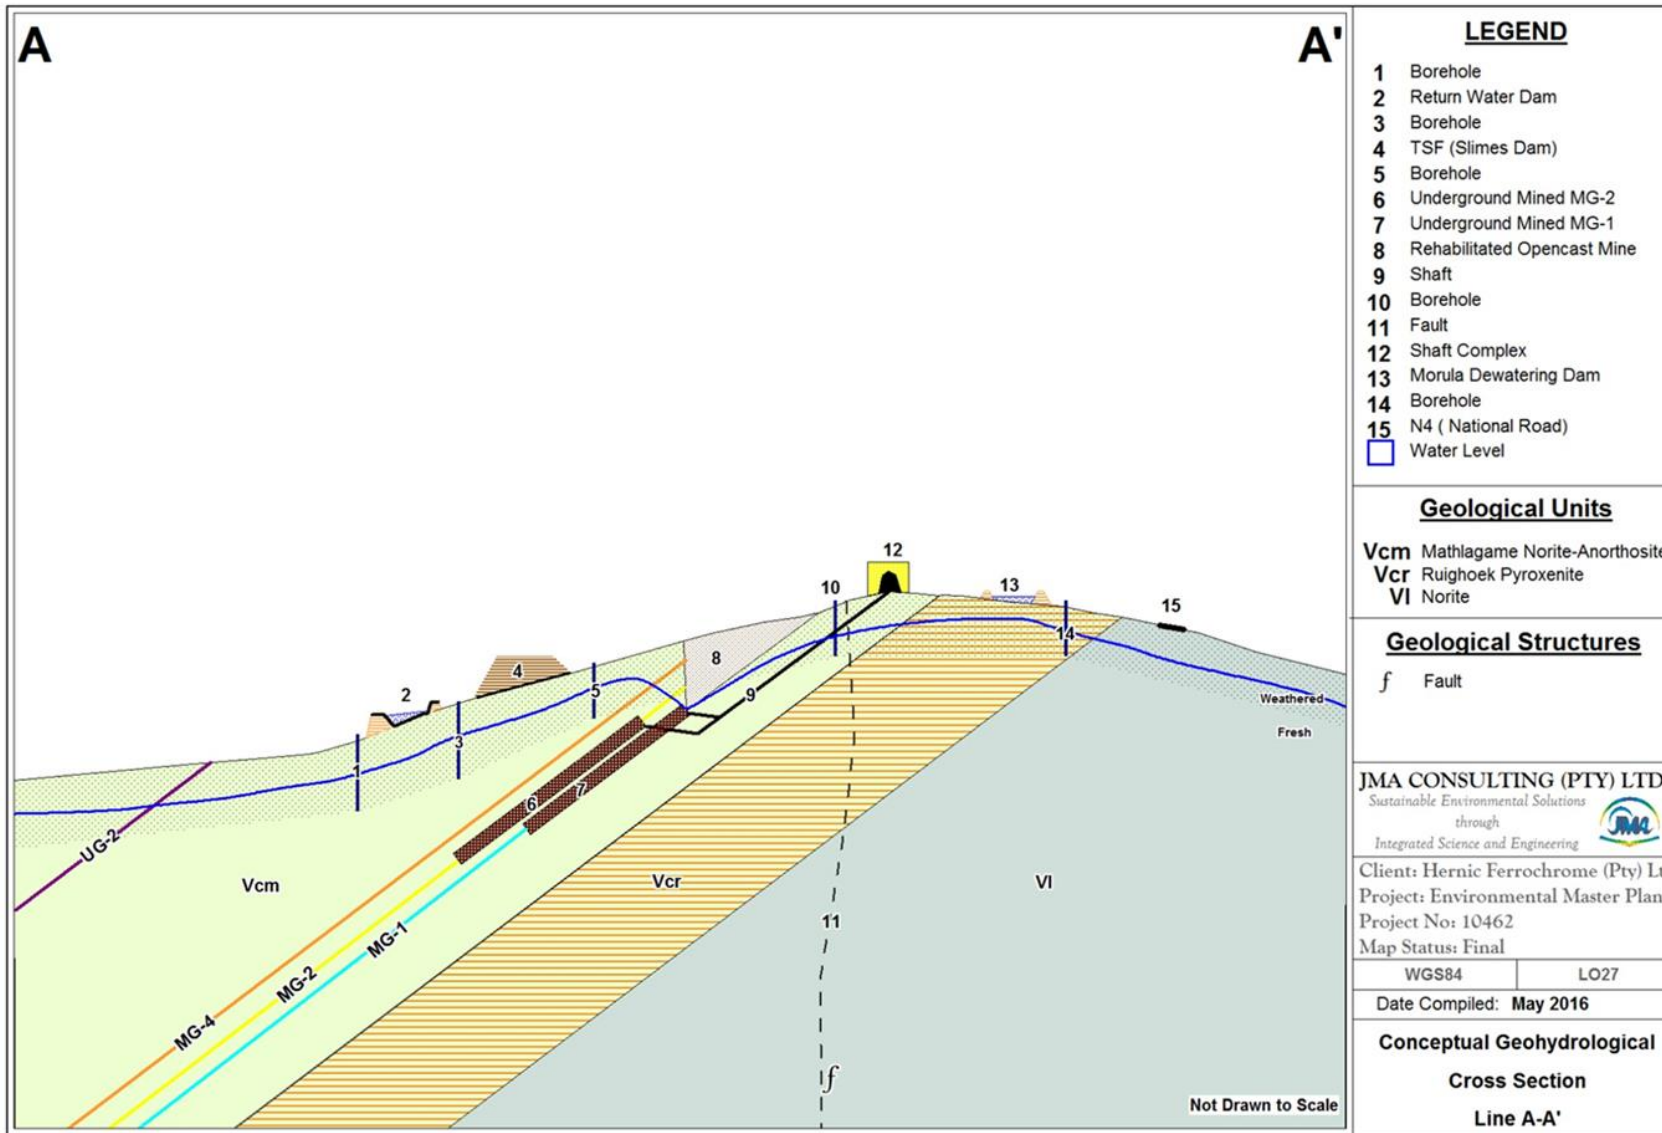
Figure 7.4.12.3(w) Conceptual Geohydrological Cross Section Line A-A'

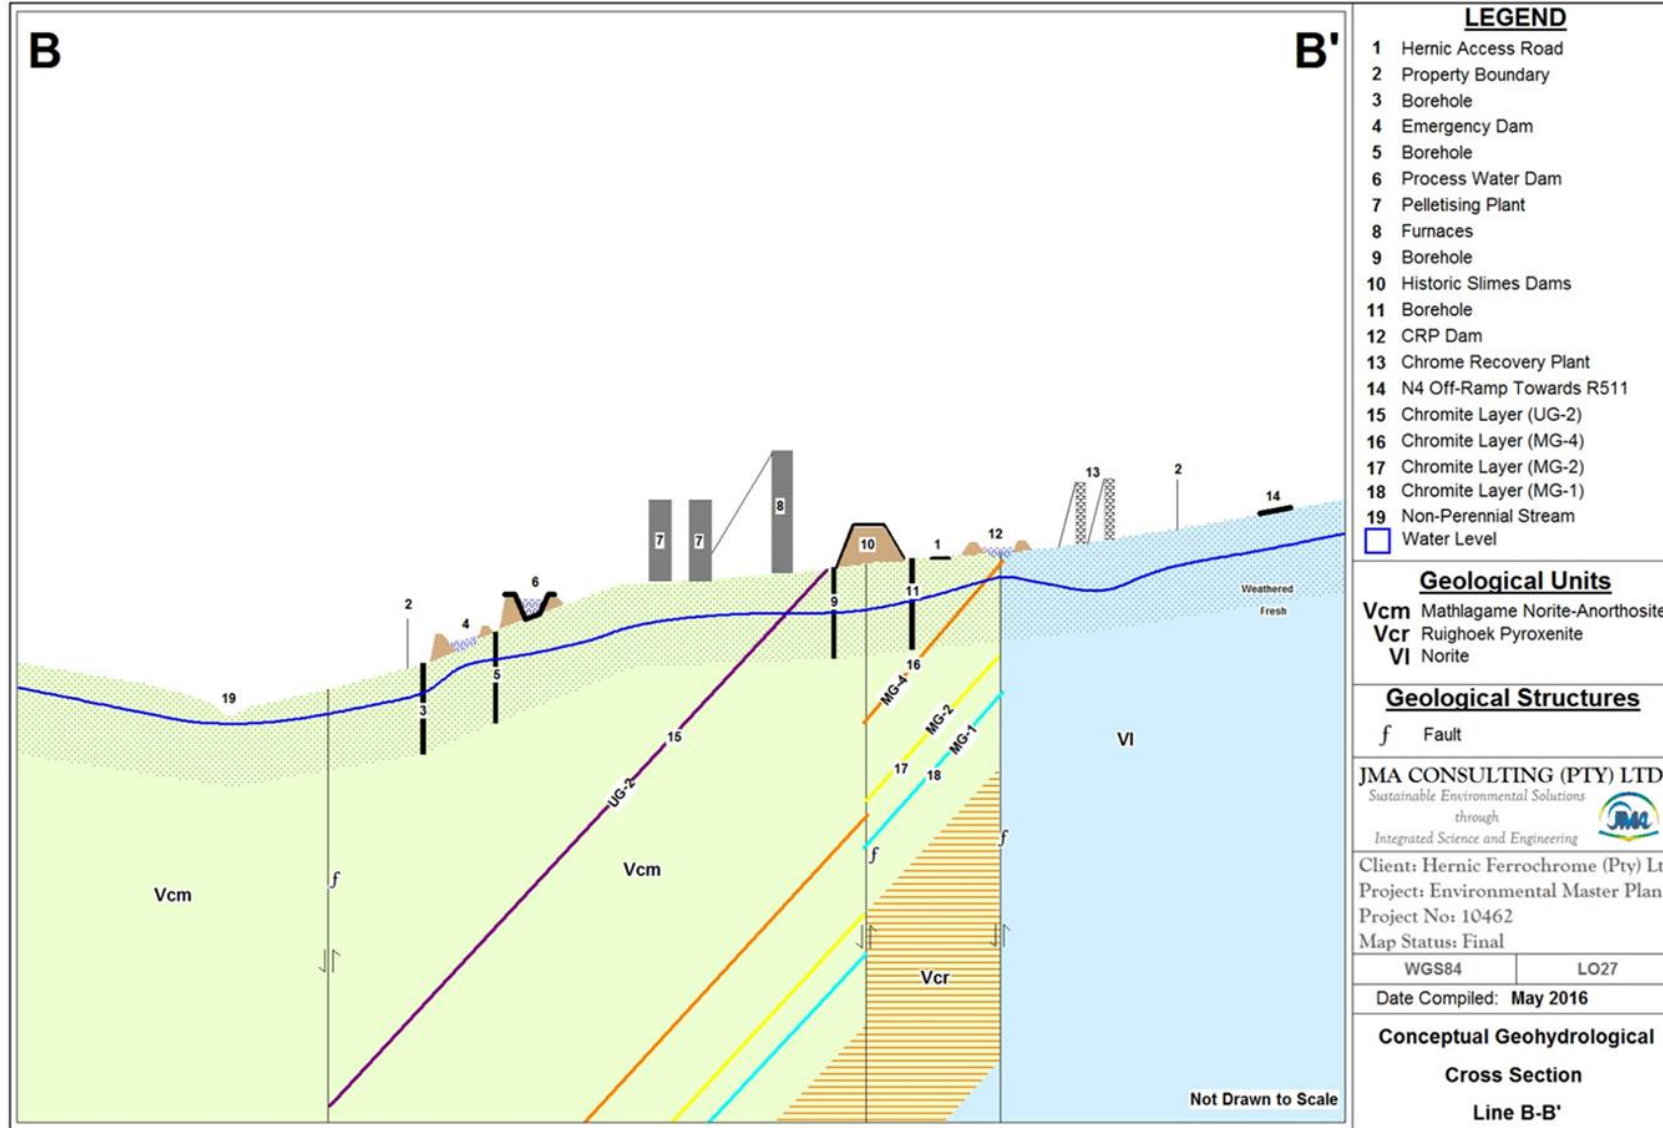
Figure 7.4.12.3(x) Conceptual Geohydrological Cross Section Line B-B'
