8. SELECTION OF PREFERRED ACTIVITY, SITE AND LOCATION

8.1. DETAILS OF ALTERNATIVES CONSIDERED

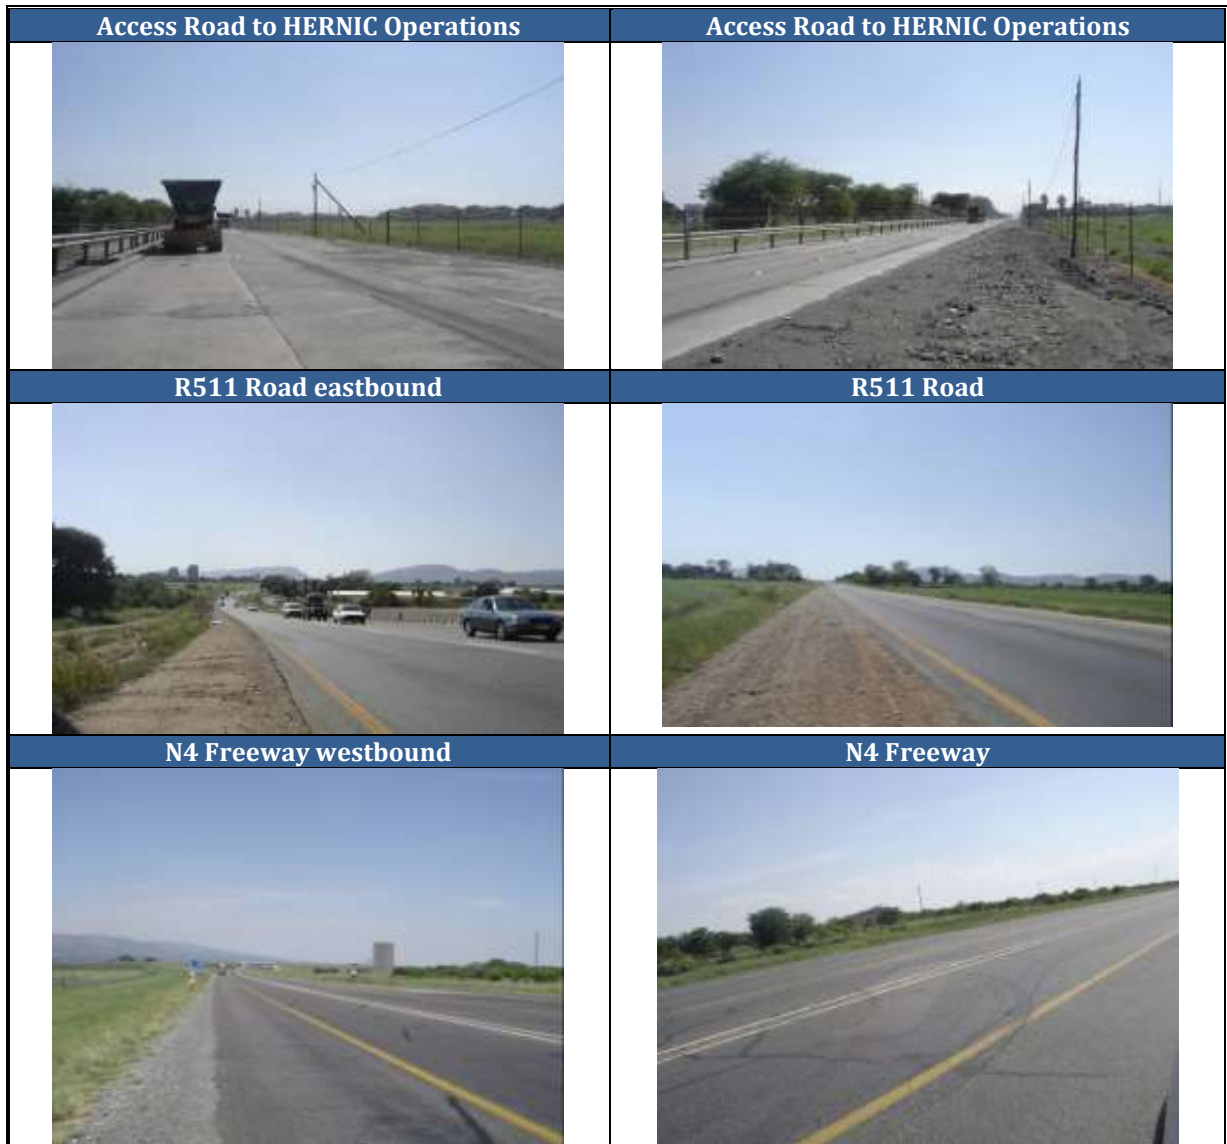
Figure 8.4.5(a): Photo Collage of Main Access Roads showing current Road Condition

The main access road to the HERNIC's Brits operations is from the R 511 Road. Photographs of the access roads to the HERNIC site are provided below (Figure 8.4.5(a)).

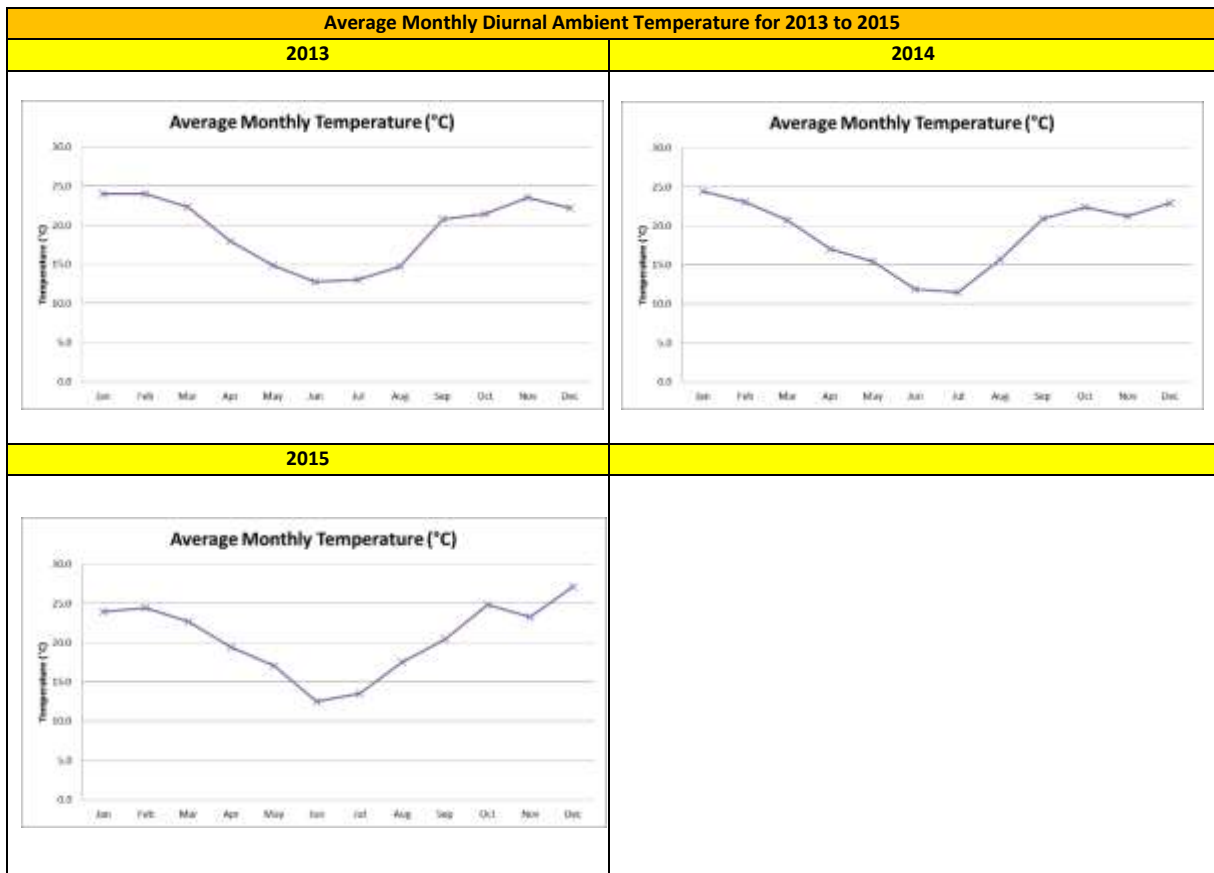
Figure 8.4.8.1(a): Average Monthly Diurnal Ambient Temperature for 2013 to 2015

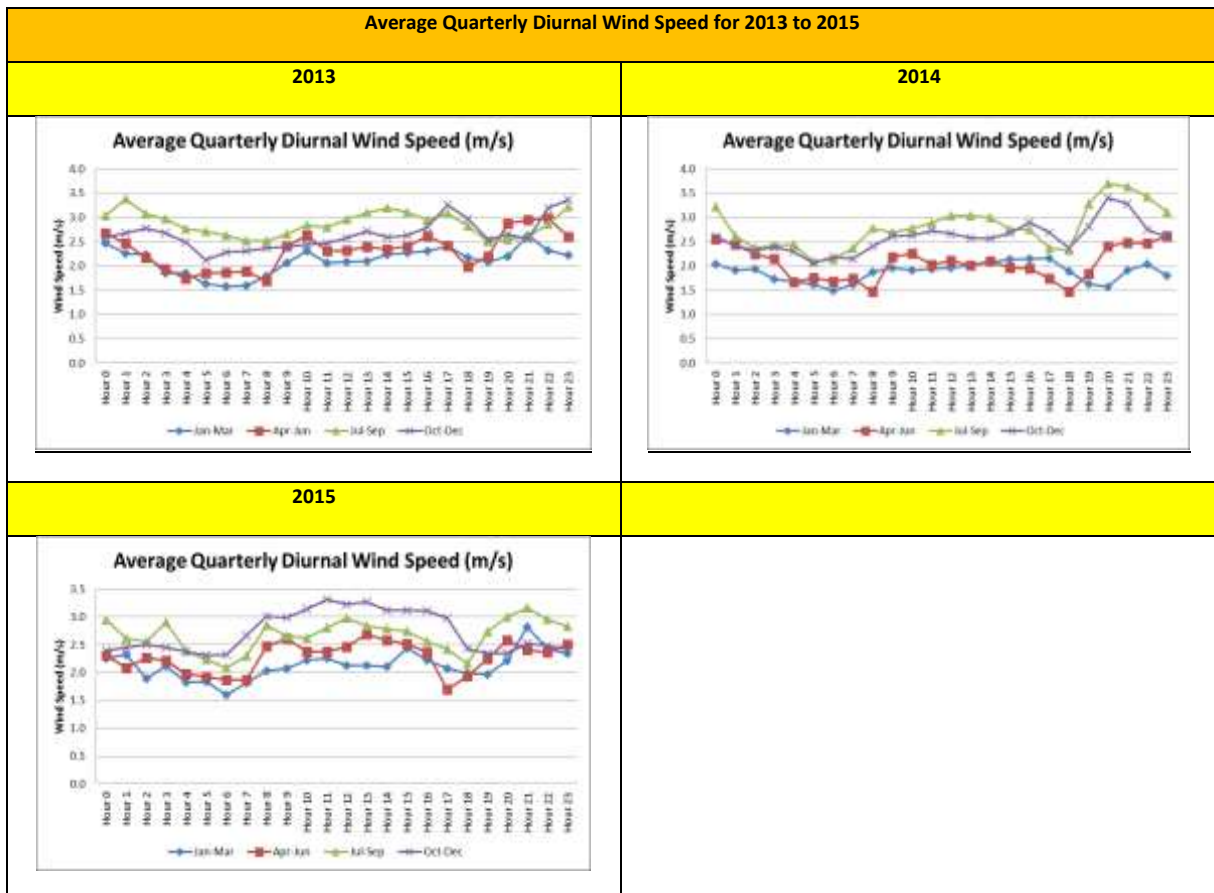
Figure 8.4.8.5(c): Average Quarterly Diurnal Wind Speed for 2013 to 2015

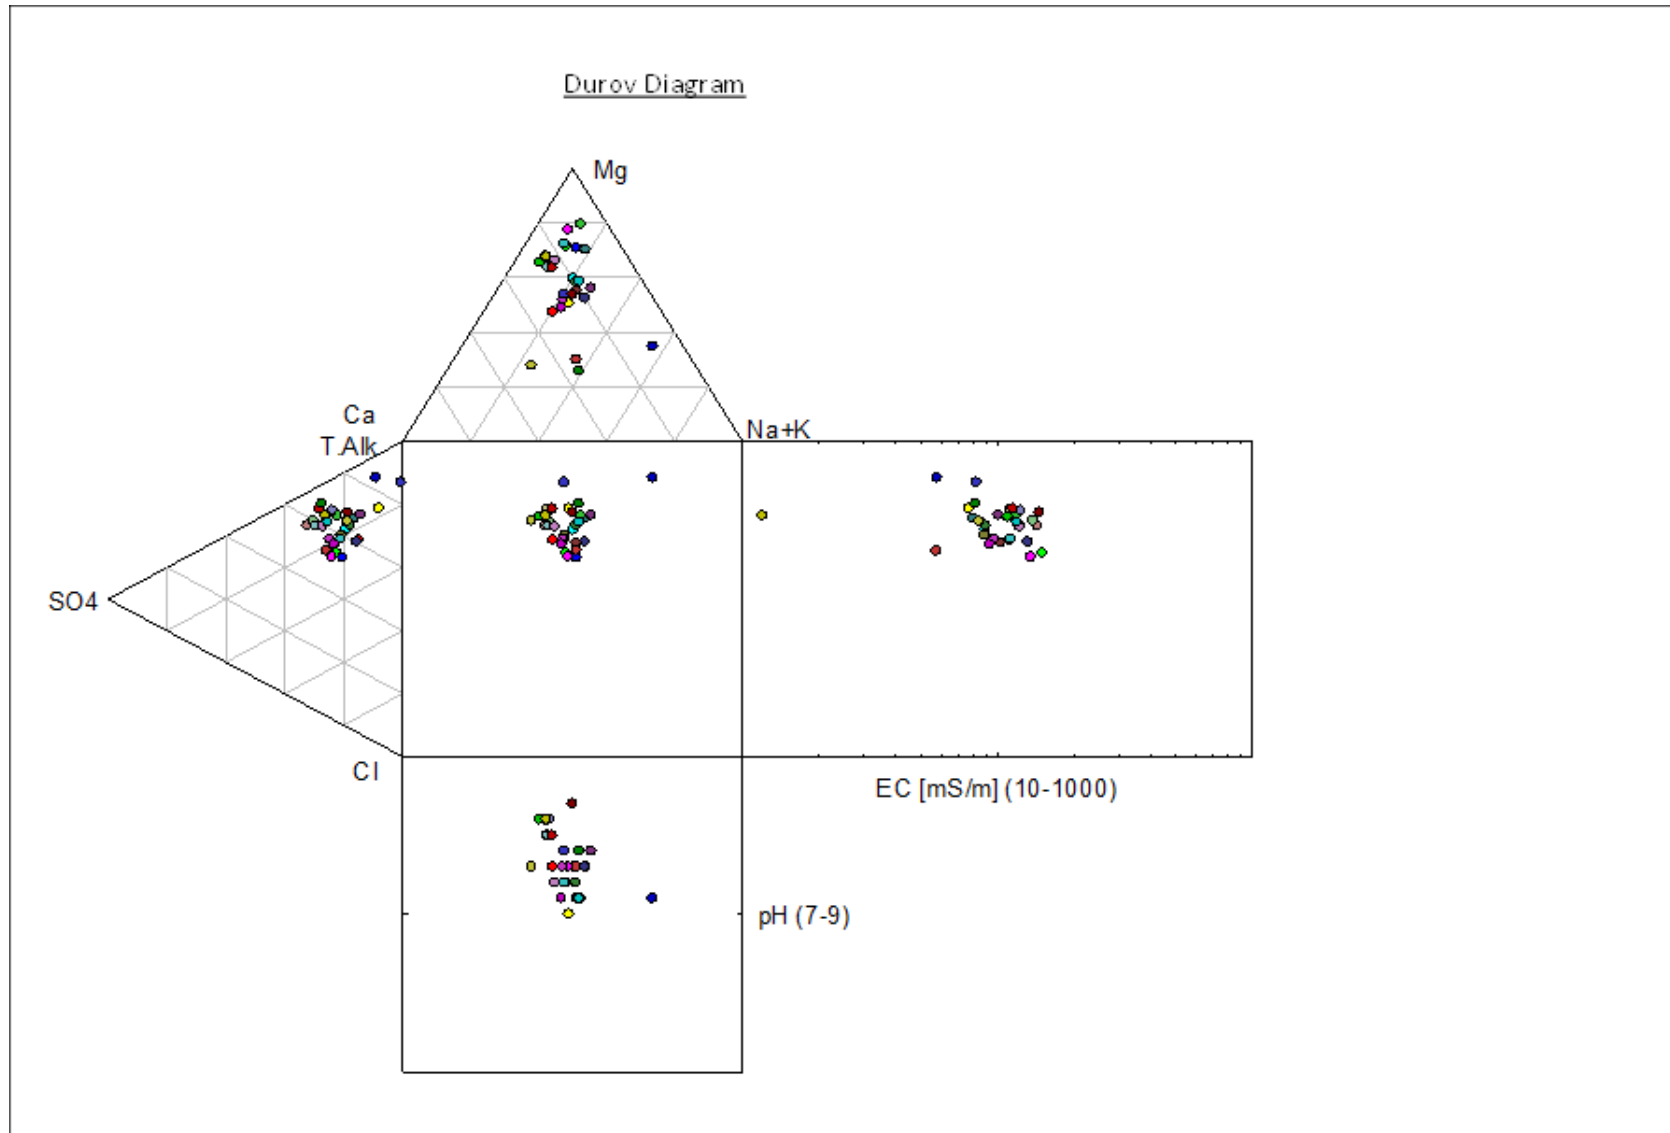
Figure 8.4.12.3(k): Background Groundwater Quality – Durov Diagram

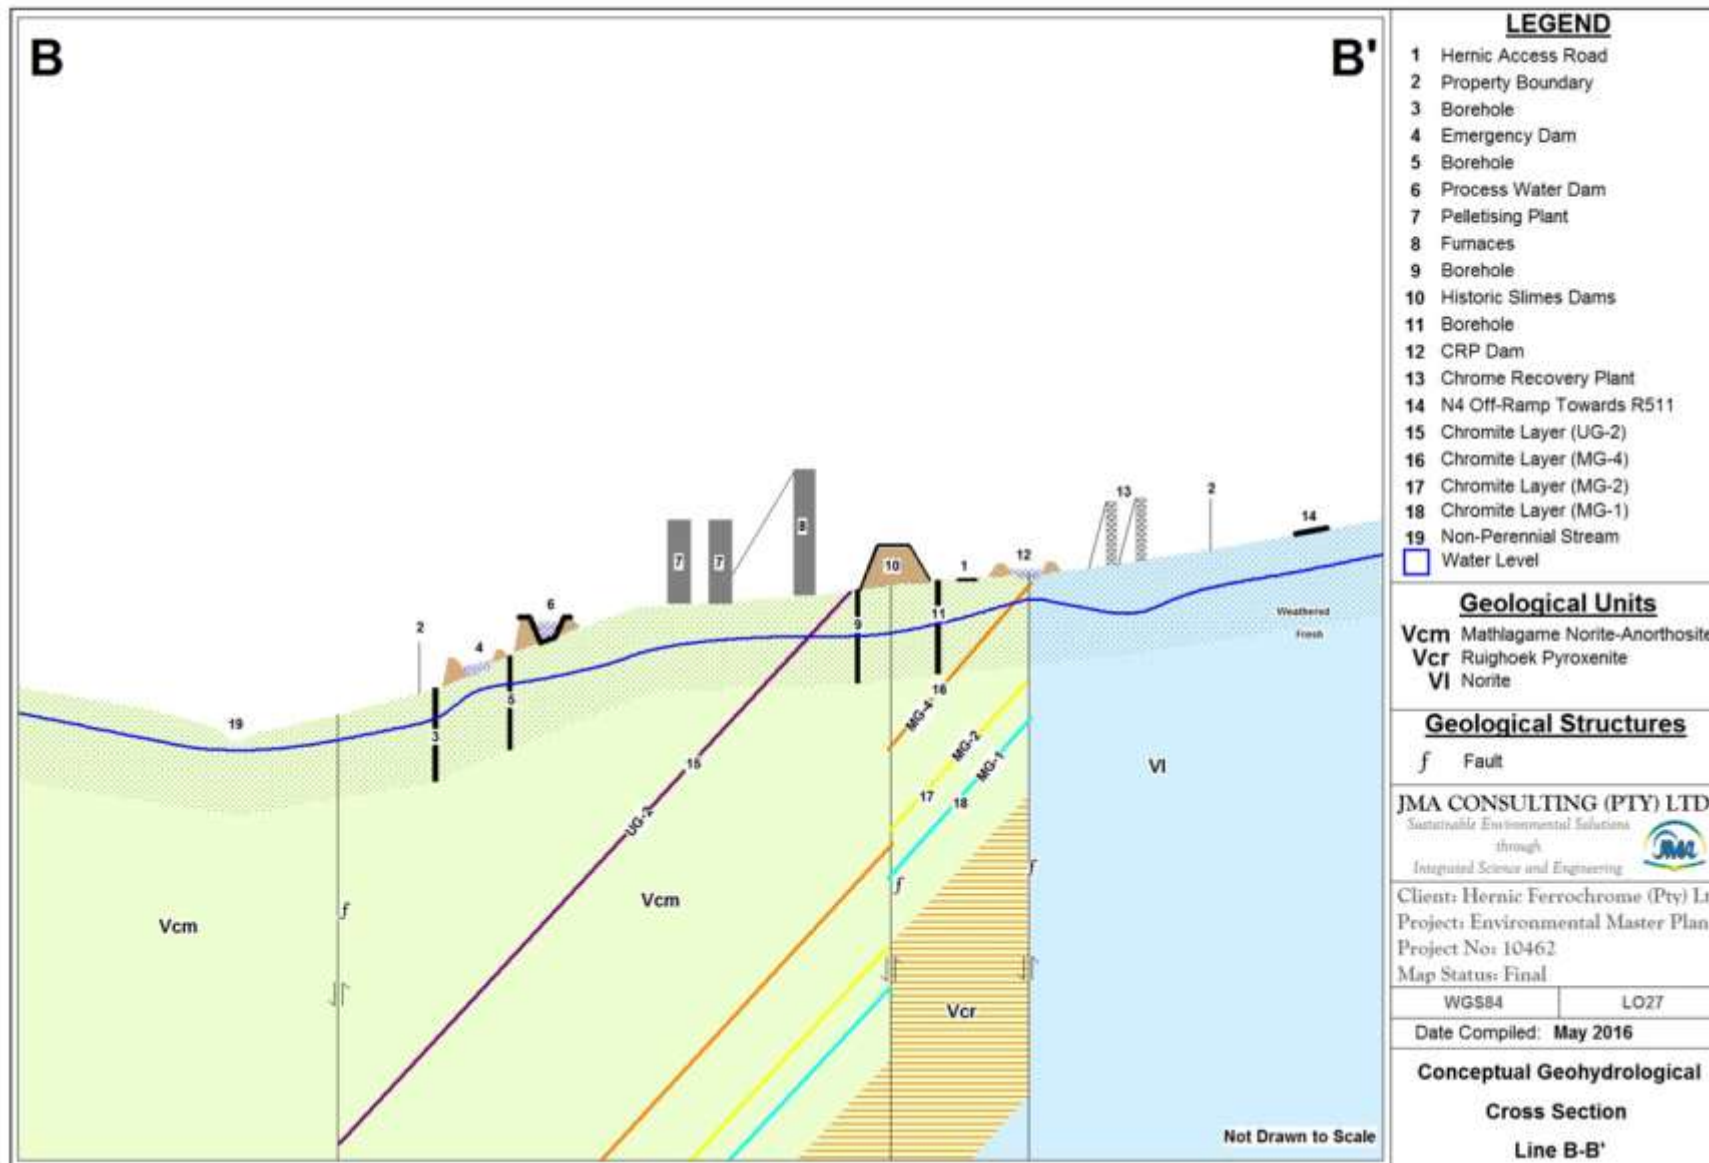
Figure 8.4.12.3(x) Conceptual Geohydrological Cross Section Line B-B'

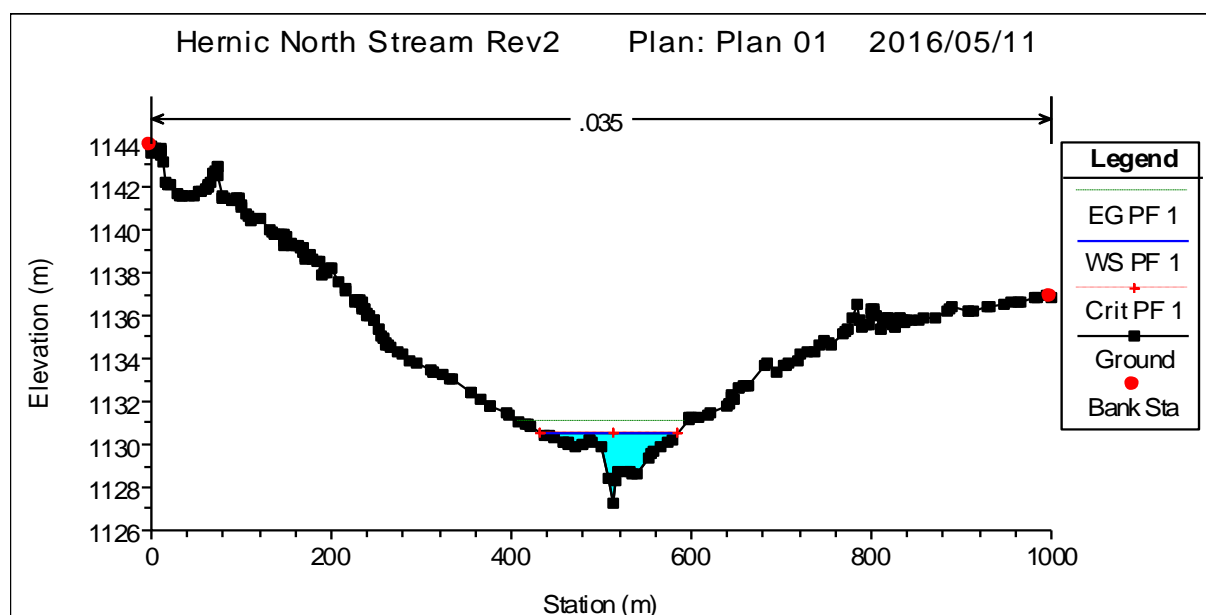
Figure 8.4.13.9(a): North Stream 100 yr Flood Level @ RS 1050 m
