ENVIRONMENTAL MANAGEMENT PROGRAMME
INFILLING AND EXCAVATION OF MATERIAL AND CLEARANCE OF INDIGENOUS
VEGETATION WITHIN 100M OF THE HIGH-WATER MARK OF THE SEA AT 57A
NORTH BEACH ROAD, WESTBROOK
ETHEKWINI MUNICIPALITY
DM/0034/2021

NOVEMBER 2021

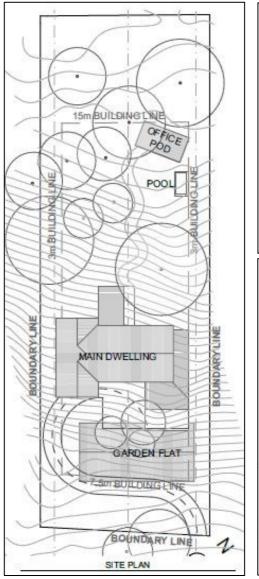
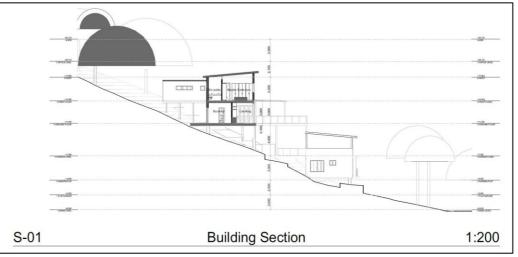
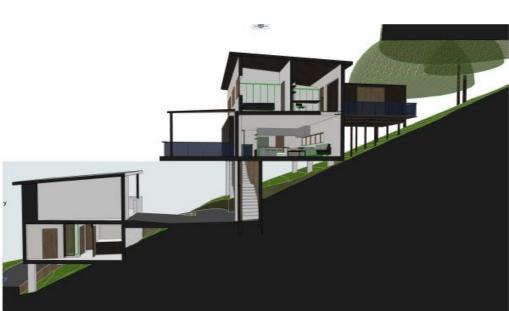
Figure 1: Site Development Plan Showing the Preferred Layout of the Proposed Infrastructure for House Du Plessis and Building Cross Sections of the Main Dwelling and Garden Flat (Source: Maker Architects, 2021).

The total development footprint is therefore 465m² (Figure 1). The preferred layout and design conforms to the topography of the site to minimise excavation. There are existing municipal bulk services available to provide the house with an electrical connection, potable water and waterborne sewage disposal.

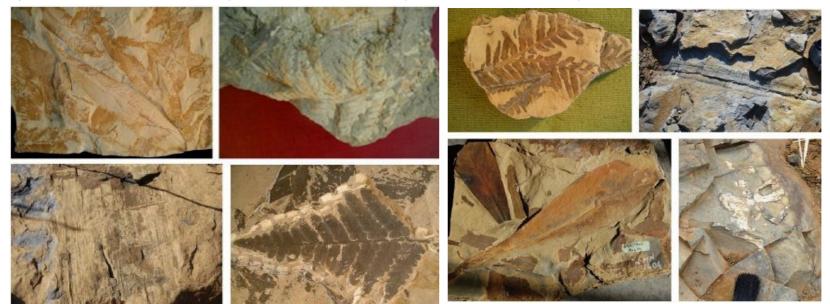
Figure 4: Example of fossils from the Vryheid Formation farther inland (source: Proff. Marion Bamford).

- The underlying geology is that of the Vryheid Formation, which is very highly sensitive, with this type of geology having the potential to preserve fossils of the *Glossopteris* flora. A Fossil Chance Find Protocol has been included in the EMPr.
