# PROPOSED DIEPSLOOT UPGRADE OF NGONYAMA ROAD Flood Hydrology Report

**PROPOSED DIEPSLOOT UPGRADE  
NGONYAMA ROAD  
FLOOD HYDROLOGY REPORT**

DATE November 2012

REFERENCE NUMBER 6496/HLA

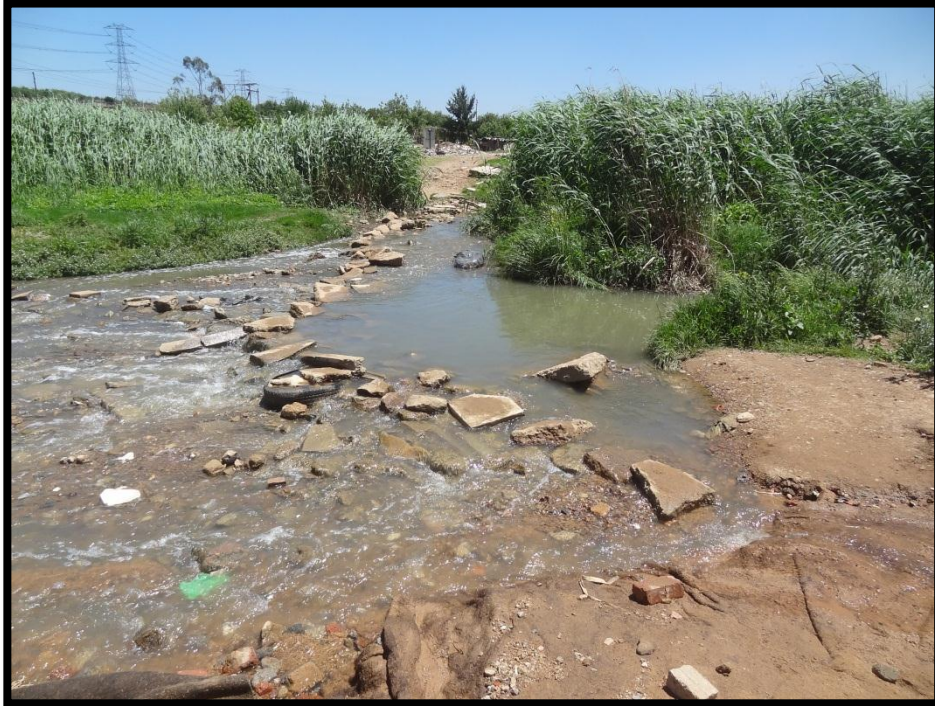
**Photo 3: Stepping stone crossing**

On 31 October 2012 two members of the ARQ bridge office went to do a site inspection. The site inspection was mainly to determine the Manning n values for the stream. Only the section of the stream between the proposed bridge site and the footbridge upstream were inspected. On this section a waste dump was encountered and also a leaking sewer pipe that disperse raw sewer water straight into the stream. The lower part of the stream is a wetland with thick reeds and an undefined water course. It was observed that the locals cross the river close to the proposed bridge site. This river crossing comprise out of stepping stones to get the people from one side to the other side. A photo of this crossing is included in **Appendix A**.

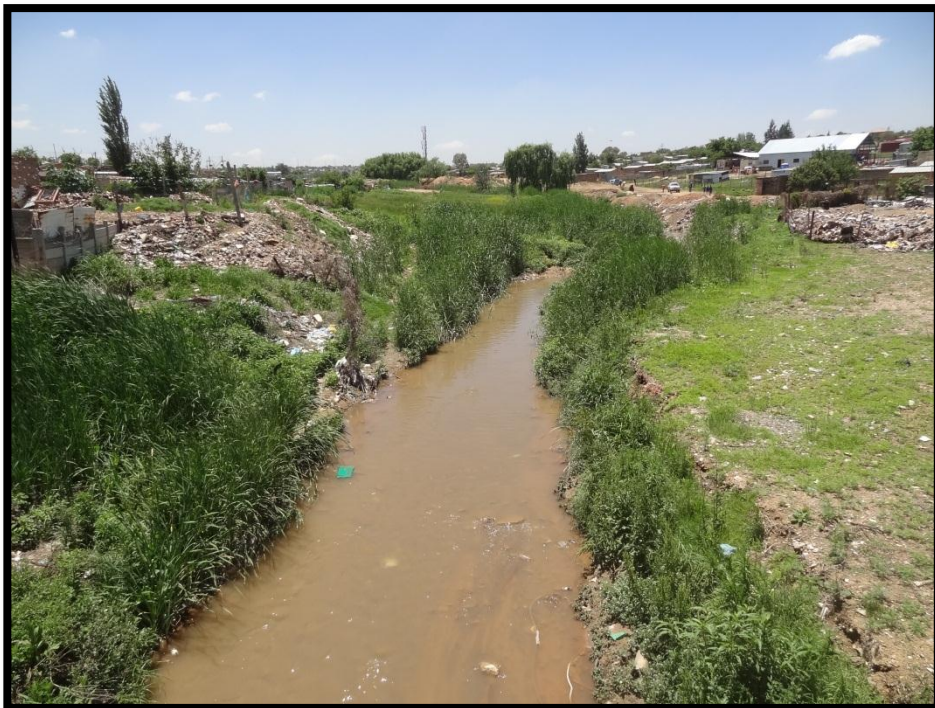
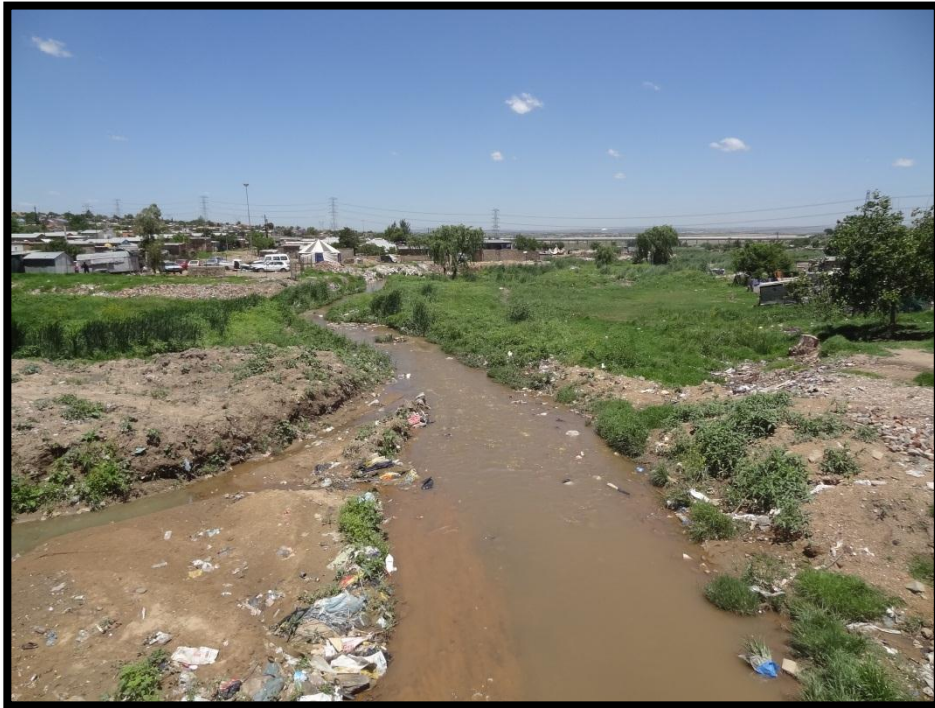
**Photo 4: Vegetation for Upper section of stream**

**Photo 5: Vegetation for Upper section of stream**

475m the Middle section is from 475m-617m and the Lower section from 617m-920m. As per Chow, 1959, a representative Manning's roughness value of  $n=0.035$  was allowed for the incised stream course of the Upper section and  $n=0.04$  for the overbanks. No bank flow for the Middle and Lower sections were anticipated because of the wetland located in these sections. The representative Manning roughness value of  $n=0.055$  were assumed for the middle section and 0.11 for the lower section.

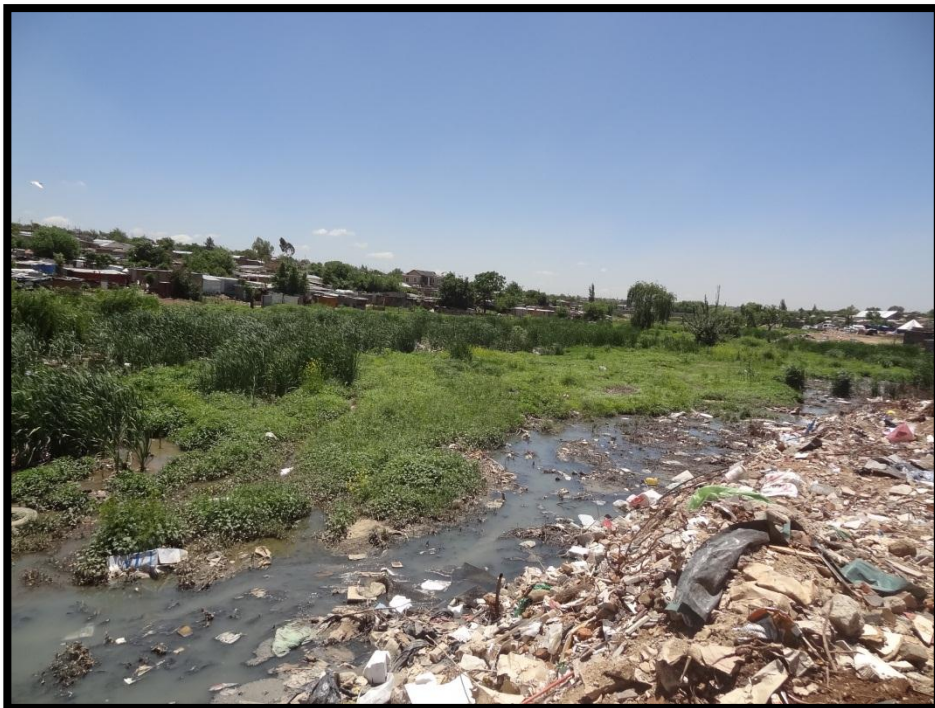
**Photo 6: Vegetation for Middle section of stream**

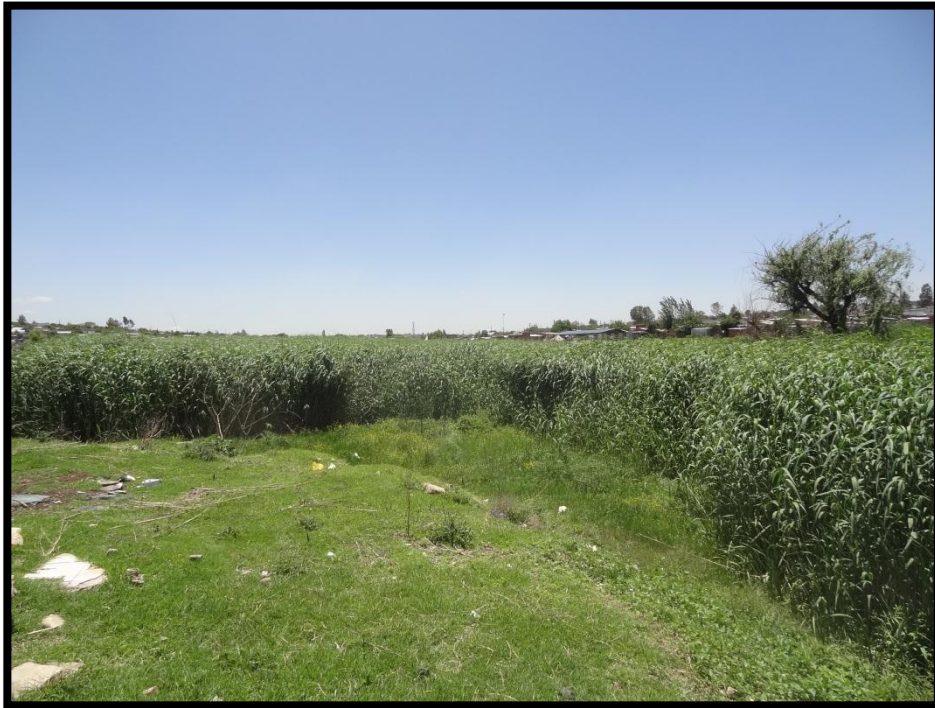
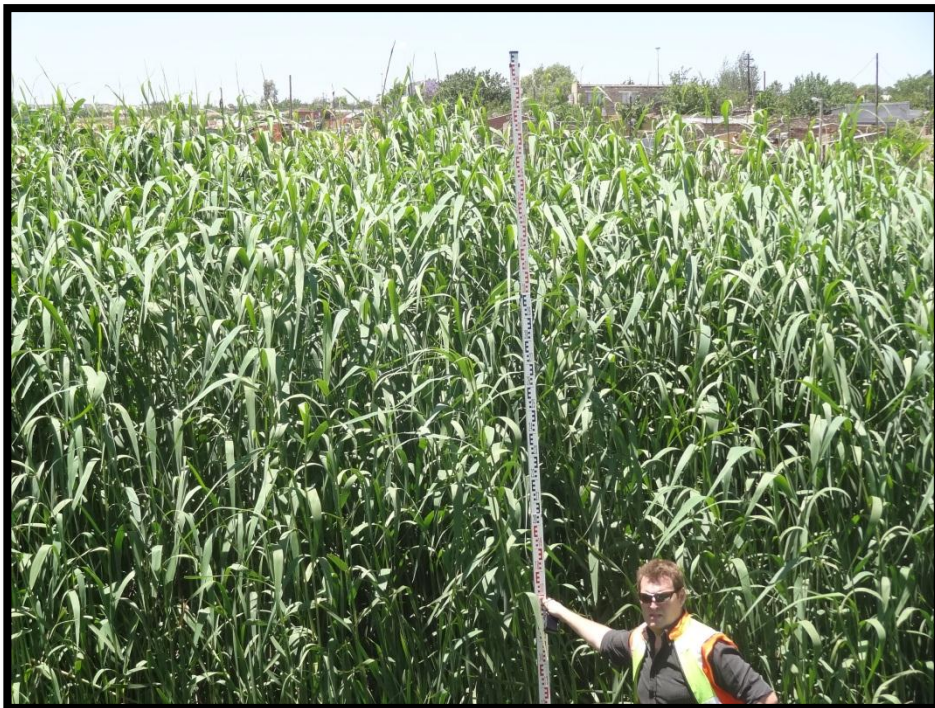
**Photo 7: Vegetation for Lower section of stream**

**Photo 8: Vegetation for Lower section of stream**

The lower section had a high Manning  $n$  value because of the thick and high reeds located on this section. Reeds up to 4m high were observed in the lower section. In **Appendix A** Photos of each section is included.

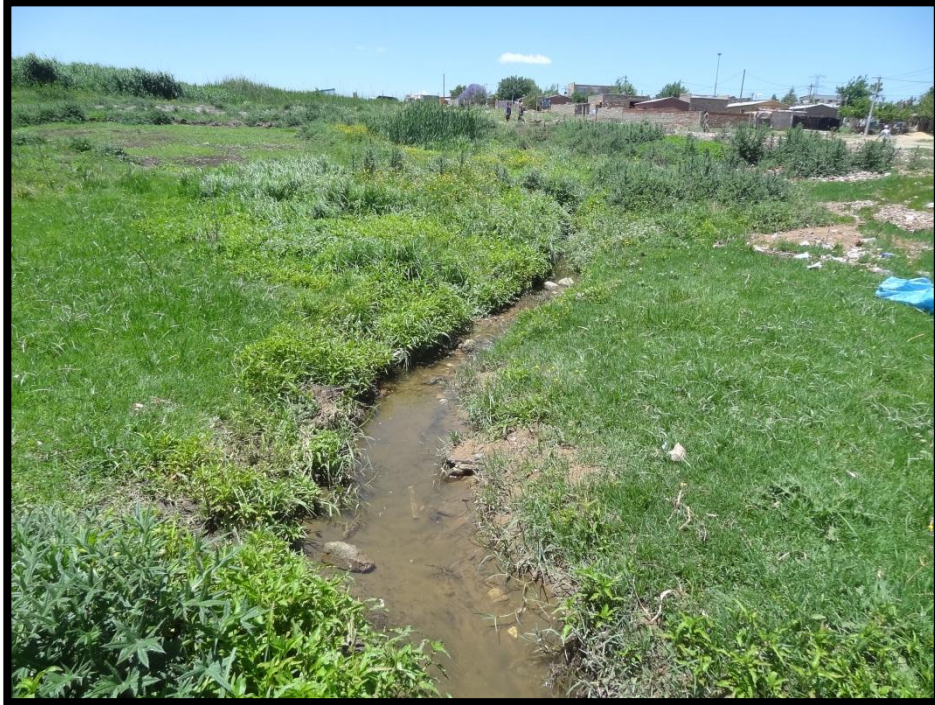
**Photo 11: Tributary joining from the East just before the bridge**

The hydraulic effects of the tributary joining the stream from the East just before the bridge site were not taken in to account in this study. This tributary is a small stream and the effects that it will have on the backwater of the bridge is negligibly small.

Although the hydraulic effect of the tributary joining the stream from the East just before the bridge is neglectably small, protection works is required on the side of the approach road embankment to prevent scouring. Scouring could be prevented in two ways. One is to construct a channel upstream as far as necessary to keep the water away from the road approach embankment. The second is to use embankment protection to prevent scouring.

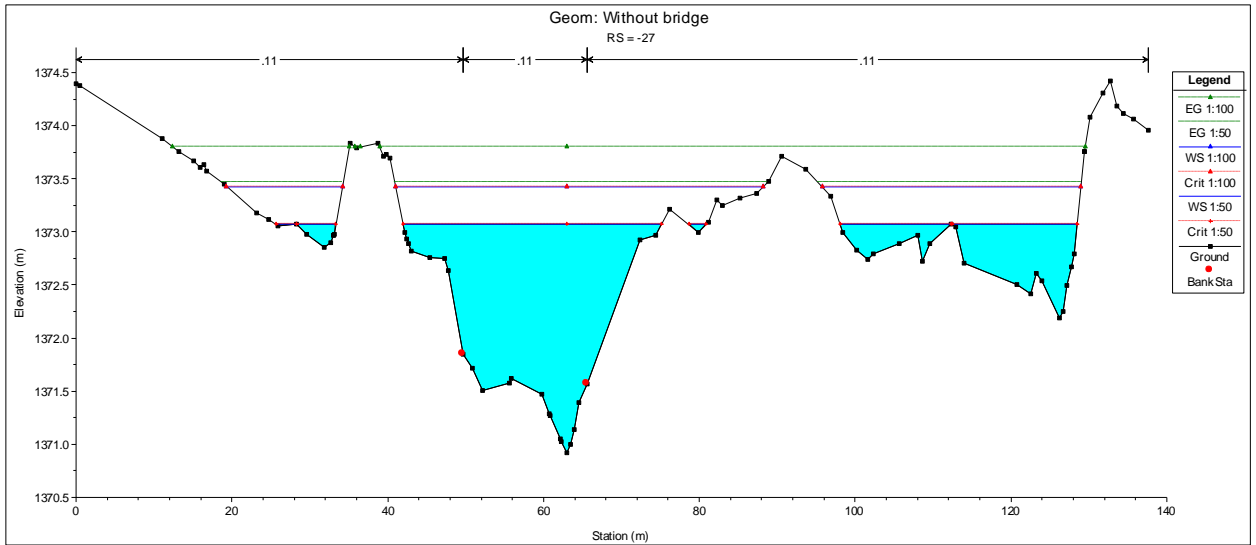
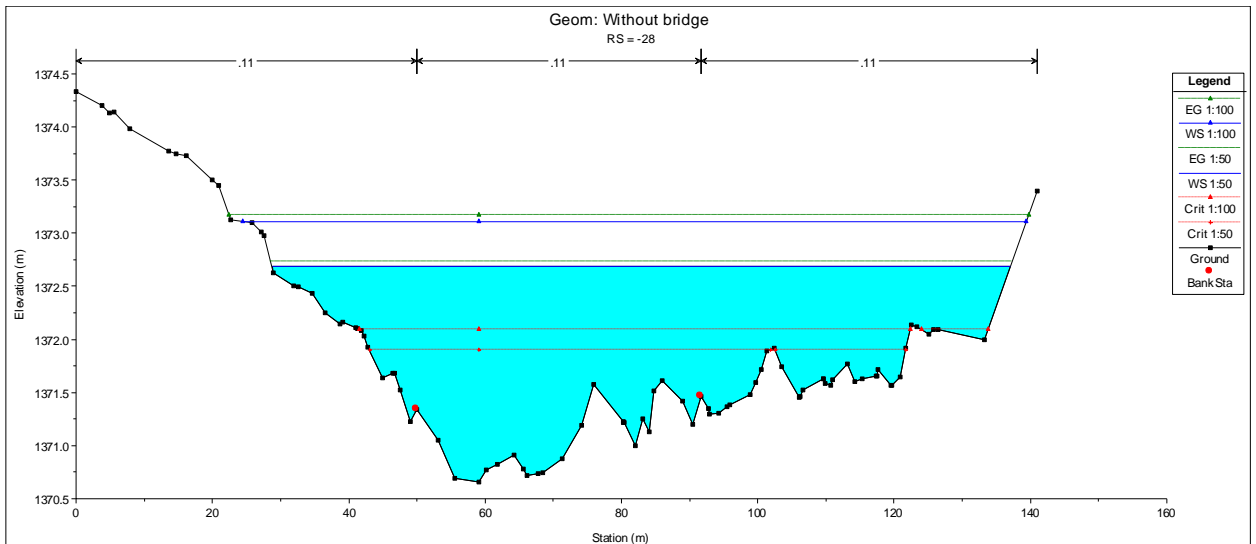
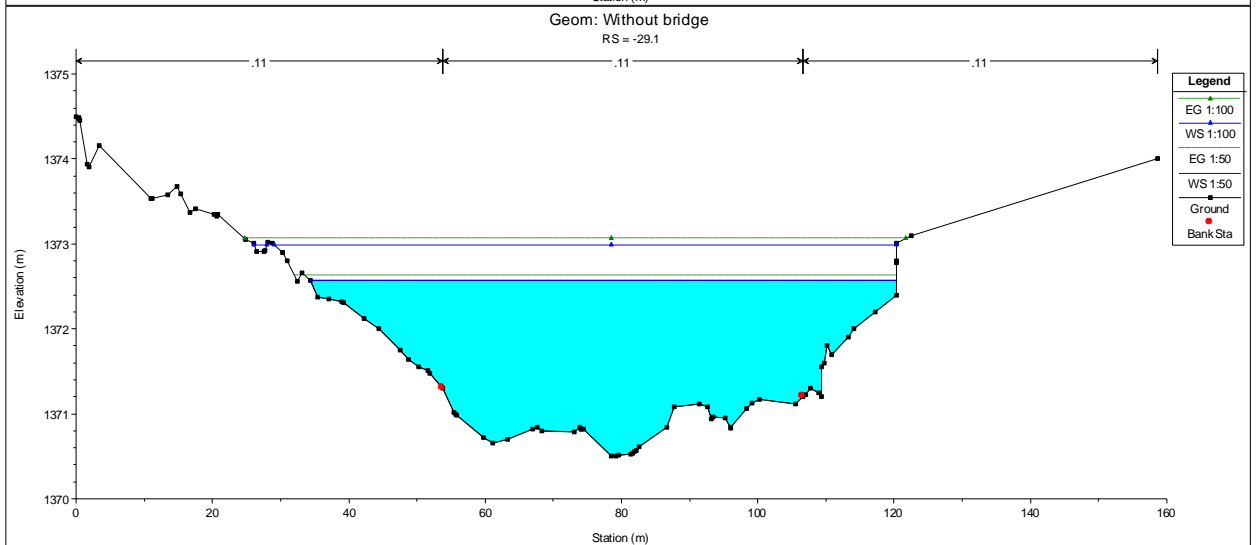
**APPENDIX B**  
**STREAM CROSS SECTIONS**

According to *SANRAL Drainage Manual 5<sup>th</sup> Edition*, the NGONYAMA Road will be a class 2 road and need to clear the 1:50 year flood level with a minimum freeboard of 0.3m. A bridge were placed on the centre line of the road at the appropriate level to clear the 1:50 year flood level with at least 0.3m. The critical cross sections were investigated to determine the backwater. Cross section -29.1 is 5m upstream of the proposed bridge site. Section -28 is 36m upstream from the bridge and -27 is 68m upstream. These sections are included in **Appendix B**. **Table 2-4** indicate the levels at critical cross sections.
