**SCOPING HERITAGE IMPACT ASSESSMENT:
PROPOSED HYPERION SOLAR DEVELOPMENT 2,
LYNDOCH 432/REM, KURUMAN MAGISTERIAL
DISTRICT, NORTHERN CAPE**

Required under Section 38(8) of the National Heritage Resources Act (No. 25 of 1999).

SAHRA Case No.: 12966

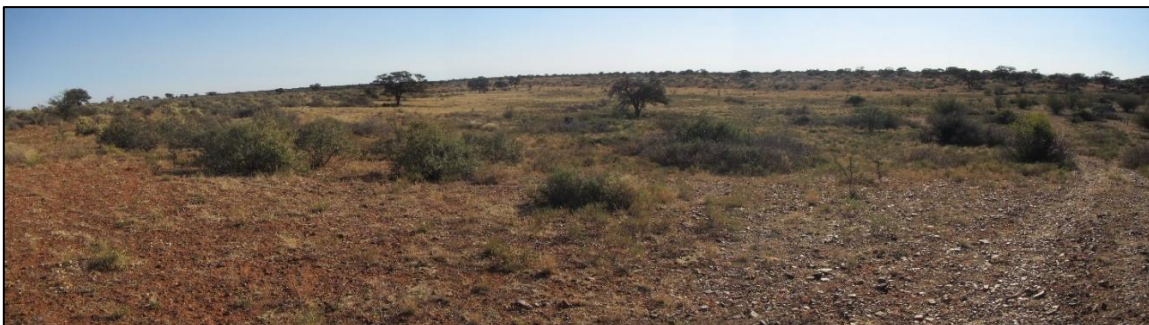
Figure 4: View towards the northeast across the Vlermuisleegte showing a gravel-rich part of the western bank.

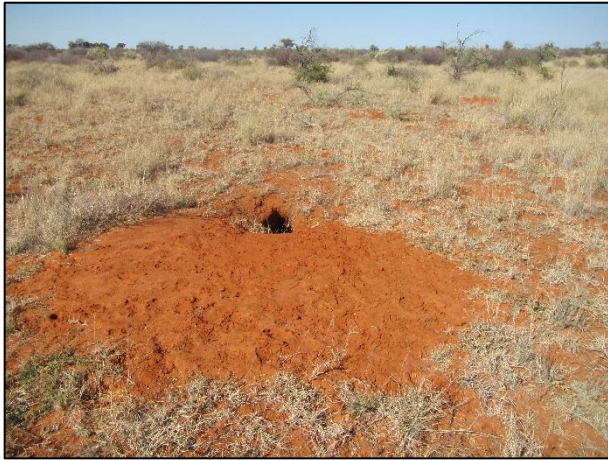
Figure 9: View of a burrow showing the clean red sand that occurs beneath the grass.

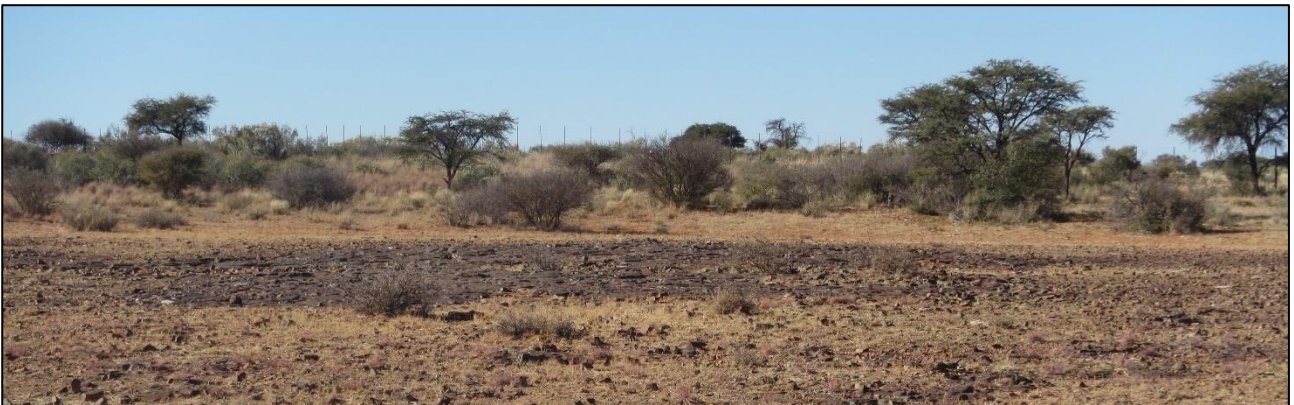
Figure 11: View across the only bedrock exposure on site. It lies within the channel of the Vlermuisleegte.

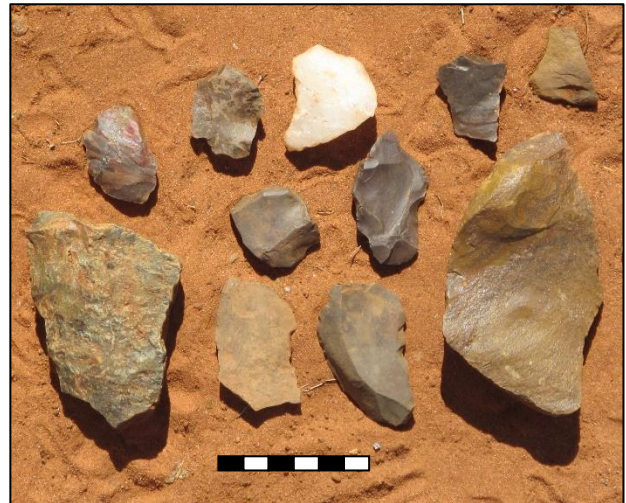
Figure 29: Artefacts at waypoint 1179 including one in quartz. Scale is in cm intervals.

1179	S27 32 39.9 E23 04 49.6	Stone artefacts on the south-western bank of the Vlermuisleegte but located on the sandy substrate that overlies the gravel bed.	GPA
1180	S27 32 49.4 E23 04 58.2	Very ephemeral scatter of stone artefacts close to the bedrock outcrop in the Vlermuisleegte noted under waypoint 1167.	GPC
1181	S27 32 46.0 E23 05 01.8	Loose scatter of rocks on the sand about 50 m northeast of the edge of the Vlermuisleegte. It has been disturbed by burrowing animals and may represent a grave. The rocks have definitely been	IIIA

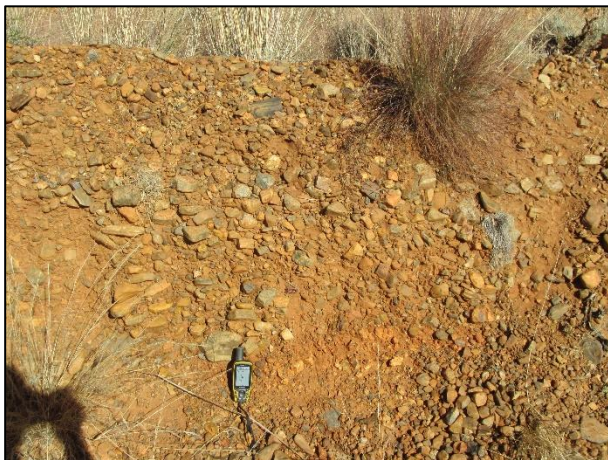
The most interesting artefact seen during the survey was located in an open test excavation (apparently a search for diamonds) on the north-eastern bank of the Vlermuisleegte at waypoint 1187. A standing section of about 1 m high had artefacts present in it (Figure 30). One of these was a broken bifacial point of the sort commonly referred to as a ‘Still Bay point’ after the location where such artefacts were first described (Figure 31). The Still Bay period is part of the MSA and dates to between 77 and 70 000 years ago (Lombard *et al.* 2012).

Figure 30: The standing section in which artefacts were seen at waypoint 1187.

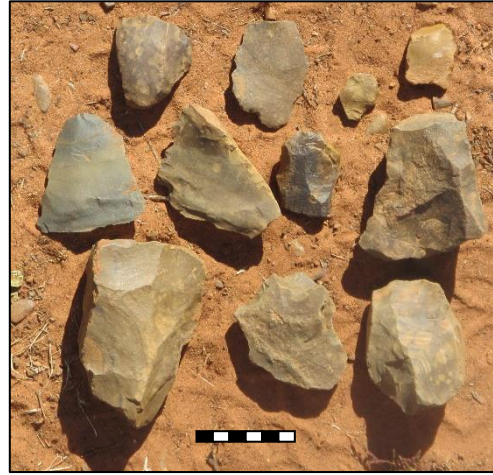
Archaeology was also seen along the Alternative 1 access road, which runs alongside the Vlermuisleegte. Once more, the artefact density was strongly variable, but wherever there was gravel present, there were also artefacts (Figures 32 & 33). In some places it was evident that gravel had been imported to surface the road. This gravel, too, contained artefacts. A number of excavations alongside the road were present and examined for archaeology.

Figure 32: Artefacts seen at waypoint 1200 along the Alternative 1 access road alignment. Scale is in cm intervals.

Figure 33: Artefacts seen at waypoint 1200 along the Alternative 1 access road alignment. Scale is in cm intervals.

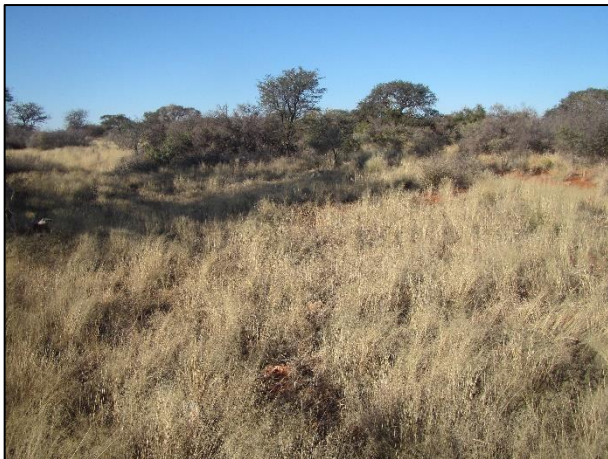
Several graves were identified on the farm. An informal farm workers' graveyard was located at waypoint 1158 (Figure 36). There were five 'stone-packed' graves present but just one had a 'headstone' which was made from a piece of corrugated iron (Figure 37). Another sheet of flat metal was found in the grass and had once been part of one of the graves. It was dated (1973). This was the only date associated with the five graves. The graves were packed with a variety of materials sourced from the farm including stones, bricks and fragments of broken asbestos sheeting. Very close by, at waypoint 1157, there was a single more formal grave (Figure 38). Its headstone indicated

Figure 36: View of the area at waypoint 1158 in which five graves were found.

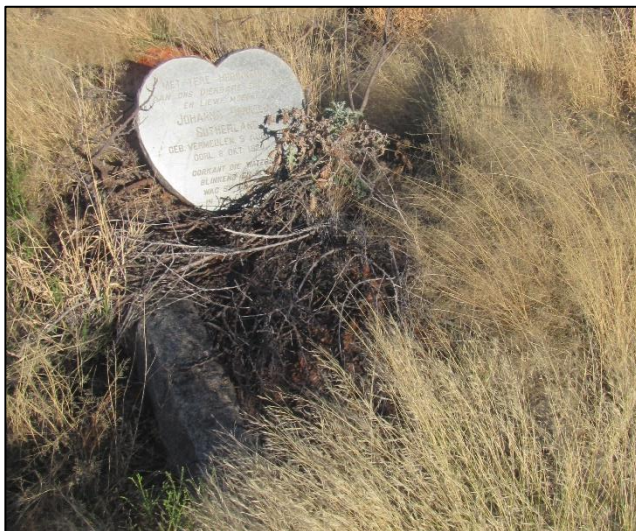
the date of death as being 8 October 1928. According to the landowner, the grave is somewhat of a mystery because some years ago some family of the deceased came to remove the remains to another location but, despite excavating the grave and some of the surrounding area no remains were located. The grave was then rebuilt in the same location and left as is. A fragment of mortar was found in the grass which supports this destruction and rebuilding. These graves are all within the development exclusion zone near the farm buildings. To the east of the Vlermuisleegte a suspicious collection of stone was located in a sandy area on the upper part of the bank of the leegte (Figure 39). No other stone were present in the vicinity and the collection is clearly anthropogenic. It may represent a grave.

Figure 38: The grave at waypoint 1157.

Waypoint	Location	Description	Significance
1157	S27 33 15.6 E23 05 01.4	Isolated grave of Johanna Cornelia Sutherland dated 8 October 1928. Many years ago the family of the deceased came to exhume the grave and remove the remains to another location, presumably closer to home, but no remains were found. The granite grave covering and headstone were dismantled and a large area searched. On finding nothing the grave covering was rebuilt in the original location. Despite the lack of human remains the site is still considered as a grave site but the significance is reduced.	GPA
1158	S27 33 15.6 E23 04 57.9	Five graves of past farm workers. Only one is dated and is believed to be the most recent. It is dated with painted writing on a metal sheet which is lying loose in the grass and it is thus uncertain which grave it belongs to. The inscription names the person as 'Tities Manyana Katerina' and notes the date of death as '0_.05.1973' and date of burial as '12.05.1973'. The month is not completely clear but May seems most likely. She was born on 02.08.1935. Another grave has a metal sheet standing at the head but there is no inscription. All five graves are 'stone-packed' graves but using various items from the vicinity, a few stones, some bricks and some fragments of asbestos sheeting.	IIIA

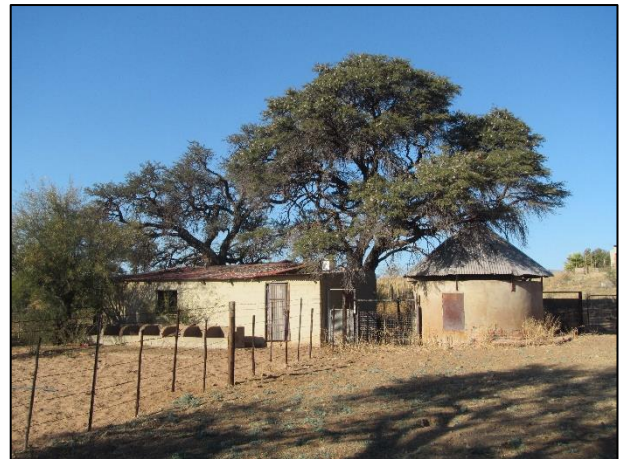
examination of them showed that they were fairly generic disused farm structures and not of any significance. The presence of a rondavel is somewhat unusual but still of no obvious significance. A *waterput* (water well) used to be present close to the rondavel but has been filled in. It was not seen during the survey. The main house on the farm was originally an older building but it has been completely renovated and is now essentially modern. Some labourers' cottages near the main farm house and two other houses to the east of the Vlermuisleegte are modern. Two farm houses and some associated outbuildings lie along access road Alternative 1 (Figures 42 & 43). They all appear to date no earlier than the mid-20th century and none carry any heritage significance. No buildings occur within the proposed development area.

Figure 41: Outbuildings at waypoint 1162.
