**Imerys (South Africa) (Pty) Ltd –
Anref Operation**

**Final rehabilitation, decommissioning
and mine closure plan**

Date: July 2018

Project Title: Anref Mine – Final Rehabilitation, Decommissioning and Mine Closure Plan

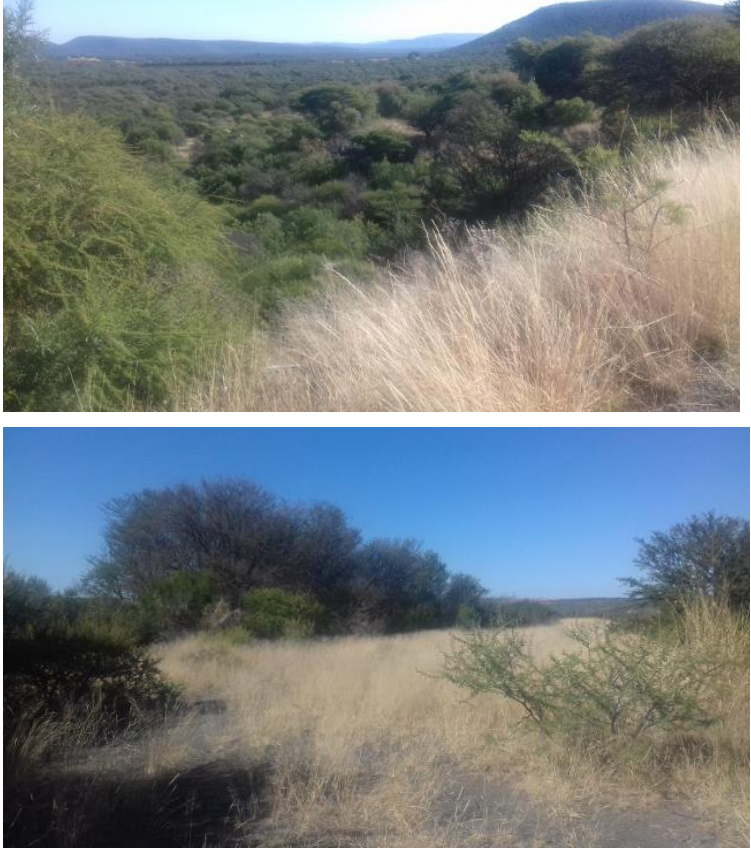
Aspect	Closure objective	Success criteria	Further action required	Photograph (if applicable)
Old slimes dam	Although the slimes dam walls are very steep, it is already well vegetated and further disturbance will not add value.	<p>Indigenous vegetation has established on the slimes dam rehabilitated surfaces.</p> <p>Alien species should not be dominating plant cover and indigenous species should be present.</p> <p>Water drainage flows naturally without pooling or flooding.</p> <p>Minimal erosion where water flows from drainage structures.</p>	<p>Biodiversity survey to verify that adequate vegetation cover has been achieved and that the balance between indigenous and alien species is acceptable.</p> <p>Mitigate areas where erosion is visible through redirecting storm water.</p>

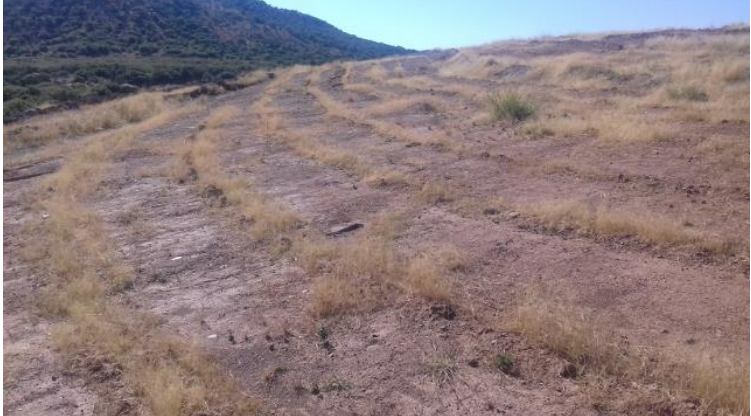
Large waste rock dump	Visually, the southern side wall is the most significant as it is visible from the national road. The objective is to decrease the height and reduce the slope in order to successfully re-vegetate.	<p>The dump has been sloped per closure objectives.</p> <p>Vegetation has established on shaped slopes which limits visual impact.</p>	<p>Re-seed the dump, as seeds that were sowed may be washed away after storm events. After completion of this step, monitoring will be conducted until the end of 2018 to verify establishment of vegetation.</p>

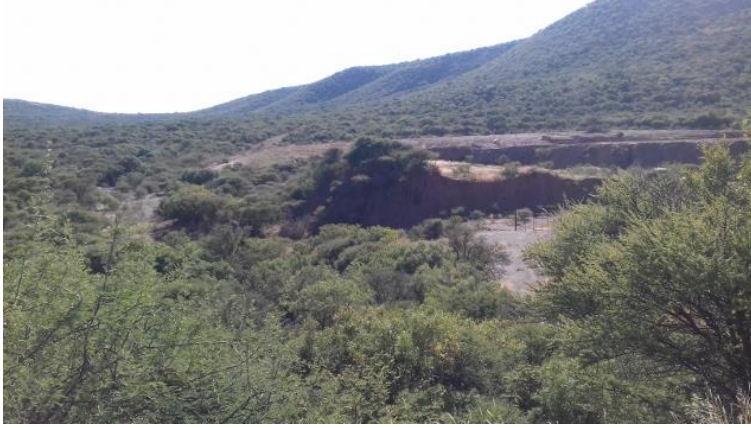
Material from the waste rock dump will also be used to fill the depression to the north of the WRD and the eastern quarry	N/A	N/A	
	The mine may also consider selling some of the waste rock material to use during construction or upgrading of roads.	N/A	N/A	
Topsoil stockpiles east and west	Material from the topsoil stockpiles will mainly be used for final sloping and cover to promote vegetation growth. Unused topsoil will be sloped into low lying cavities to allow gradual topography with free drainage.	Any remaining topsoil stockpiles have been sloped as per objective.	One topsoil stockpile was observed during the site visit (14 June 2017). This stockpile will be sloped as per objective.

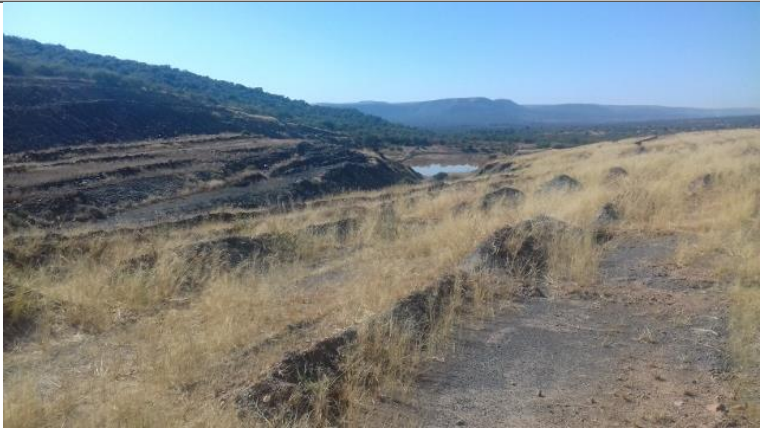
Aspect	Closure objective	Success criteria	Further action required	Photograph (if applicable)
Quarry east	Benches will be sloped using cut and fill techniques.	Benches have been sloped.	None.

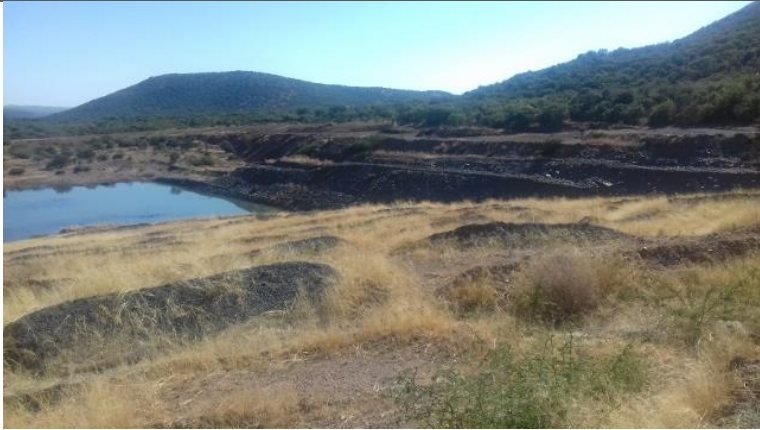
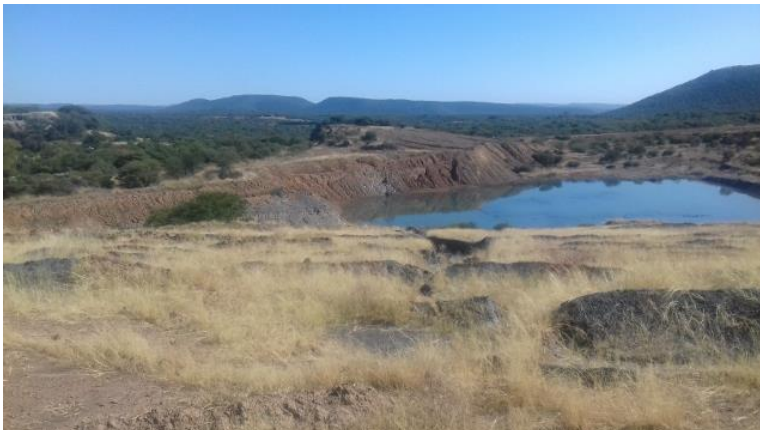
The water body to the east will remain intact while the floor to the west of this quarry will be filled with material from the north and south slopes.	Infilling was done where required.	None.	
	Rocky contours are proposed within main drainage lines to reduce runoff velocity and prevent siltation of the water body.	Berms / sediment traps are installed where necessary to reduce sediment loads. No evidence of siltation of nearby natural drainage lines.	None.	
Quarry west	Benches will be sloped using cut and fill techniques.	Benches have been sloped.	None.

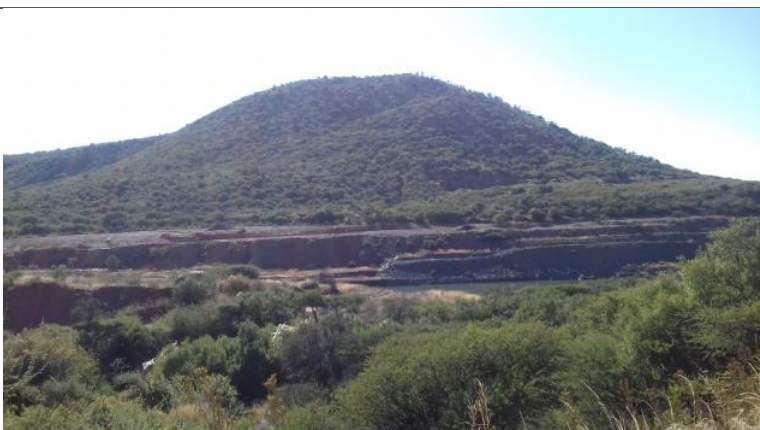
Prevention of siltation is proposed using rocky bund walls within the main drainage lines towards the water body.	Berms / sediment traps are installed where necessary to reduce sediment loads. No evidence of siltation of nearby natural drainage lines.	None.	
	Final slopes around both quarries should allow at least one section with safe and easy access for animals to reach the water.	Cattle and other fauna on site has safe access to the water.	None.	
Quarry north	The only objective for the northern quarry is to make it safe by sloping the benches using cut and fill techniques	Quarry is fenced off, restricting access.	None

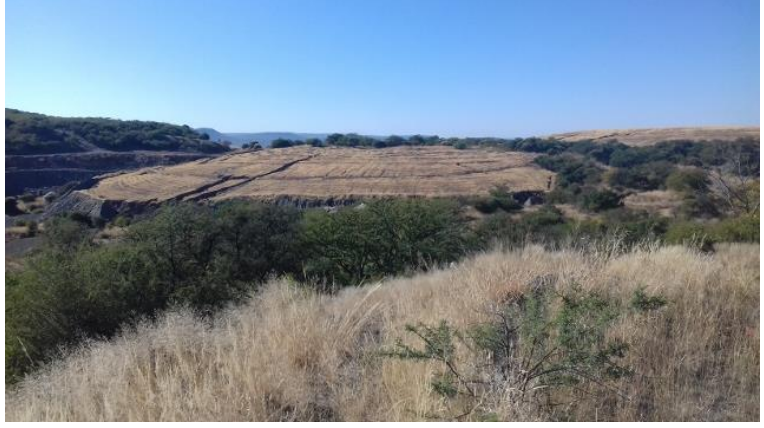
Aspect	Closure objective	Success criteria	Further action required	Photograph (if applicable)
Topography	<p>During the decommissioning phase, all slopes need to be finished to the prescribed 1:3 slope.</p> <p>Reduce the visual impact of the altered topography by a process of sloping, benching and rehabilitation.</p>	Dumps have been sloped as per closure objective and vegetation has established on shaped slopes which limits visual impact.	In-filling of erosion gully's that may appear after storm events. Reshape, rip and seed areas.

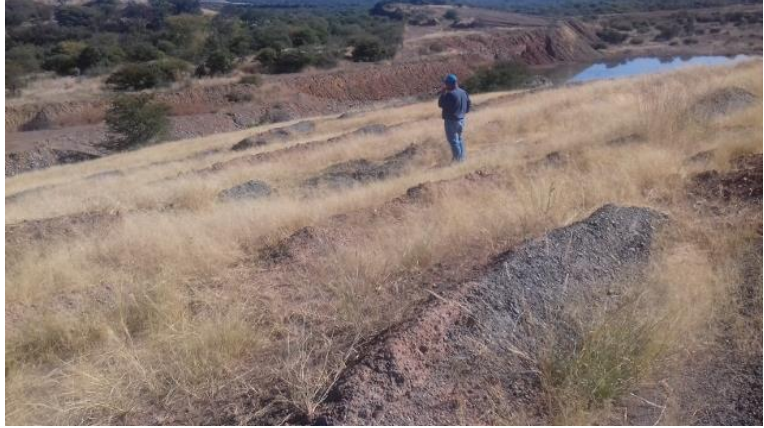
Soils	The re-introduction of the topsoil will return the land to its previous land capability.	Refer to Section 8.1.1	No

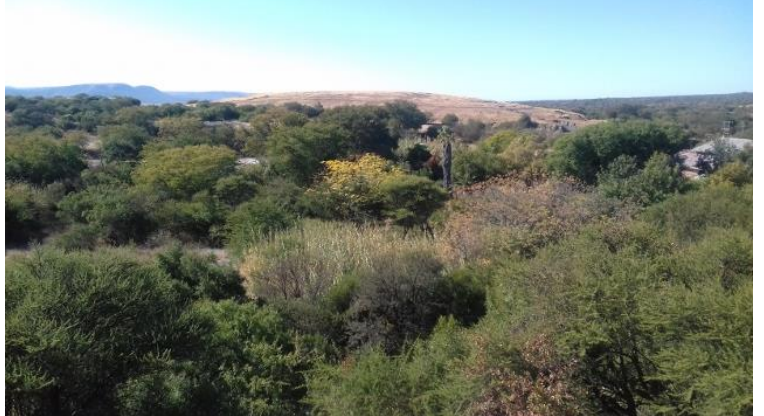
Natural vegetation	During the decommissioning phase the final portions of the mined area must be vegetated and care should be taken to investigate the total area previously mined to identify areas where the progressive rehabilitation and vegetation has not been totally successful.	<p>Vegetation has established on shaped slopes which limits visual impact.</p> <p>Weed species should not be dominating plant cover and indigenous species should be present.</p>	Removal of invader plants as per the rehabilitation procedure.

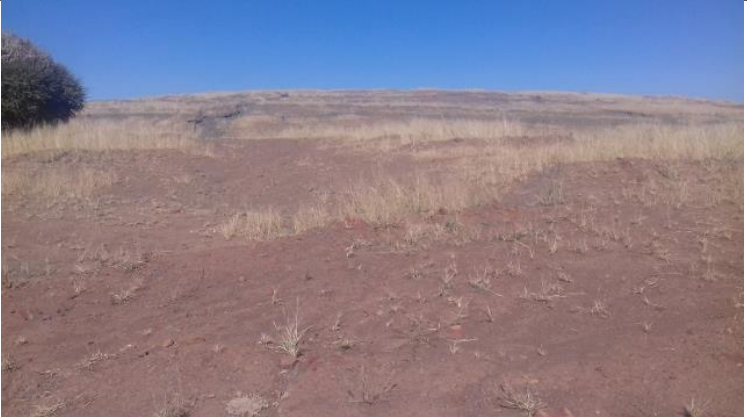
Aspect	Closure objective	Success criteria	Further action required	Photograph (if applicable)
	Special care should be given to: <ul style="list-style-type: none"> Quality of vegetation; Any noxious plants and exotic plants that have established themselves and that have to be removed; and Any signs of erosion. Corrective measures need to be taken depending on the problems identified.	Monitoring according to year 1 template demonstrates that seeded species are establishing.	Re-seed bare areas.

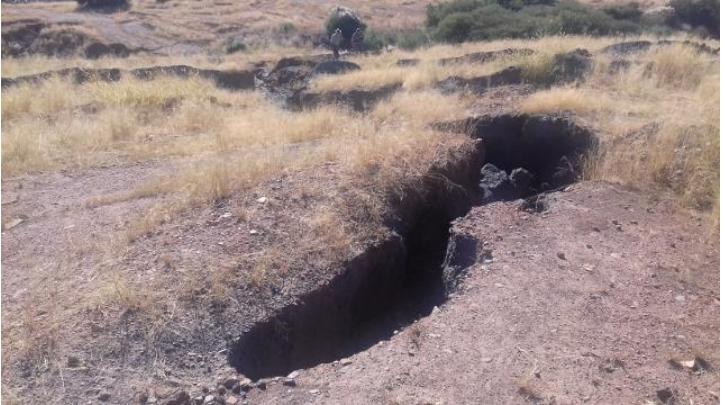
Animal life	Animal life will start returning throughout the process of continuous rehabilitation and it is important that disturbance in rehabilitated areas be limited to the minimum.	Potential fauna habitat should be present.	None. During the site visit, evidence of wildlife was found, such as <i>spoor</i> and droppings. A local farmer also uses certain areas of the mine for cattle grazing.	None
Surface water	Landscaping should facilitate surface runoff and result in free draining areas.	Berms were constructed to manage surface water runoff. Water drainage flows naturally without pooling or flooding. Minimal erosion where water flows from drainage structures.	In-filling of erosion gully's that may appear after storm events. Reshape, rip and seed areas.	<p>Before</p>
