IMERYS (PTY) LTD
ANREF ANDALUSITE MINE CLOSURE
LIABILITY UPDATE

EMP REFERENCE NO: NW30/5/1/2/2/522MR

June 2017

MINE CLOSURE COST ASSESSMENT REPORT

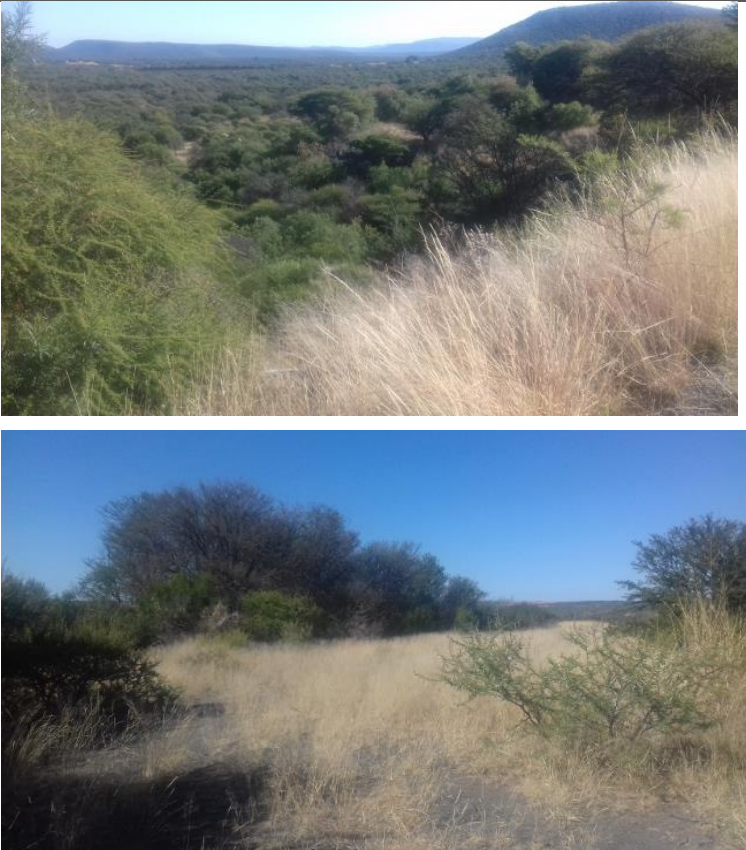
Aspect	Closure objective	Success criteria	Further action required	Photograph (if applicable)
Old slimes dam	Although the slimes dam walls are very steep, it is already well vegetated and further disturbance will not add value.	<p>Indigenous vegetation has established on the slimes dam rehabilitated surfaces.</p> <p>Alien species should not be dominating plant cover and indigenous species should be present.</p> <p>Water drainage flows naturally without pooling or flooding.</p> <p>Minimal erosion where water flows from drainage structures.</p>	<p>Biodiversity survey to verify that adequate vegetation cover has been achieved and that the balance between indigenous and alien species is acceptable.</p> <p>Mitigate areas where erosion is visible through redirecting storm water.</p>

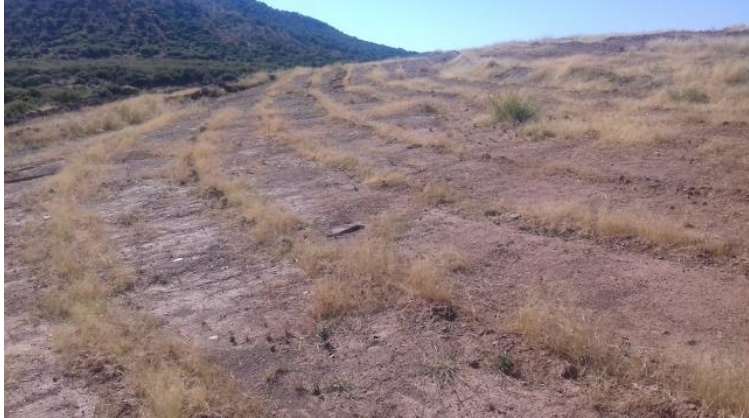
Large waste rock dump	Visually, the southern side wall is the most significant as it is	The dump has been sloped per closure objectives.	Re-seed the dump, as seeds that were sowed was washed away

Aspect	Closure objective	Success criteria	Further action required	Photograph (if applicable)
	<p>visible from the national road. The objective is to decrease the height and reduce the slope in order to successfully re-vegetate.</p>	<p>Vegetation has established on shaped slopes which limits visual impact.</p>	<p>during March 2017 storm. After completion of this step, monitoring will be conducted until the end of 2018 to verify establishment of vegetation.</p>

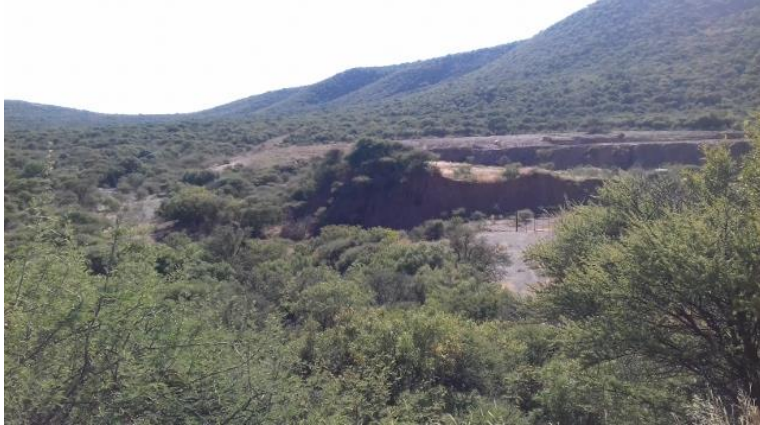
Aspect	Closure objective	Success criteria	Further action required	Photograph (if applicable)
Topsoil stockpiles east and west	Material from the topsoil stockpiles will mainly be used for final sloping and cover to promote vegetation growth. Unused topsoil will be sloped into low lying cavities to allow gradual topography with free drainage.	Any remaining topsoil stockpiles have been sloped as per objective.	One topsoil stockpile was observed during the site visit (14 June 2017). This stockpile will be sloped as per objective.

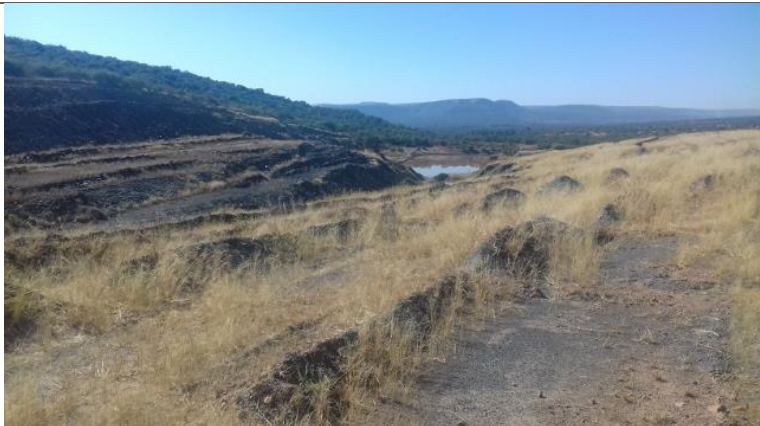
Quarry east	Benches will be sloped using cut and fill techniques.	Benches have been sloped.	None.

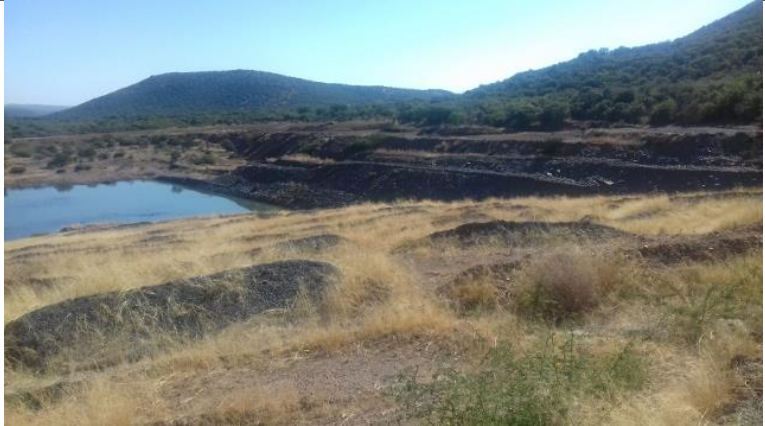
Aspect	Closure objective	Success criteria	Further action required	Photograph (if applicable)
	and prevent siltation of the water body.	No evidence of siltation of nearby natural drainage lines.		
Quarry west	Benches will be sloped using cut and fill techniques.	Benches have been sloped.	None.
