Impala No.16 Shaft

Design Report - Impala No.16 Shaft Waste Rock Dump

SLR Project No.: 710.09003.0091

Impala Platinum Limited

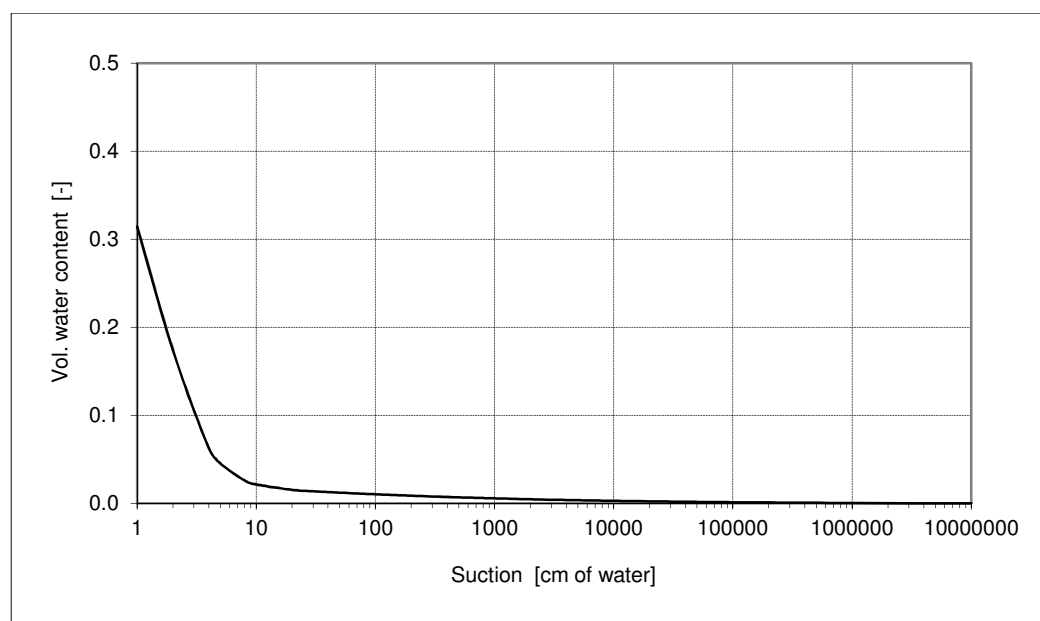
FIGURE 1: WATER RETENTION CURVE FOR WASTE ROCK

A water retention curve shown in Figure 1 was derived for the waste rock using the using a water retention curve prediction model (Aubertin et al. 2003). The low volumetric water content achieved at relatively low suction values indicates that rainfall will essentially infiltrate the dump and then move as a wetting front to the base the dump.

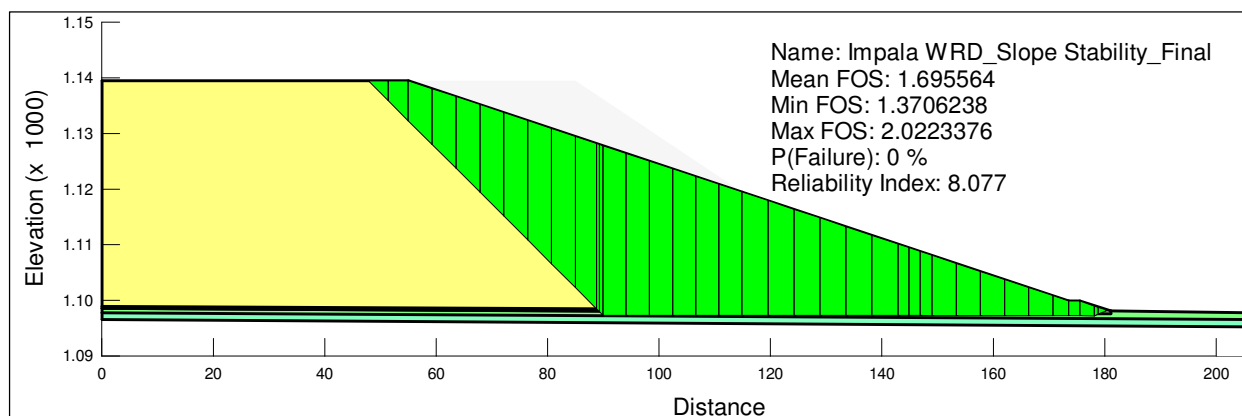
**FIGURE 2: SLOPE STABILITY ASSESSMENT FOR FINAL SLOPE PROFILE**

The results from the stability analysis (reshaped slopes with 5% rainfall infiltration case) are summarised in Table 9, and the analysed failure mode is shown in Figure 2.

The slope stability assessment results show that the WRD will be stable as the calculated mean FOS value is above the recommended values (Table 10).

However it should be noted that during the operations, before the slopes are reshaped, the FOS will be 1.0 as the waste rock material will be standing at an angle of repose. It is recommended that the WRD side slopes be reshaped as soon as practically possible after deposition.
