**PHASE 1 ENGINEERING GEOLOGICAL INVESTIGATION
to DETERMINE the POTENTIAL for TOWNSHIP DEVELOPMENT
at IXOPO, UBUHLEBEZWE LOCAL MUNICIPALITY, KWAZULU-NATAL.**

June 2019

Report number: GS201906X

REPORT ON THE ENGINEERING GEOLOGICAL INVESTIGATION CONDUCTED AT IXOPO, KWAZULU-NATAL.

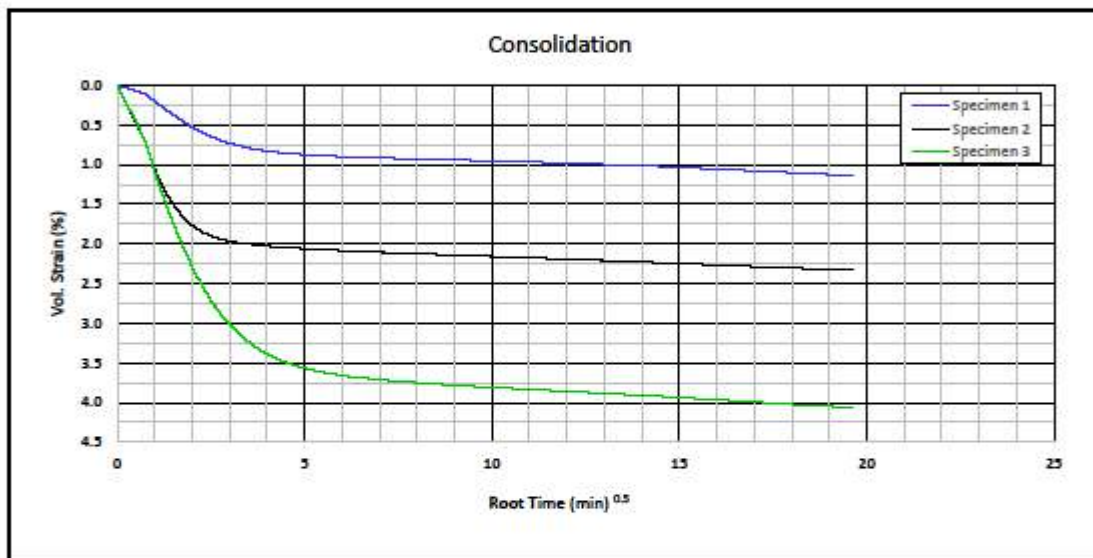
CONSOLIDATED UNDRAINED TRIAXIAL TEST

Client Name: Geoset	Job Number: DVM-85
Project Name: Ixopo	Lab Number: DVM-85-825
Sample: I8	Date: 23/08/2019
Depth: (m) 2.0	Method: BS 1377 Part 8

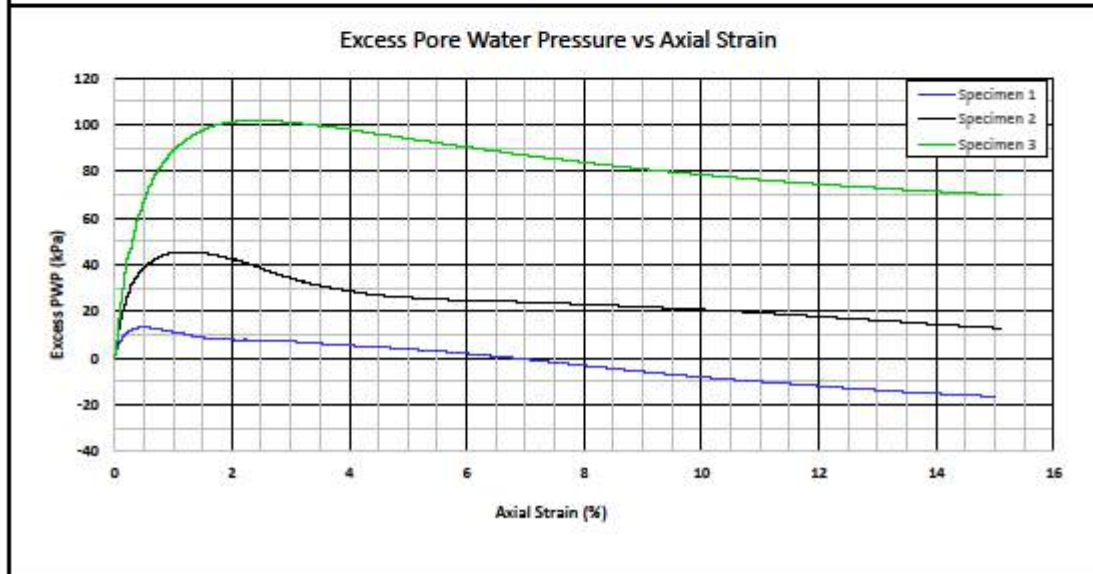
CONSOLIDATED UNDRAINED TRIAXIAL TEST

Client Name:	Geoset	Job Number:	DVM-85
Project Name:	Ixopo	Lab Number:	DVM-85-825
Sample:	1B	Date:	23/08/2019
Depth: (m)	2.0	Method:	BS 1377 Part 8
