WETLAND ASSESSMENT OF THE SUBLIME ROAD UPGRADE

J37158

November 2017

GIBB (Pty) Ltd thanks Exxaro for the opportunity to provide a wetland assessment of the Matla Power Station for the upgrading of the Sublime Road.

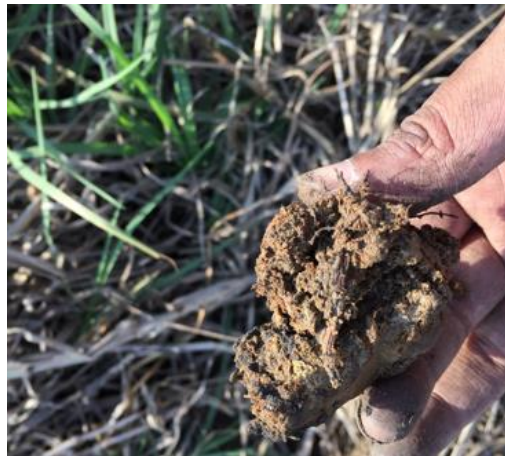
Auger samples were taken on either boundary of the HGM unit. Sample 1 was taken along the boundary of the WWTW. The matrix of Sample 1 was identified to be brownish grey. Within both the 0-20 cm and 30-50 cm horizons many dark orange and yellow mottles were present (Figure 6). The clay content increased from the upper 0-20 cm layer to the bottom 30-50 cm layer, as the upper layer had a moderate amount of clay with a high sand content, whereas the bottom layer was predominantly clay.

Figure 6: Sample 1 in HGM 1 showing presence of yellow mottles

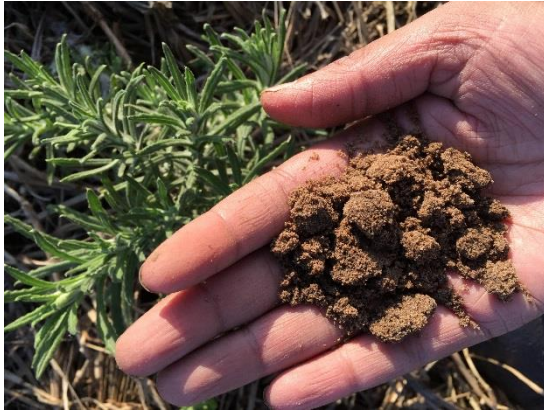
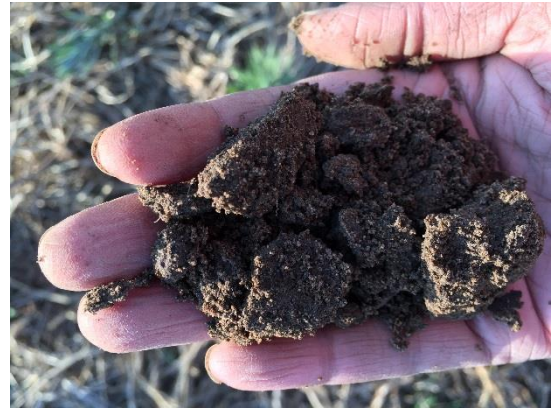
Sample 2 was taken along the boundary of the crop lands. The sample had a brown matrix with very low OM content. Mottles were completely absent in the 0-20 cm layer, with a few occurring in the 30-50 cm layer. There was a distinct change in horizon, with the soils transitioning from a light brown colour and sandy texture, to a darker brown clayey textured soil (Figure 7). Sample 2 was therefore indicative of the outer temporary zone of the wetland.

Figure 7: Sample 3 in HGM 1

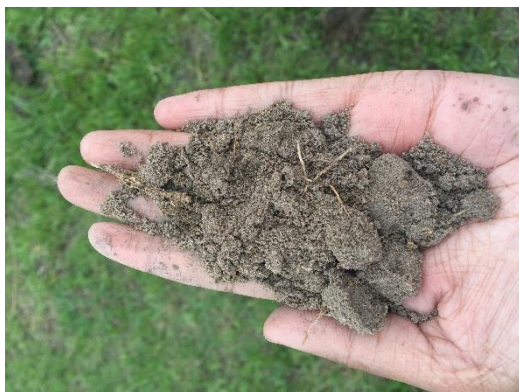
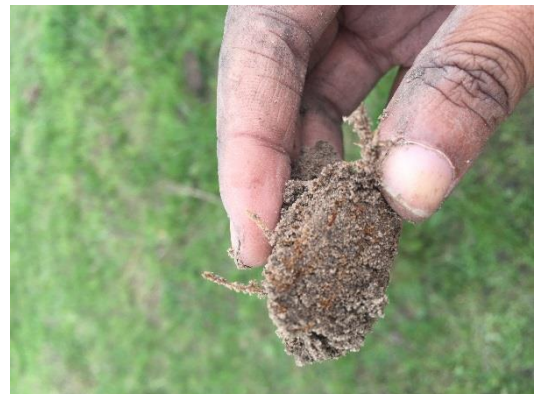
Transects were taken through the arm of the system, as well as through the larger portion. Sample 1 was taken along the boundary of the arm of the system. The matrix of Sample 1 was identified to be brown, and consisted of low amount of organic matter. Within the 0-20 cm layer the presence of mottles were non-existent, whereas in the 30-50 cm layer there was an abundance of small clear mottles present (Figure 8). Furthermore, the soil sample taken was found to be high in sand content.

Figure 8: Sample 1 in HGM 2

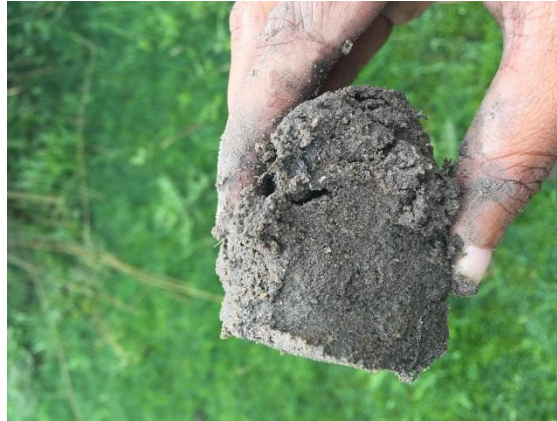
Sample 2 was taken in the lower middle portion of the arm. The sample had a grey matrix with very high Organic Matter (OM) content. Mottles were completely absent in both the 0-20 cm and 30-50 cm layers (Figure 9). There was a distinct change in horizon, with the soils

transitioning from an organic rich, dark brown layer to a gleyed, greyish brown layer. Within both layers the samples were high in clay content. Gleyed soils implies long periods of waterlogging which causes all the colour-forming minerals to go into solution, therefore this was indicative of permanently saturated soils.

Figure 9: Sample 2 in HGM 2

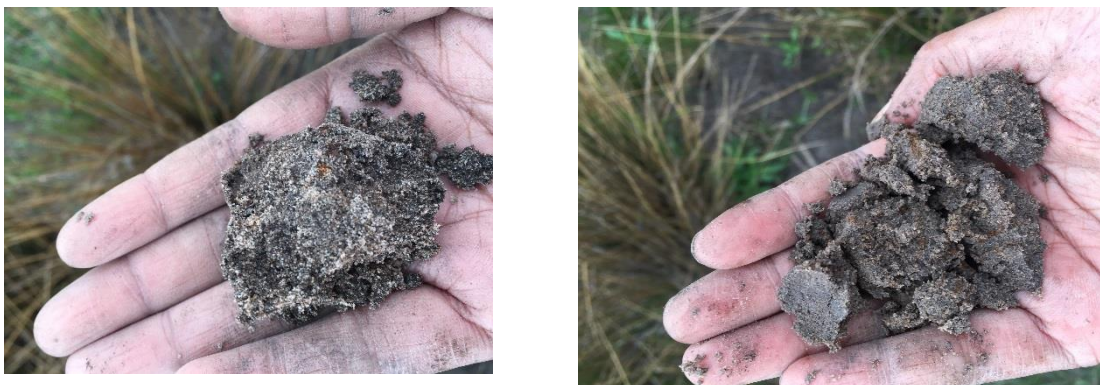
Samples 3 to 5 were taken in the main body of HGM 2. Sample 3 and Sample 5 were found to be very sandy in texture, with the top layers encompassing calcium carbonate from calcrete used on the adjacent road (Figure 10 – sample 3). The matrix of these samples were identified to be greyish brown with very low OM content. Mottles were absent in the 0-20 cm layer, with few feint, small, orange mottles present in the 30-50 cm layer (Figure 10 – sample 5). In addition, Samples 3 and 5 were found to be predominantly sandy in texture. These samples were therefore indicative of the outer most boundaries of HGM unit 2.

Figure 10: Sample 3 (left) and Sample 5 (right) in HGM 2

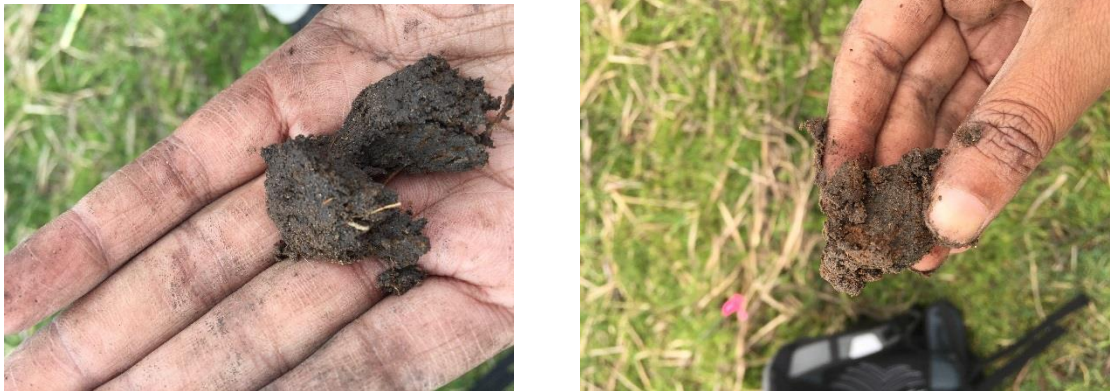
Figure 11: Sample 4 in HGM 2

Sample 4 was taken in approximately the middle of the system. The soil matrix of Sample 4 was found to be brownish grey with a relatively high OM content. Within both the 0-20 cm and 30-50 cm layers there were many mottles present (Figure 11). The soil within this sample was found to be very high in clay content throughout both layers and was therefore indicative of the seasonal zone.

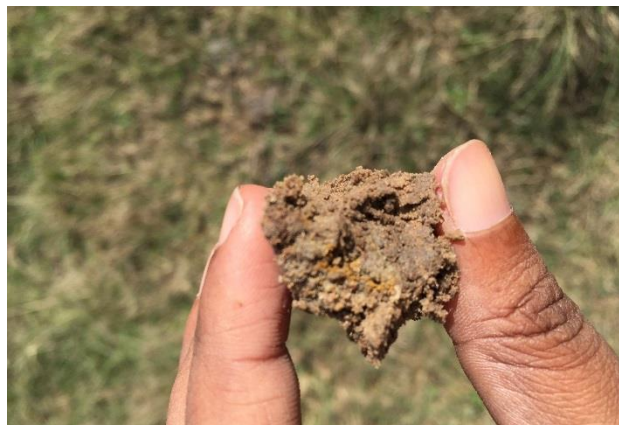
Three auger samples were taken throughout the HGM unit. Sample 1 was taken along the boundary closest to the road. The matrix of Sample 1 was identified to be brownish, and consisted of an intermediate amount of organic matter. Within both the 0-20 cm and 30-50 cm layers there was an abundance of yellow and orange mottles (Figure 12). The soil sample also revealed a clear distinction in the soil horizons, as the sample transitioned from a very sandy A-horizon to a more clay rich and greyer than the B-horizon, indicating seasonally saturated soils.

Figure 12: Sample 1 in HGM 3

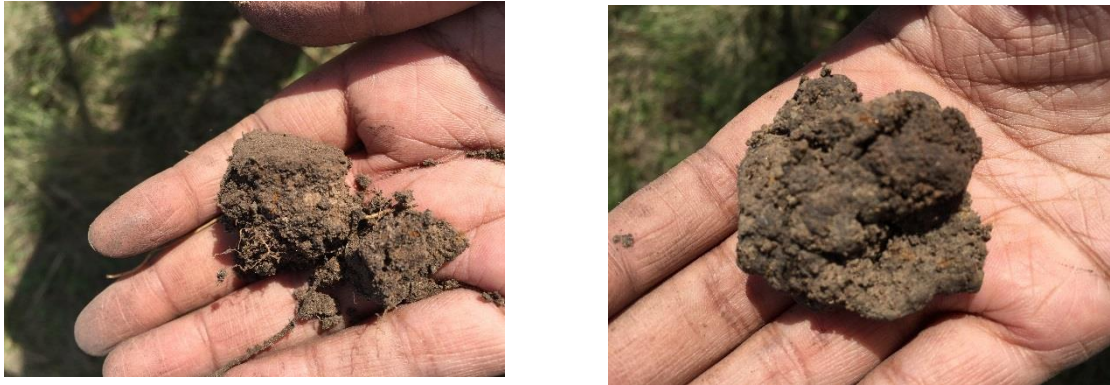
Samples 2 and 3 were taken on opposite boundaries of the HGM unit. These samples had a brown matrix with very low OM content. Mottles were lacking in the 0-20 cm layer, with a few occurring in the 30-50 cm layer (Figure 13). Samples 2 and 3 were therefore indicative of the boundary of the temporary zone of HGM unit 3.

Figure 13: Sample 2 (left) and 3 (right) in HGM 3

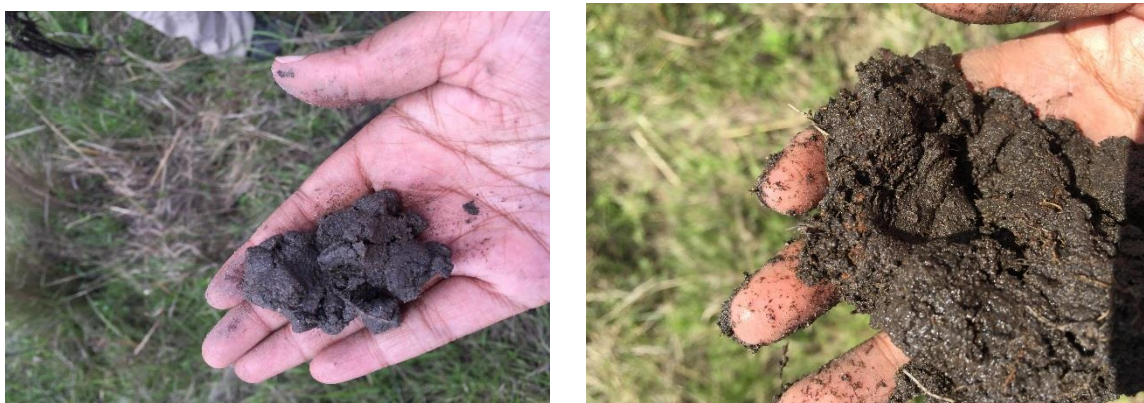
Sample 1 was taken at the closest boundary of the WWTW. The sample was found to have a greyish brown matrix with a high OM content and evidence of gleyed soils were present (Figure 14). In the 0-20 cm there were no mottles present, whereas in the 30-50 cm layers there were a few mottles present (Figure 14). The soils within this sample were saturated and were rich in clay.

Figure 14: Sample 1 in HGM 4

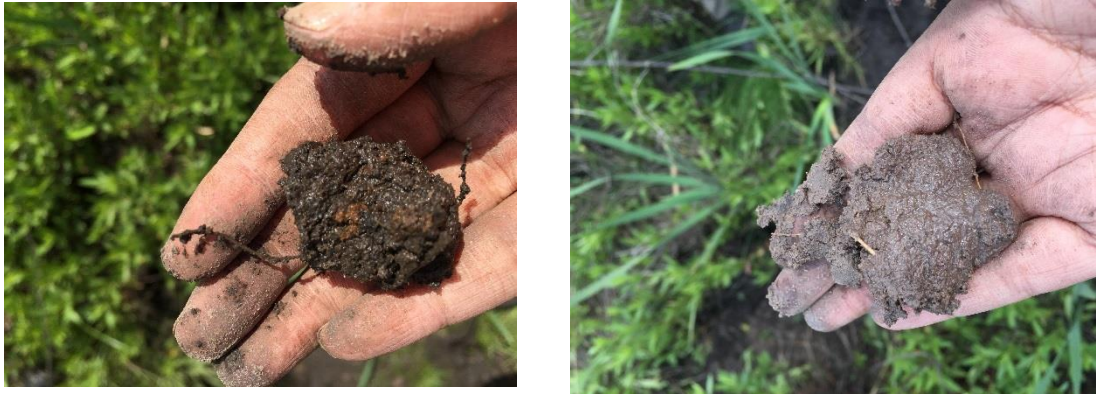
A transect was taken through HGM 4 at the opposite end of the WWTW, at which samples 2-5 were taken. Sample 2 comprised of a grey matrix with a high OM content and was waterlogged. There were no mottles present in the upper 0-20 cm layer, with a few mottles present in the 30-50 cm layer (Figure 15). This sample was clearly indicative of permanently saturated soils.

Figure 15: Sample 2 in HGM 4

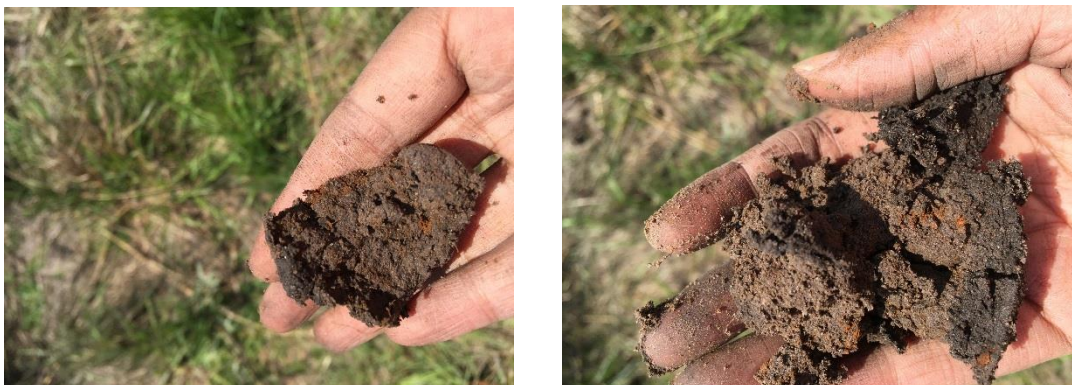
The matrix of sample 3 was brownish grey and had an intermediate OM content. Within this sample there was an abundance of mottles present in both the 0-20 cm and 30-50 cm layers (Figure 16). Sample 3 was therefore indicative of soils which are seasonally inundated.

Figure 16: Sample 3 in HGM 4

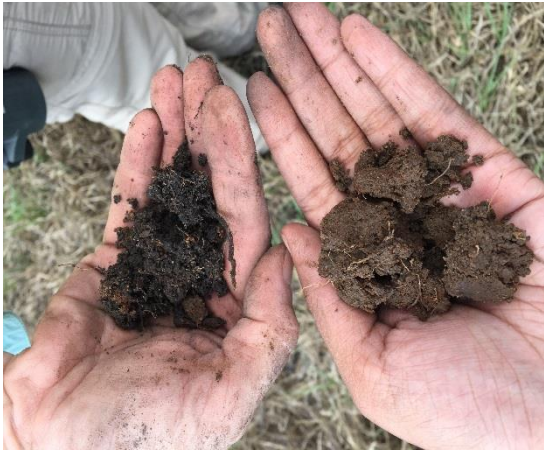
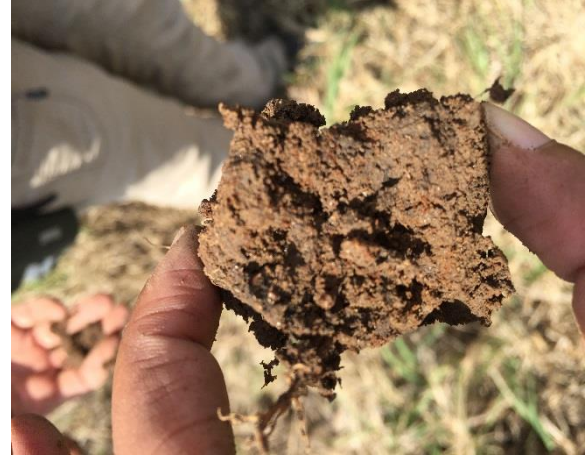
Sample 4 had a matrix of brown with an intermediate amount of OM. Mottles sparsely occurred in the lower 30-50 cm layers, with no mottles present in the upper 0-20 cm layer. The soil profile was indicative of temporary wet soils (Figure 17).

Figure 17: Sample 4 in HGM 4

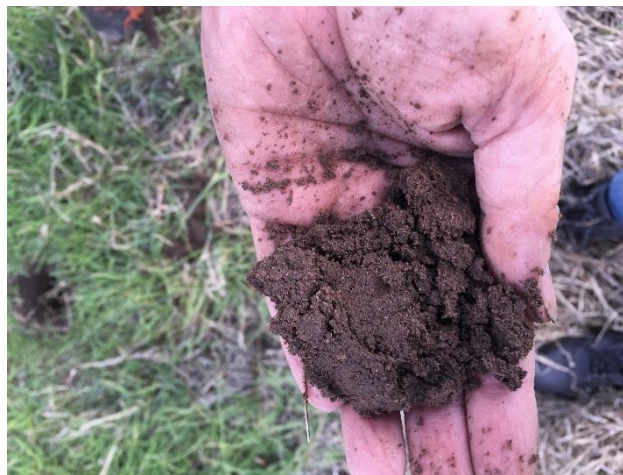
Sample 5 displayed a brown matrix, with no mottles present and no indication of wetness. Sample 5 was therefore indicated the terrestrial zone (Figure 18).

Figure 18: Sample 5 in HGM 4

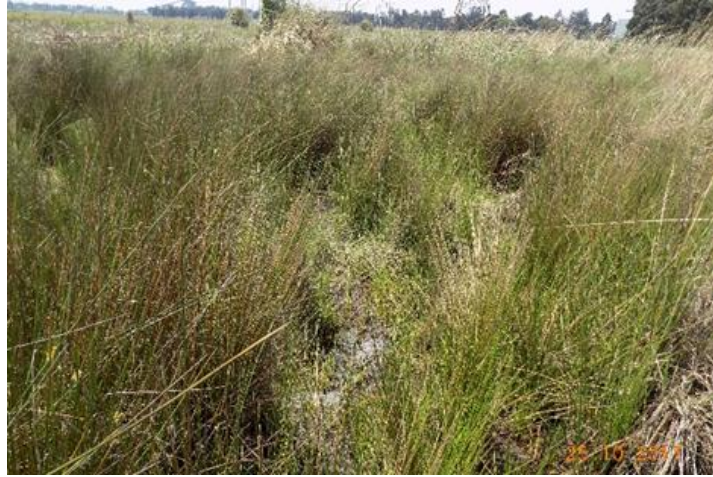
Vegetation within the wetland systems consisted of hygrophilous vegetation. Larger reed species occurred where there was standing water on the east side of the road, while perennial grasses and sedges were more common on the west side. Common grass species included *Juncus effusus*, *Cyperus spp.*, *Hyparrhenia sp.*, *Eragrostis chloromelas*, *Leersia hexandra*, *Pennisetum clandestinum*, *Typha capensis*, *Cynodon dactylon*, *Imperata cylindrica*, *Phragmites australis*, and *Paspalum distichum*. Few herbaceous species were observed. Common species included *Homeria pallida*, *Limosella major*, and *Arctotis arctotoides*.

Figure 19 Dominant Vegetation type (*Juncus Effusus*) found in HGM 2, 3, 4
