**A 3RD REPORT ON THE ARCHAEOLOGICAL MONITORING WORK
AT THE KATHU EXTENSIONS 6-10 TOWNSHIP ESTABLISHMENT ON
PORTIONS 1 & 2 OF THE FARM KALAHARI GHOLF & JAG LANDGOED 775
GAMAGARA LOCAL MUNICIPALITY (KATHU), NORTHERN CAPE PROVINCE**

REPORT: APAC022/59

June 2022

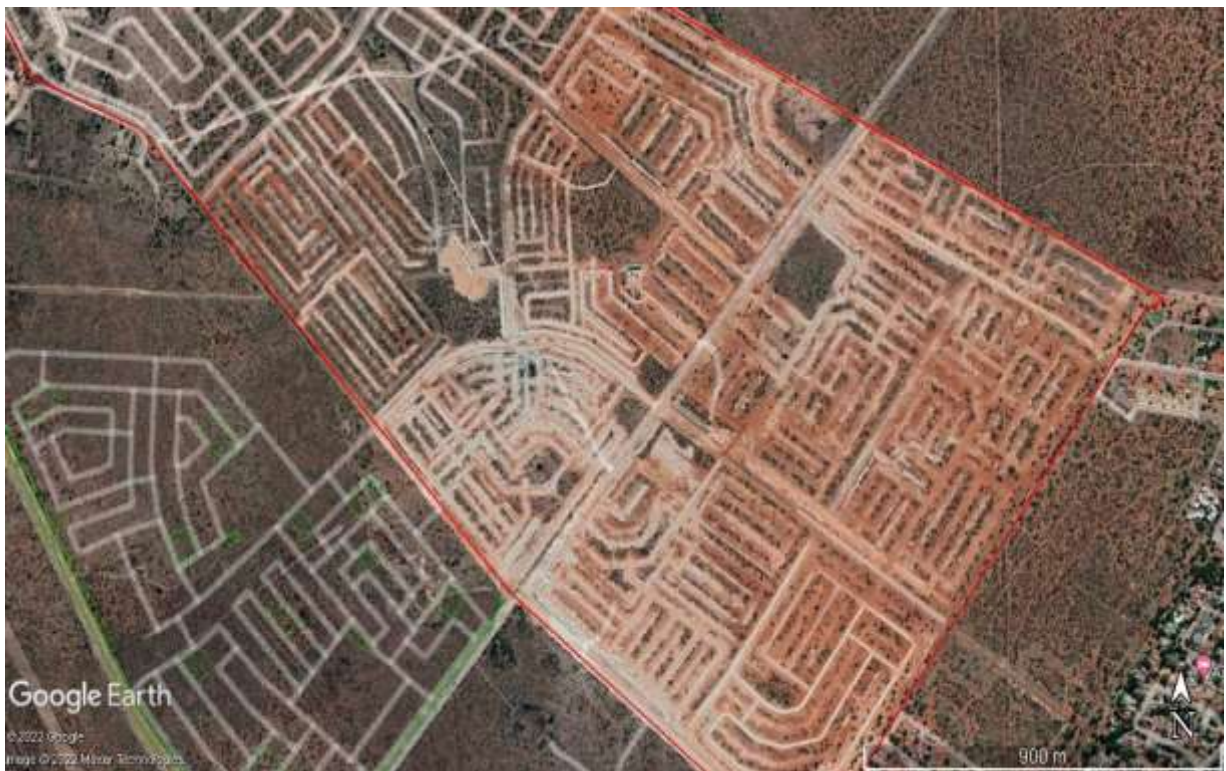
Figure 3: A closer view of the study & development area in March 2022 showing the extent of the earthworks related to the installation of services (sewerage, water pipelines & internal road networks) (Google Earth 2022).

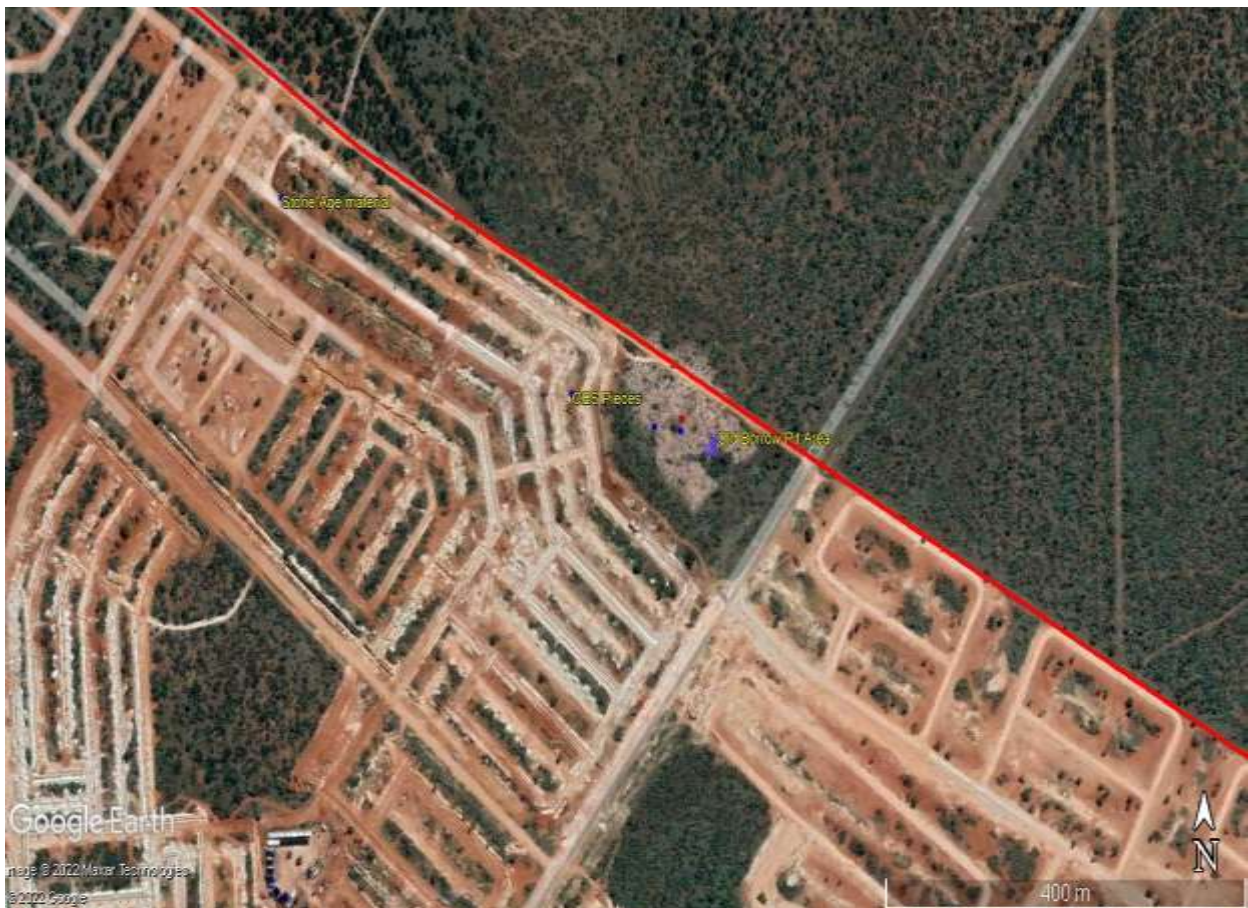
1. Ostrich Egg Shell (OES) fragments: S27.67683 E23.03275
2. Spoil heap with possible raw material, cores, waste flakes & flake-tools: S27.67529 E23.02944
3. Old Borrow Pit with stone tools: S27 40 37.30 E23 02 02.40 (March 2022); S27.67710 E23.03364 & S27.67712 E23.03398

Figure 4: Areas where Stone Age material was recorded during the 3rd Monitoring Site Visit in June 2022. The old borrow pit locality is also indicated again (Google Earth 2022).

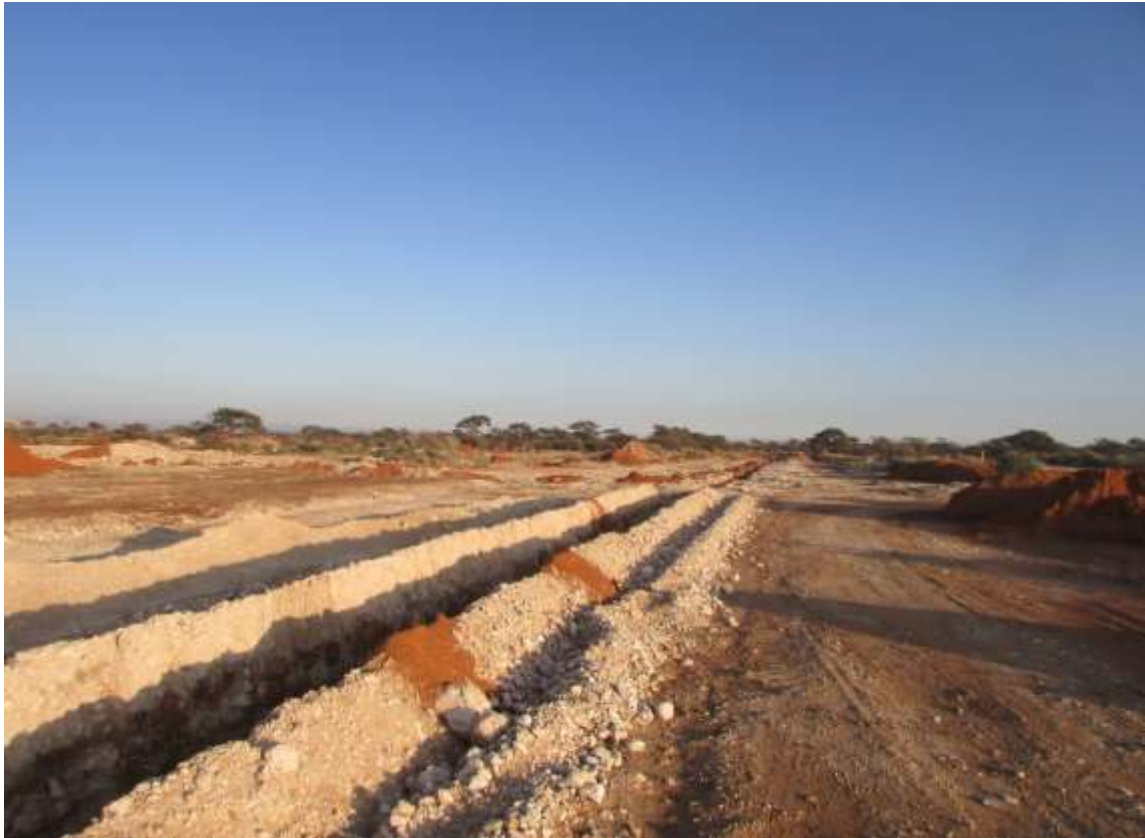
1. In areas where open excavation trenches is still visible there is a thin layer of red Aeolian (Kalahari) sand overlaying a thick layer of calcrete. Very few artifacts (Stone Age stone tools) are present, but where they are these are located between the red sand and calcrete layers

Figure 5: Some of the trenches and areas checked in June 2022.

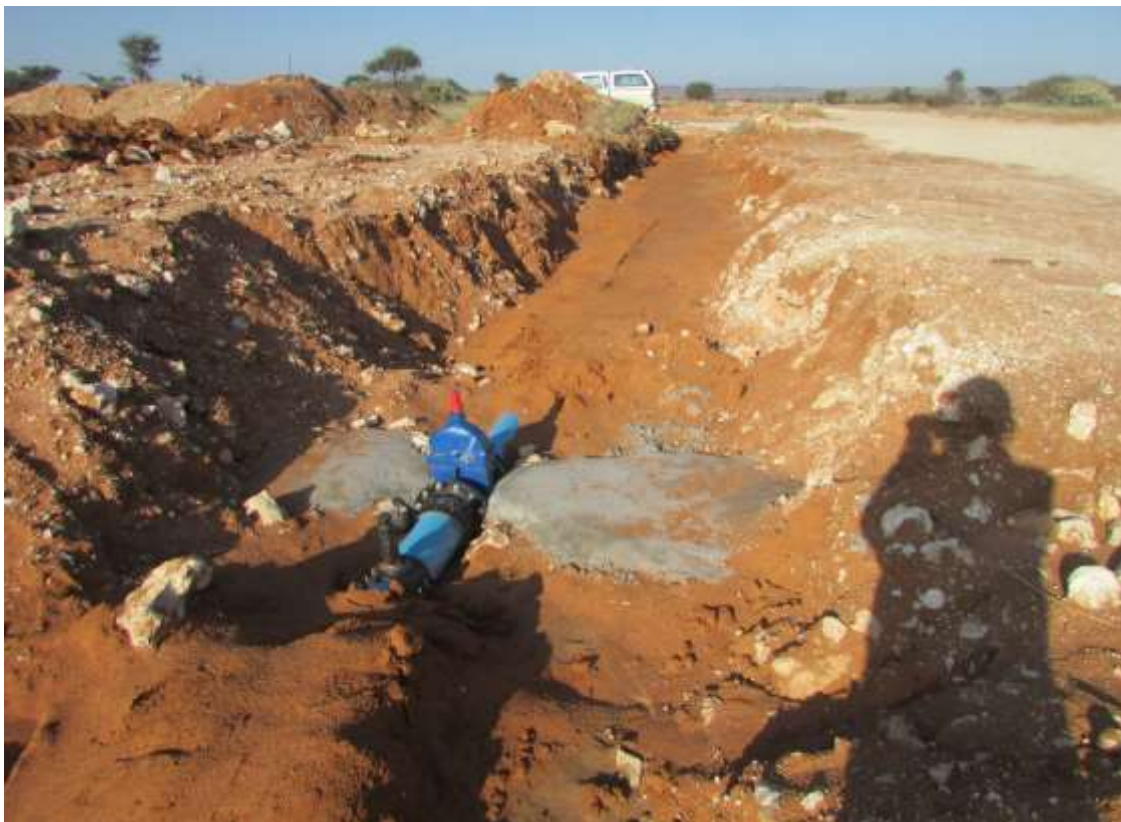
Many of the old trenches have been covered since the last visit, with pipes and other services installed, while a few new ones have been opened. Work on the development is continuing, with intermittent breaks as a result of public holidays and long weekends. Monitoring will continue in the forthcoming months as required.

Figure 6: Some of the trenches have been closed and services installed.

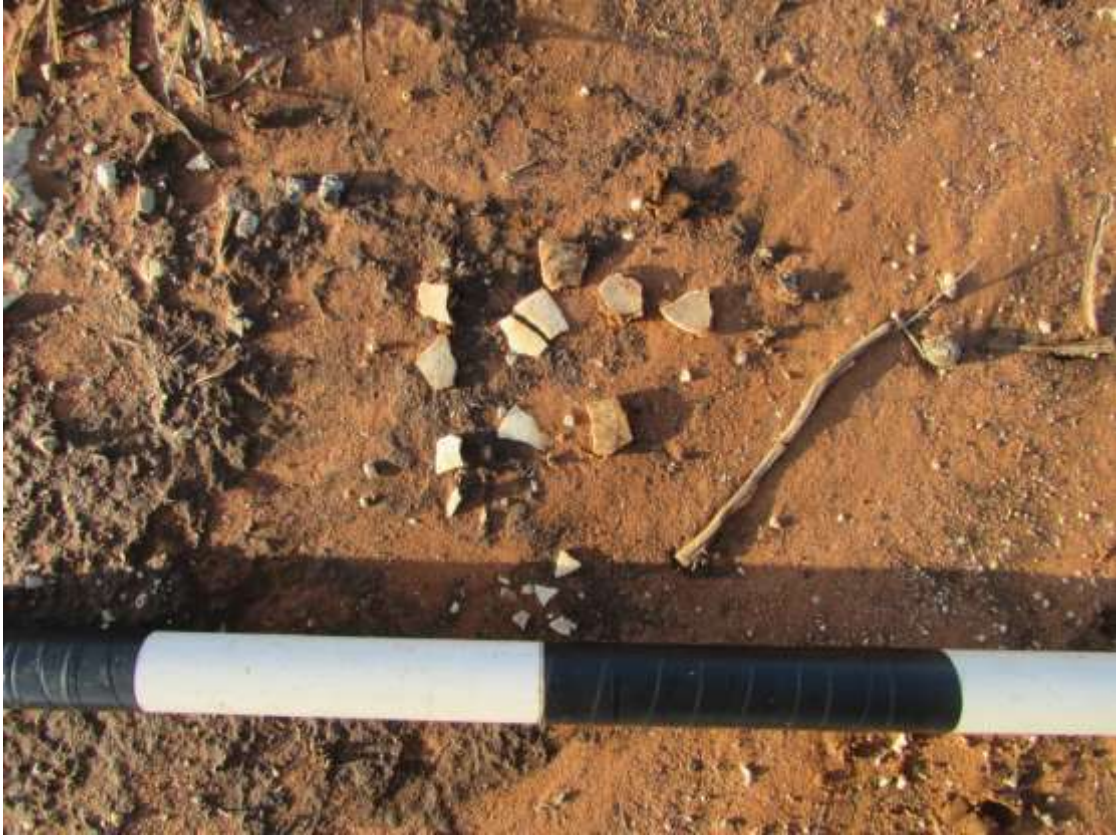
Figure 7: Pieces of Ostrich Egg Shell.

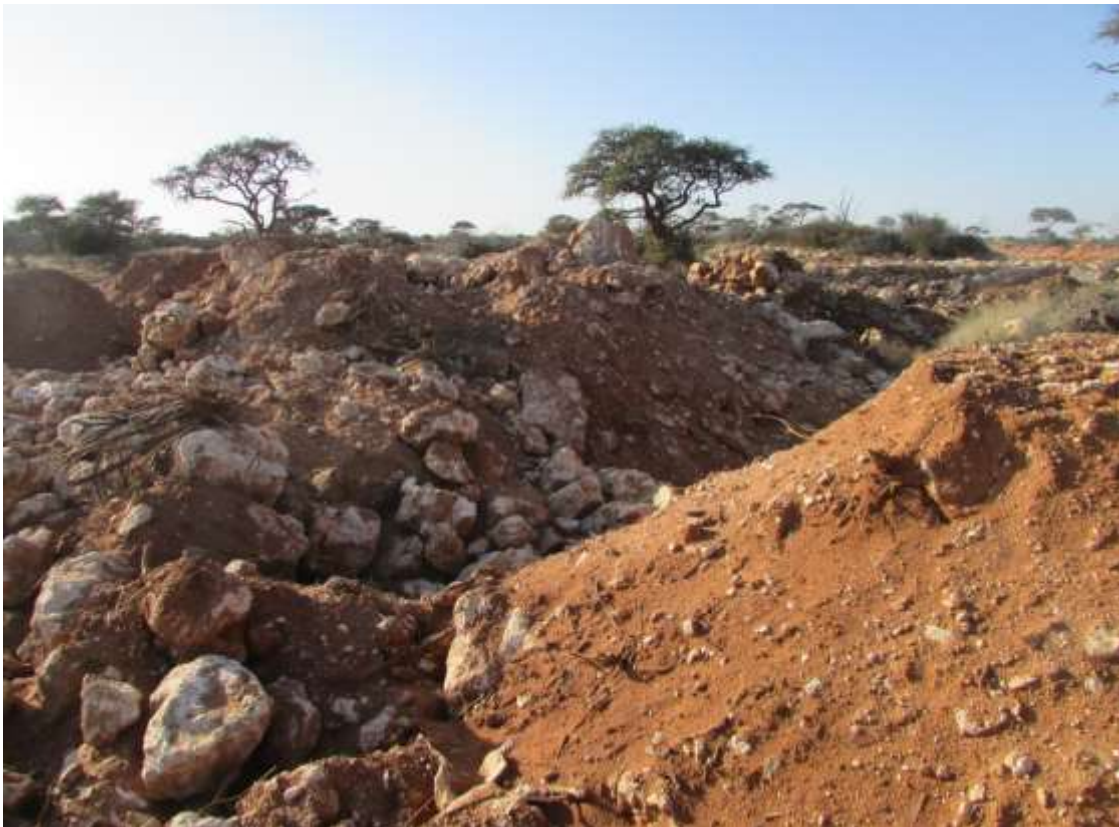
2. There is no indication of extensive artifact scatters or deposits in the waste rock dumps and soil spoil heaps. Small numbers of objects occur in some locations. These included waste-flakes, cores and flake tools such as scrapers. Determining the exact origin of these artifacts is however not possible as the waste rock and soil dumped here could have come from anywhere on the larger development site. Some Ostrich Egg Shell (OES) pieces were also identified in one location in an area that has been scraped/leveled as part of the construction work taking place.

Figure 8: Some of the new waste rock and soil dumps inspected in June 2022.

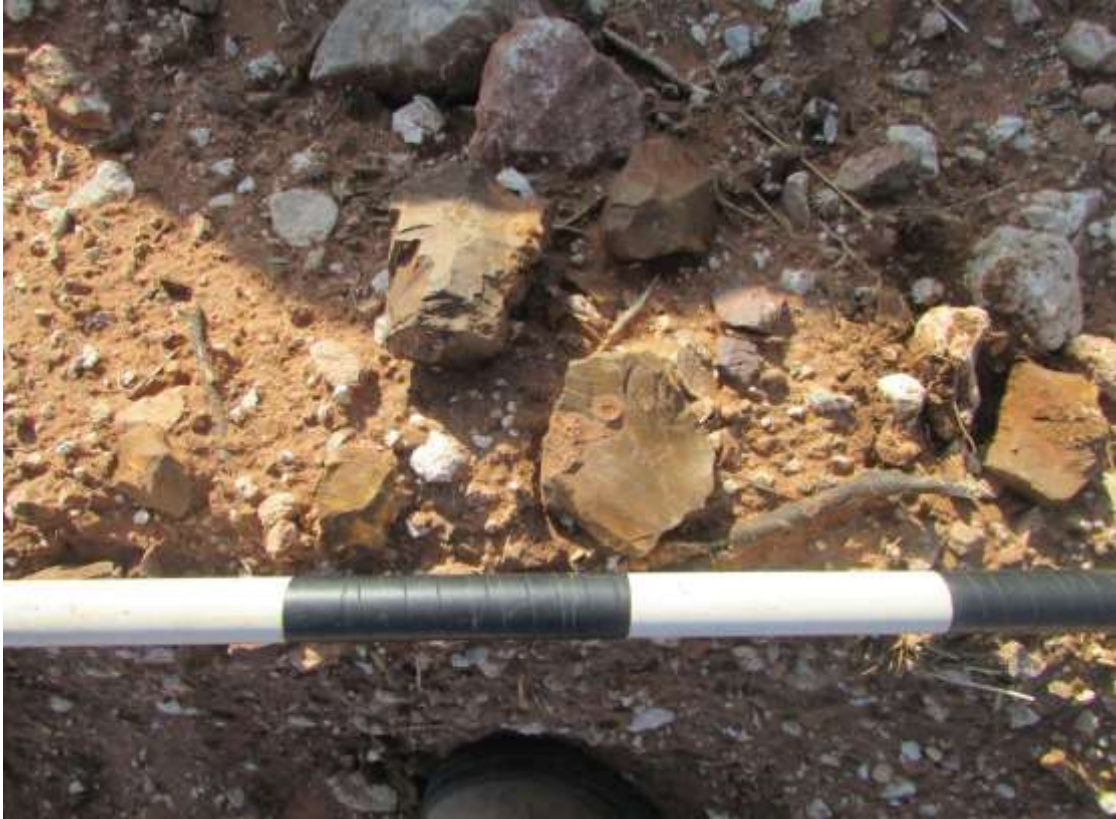
Figure 9: Cores, waste-flakes and a possible scraper found here.

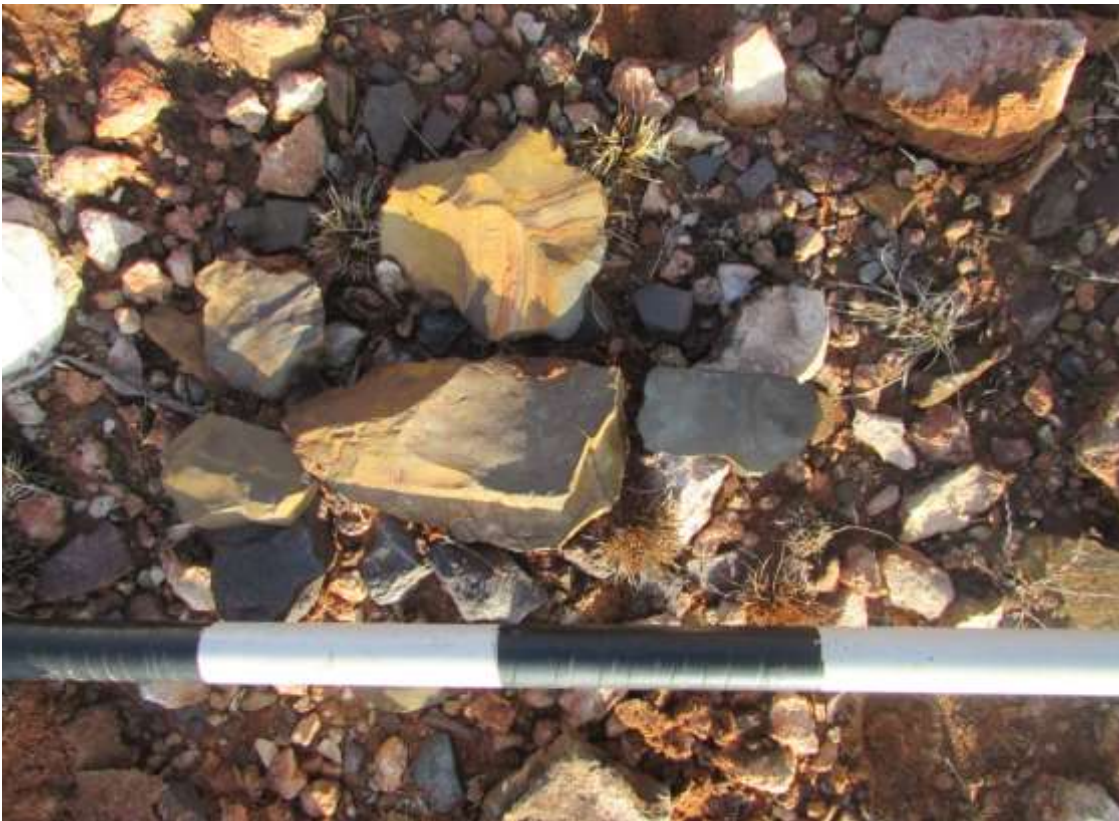
During the 3rd Visit this area was again inspected in a bit more detail and a number of scatters of Stone Age material were recorded. Although the previous activities at the location (related to the borrowing/quarrying work) have obviously impacted on the archaeology of the site, there remains a possibility that in situ deposits could still be located in and around the borrow pit. It is recommended that this location be kept in tack and that the Kathu 6-10 Township Development incorporate the site into their plans and that the site be properly demarcated and fenced-off with Site Signage. It should be included in a Heritage Site Management Plan for the Development, together with the Grave Site that has already been included in a similar Plan.

Figure 10: Stone Age tools in the old borrow pit area (found in June 2022).

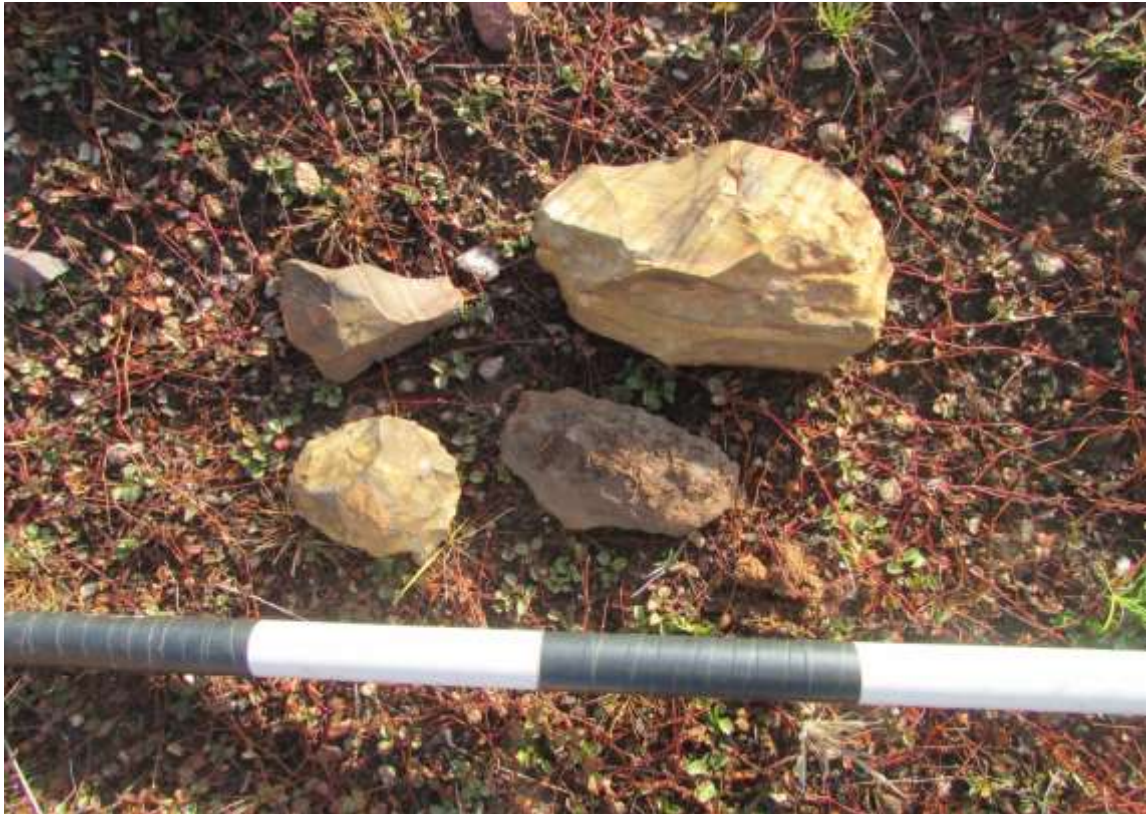
Figure 11: More Stone Age tools in the old borrow pit site.

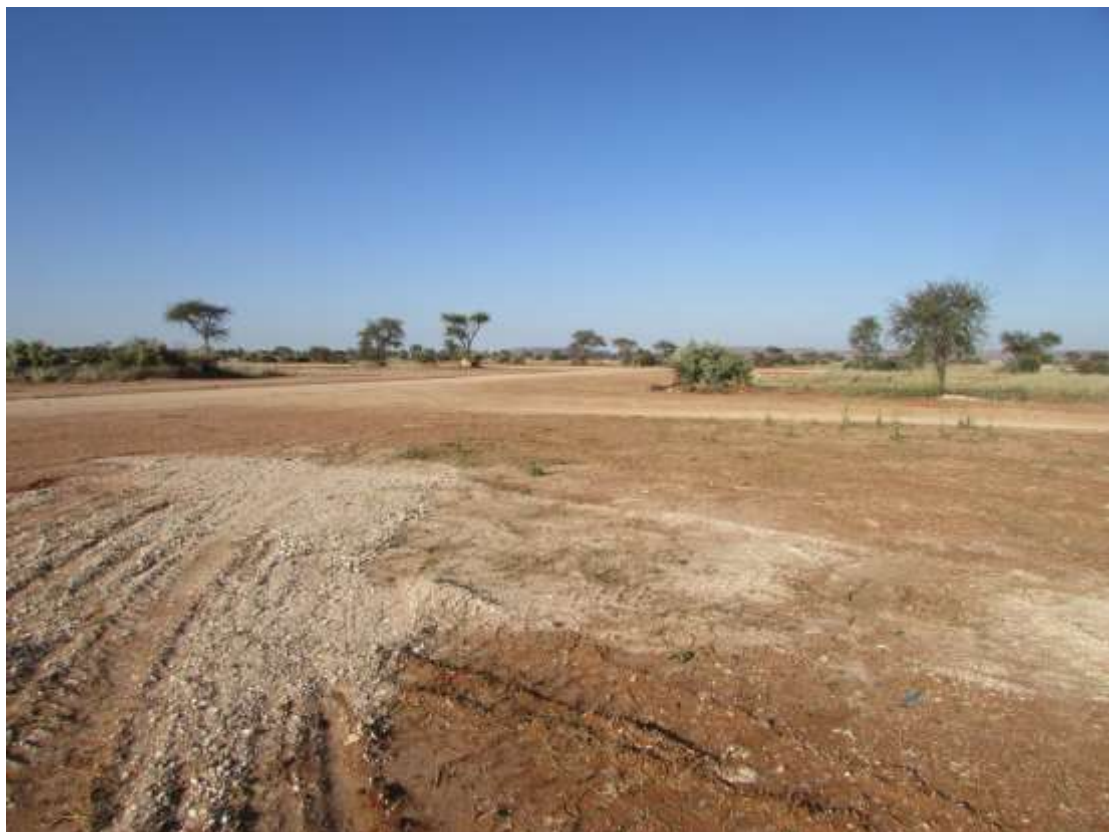
Figure 12: Another section of the Development where internal roads have been established and services had been installed.

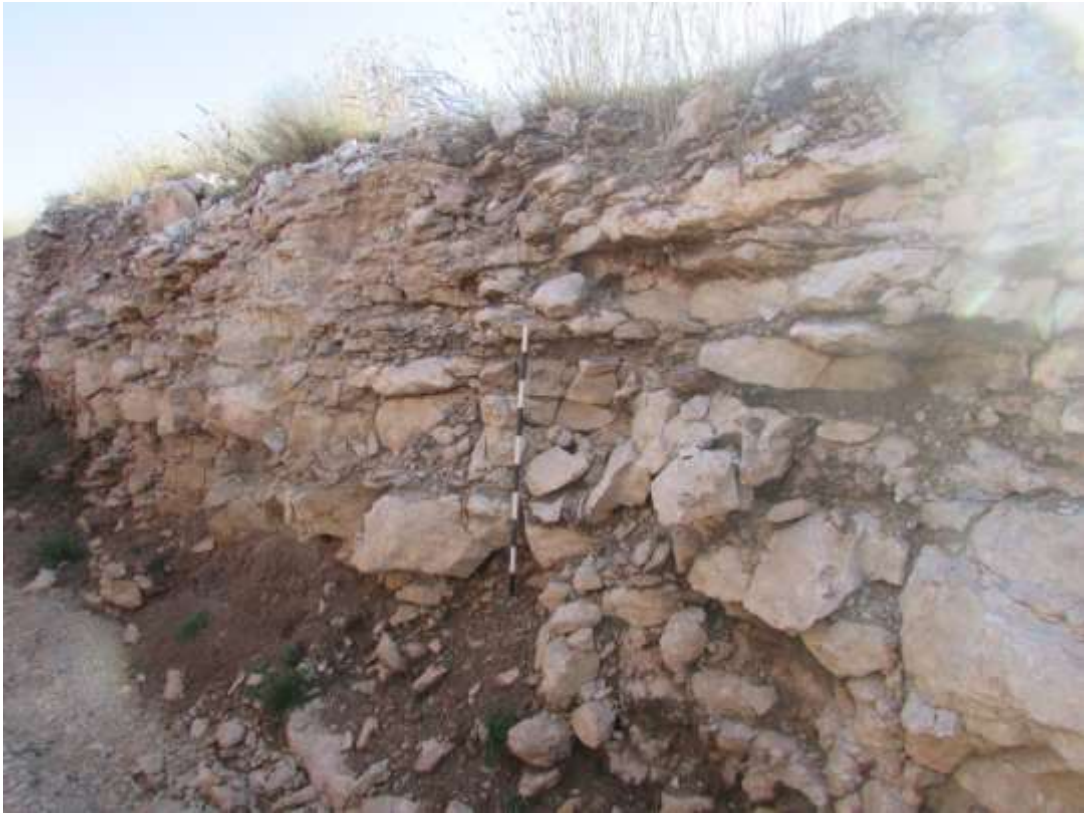
Figure 13: One of the new trenches inspected in June 2022. Note the thick calcrete.

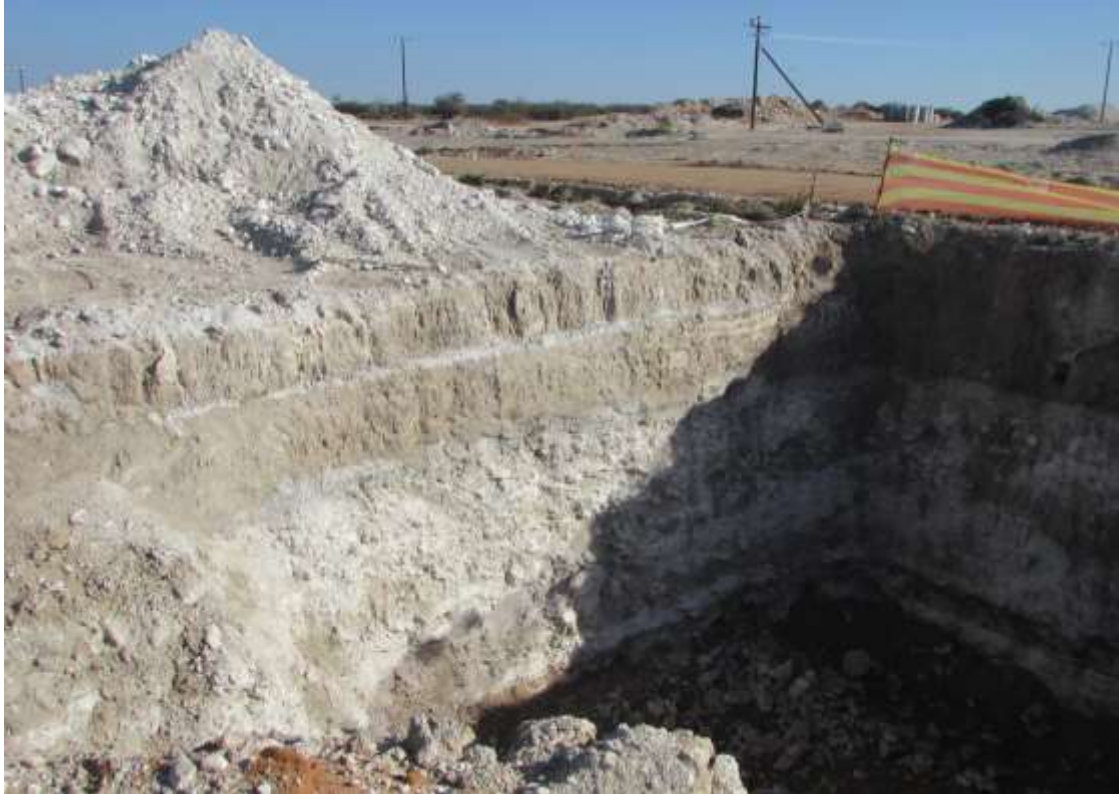
Figure 15: A deep trench/test pit in a part of the development area. Note the very thick calcrete layers.
