APPENDIX A : VEGETATION REPORT

AIR QUALITY

Kapstewel – Proposed Iron ore/Manganese mine

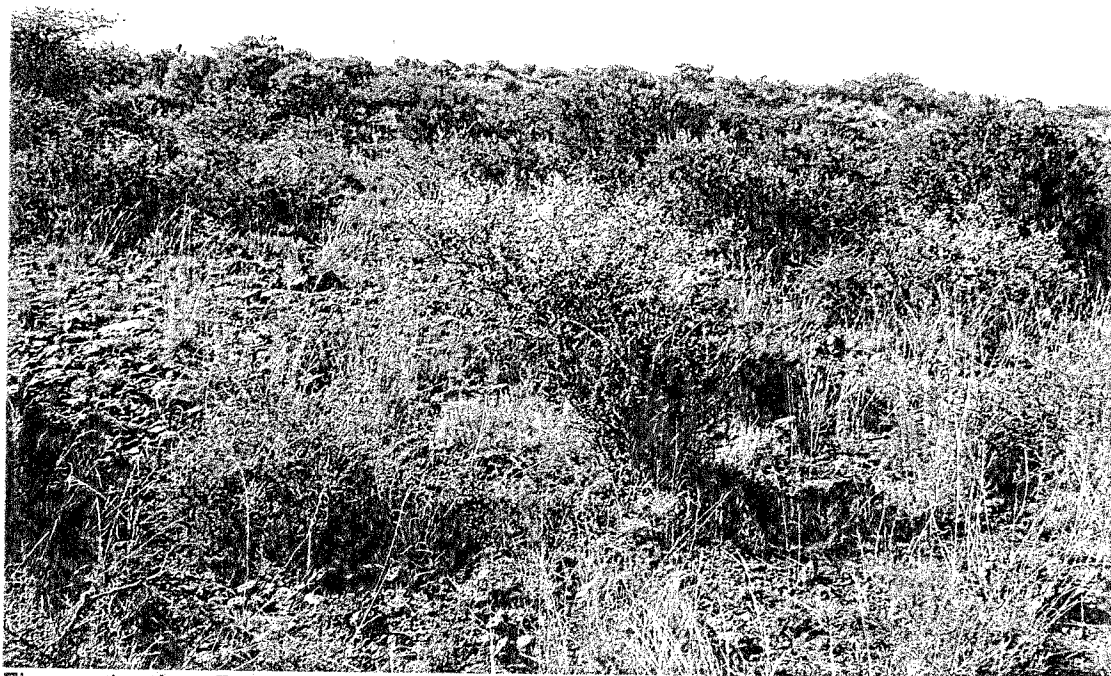
The dominant woody species in this vegetation unit are *Putterlickia saxatilis*, *Rhus ciliata*, *R. burchellii*, *Tarchonanthus camphoratus*, *Lebeckia macrantha* and *Euclea undulata*. Dominant grass species are *Cymbopogon pospischilii*, *Aristida scabrivalvis*, *Eragrostis curvula*, *Sporobolus fimbriatus*, *Eragrostis nindensis* and *Brachiaria nigropedata*. The most prominent herbs include *Chrysocoma ciliata*, *Chascanum pinnatifidum* var. *pinnatifidum*, *Peliostomum leucorrhizum*, *Sutera halimifolia*, *Hermannia bryoniifolia*, *Anthospermum rigidum* subsp. *pumilum* and the shrub *Stachys burchelliana*.

Figure 1: the *Putterlickia saxatilis* – *Cymbopogon pospischilii* Open Mountain Shrubland.

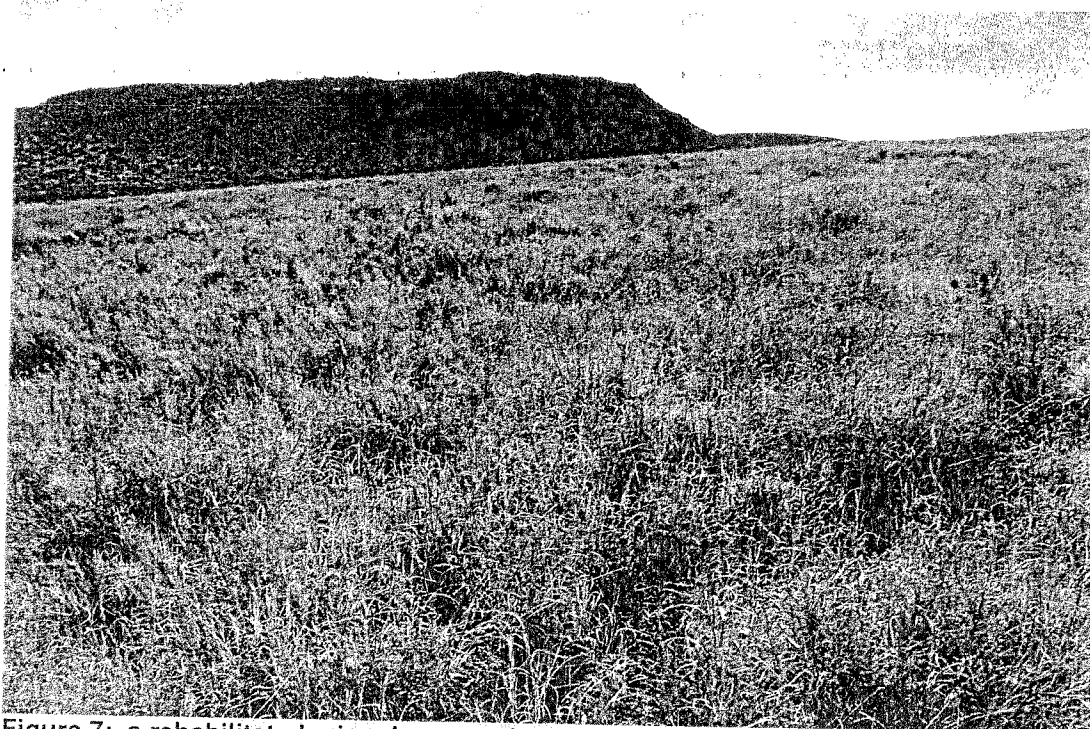
Figure 7: a rehabilitated mine dump on the farm Kapstewel

This vegetation unit is situated on areas that were partially or totally destroyed as a result of prospecting; mining; ore processing or other anthropogenic land uses and is still operational or un-rehabilitated (Figure 6). The vegetation occurring on these areas consists of a mixture of fragmented natural vegetation and pioneer vegetation in areas where the soil surface has been disturbed or totally stripped of natural vegetation. It also includes vegetation that has established on un-rehabilitated mine dumps, processing areas, opencast mining areas, etc. One rehabilitated mine dump (Figure 7), where the grass species *Cenchrus ciliaris* dominates, is included in this vegetation unit.

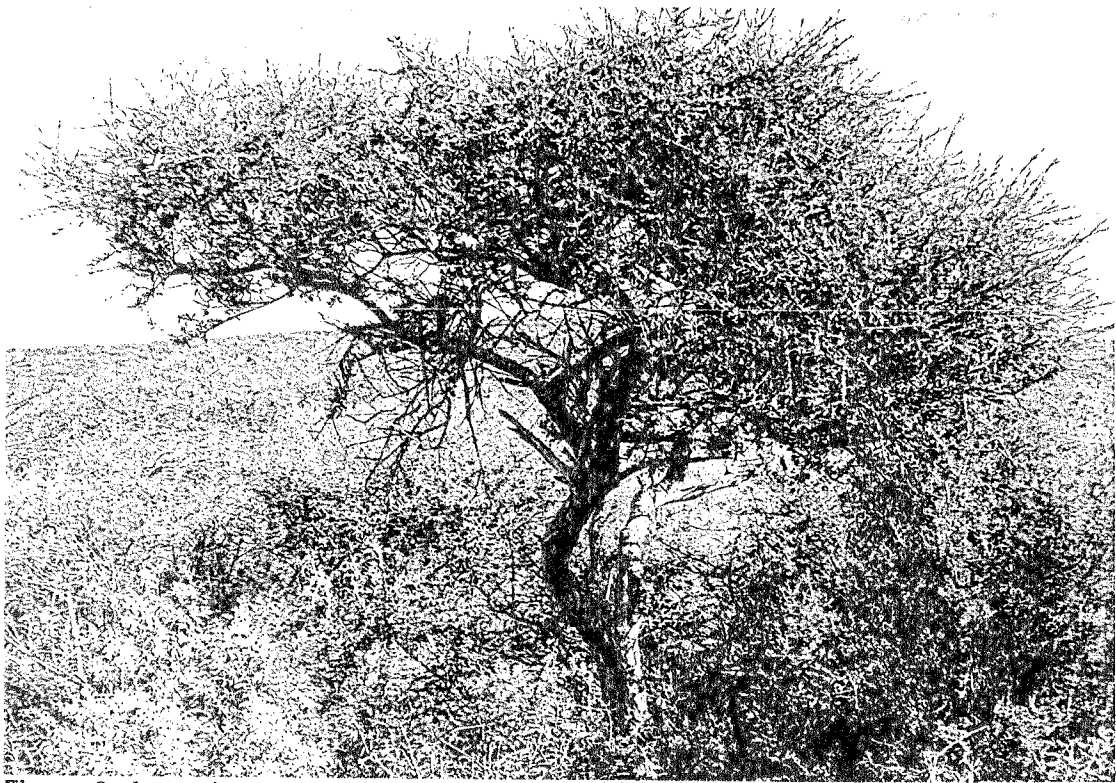
Figure 9: A specimen of the protected *Boscia albitrunca*

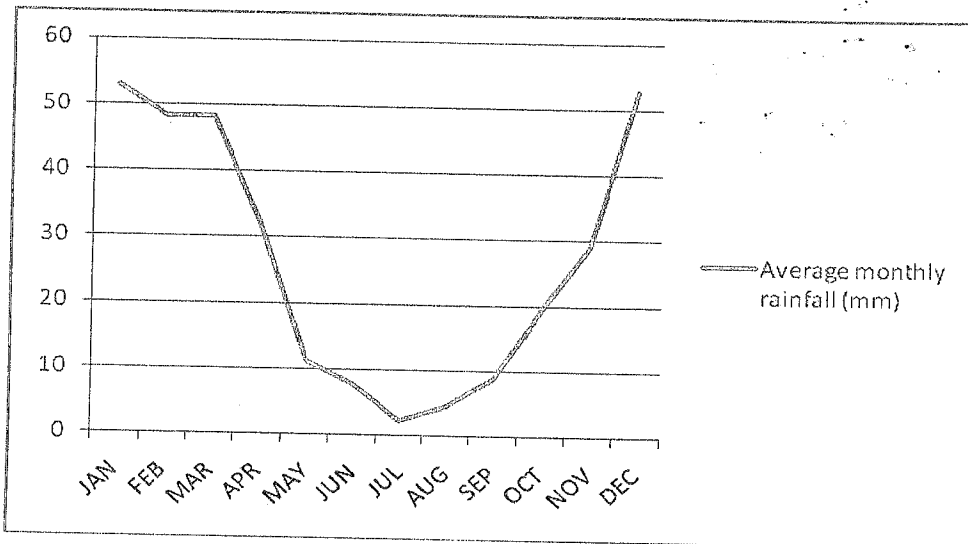
Figure 1: Average monthly rainfall - Postmasburg, Northern Cape (SAWS, 1993 - 2009)

The mine is set on the arid flats of the Northern Cape. It is in South Africa's summer rainfall region with an annual average rainfall of under 400mm per year. Rain peaks mid-season, in December and January, while the winter months are characterized by a long, very dry period. Rain is generally delivered in short duration convective thunderstorms.

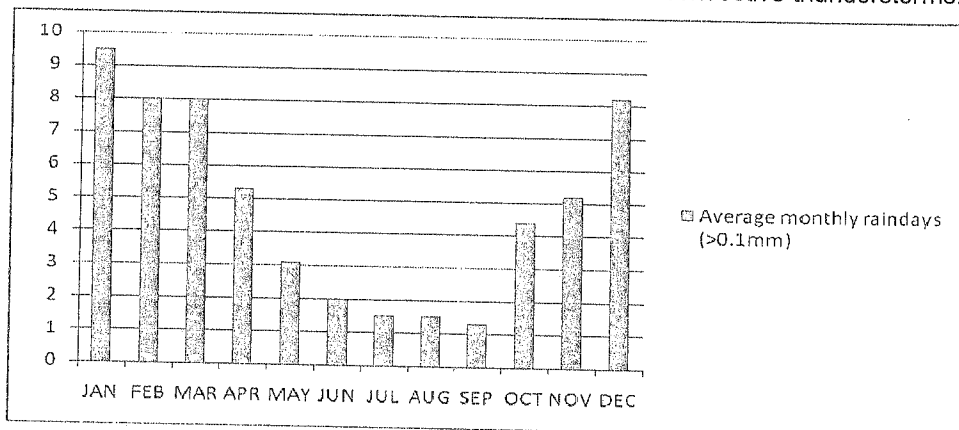
Figure 2: Average monthly rain days > 0.1mm – Postmasburg, Northern Cape (SAWS, 1993-2009)

Even the addition of a small amount of moisture can have a dramatic effect on the reduction of potential dust emissions. Similarly, a long spell without rain will necessitate intervention in the form of dust control measures in order to manage impacts on the surrounding environment. These will be particularly necessary during the months from April to October but the very hot dry climate will likely necessitate almost permanent dust mitigation.

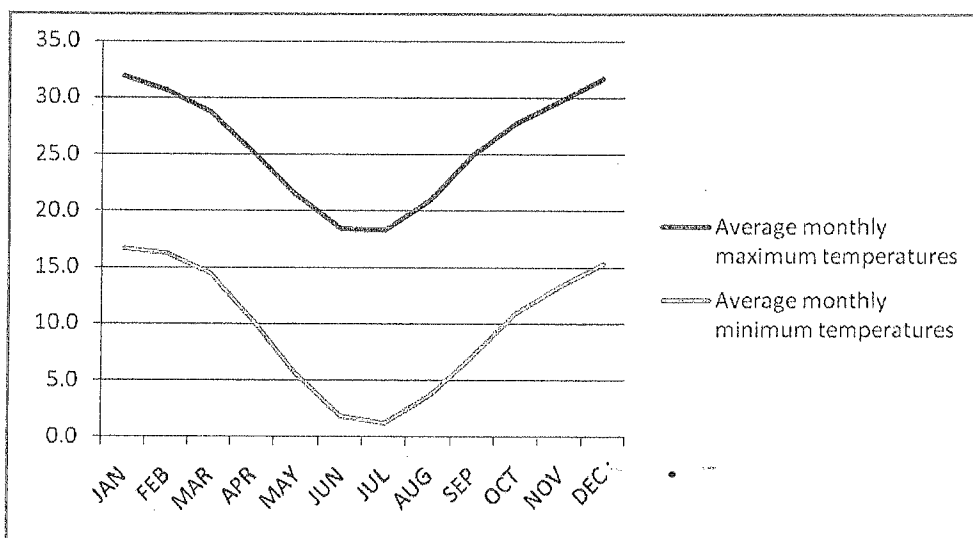
Figure 3: Average monthly temperatures - Postmasburg, Northern Cape (SAWS, 1993-2009)

The warmest period is December / January, when maximum temperatures averaging above 30 degrees centigrade while July is the coldest with daytime temperatures averaging 18.3 degrees and overnight temperatures frequently dropping below freezing. The winter period is also very dry with little or no rainfall and relative humidity dropping below the 40% mark.

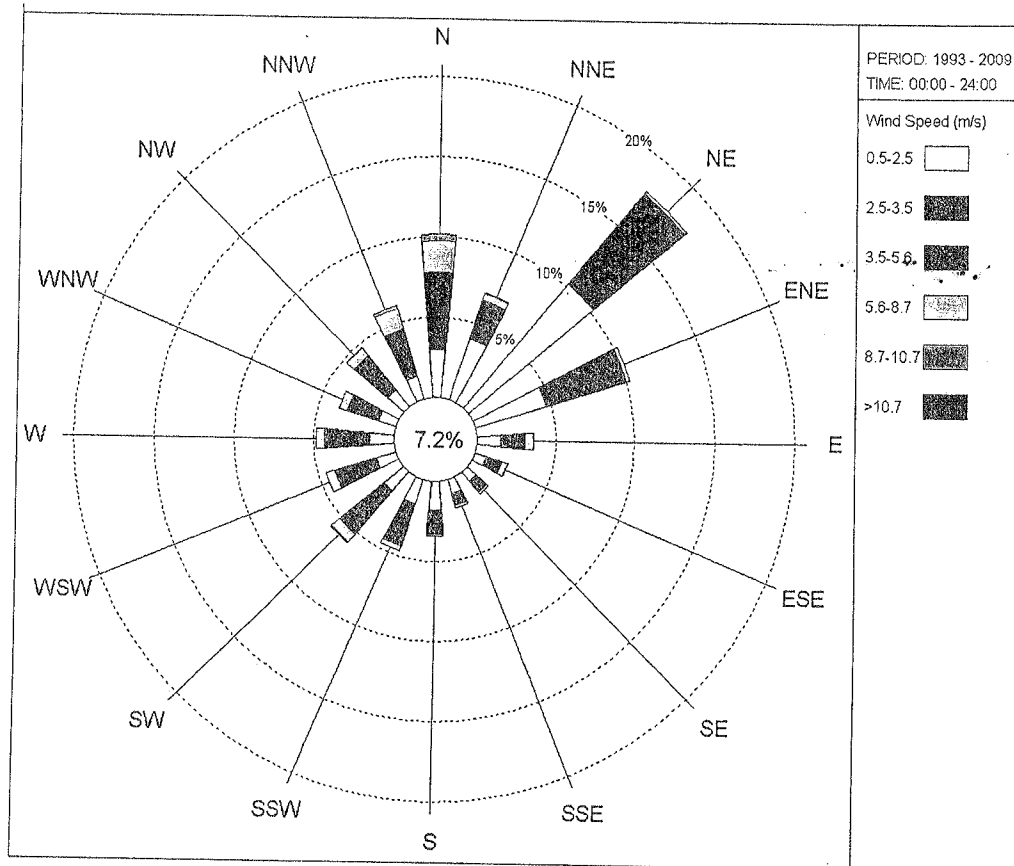
Figure 4: Annual average wind speed and direction - Postmasburg, Northern Cape (SAWS, 1993 - 2009)

Winds are predominantly northeasterly with a strengthening westerly component in summer. Strongest wind speeds are recorded in winter, and are associated with frontal southwesterlies. More than a third of the data shows periods of calm (wind $<0.5 \text{ m.s}^{-1}$).

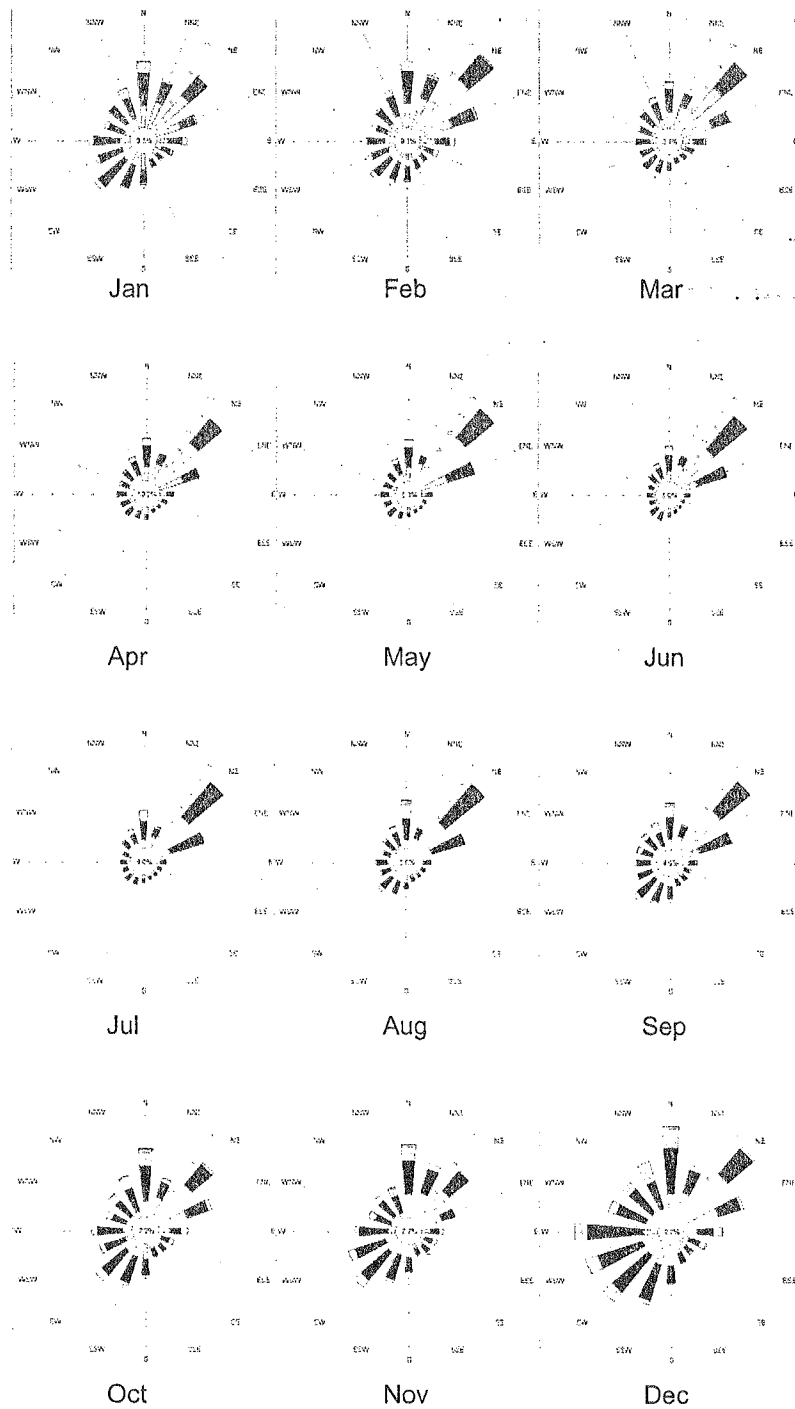
Figure 5: Monthly average wind speed and direction - Postmasburg, Northern Cape (SAWS, 1993 - 2009)

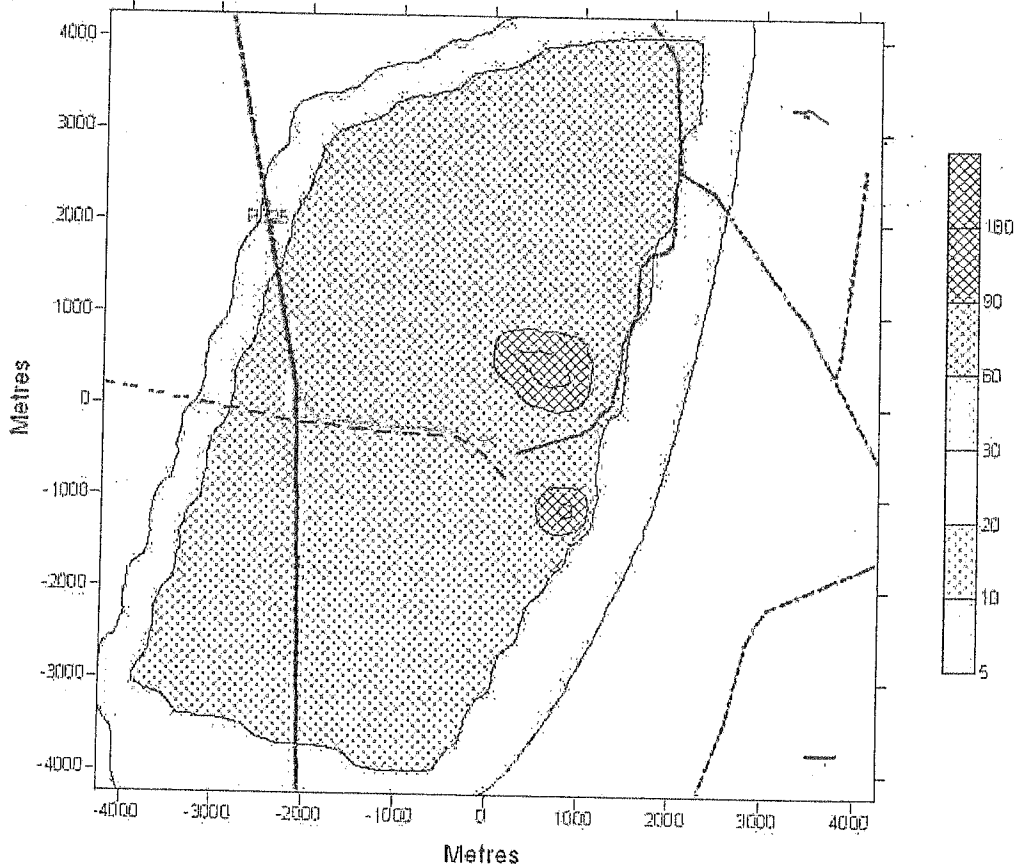
Figure 6: Modelled representation of PM₁₀ dispersion from the proposed Kapstewel mine. Long term averages, 24 hour averaging period, levels indicated in µg/m³

The representation above indicates that dispersion from the proposed additions is likely to be limited to the areas immediately adjacent to the actively mined areas. The modelled levels are generally below South Africa's 24 hour average ambient guidelines (180µg/m³) although areas around the mining activity may exceed this level if sufficient mitigation is not in place. It should be noted that peak dust levels in proximity to haul roads and active heavy machinery may sporadically exceed these levels on a shorter time scale. Dust should not significantly impact areas beyond the mine boundary.

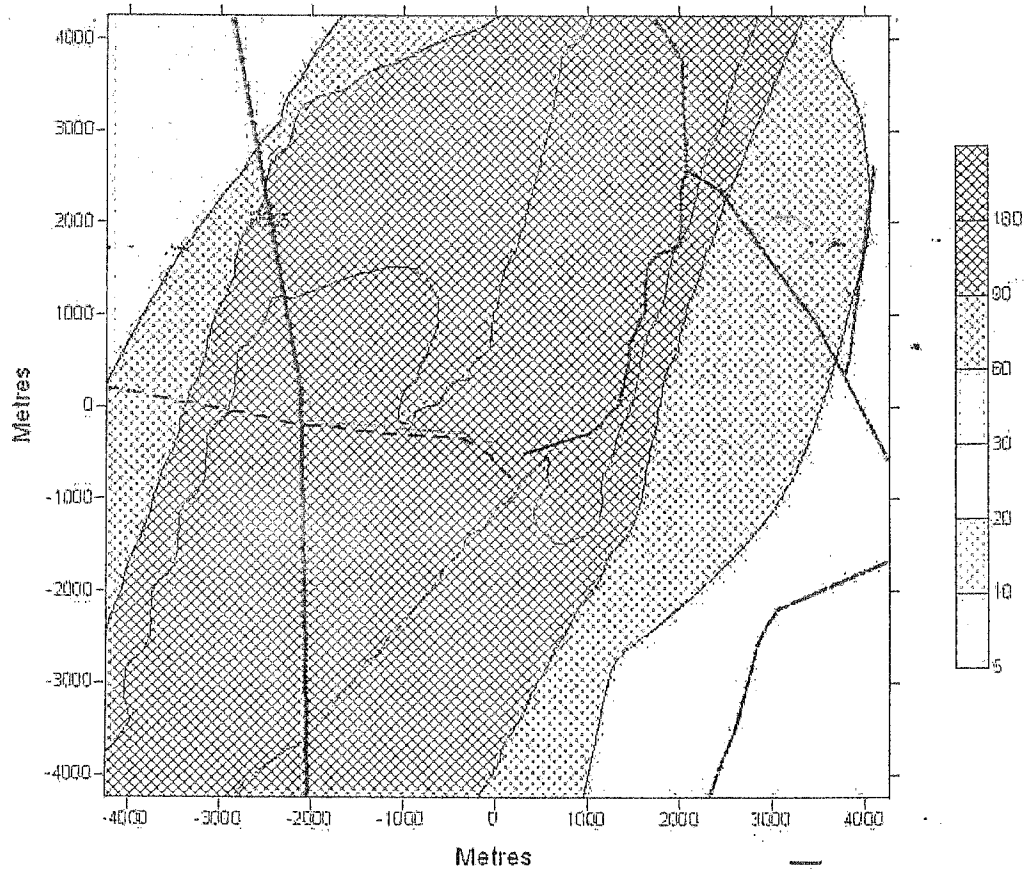
Figure 7: Modelled representation of 'worst hour' PM₁₀ dispersion from the proposed Kapstewel mine. Long term averages, 24 hour averaging period, levels indicated in µg/m³

Figure 7 shows a plot of the worst hour for each grid point of the 8640 hours that make up the year long model run. From this it can be recognised that occasional exceedence of the 180 µg/m³ level is likely to the southwest and northeast of the mine. These are likely to be highly localised and associated with specific activities.

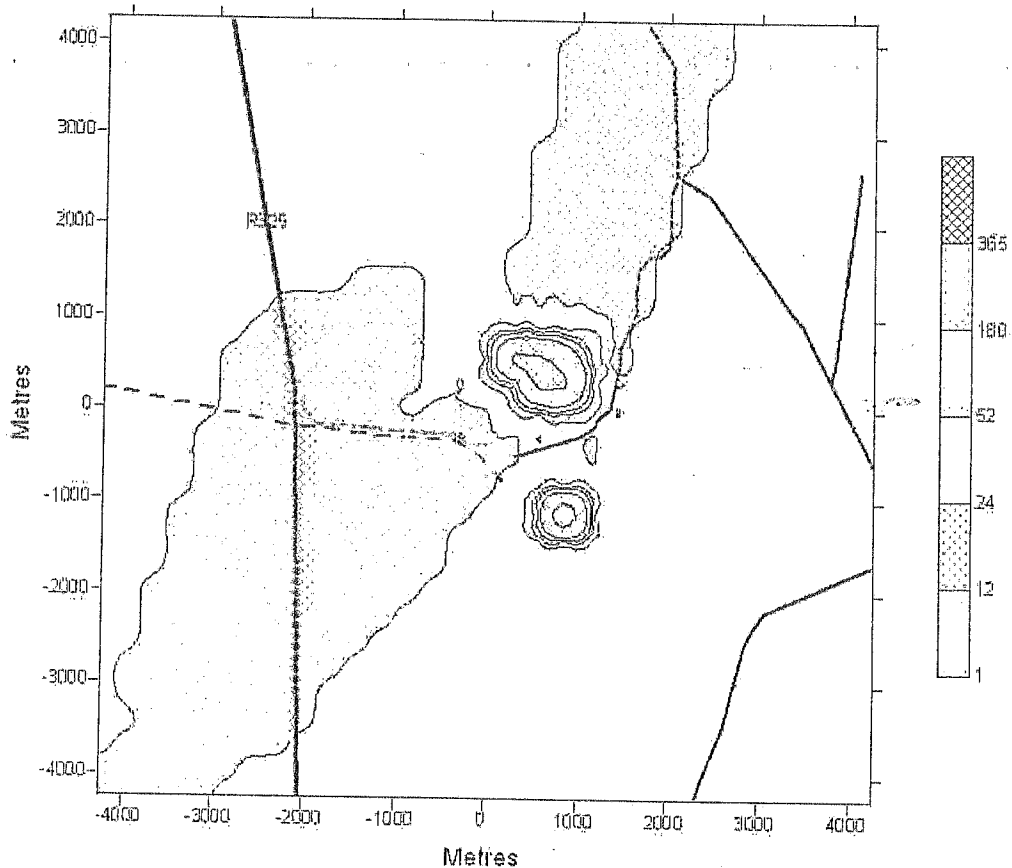
Figure 8: Modelled representation of incidences of ambient PM₁₀ levels from the proposed Kapstewel mine exceeding the 180 µg/m³ level.

Figure 8 shows the likely number of exceedence in any one year of the 180 µg/m³ level. Areas away from the mined areas are unlikely to exceed these levels with the exception of areas within the regular dispersion corridors to the southwest and the northeast of the mine. The 180 µg/m³ level is recommended as the legal ambient dust limit so this plot serves to stress the importance of ensuring that appropriate mitigation remains in place around the activity areas.

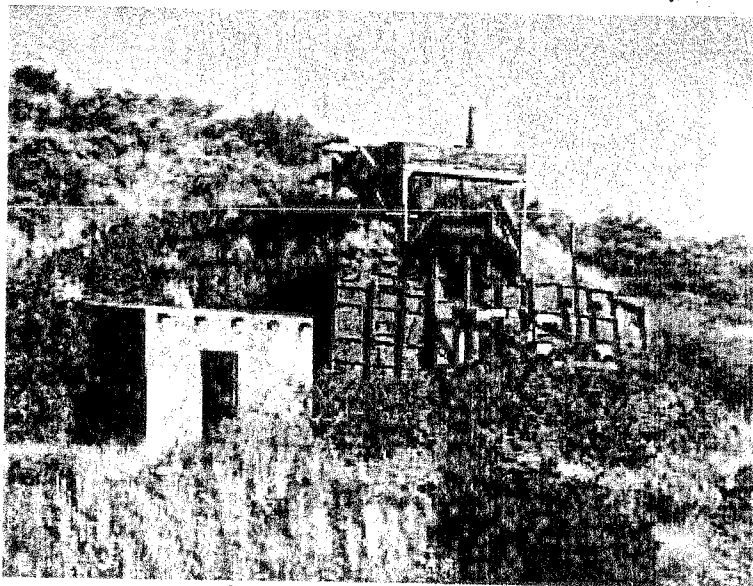
Site 1: Ore crushing facility

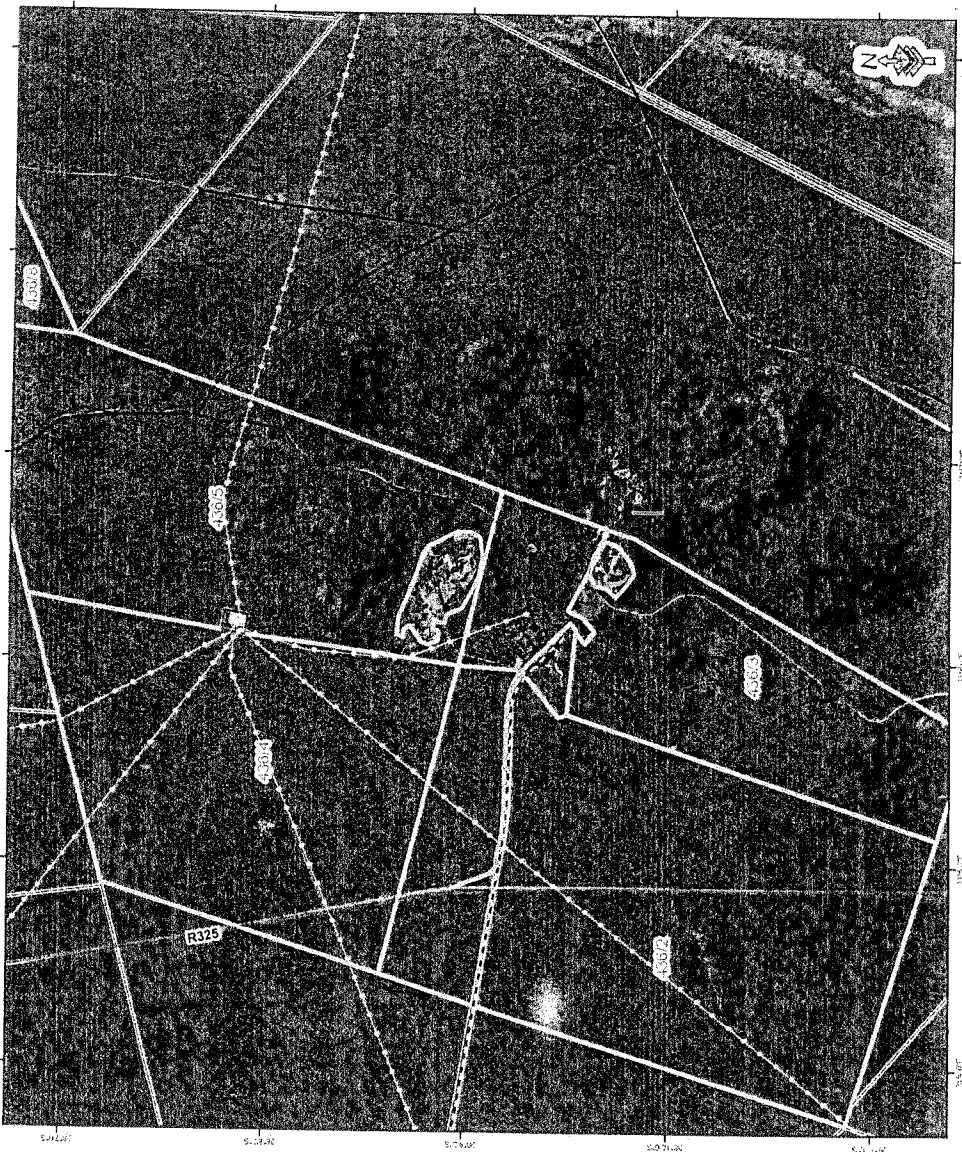
KAPSTEWEL: SITE LAYOUT

Figure 1.2 Site Layout (GCS)

The northern historical open-cast and dumps are shown in Photo 4 below. (See Figure 1.2)

The southern historical open-cast and dumps are shown in Photo 5 below. (See Figure 1.2)

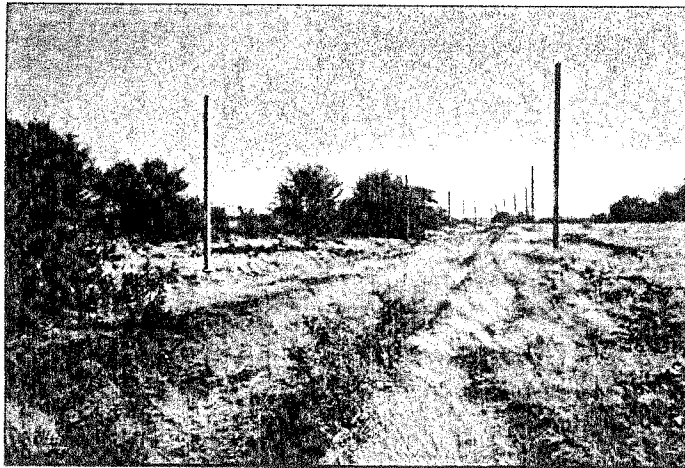
In this instance, material will be transported from the site by means of the existing railway line shown in the photo below and no trip generation of material will take place on the main provincial road network due to the mining activities. The railway line will have to be repaired as it is currently not used as shown below.

Photo 2: Railway line to be used

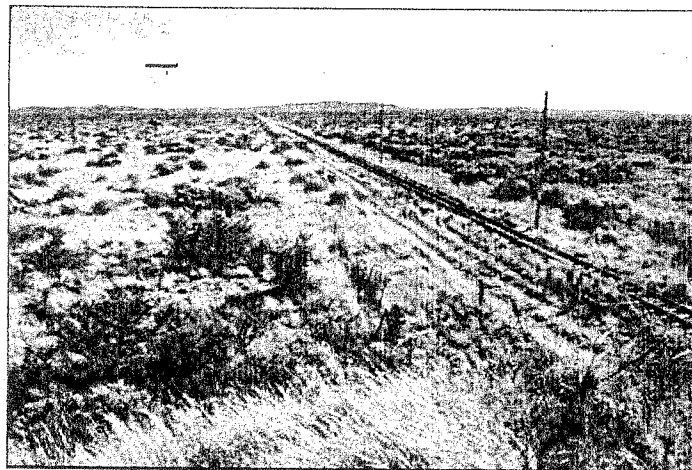
The road that will be used as a link between the eastern and western portions of the site runs parallel to the railway line, passing underneath the R325. Also shown in the photo is the western portion of the site.

Photo 6: Link road between eastern and western portions

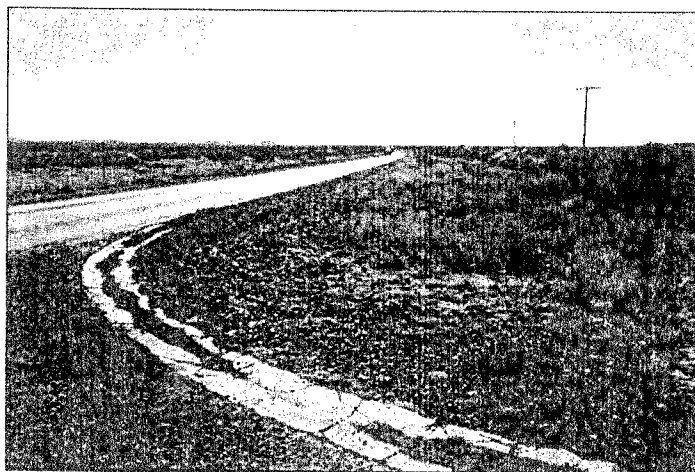
Shoulder sight distance to the north is not restricted as shown in Photo 8 below:

Photo 8: Sight distance to the north

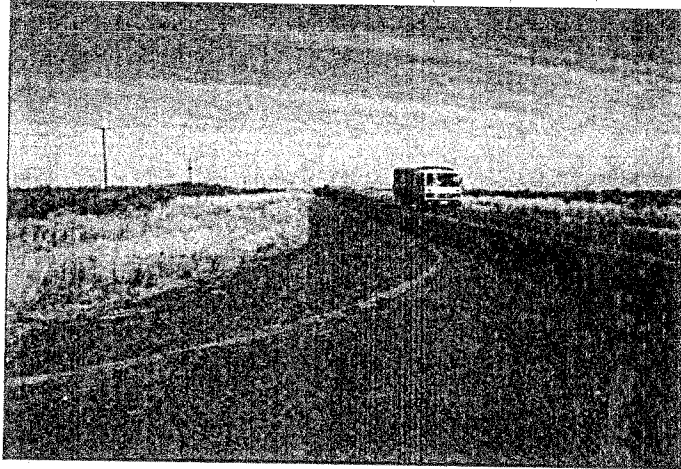
Shoulder sight distance to the south is however affected by the road-over-rail-bridge as shown.

Photo 9: Sight distance to the south

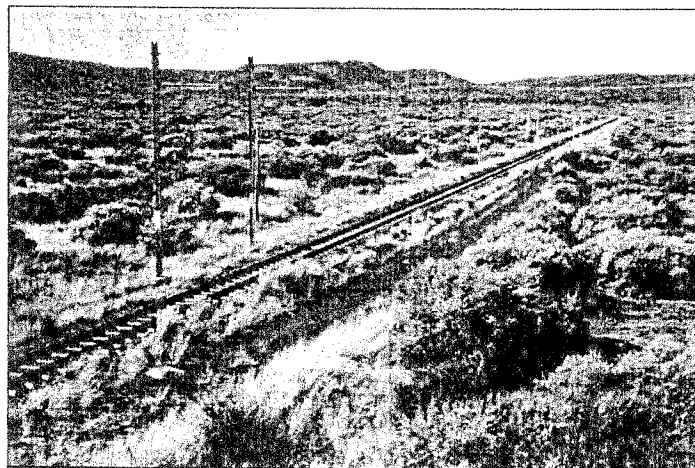
The mining activities will result in an increase in train operations. Although not currently in use, rail infrastructure is available and importantly, a grade separated crossing is provided where the railway line crosses the R325, with the result that an increase in rail activities will not have an effect on road safety. The photo below shows the rail facilities from the road over rail bridge on the R325.

Photo 10: Railway line from bridge on R325
