# **IMERYS REFRACTORY MINERALS SOUTH AFRICA (PTY) LTD – KRUGERSPOST ANDALUSITE MINE – KLIPFONTEIN MINE**

## **Closure Plan and Rehabilitation Plan**

**Name of Applicant: Imerys Refractory Minerals South Africa, Krugerspost Mine**

**November 2020**

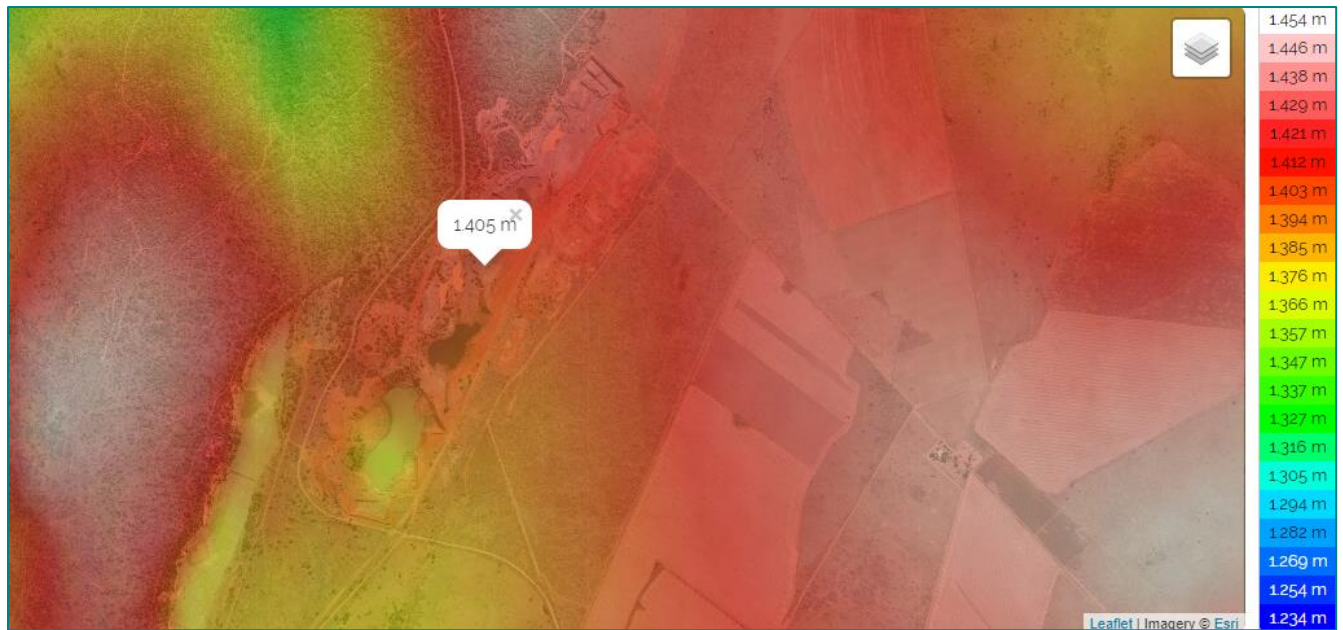
Figure 3: Topography of Quarry 6 (<https://en-za.topographic-map.com/maps/jmbz/Mashishing-Lydenburg/>)

The site is located along a flat regional area with a slight drainage to the East. Most of the surroundings are naturally vegetated bushveld. The site has a slight drainage towards the North East. Drainage within the site is uniform with clean runoff will be diverted around the operations, while internal runoff will be collected within the quarry and dewatering discharged into the adjacent quarry. There is no surface water exiting the site. According to Figure 3 below, the topography of the site ranges from 1400m to 1450m.

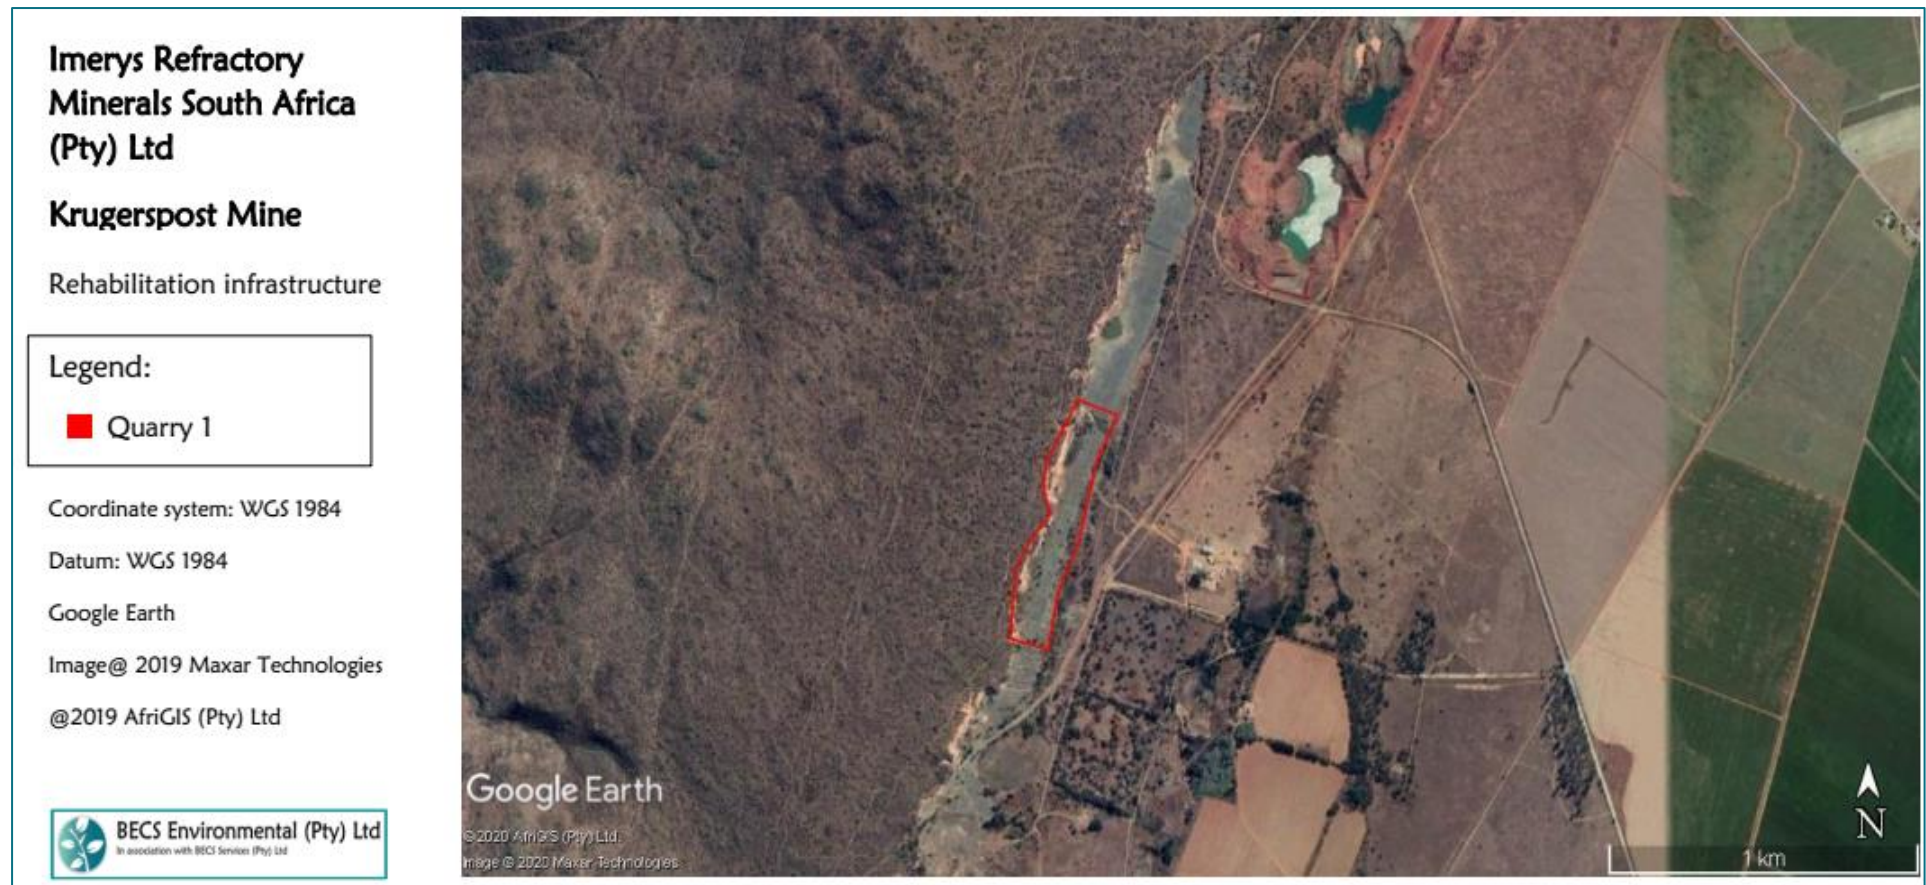
Figure 28: Quarry 1

Updated action plans	Revegetation with the aid of the surveyor is proposed as part of rehabilitation. Final maintenance of Quarry 1 will include erosion monitoring and repair if necessary, as well as alien vegetation monitoring and eradication if necessary.
Schedule	The revegetation and maintenance of Quarry 1 is an ongoing process.
Description and evaluation of alternative closure and post closure options	There are no alternative closure and post closure options that were evaluated in this instance as the best method of rehabilitation for Quarry 1 has already been implemented.
Motivation for the preferred closure action within the context of the risks and impacts that are being mitigated	The sloping of the quarry has already been completed which ensures the free flow of water as well as revegetation. It also ensures that the quarry is safe, and the planned land use is obtained.
Details associated with any on-going research on closure options.	All research regarding the rehabilitation and maintenance of Quarries 1 has already been undertaken and is currently being implemented.

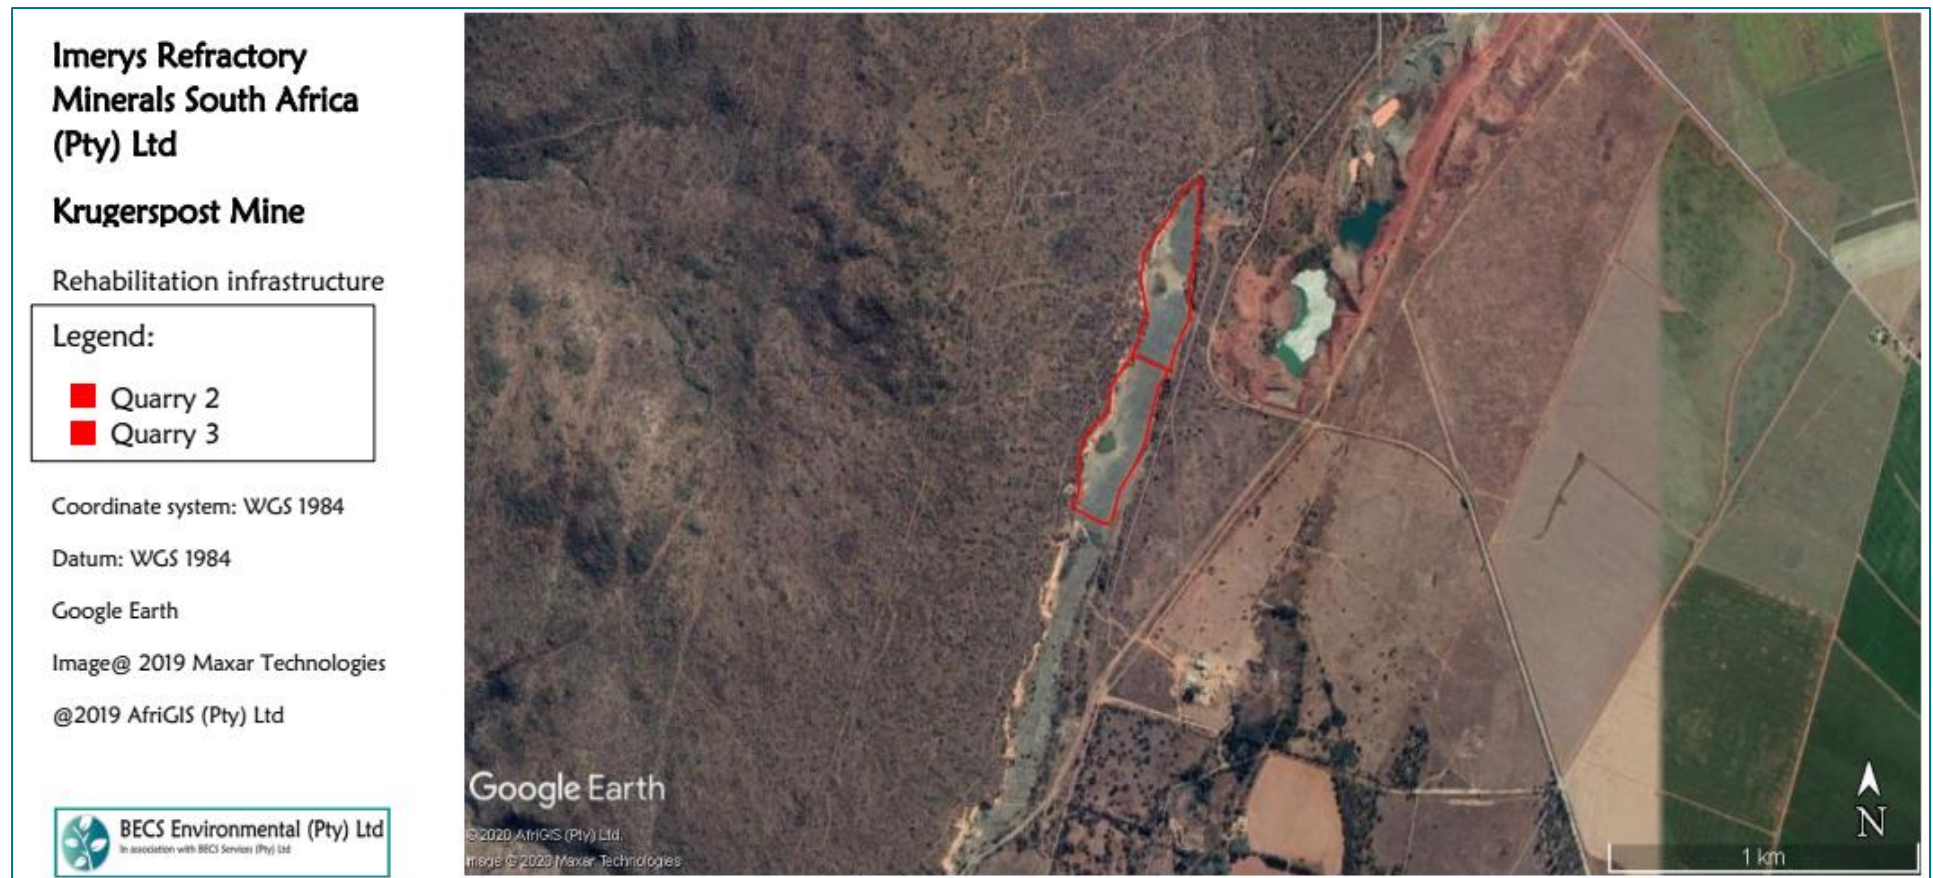
Figure 29: Quarry 2 &amp; 3

Current situation	<p>The backfilling (sloping) of Quarry 2 and Quarry 3 is complete. Topsoil is being spread over the area and berms have been incorporated to assist with water retention. There is still some topsoil that can be applied to the area.</p>
Updated action plans	<p>The mine must ensure that the revegetation process is completed. It is recommended that a surveyor ensures these quarries have been sloped to an appropriate angle in line with the closure plan and the surrounding environment. Provision has also been made to manage soil erosion and the monitoring of alien vegetation.</p>
Schedule	<p>Revegetation and alien invasive monitoring at Quarries 2&amp;3 is ongoing at the mine.</p>
Description and evaluation of alternative closure and post closure options	<p>There are no alternative closure and post closure options as Quarries 2&amp;3 have already been rehabilitated.</p>
Motivation for the preferred closure action within the context of the risks and impacts that are being mitigated	<p>The sloping of the quarries has already been completed which ensures the free flow of water as well as revegetation. It also ensures that the quarry is safe, and the planned land use is obtained.</p>

Details associated with any on-going research on closure options.	All research regarding the rehabilitation and maintenance of Quarries 2&3 has already been undertaken and is currently being implemented.
A detailed description of the assumptions made to develop closure actions in the absence of detailed knowledge on site conditions, potential impacts, material availability, stakeholder requirements and other factors for which information is lacking.	Resloping of the area was designed based on surveyor data provided by the mine.
Financial provision	R585,343.00 for seeding and R150,000.00 for soil erosion, vegetation growth, and alien vegetation monitoring.

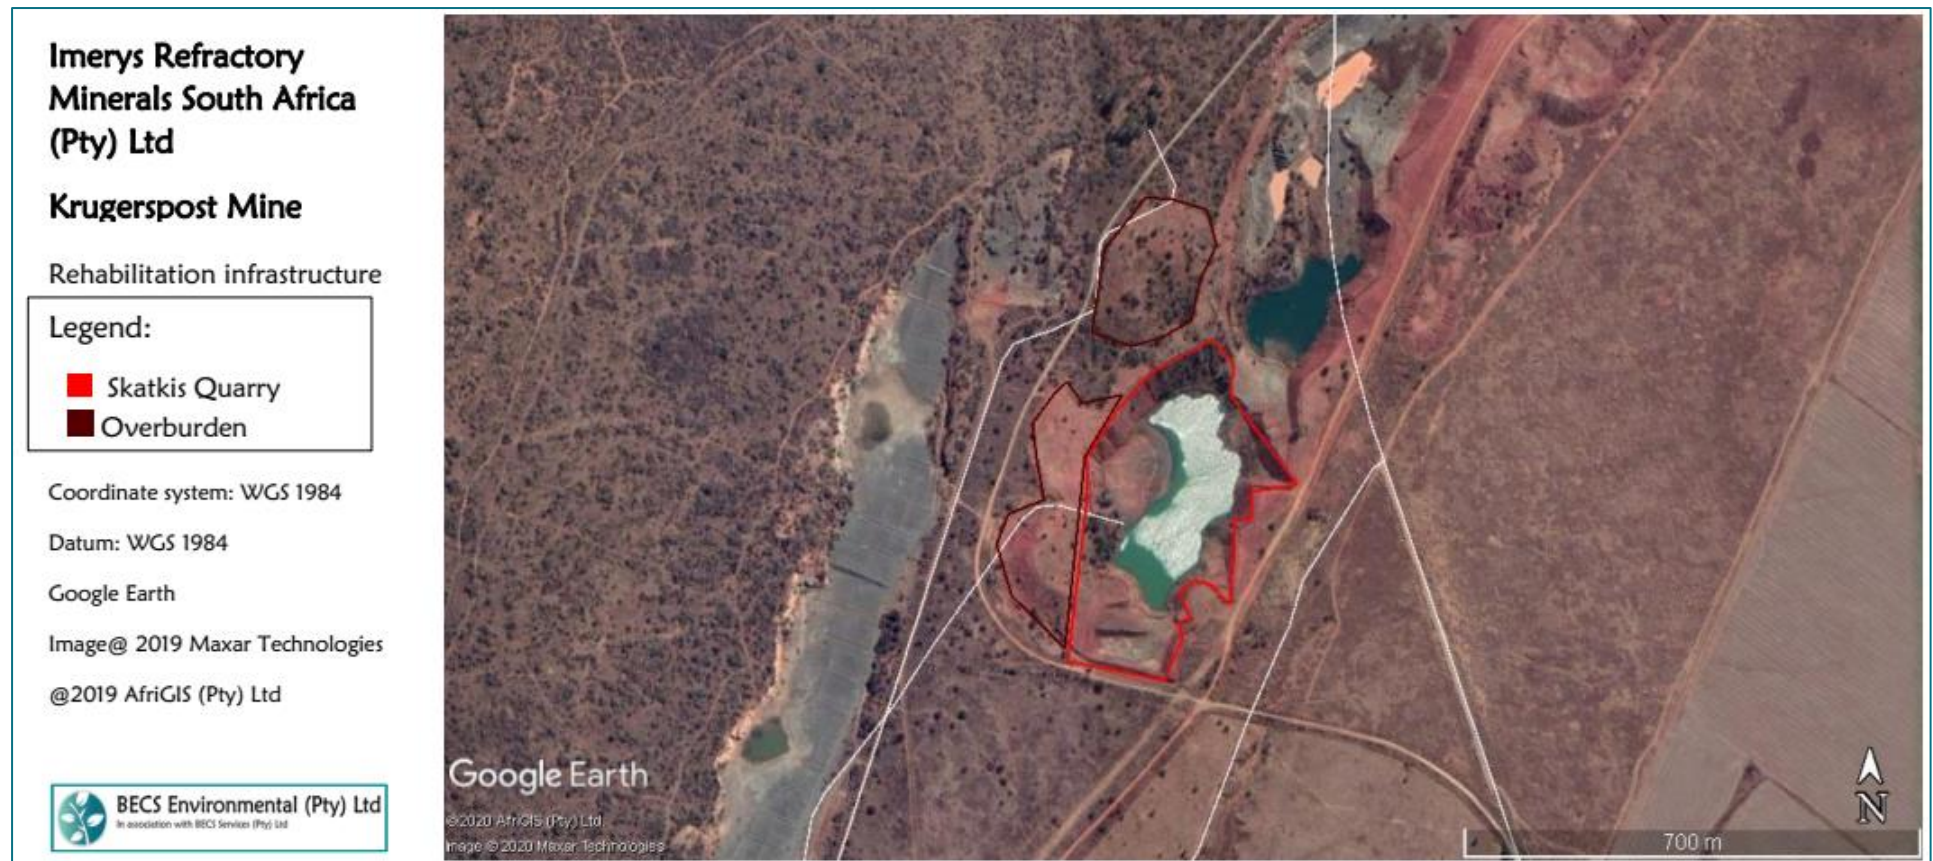
Figure 33: Skatkis Quarry / Quarry 6

Current situation	Sloping of Quarries 6 and 7 is already taking place. A Section 21g water use license for the backfilling of quarry 6 has been applied for as well as exemption under GN 704 of 1999 under NWA.
Updated action plans	Ensure that the separation wall is broken down and construct safety berms. It is recommended that a surveyor ensure these quarries have been sloped to the angle as indicated in the closure plan.
Schedule	The rehabilitation of these quarries is ongoing.
Description and evaluation of alternative closure and post closure options	Various specialist studies were conducted as part of this process to decide the rehabilitation method most applicable. Therefore, no alternative closure and post closure options have been analysed.

Motivation for the preferred closure action within the context of the risks and impacts that are being mitigated	The rehabilitation of the quarry shall ensure the free flow of water. Once the quarry is backfilled, revegetation can take place and the safety of the quarry shall be ensured. Once this complete, the end land use can be obtained.
Details associated with any on-going research on closure options.	A geohydrological study was undertaken by Shangoni AquiScience in 2020 to determine the impact of backfilling Quarry 6 on the groundwater in the environment. The following was noted; <i>“Backfilling can significantly reduce the areas of land left in a disturbed state (post-closure), related closure rehabilitation costs, e.g. ongoing water management, and the safety issues associated with leaving an open pit. In addition, backfilling makes efficient use of the excavated storage space with improved containment or encapsulation by geological materials adjacent to the void rather than constructing above ground facilities such as tailings dams with specifically engineered liners and waste rock dumps with covers. In addition, regulatory agencies are increasingly seeing backfilling as a way of returning land to a form that supports pre-mining land use.”</i>

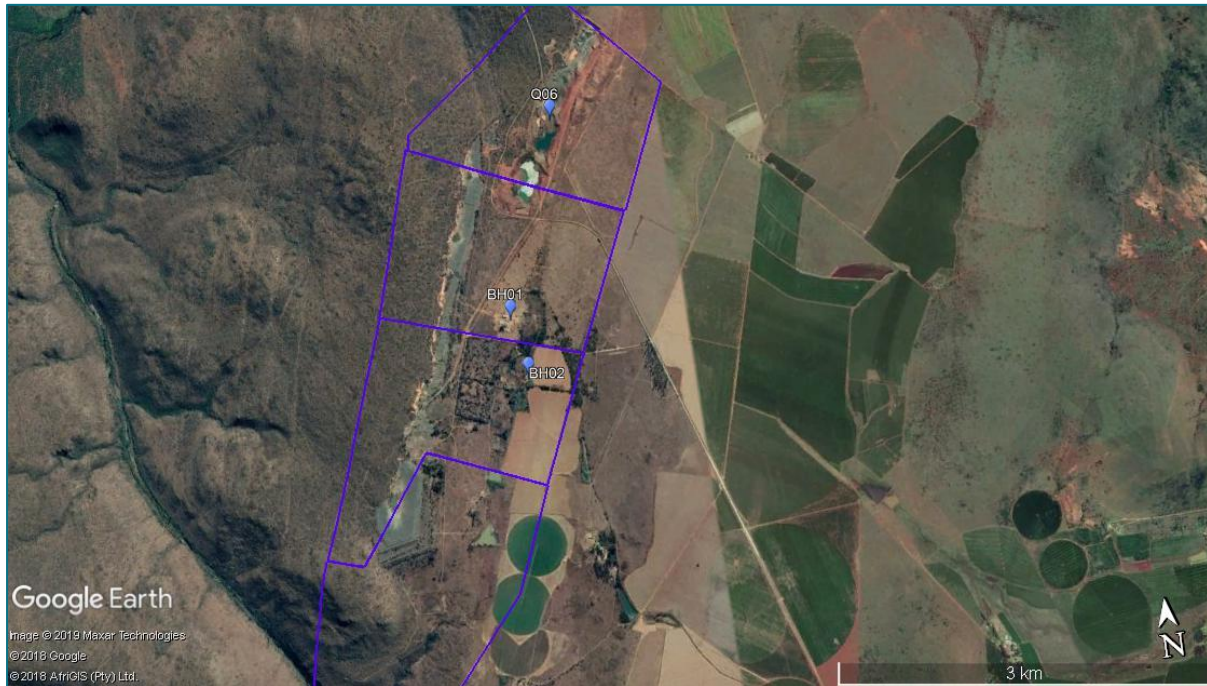
Figure 36: Water quantities abstracted

Name	Maximum volume annually (m³)	Metering frequency	Recording frequency	Reporting frequency
BH01	3,600	Daily	Monthly	Biannually
BH02	1,800			
Q06	620,000

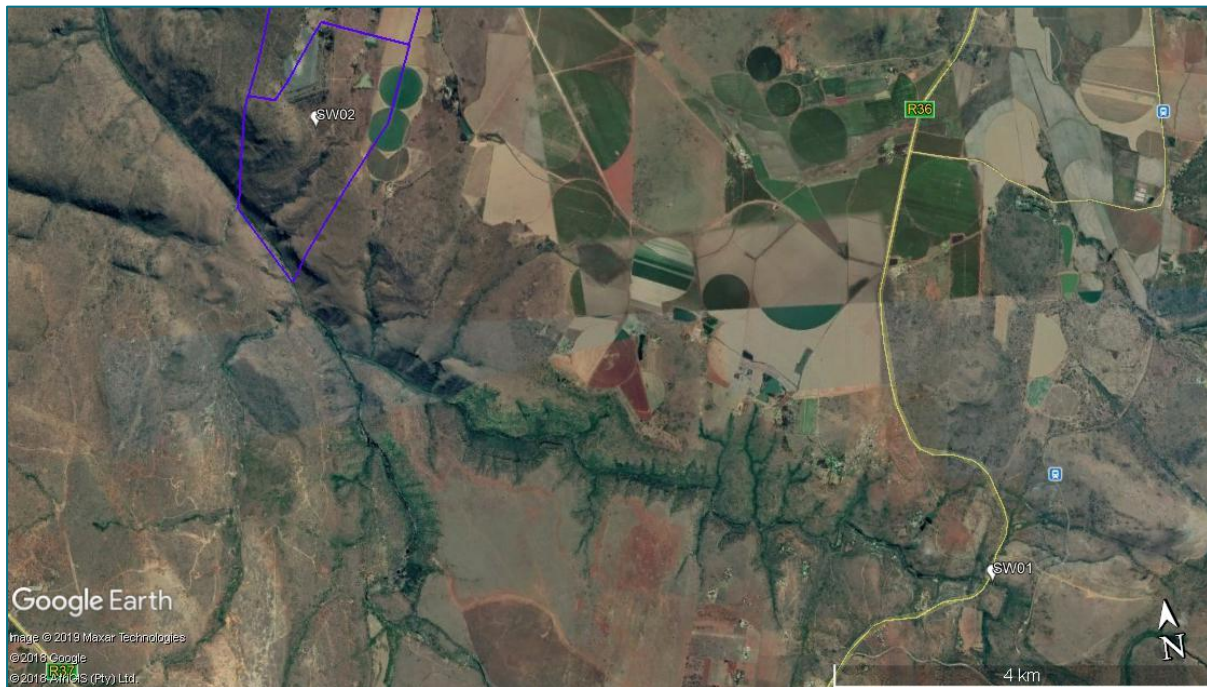
Figure 37: Surface water qualities

SW01, SW02			
Variable	Limit (Domestic use: TWQG)	Monitoring frequency	Reporting frequency
Na in mg/l	≤100		
K in mg/l	≤50		
Cl in mg/l	≤100		
SO <sub>4</sub> in mg/l	≤200		
T-Alk (HCO <sub>3</sub> <sup>-</sup> /CO <sub>3</sub> <sup>-</sup> )			
Fe in mg/l	≤0.1		
Al in mg/l	≤0.15		
Mn in mg/l	≤0.05		
Si in mg/l			
F in mg/l	≤1.0		
PO <sub>4</sub> <sup>-</sup>	≤2.5		
NO <sub>3</sub> <sup>-</sup>	≤6		
NH <sub>4</sub> <sup>+</sup>	≤1.0

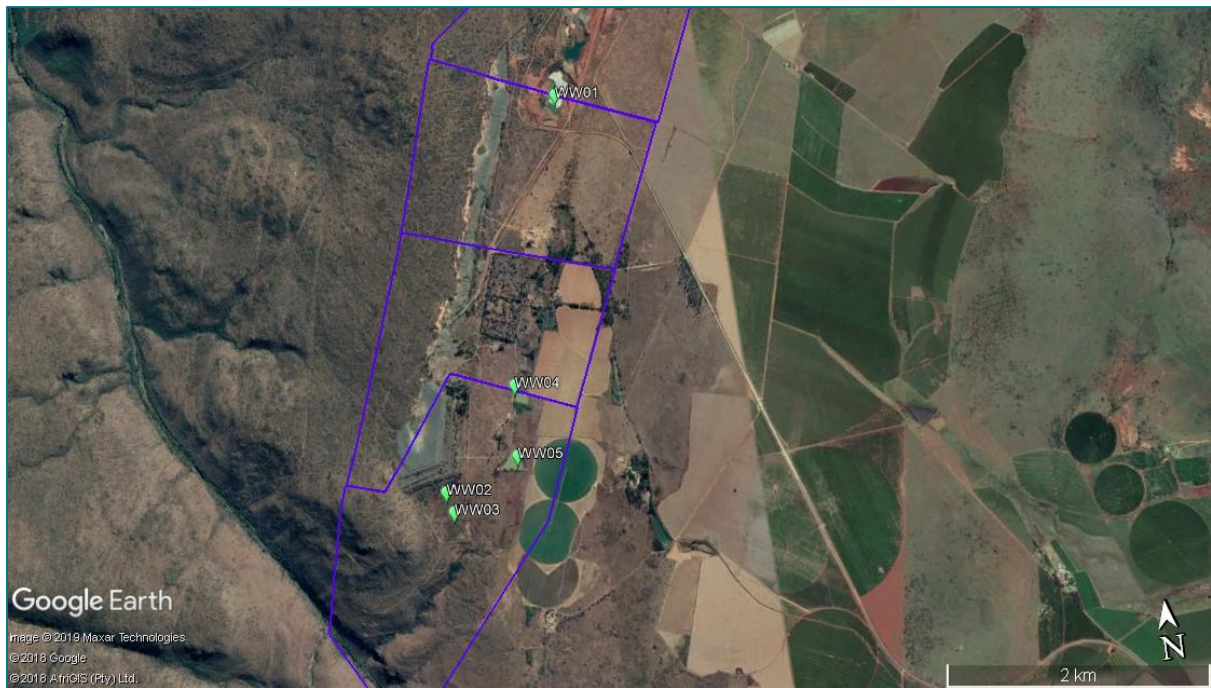
Figure 39: Wastewater qualities

WW01, WW02, WW03, WW04, WW05			
Substance / parameter	Limit (IWUL)	Monitoring frequency	Reporting frequency
pH	6.34-6.98	Quarterly	Quarterly
EC in mS/m	34		
TDS in mg/l	250		
Cl in mg/l	15		
SO4 in mg/l	60		
Na in mg/l	24

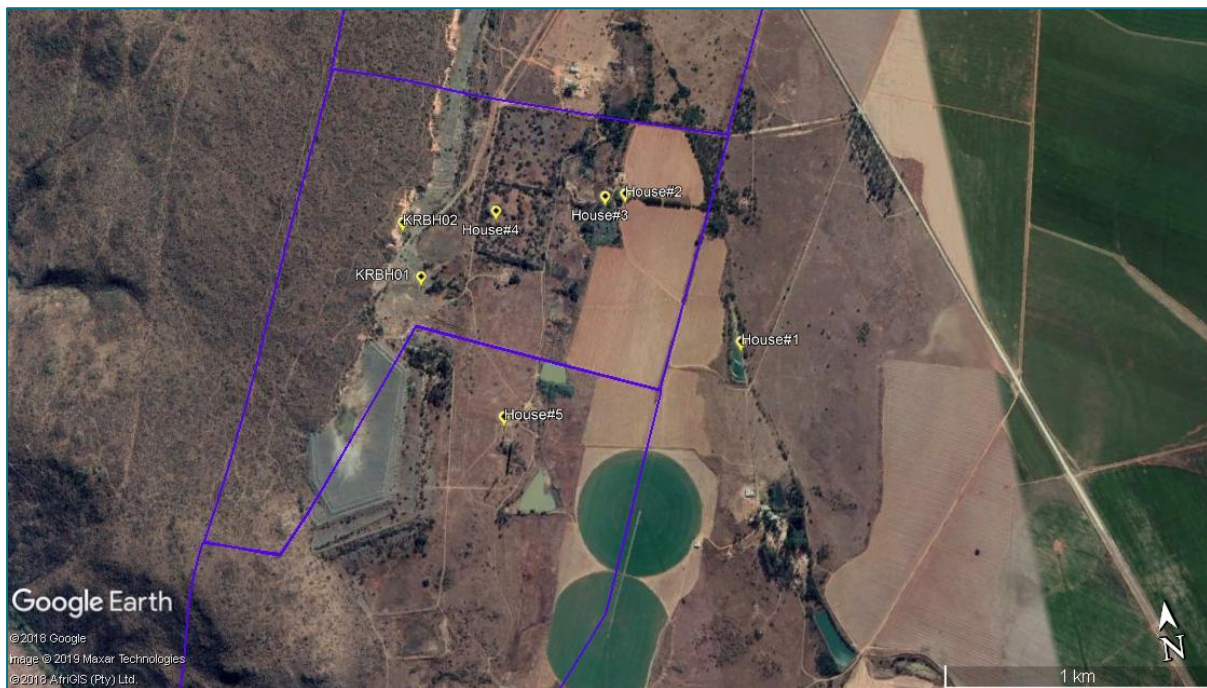
Figure 40: Groundwater qualities for potable

Name	Description of point	Origin of water / description	Comments	Owner	Coordinates
	House#3	Domestic borehole		Imerys	S 24°56'28.96" E 30°26'40.67"
	House#4	Domestic borehole		Imerys	S 24°56'28.96" E 30°26'24.36"
	House#5	Domestic borehole		Imerys	S 24°56'56.58" E 30°26'21.80"
	House#1	Domestic borehole	Potable monitoring	Imerys	S 24°56'51.28" E 30°26'56.94"

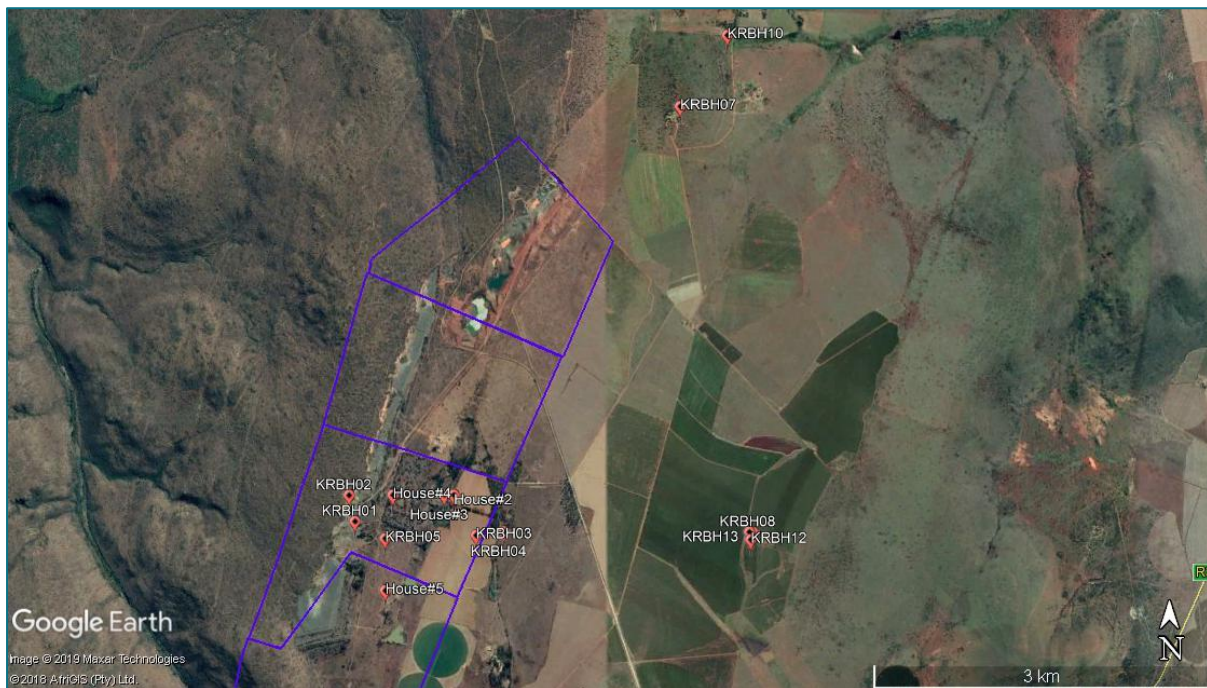
Figure 41: Groundwater qualities for pollution, receptor, zone of influence &amp; background monitoring

Name	Origin of water / description	Comments	Owner	Coordinates
KRBH03	No use	Background monitoring	Roth	S 24°56'40.49" E 30°26'50.75"
KRBH04	Domestic & garden borehole		Roth	S 24°56'39.34" E 30°26'59.64"
KRBH05	Domestic & garden borehole		Roth	S 24°56'41.52" E 30°26'21.80"
KRBH12	Livestock borehole		Steenekamp	S 24°56'41.52" E 30°28'17.58"
