CONSOLIDATED SPECIALIST SITE SENSITIVITY VERIFICATION REPORTS**FE KUDU WIND ENERGY FACILITY NEAR ABERDEEN, DR BEYERS NAUDE LOCAL MUNICIPALITY, EASTERN CAPE PROVINCE
(DFFE REFERENCE: TBA)**

**APPENDIX P1:
TERRESTRIAL ECOLOGY SITE SENSITIVITY VERIFICATION
REPORT**

APPENDIX P2: AQUATIC ECOLOGY SITE SENSITIVITY VERIFICATION REPORT

Aquatic Biodiversity Site Sensitivity Verification Report for the Proposed FE Kudu Wind Energy Facility and Associated Infrastructure

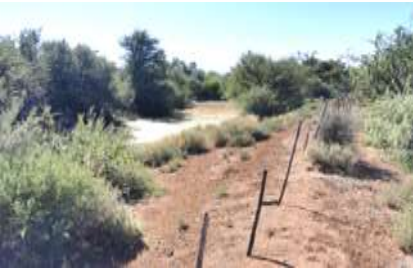
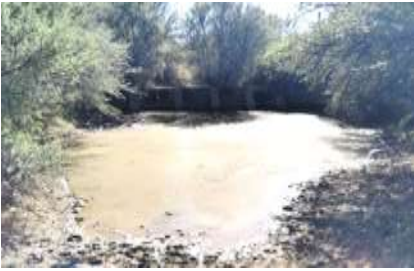
Site	Upstream	Downstream
Tul US

Comments	Site Tul US is located in the upper reaches of the Tulpleegte River, a non-perennial river in the North-western portion of the project area. The site was located at an instream weir that had inundated the upstream areas and was holding water at the time of the survey. The watercourse was not flowing. The channel has been subjected to catchment erosion and sedimentation.	
GPS-coordinates	32°23'7.06"S; 23°30'49.30"E	
Tul Trib DS

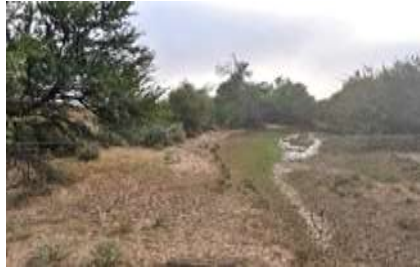
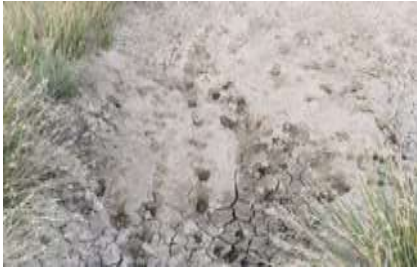
Comments	Site Tul Trib DS is located in the lower reaches of an unnamed ephemeral tributary of the Tulpleegte River to the centre of the project area. The watercourse was not flowing. The channel was largely intact and traversed by the existing main farm road.	
GPS-coordinates	32°28'7.20"S; 23°32'31.16"E	
Kar Trib US

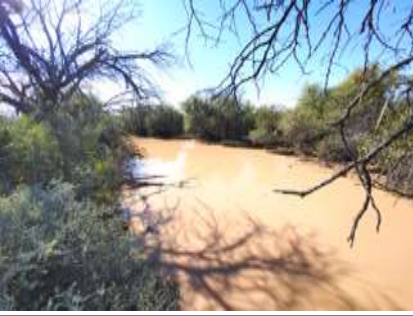
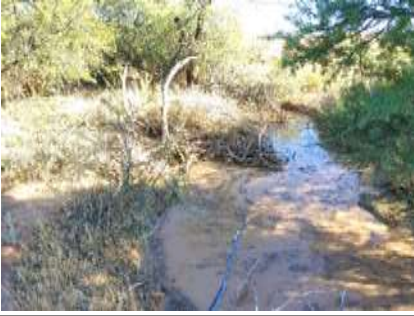
Comments	Site Kar Trib US is in the upper reaches of an unnamed ephemeral tributary of the Kariega River in the middle to western portion of the project area. The site was located at an instream earthen impoundment that had inundated the upstream areas and was holding water at the time of the survey. The watercourse was not flowing. The channel has been subjected to some catchment erosion and sedimentation.

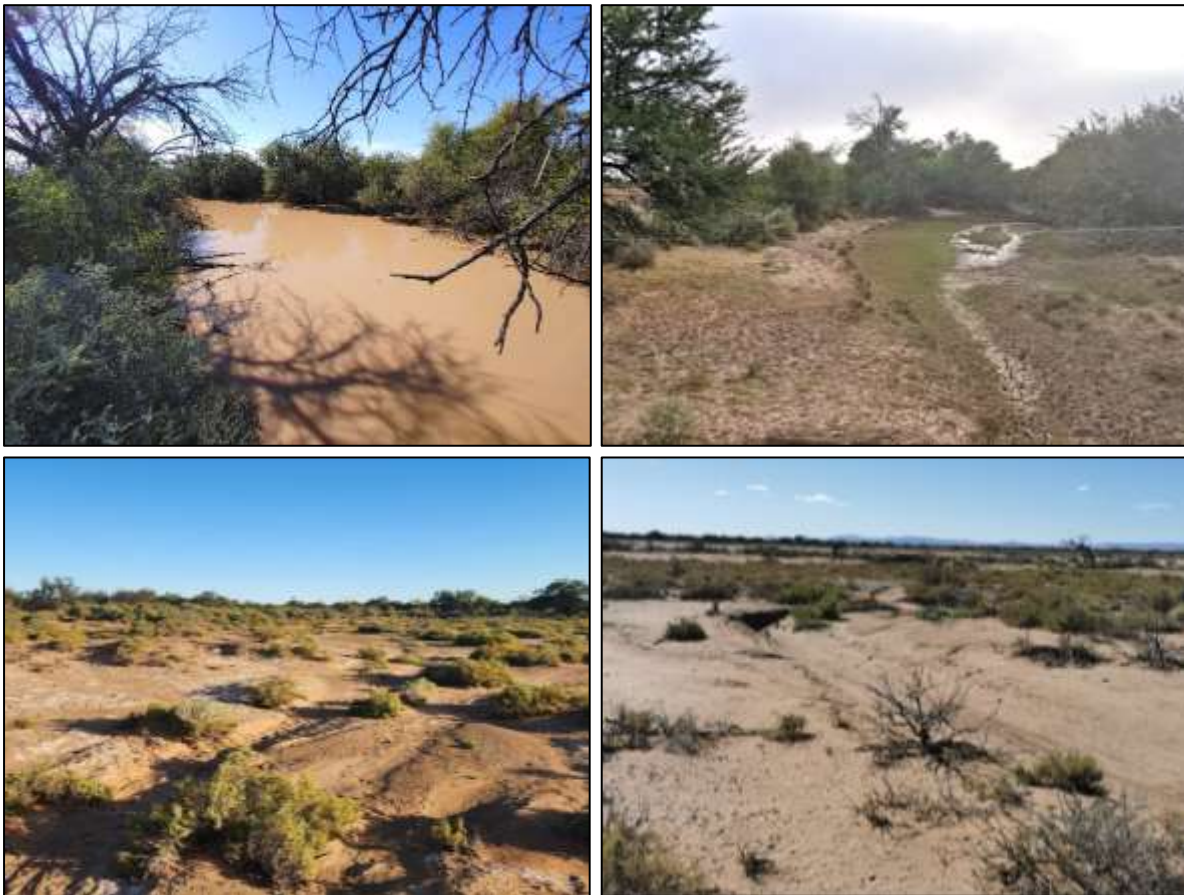
Figure 2-14 Illustration of some of the ephemeral watercourses scattered across the project area (May 2023)

The on-site assessment of the watercourses presented largely dry conditions in the smaller tributaries, with surface water presence in the larger tributaries and main river systems. Cumulatively these non-perennial systems displayed ephemeral characteristics which is typical for watercourses in an arid region (Figure 2-14). Channel habitat modification has taken place through land use activities as discussed below, however the ecosystems and adjacent terrestrial habitat is considered open and largely intact, although modified. Portions of the watercourses are braided within the site, creating an extensive alluvial fan landscape surrounding the watercourses which intersect terrestrial habitat, highlighting their interdependence. Despite their current level of modification and ephemeral nature, the watercourses are sensitive to further modification as these systems do provide drinking opportunities (following rainfall) and habitat for foraging, nesting and refugia for terrestrial biota and avifauna (see associated terrestrial report for project). Therefore, the watercourses in the project area are regarded as sensitive environments in relation to changes in habitat integrity, flow and water quality (ecological drivers) requiring avoidance from the project related disturbance activities and maintenance of baseline conditions.

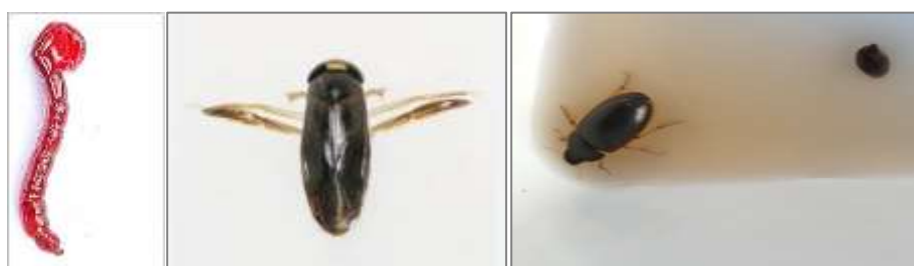
Figure 2-15 Examples of sampled macroinvertebrates juvenile Chironomidae (left), adult Corixidae (Centre) and adult Hydrophilidae & Bulininae (right)

The SASS5 score and SASS5 ecological classes obtained for the sampled systems during the survey are presented in Table 2-6. An illustration of selected macroinvertebrates are presented in Figure 2-15.

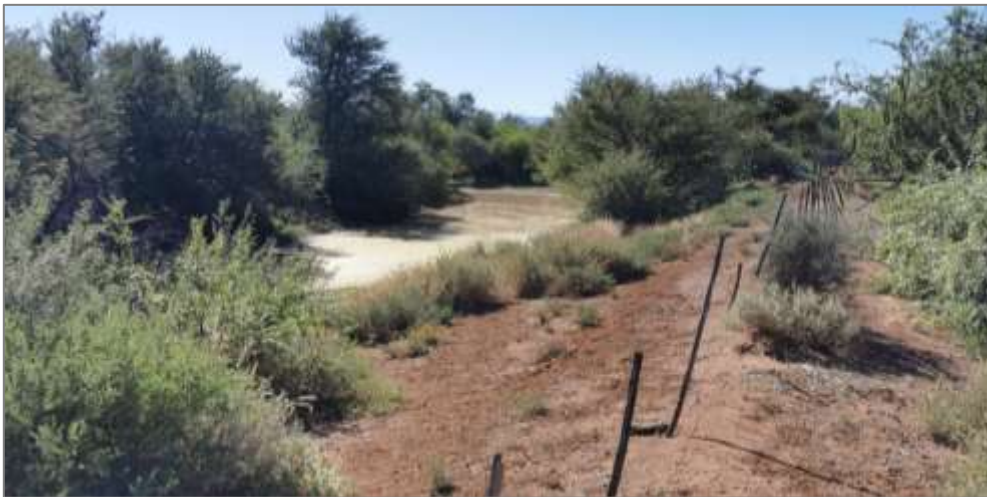
Figure 2-16 Vernal pool sampled at site Tul US (May 2023)

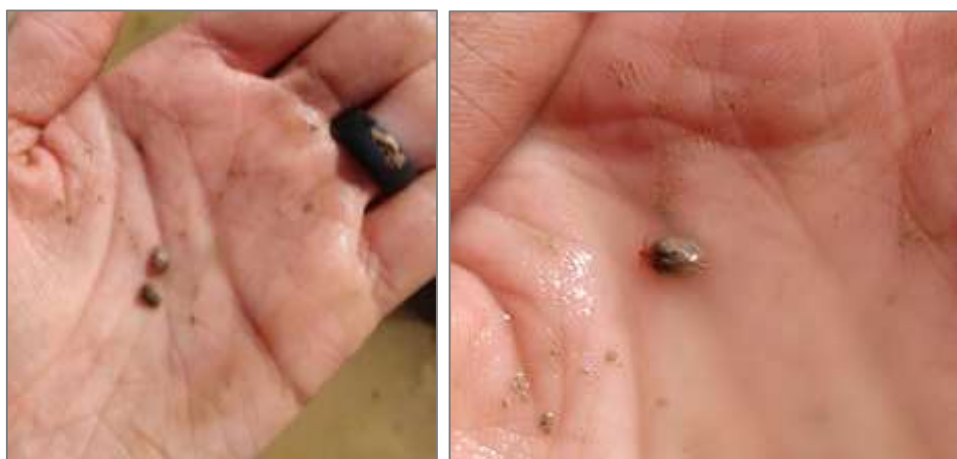
Figure 2-17 Examples of sampled clam shrimp at site Tul US (May 2023)

Ephemeral watercourses in arid environments may present aquatic biota not typically found in temperate watercourses. These ephemeral watercourses often present as vernal pools that intermittently hold water for short periods (from a few days to months) following sufficient rainfall, where by the standing surface water may support vernal biota. Vernal pool plants and animals are very sensitive to the duration and timing of ponding. Vernal pools as described by Los Huertos (2020) are “seasonal wetlands that form in shallow basins and alternate on an annual basis between a stage of standing water and extreme drying conditions”. An example of a vernal system although modified from natural conditions due to altered catchment hydrology was sampled in the upper reaches of the Tulpleegte River at site Tul US which presented as an impoundment. This pool held a number of clam shrimp (Conchostraca) which were sampled and photographed. Photographs of the clam shrimp are presented in Figure 2-17. It is expected that more of the impoundments as well as the natural vernal pools in the form of pans present across the project area will support vernal biota, which may include Anostraca (fairy shrimp), Notostraca (tadpole shrimps such as *Triops* and *Lepidurus* species).

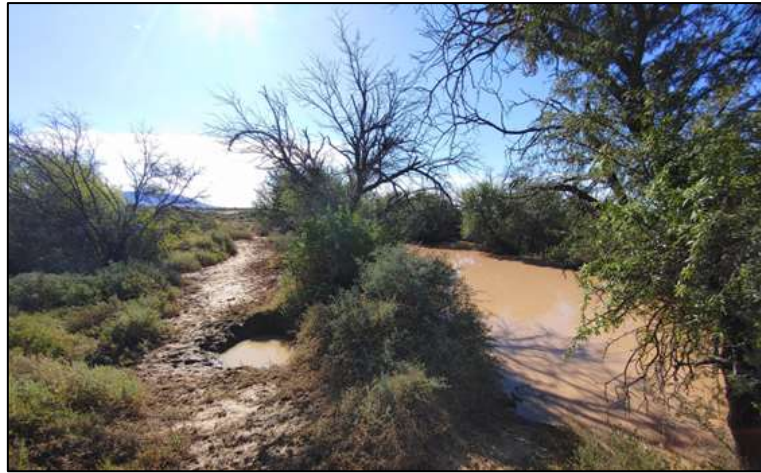
Figure 2-19 Typical arid zone watercourse and associated instream and riparian areas in the project area

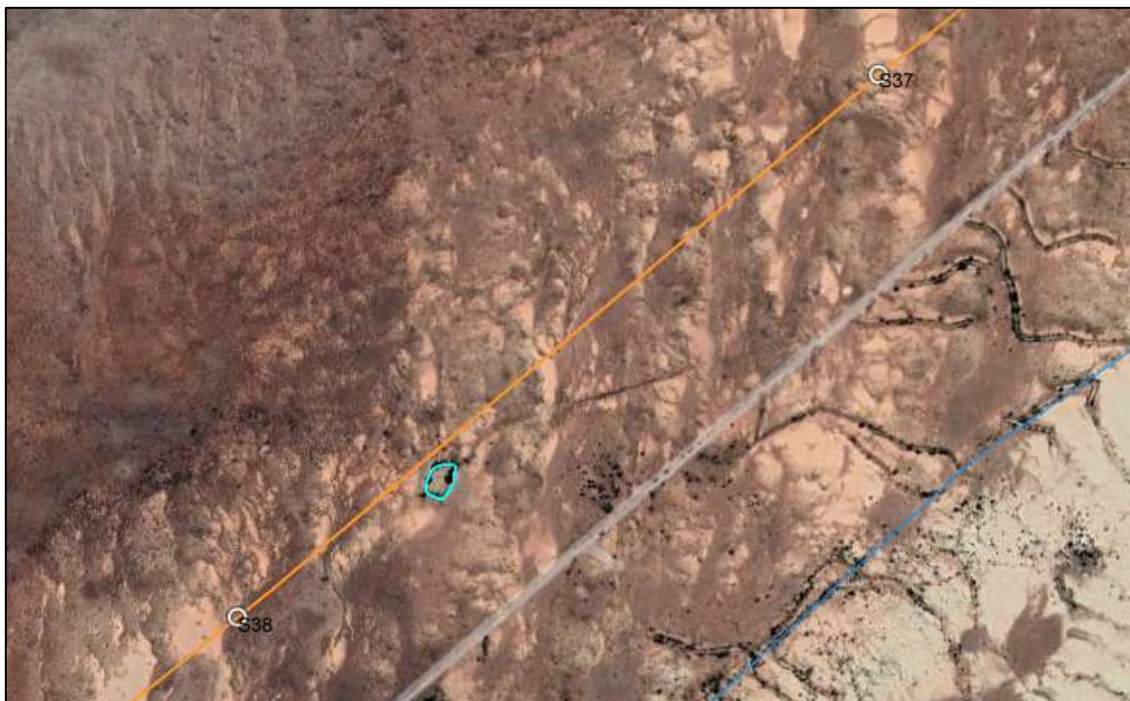
Figure 3-3 Vernal Pool (Turquoise) in proximity to road between turbines S37 and S38 (Google Earth 9/2022)

The presence of a compacted road network, and in this case a raised road is proposed, increases hard surfaces within the catchment, resulting in an increase in and alteration of runoff volumes and flow paths during high precipitation events and may be significant if poorly designed stormwater management infrastructure is implemented. The catchment alterations will have a direct impact on the sediment movement and drainage characteristics both locally within the influenced drainage network and associated downslope areas. Where turbine platforms and roads are constructed within the drainage features and associated marginal zones, a direct loss or disturbance of watercourse habitat with associated alteration of hydrology can be expected. As presented in this report, the soil and watercourse banks are highly erodible and susceptible to increased degradation from construction related disturbance. The same applies to watercourse crossing structures (box culverts) within drainage areas, as these are expected to be constructed in areas where no access roads exist. In turn, habitat disturbance may degrade habitat quality and produce watercourse and surrounding watercourse/ ecological corridor (Ecological Support Area) fragmentation. A negative shift in the biotic integrity of the watercourses within the PAOI would be expected based on the severity of baseline habitat alterations or losses. It should be taken into account that due to the arid nature of the region and limited rainfall, the Karoo may take decades to re-establish habitat cover, therefore rehabilitation may be challenging, highlighting the need to avoid disturbance of these areas. This concern has been addressed in the revised layout for the WEF and therefore is no longer of major concern, yet must still be considered for the life of the project. The grid infrastructure is located away from key aquatic features, and the position of these structures is deemed acceptable. There is however an intact vernal pool located roughly 15 meters from the proposed road between turbines S37 and S38 (Figure 3-3).

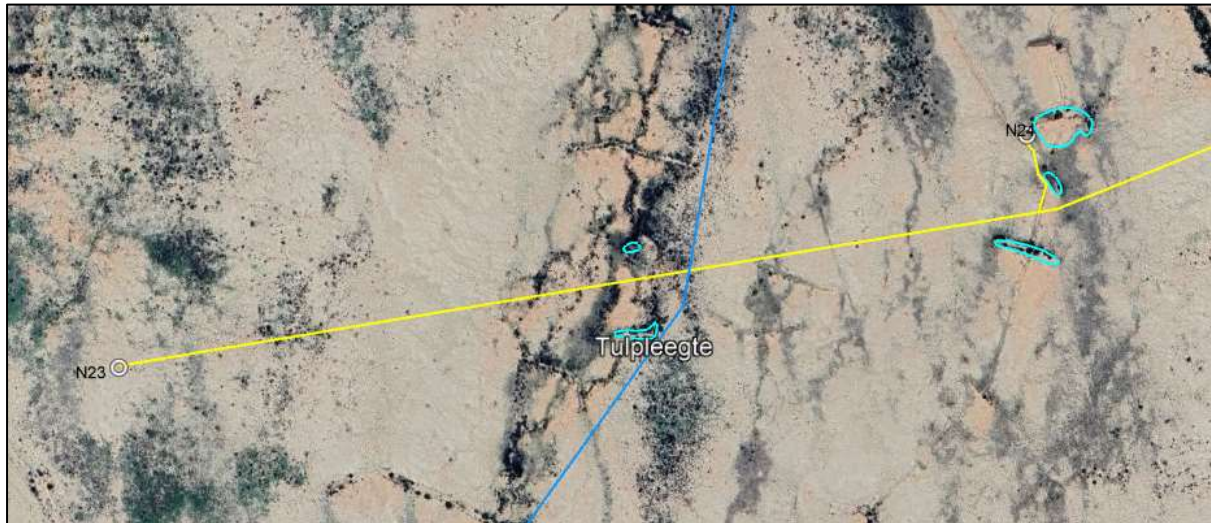
Figure 3-4 Vernal Pools (Turquoise) in proximity to road between turbines N23 and N24 (Google Earth 8/2023)

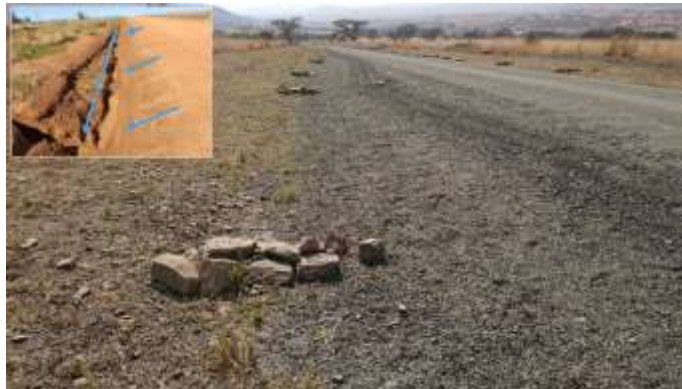
Figure 3-7 Example of road margin erosion prevention

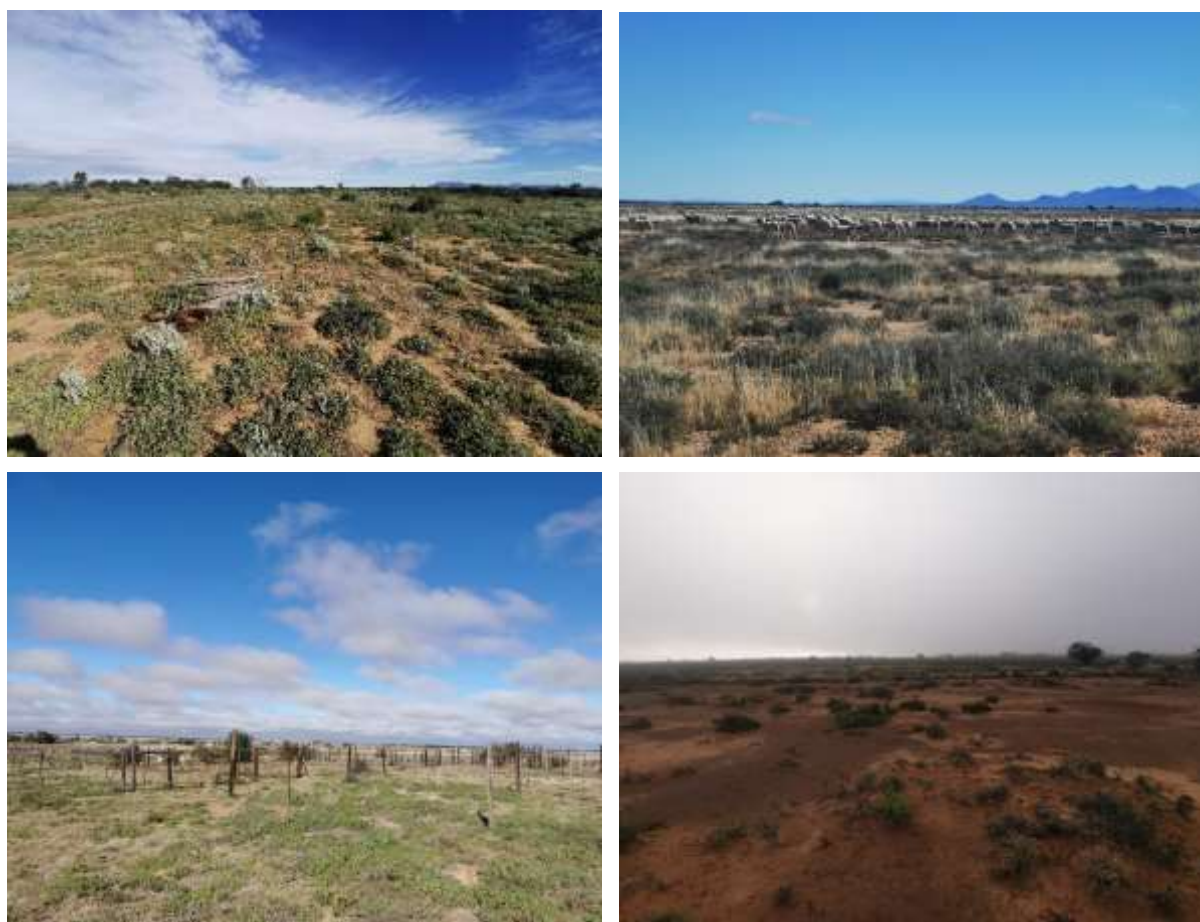
Figure 9: Photo evidence of grazing small stock within the study area with signs of water provision for animals.

The field crop boundary map (Figure 8) shows that rainfed annual crops/planted pastures are present within the development area. During the site visit no crop fields or planted pastures were found. The main land use of the development area is livestock farming with various areas having water provision for the animals (Figure 9).
