map 2 : KUDU SPV 3 Local Context

map 3 : KUDU SPV 3 • Fieldwork and Viewpoints

map 4 : KUDU SPV 3 • Facilities Layout

CHAPTER II: Heritage Impact Assessment (Archaeology and Cultural Heritage)

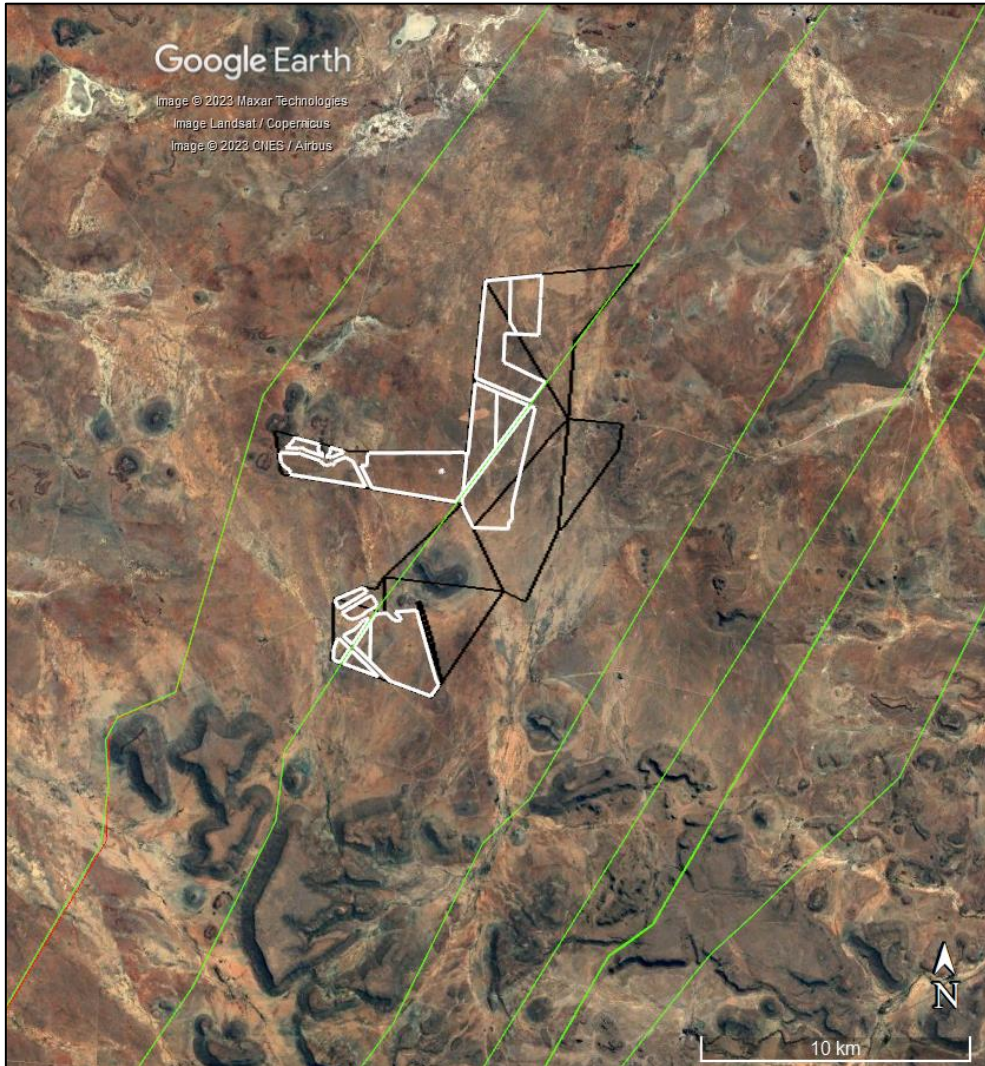
Figure 5: Map showing the project location in relation to existing HV powerlines (green lines).

The broader Kudu study area is very remote and lies far from any towns. Philipstown is the nearest and lies some 27 km to the southeast. Petrusville is some 33 km east-northeast and De Aar is 57 km to the southwest. The area is used for livestock grazing. Access is all on gravel roads and the only other infrastructure present aside from farming-related features are several high voltage (HV) powerlines. One of these passes through the middle of the Kudu study area (Figure 5). The study area does not fall within a Renewable Energy Development Zone (REDZ; the nearest is Kimberley REDZ 130 km to the northeast) but is entirely contained within the Central Electricity Grid infrastructure (EGI) Corridor.
