Appendix G8

Wetland delineation

**WETLAND DELINEATION OF THE PROPOSED
DEVELOPMENT ROOIHUISKRAAL
EXTENSION 29**

Prepared by:	Scientific Aquatic Services
Report Authors:	Natasha van de Haar (Cand. Sci. Nat.) Stephen van Staden (Pr. Sci. Nat)
Report Reference:	SAS 210074
Date:	May 2010

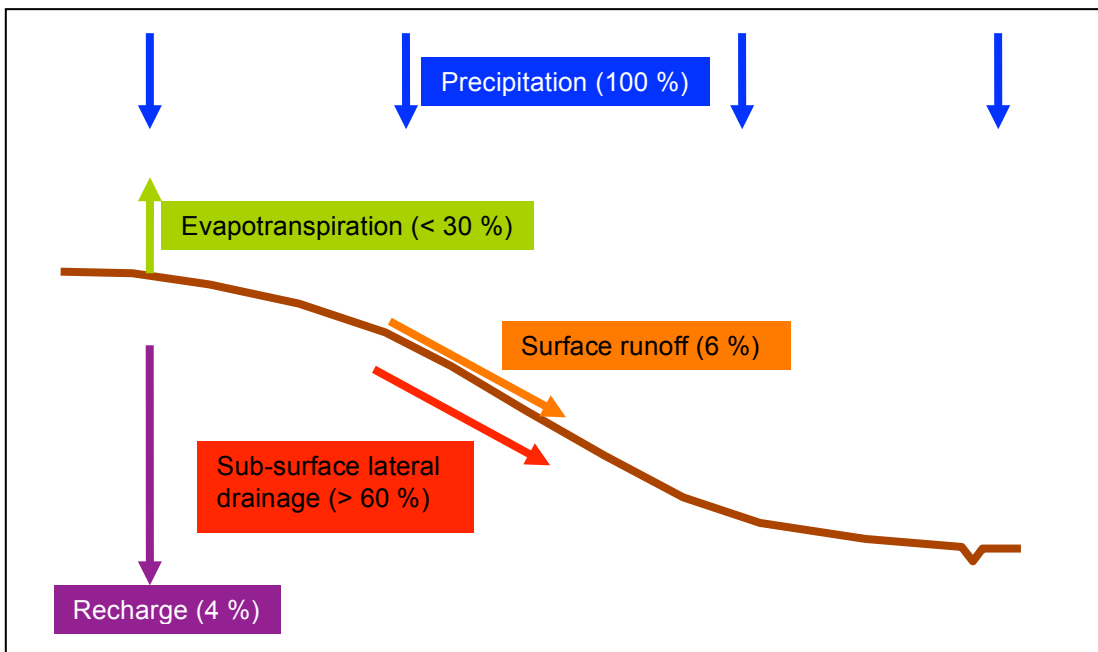
Figure 6 Idealised landscape with assumed quantities of water moving through the landscape expressed as a percentage of total precipitation (100 %).

To illustrate: If the assumption is made that the area of interest is 100 m wide it follows that the first 100 m from the crest downwards has 4 500 m³ (or 4 500 000 litres) of water moving laterally through the soil (100 m X 100 m X 0.45 m) per rain season. The next section of 100 m down the slope has its own 4 500 m³ of water as well as the added 4 500 m³ from the upslope section to contend with, therefore 9 000 m³. The next section has 13 500 m³ to contend with and the following one 18 000 m³. It is therefore clear that, the longer the slope, the larger the volume of water that will move laterally through the soil profile.

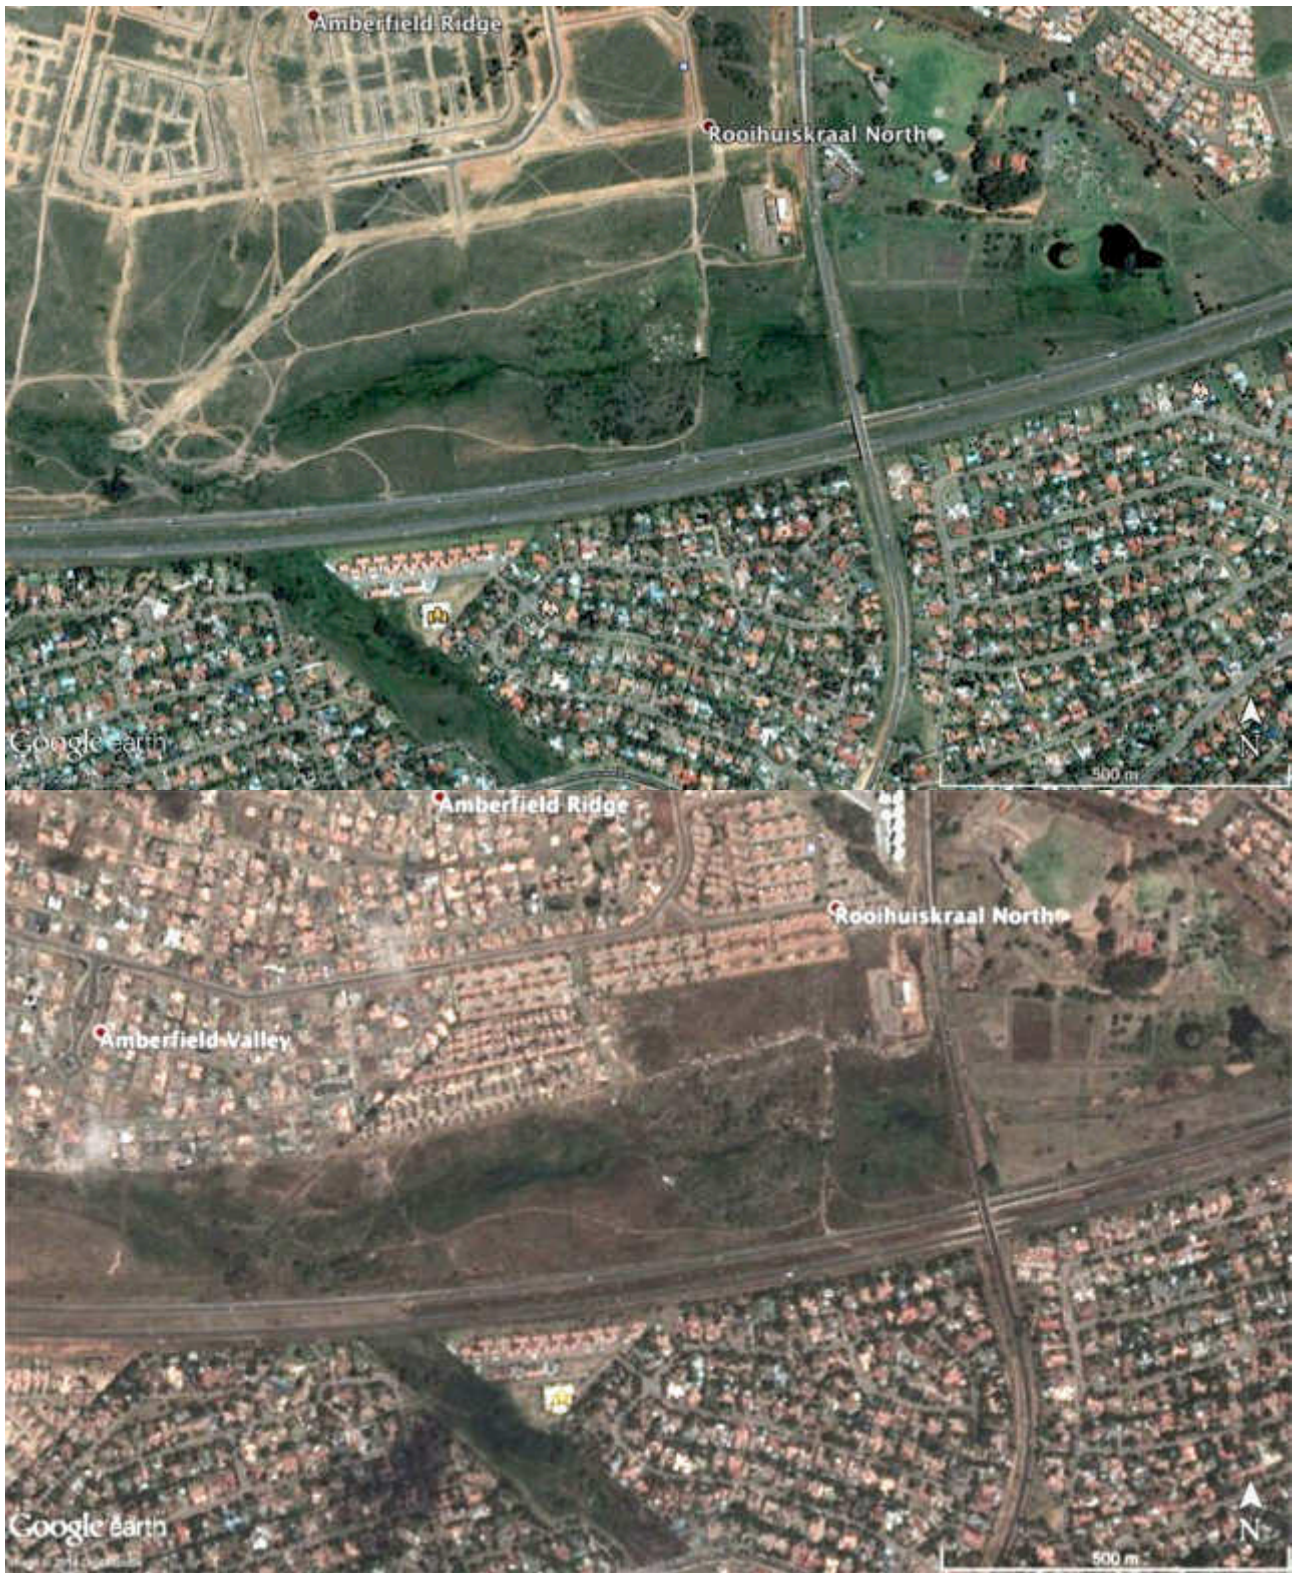
Figure 17 Google Earth images from 2005/01/03 (top) and 2013/10/29 (bottom) indicating land use changes on and around the site over a decade

The Google Earth images of the site were used to identify specific impacts and their timing in high resolution. **Figure 17** indicates the overall land use changes from 2005 to 2013. The changes were predominantly the intensification of residential developments surrounding the site. At this stage (2005) most of the road infrastructure around the site had been established and the specific storm water dynamics altered significantly when compared from the images before 1980 (**Figure 16**). **Figures 18 to 21** indicate the specific wetland area and the residential development north of the site from 2005 to 2013. The rubble that is evident on the image in **Figure 22** is also evident on images from 2005, indicating that the rubble dumping is not a recent development. In **Figure 23** a highly altered drainage feature is evident when compared to the images from the '50s and '60s. This aspect is addressed in more detail later in the report with respects to the functional and ecological assessment of the wetland.

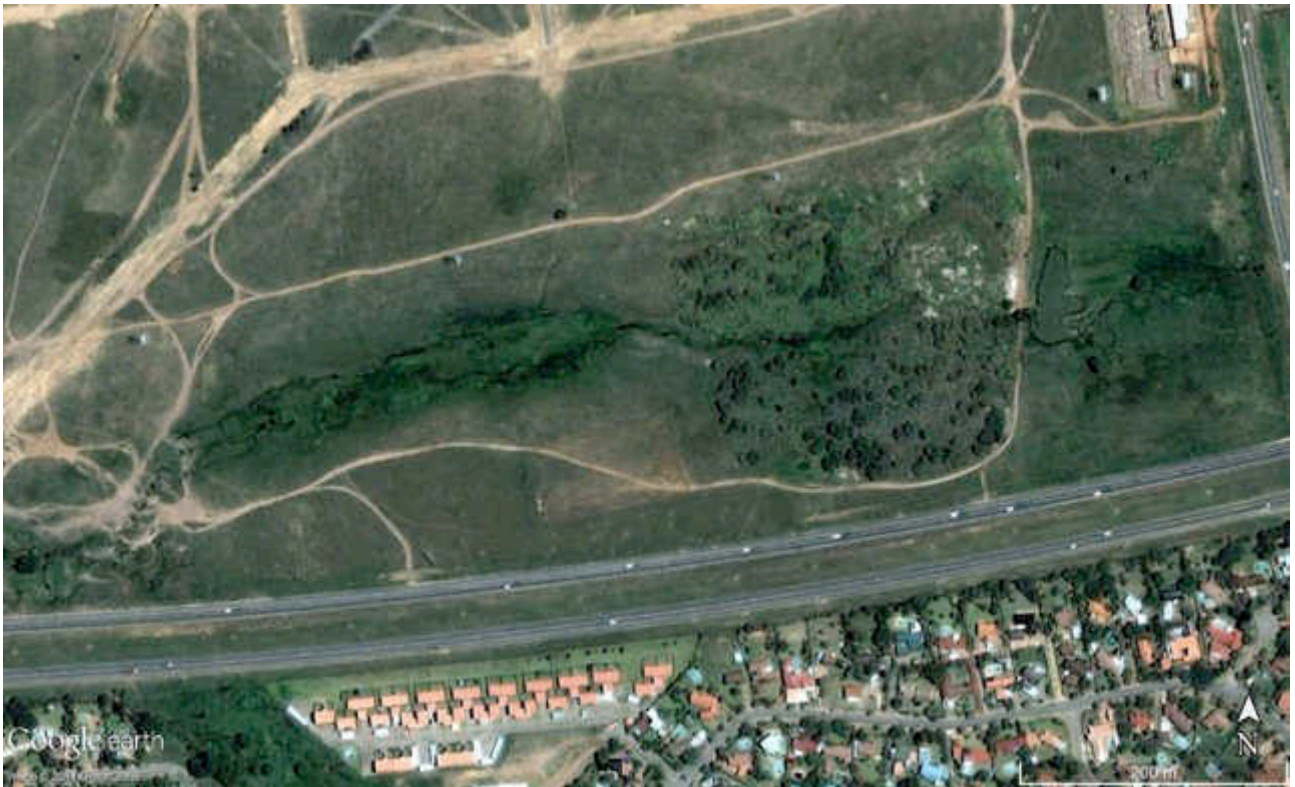
Figure 18 Google Earth image (2005/01/03) indicating the wetland area under investigation

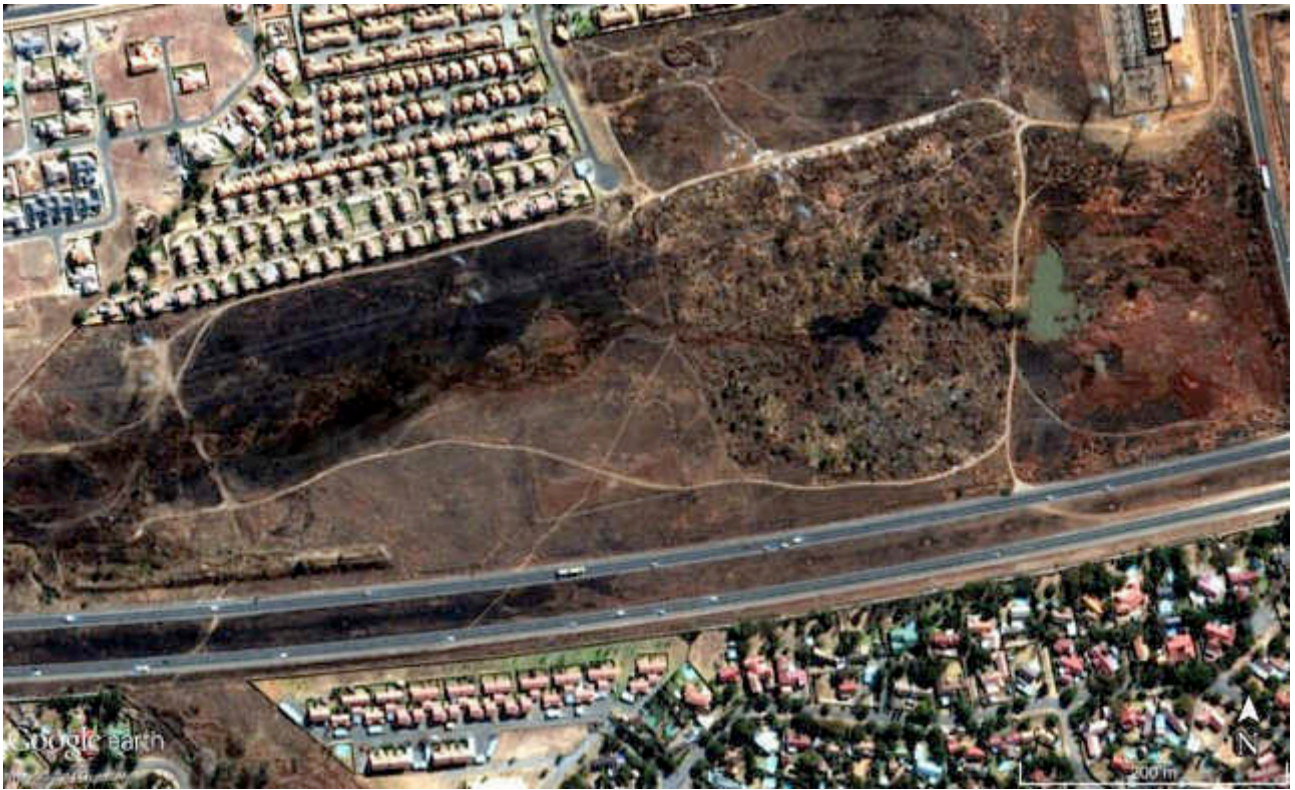
Figure 20 Google Earth image (2012/07/03) indicating the wetland area under investigation

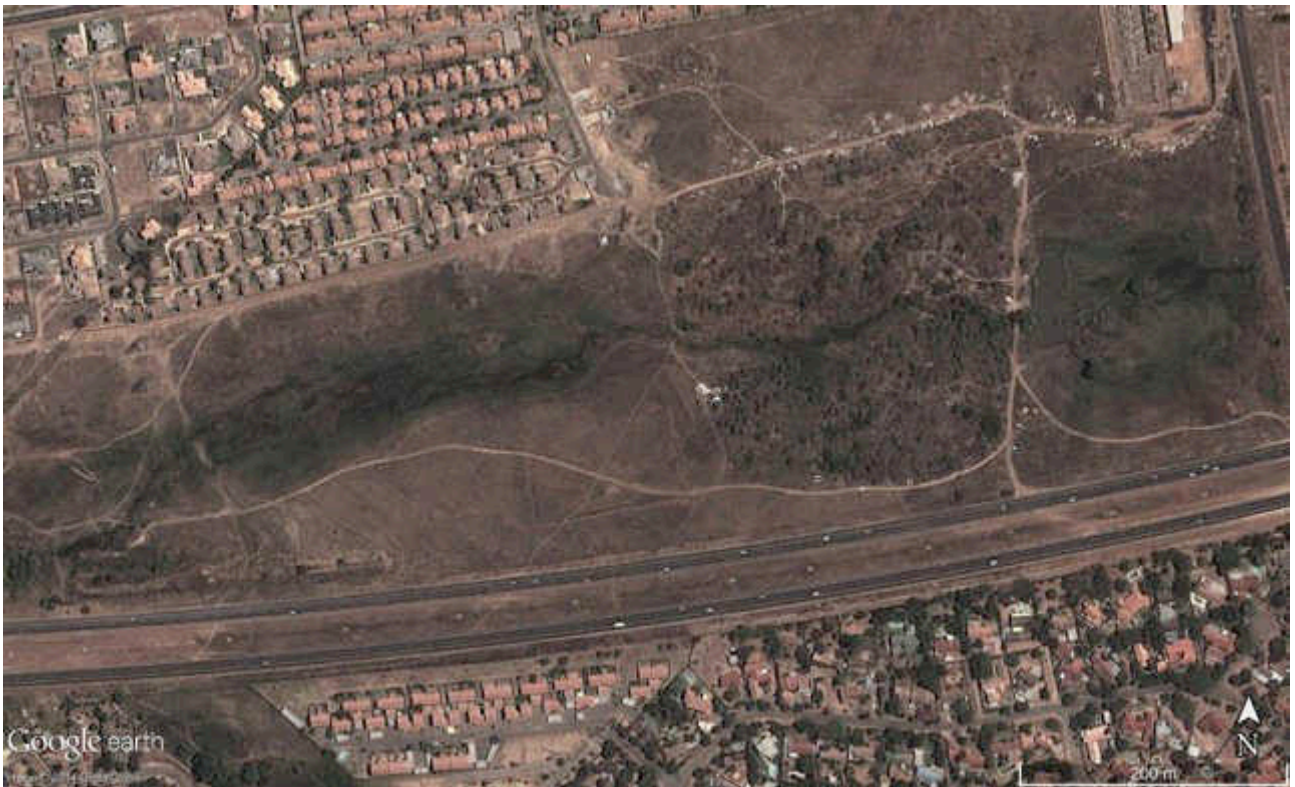
Figure 21 Google Earth image (2013/10/18) indicating the wetland area under investigation

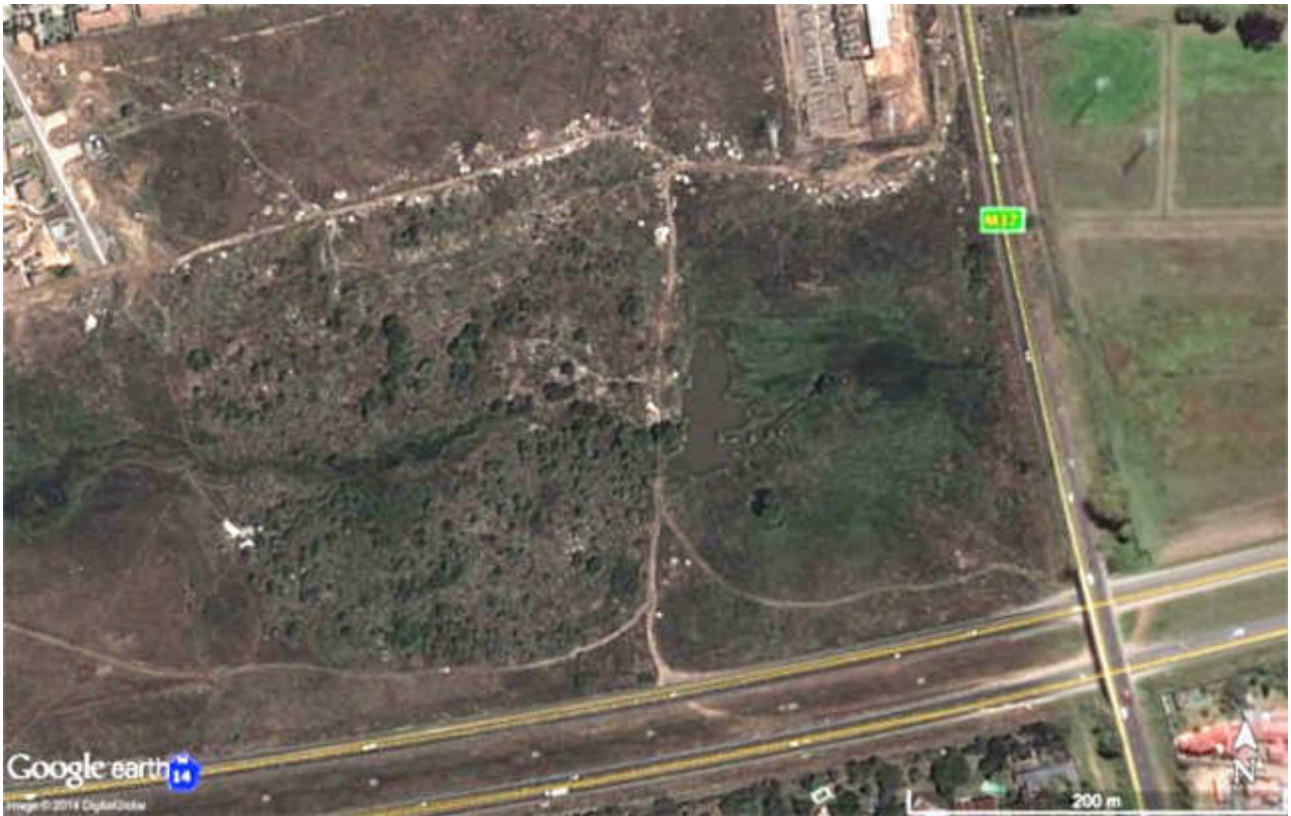
Figure 22 Google Earth image (2014/04/05) indicating the eastern section of the site with rubble dumped across the drainage feature

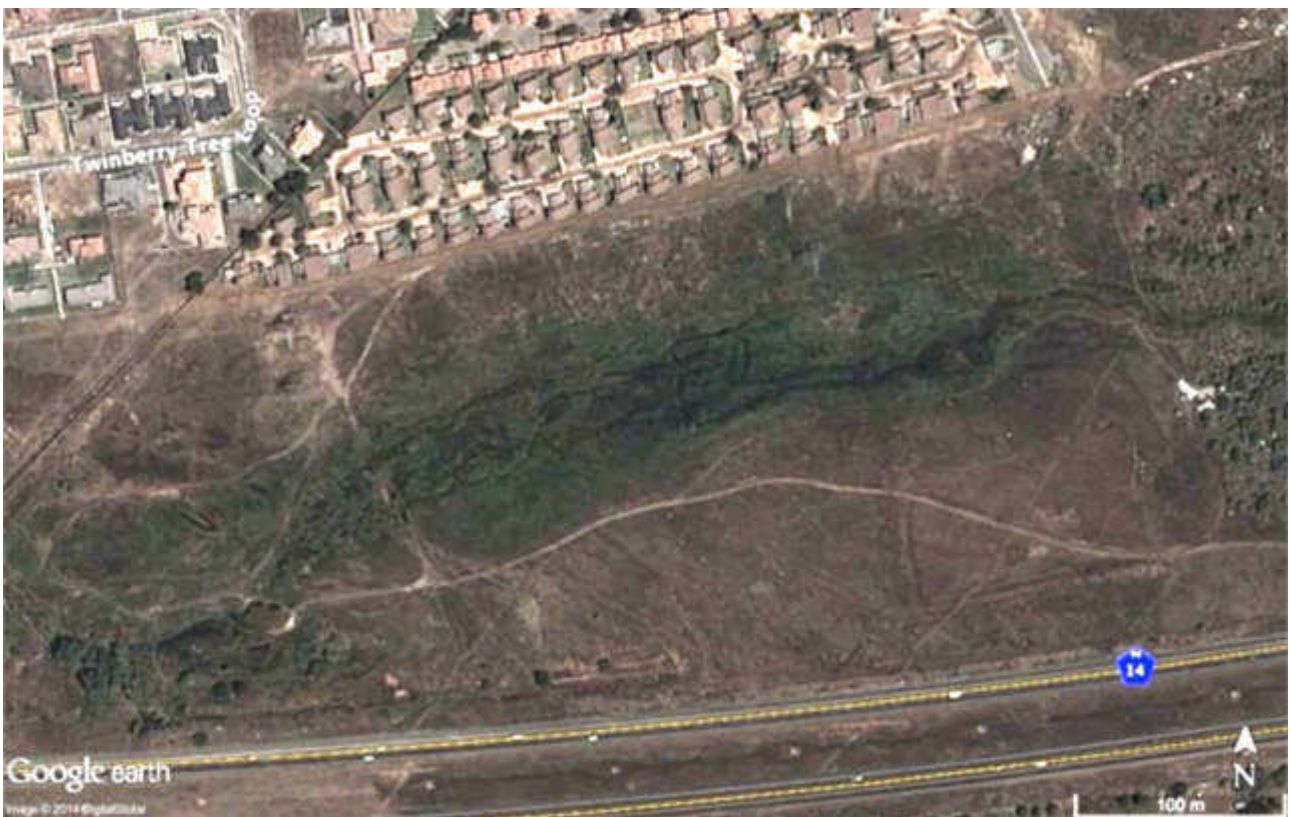
Figure 23 Google Earth image (2014/04/05) indicating the western section of the site with a highly altered stream flow regime

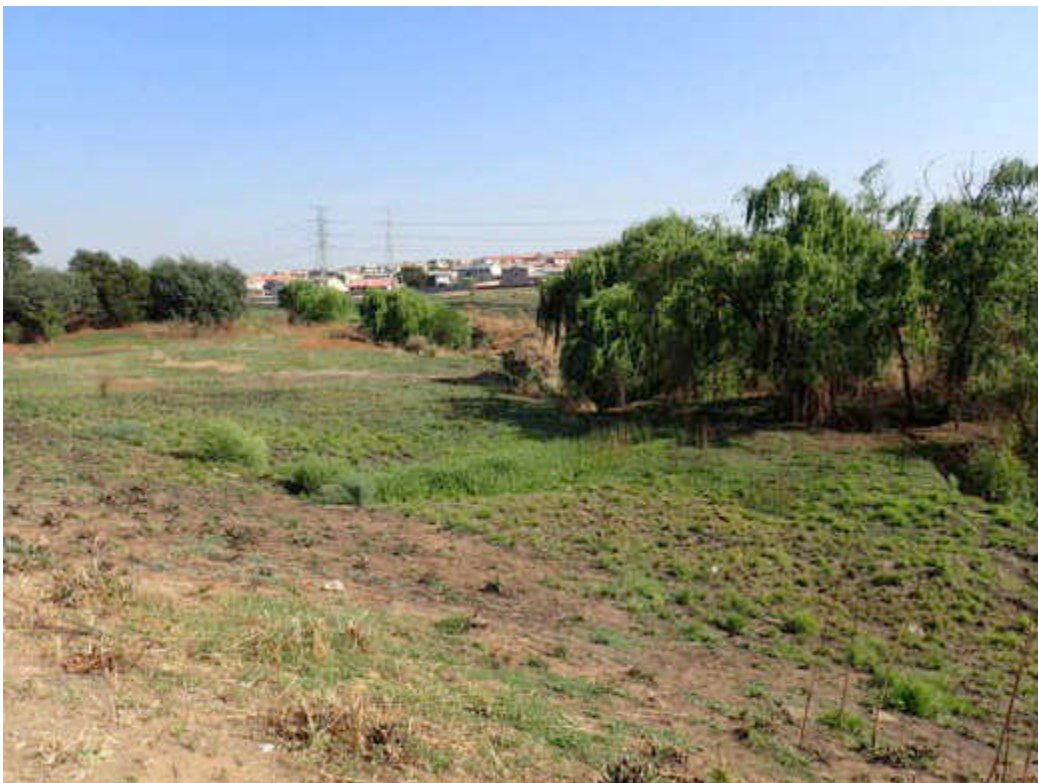
Figure 25 Alteration of the drainage feature through road development, storm water infrastructure and alien vegetation establishment

A dedicated field verification exercise was conducted through the auguring of the soils within the wetland feature. The soils found on the site conform to the description provided in section 5.5 to 5.7 and will therefore not be described in further detail. Suffice to say that the soils indicate a large degree of alteration due to the historical human activities and associated erosion of the drainage feature (Figures 25 to 27).

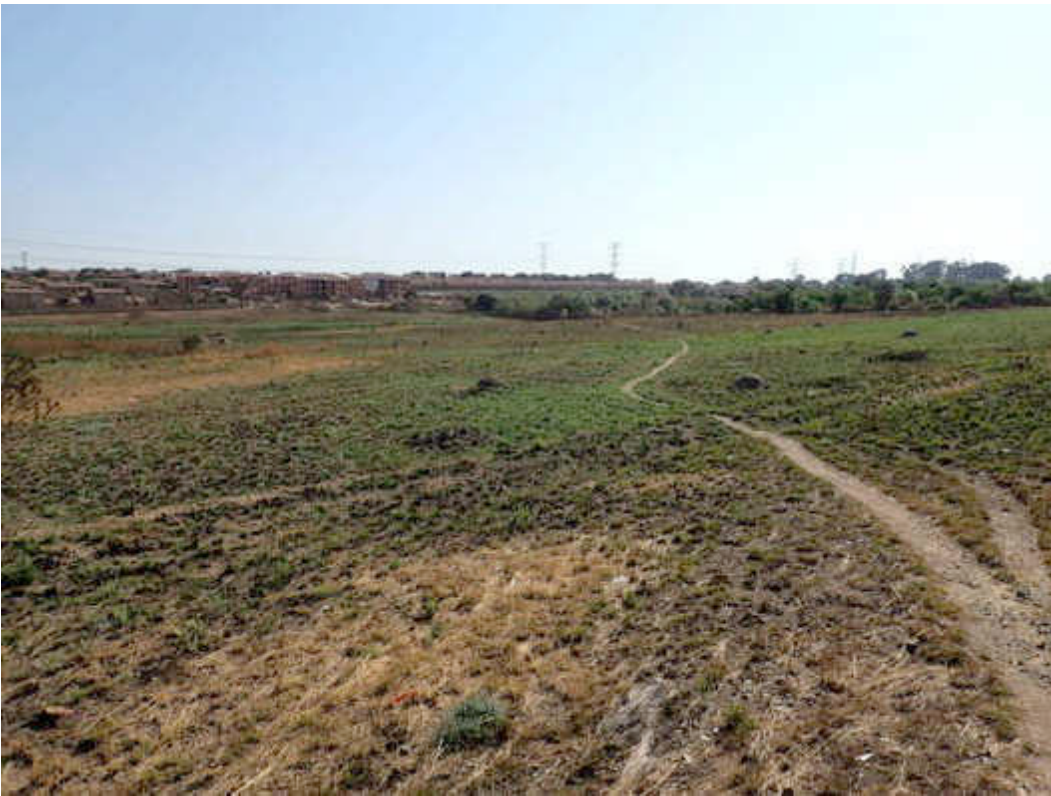
Figure 26 Alteration of the land due to human activities

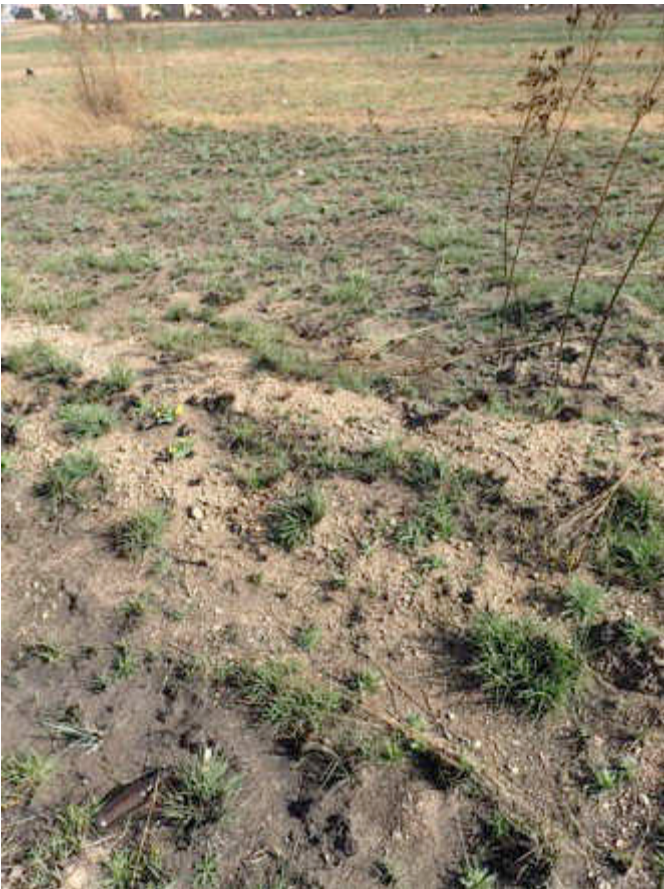
Figure 27 Alteration of the soils due to human activities in the form of excavations and historical agricultural activities

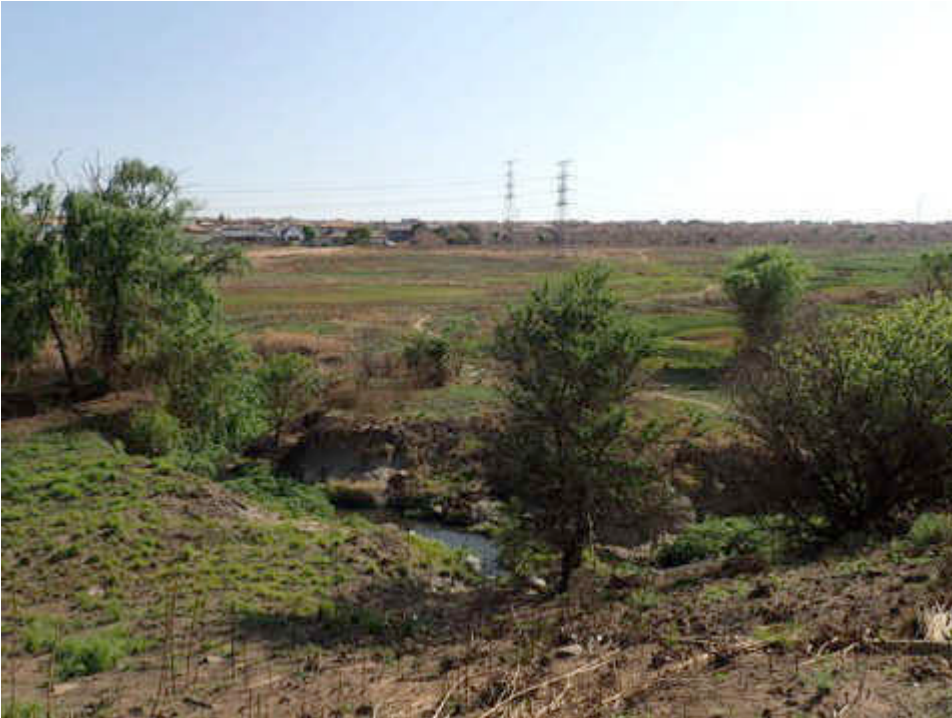
Figure 27 Alteration of the drainage channel through erosion and human activities

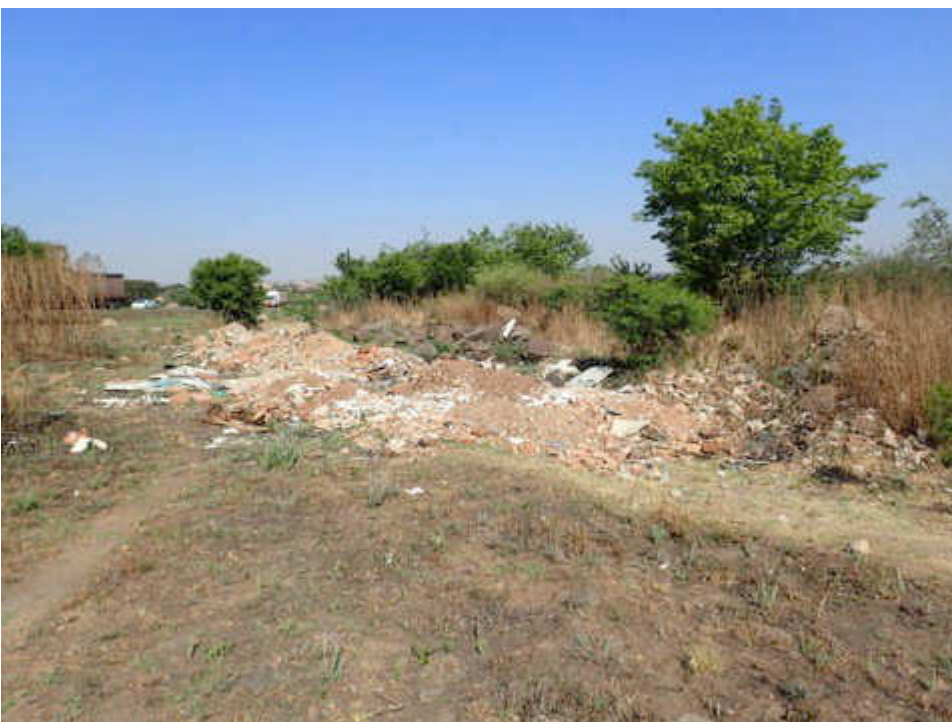
Figure 28 Dumping of building rubble on the site

Some of the physical historical artificial modifiers on the site were addressed in the sections above. The driver of most of the modifications is the altered hydrology of and runoff from the urban structures in the catchment area (**Figure 28**). Large sections of the site suffer from rubble dumping (**Figures 28 to 34**). **Figure 35** provides a view of the survey site from Rooihuiskraal Road.

1. The wetland area and its catchment have been altered significantly through historical human activities. These activities include urban infrastructure development, storm water alteration and increase, dumping of rubble and general degradation of the drainage feature through foot and vehicle traffic.

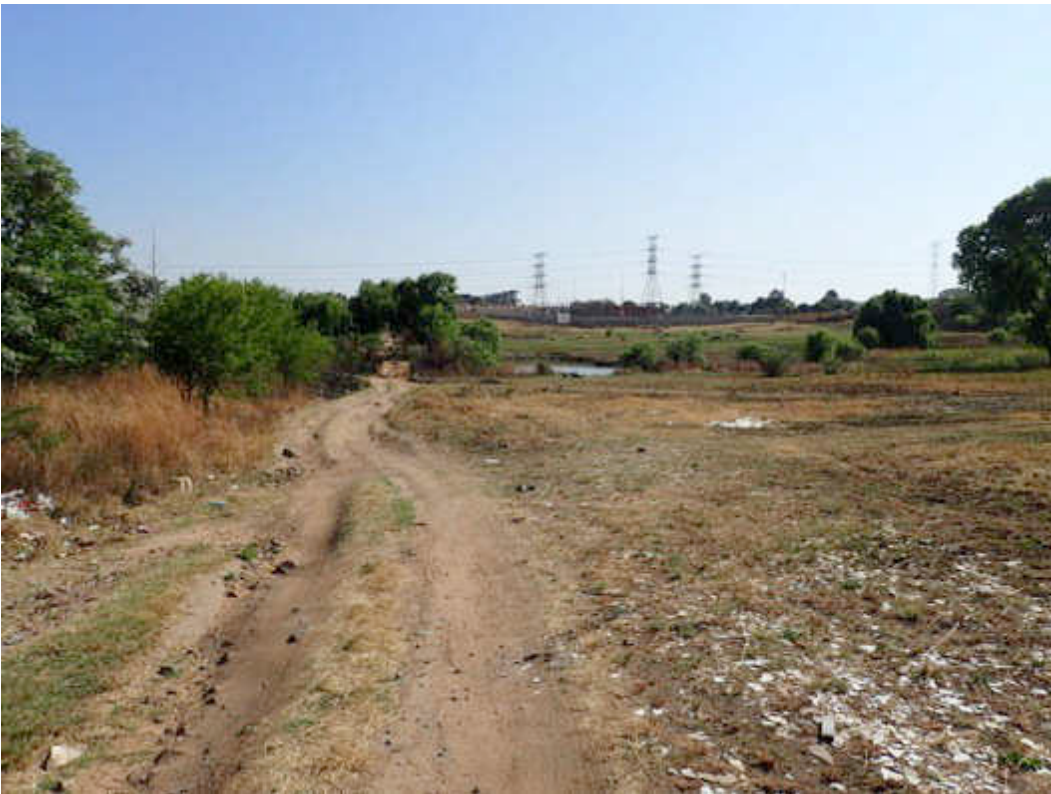
Figure 29 Human impacts and dumping of building rubble on the site

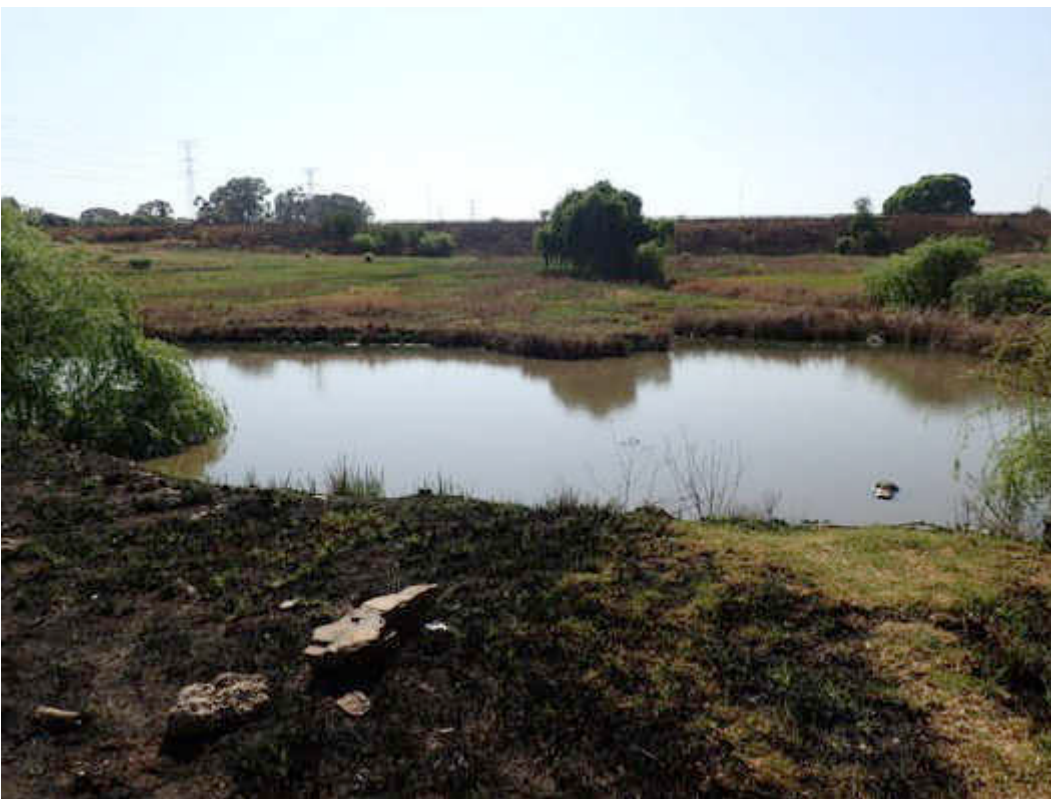
Figure 30 Man-made dam on the site due to dumping of building rubble in the drainage feature downslope

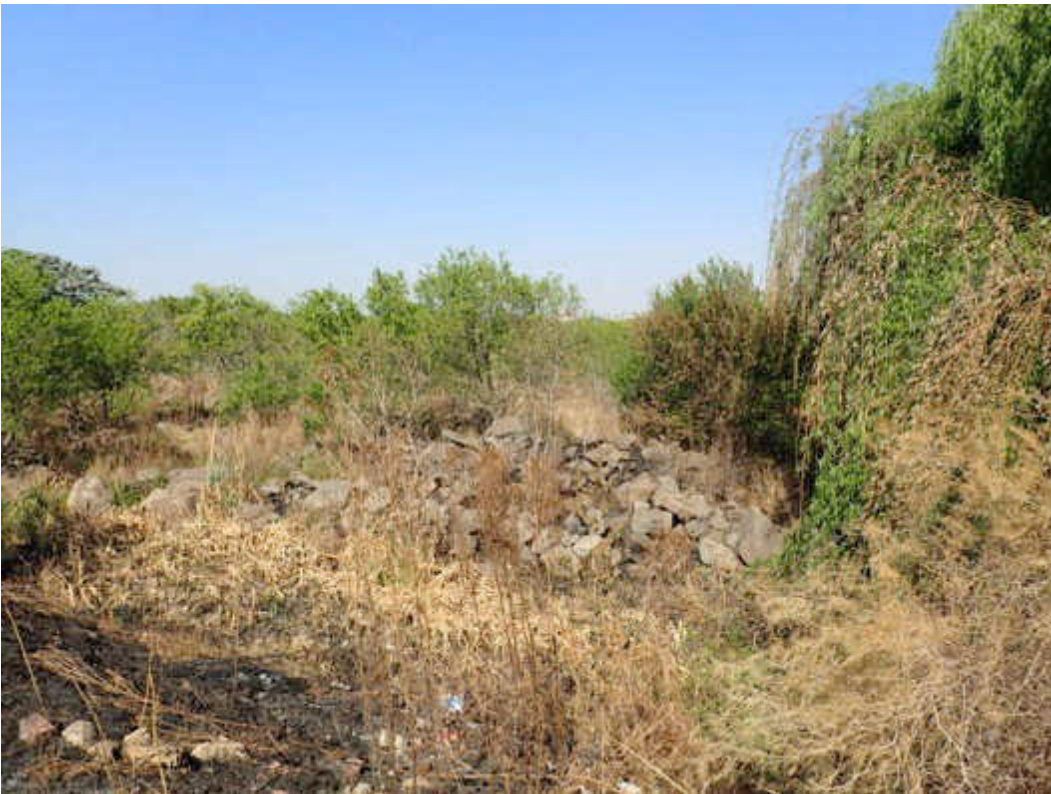
Figure 31 Dumped dolomite rock within the original drainage feature

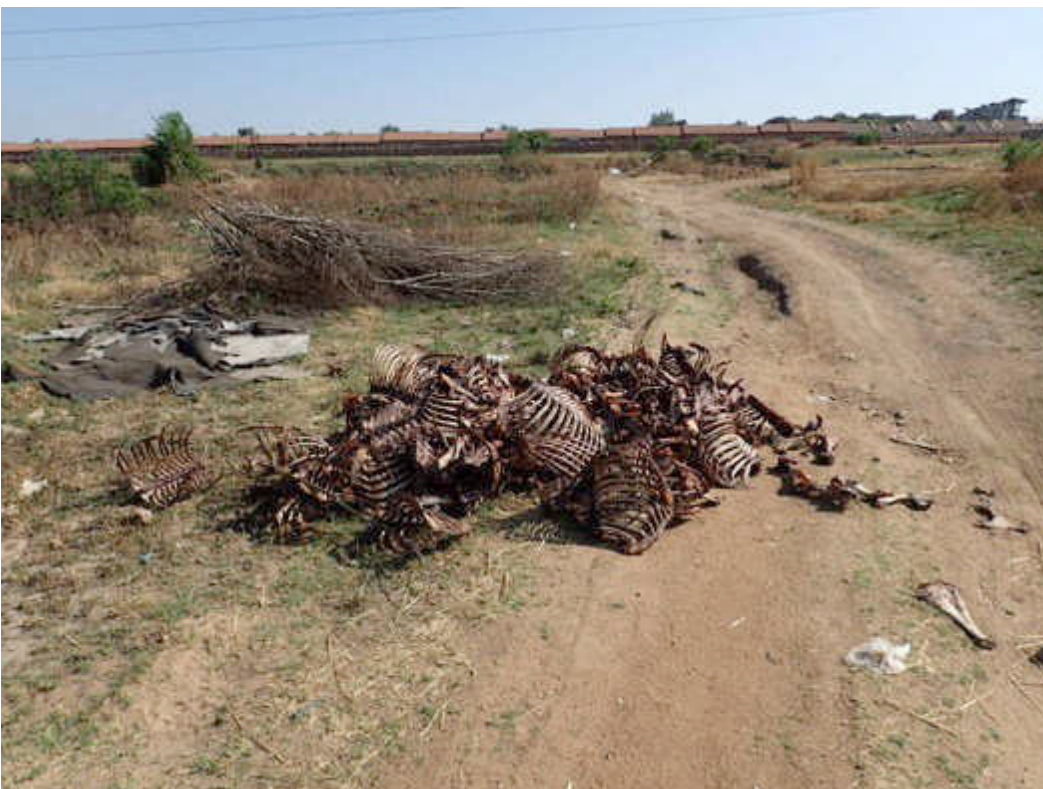
Figure 32 Dumped animal carcasses on the site near the drainage feature

3. From the field survey it is clear that hazardous materials in the form of animal carcasses are being dumped within close proximity to the drainage feature. This aspects

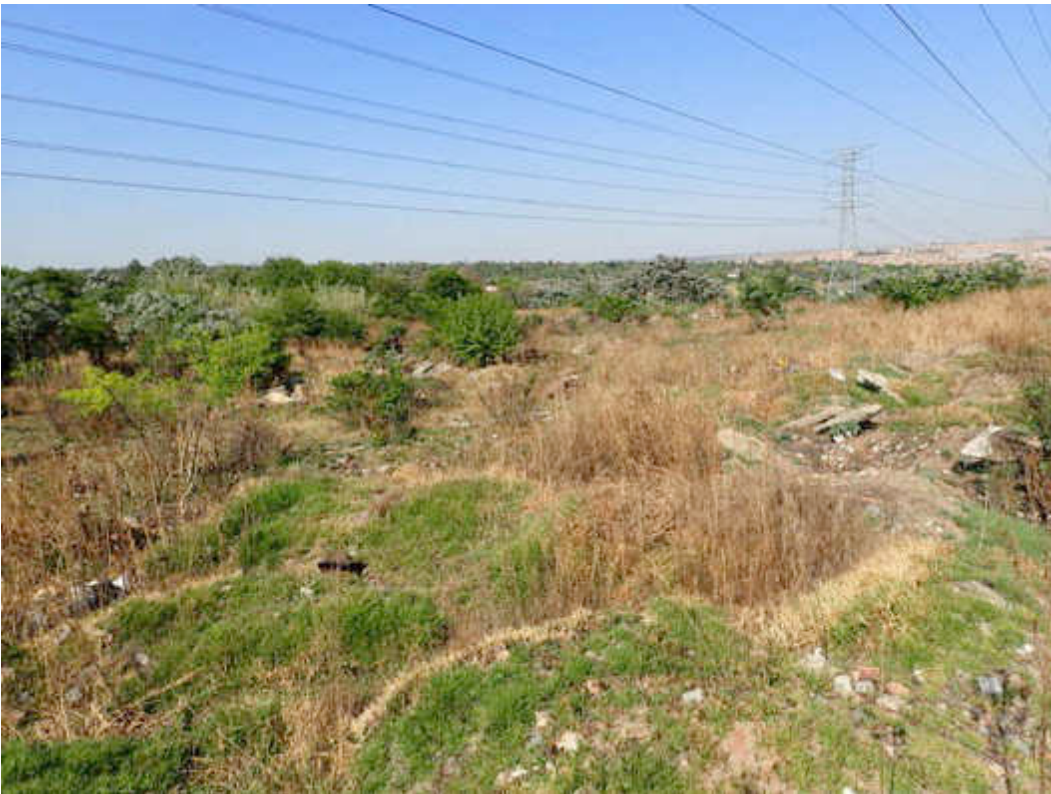
Figure 33 Dumped rubble within and on the edge of the original drainage feature

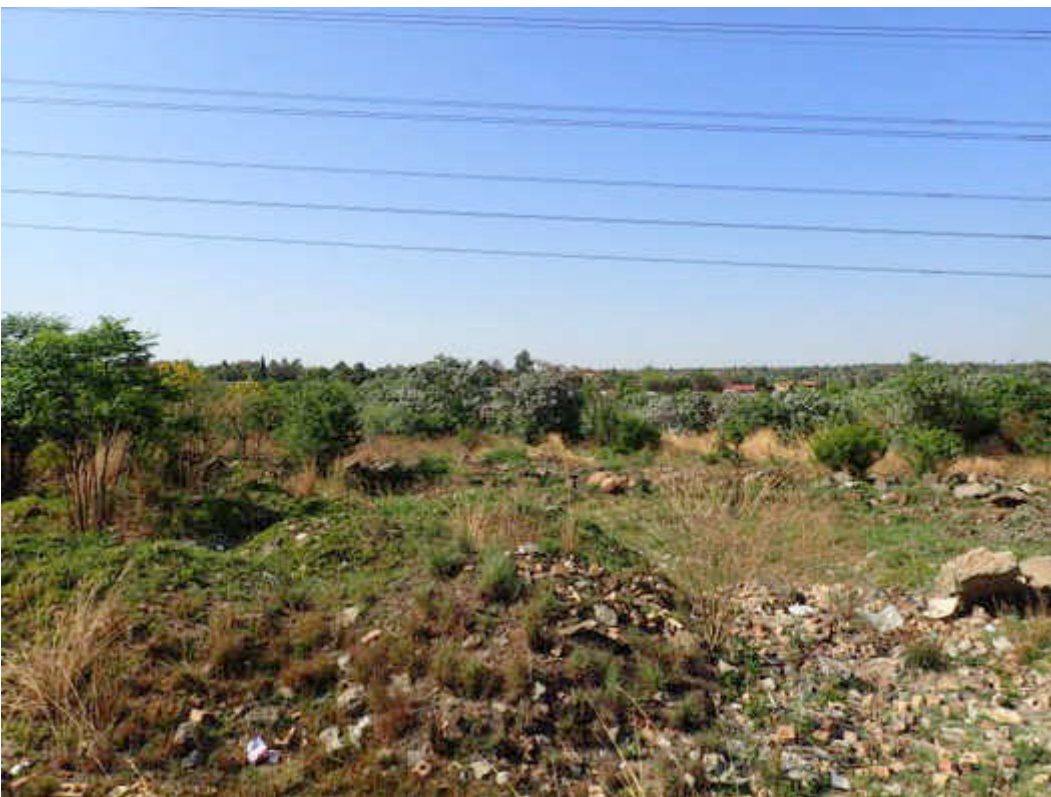
Figure 34 Dumped rubble within and on the edge of the original drainage feature as well as numerous syringe trees

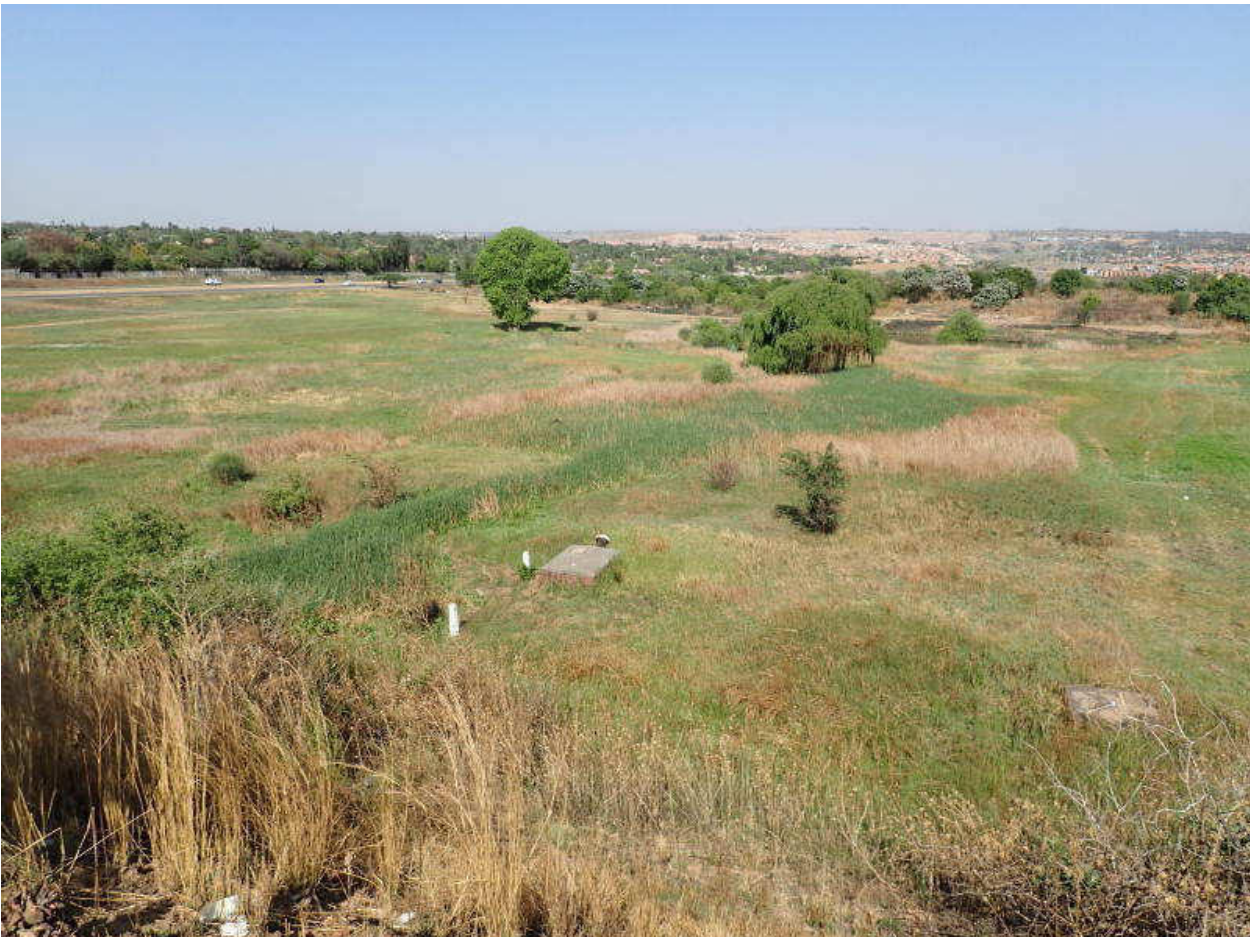
Figure 35 View from Roohuiskraal Road towards the site in the west indicating a range of human alteration of the drainage feature – including dumped rubble in the distance

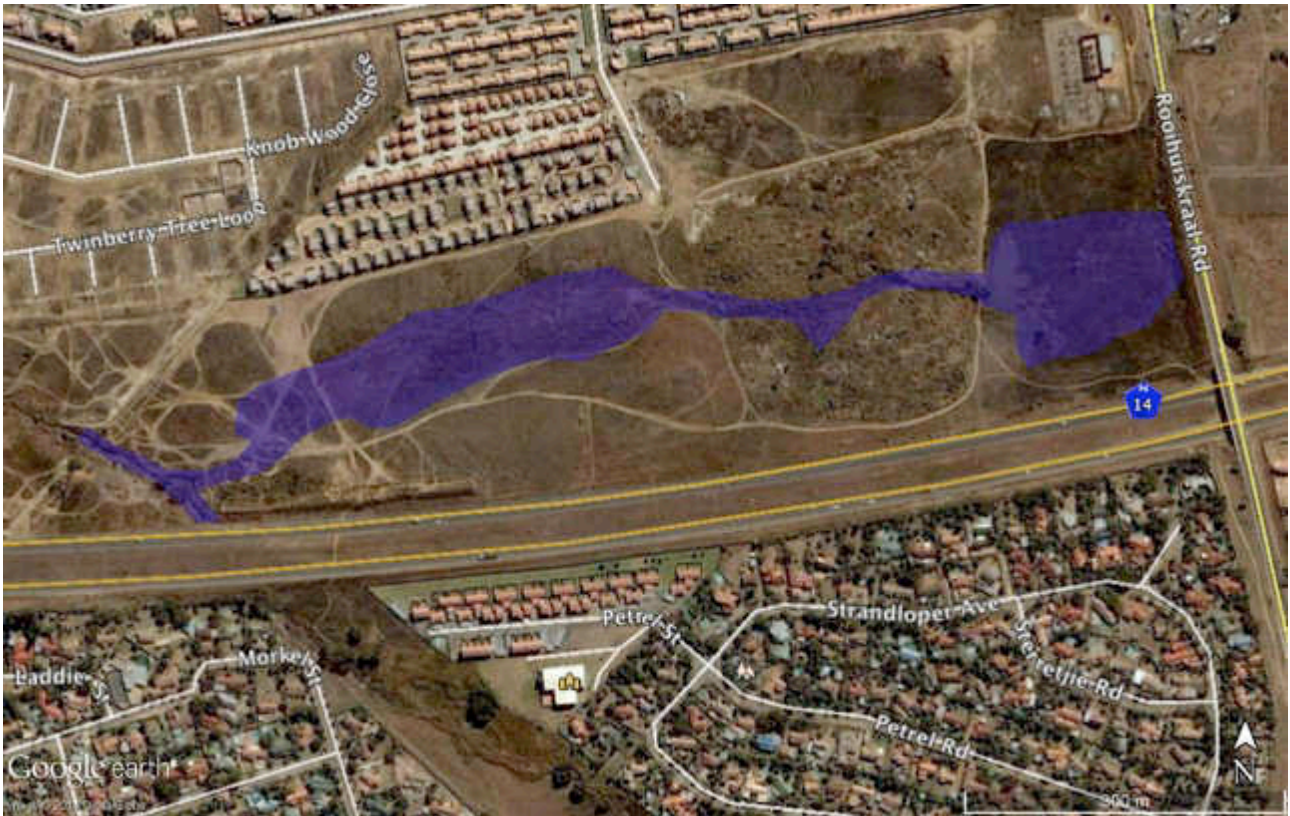
Figure 36 Proposed wetland delineation for the survey site

Due to the highly impacted nature of the wetland on the site, taking into account all the historical modifiers, a wetland delineation exercise would mean very little. The result of a delineation exercise would invariably be limited to the areas that currently exhibit wetland character in the form of vegetation and would not serve any purpose in informing the management and rehabilitation of the wetland. A delineation outcome is therefore only provided as an indication of the current extent of the wetland (**Figure 36**). Similarly, due to the significant impacts a buffer is a meaningless property. This is especially relevant in the context of the altered hydrology, continued human impacts in the form of dumping of rubbish, uncontrolled human movement and highly altered storm water dynamics. Rather, it is strongly advised that the wetland area be managed in terms of future human impacts and that it be rehabilitated regarding foreign materials (rubbish) and hydrological functioning. In the sense of the latter the main aspects that have to be addressed are sediment generation and erosion.
