Appendix G8

Wetland delineation

**WETLAND DELINEATION OF THE PROPOSED
DEVELOPMENT ROOIHUISKRAAL
EXTENSION 29**

Prepared by:	Scientific Aquatic Services
Report Authors:	Natasha van de Haar (Cand. Sci. Nat.) Stephen van Staden (Pr. Sci. Nat)
Report Reference:	SAS 210074
Date:	May 2010

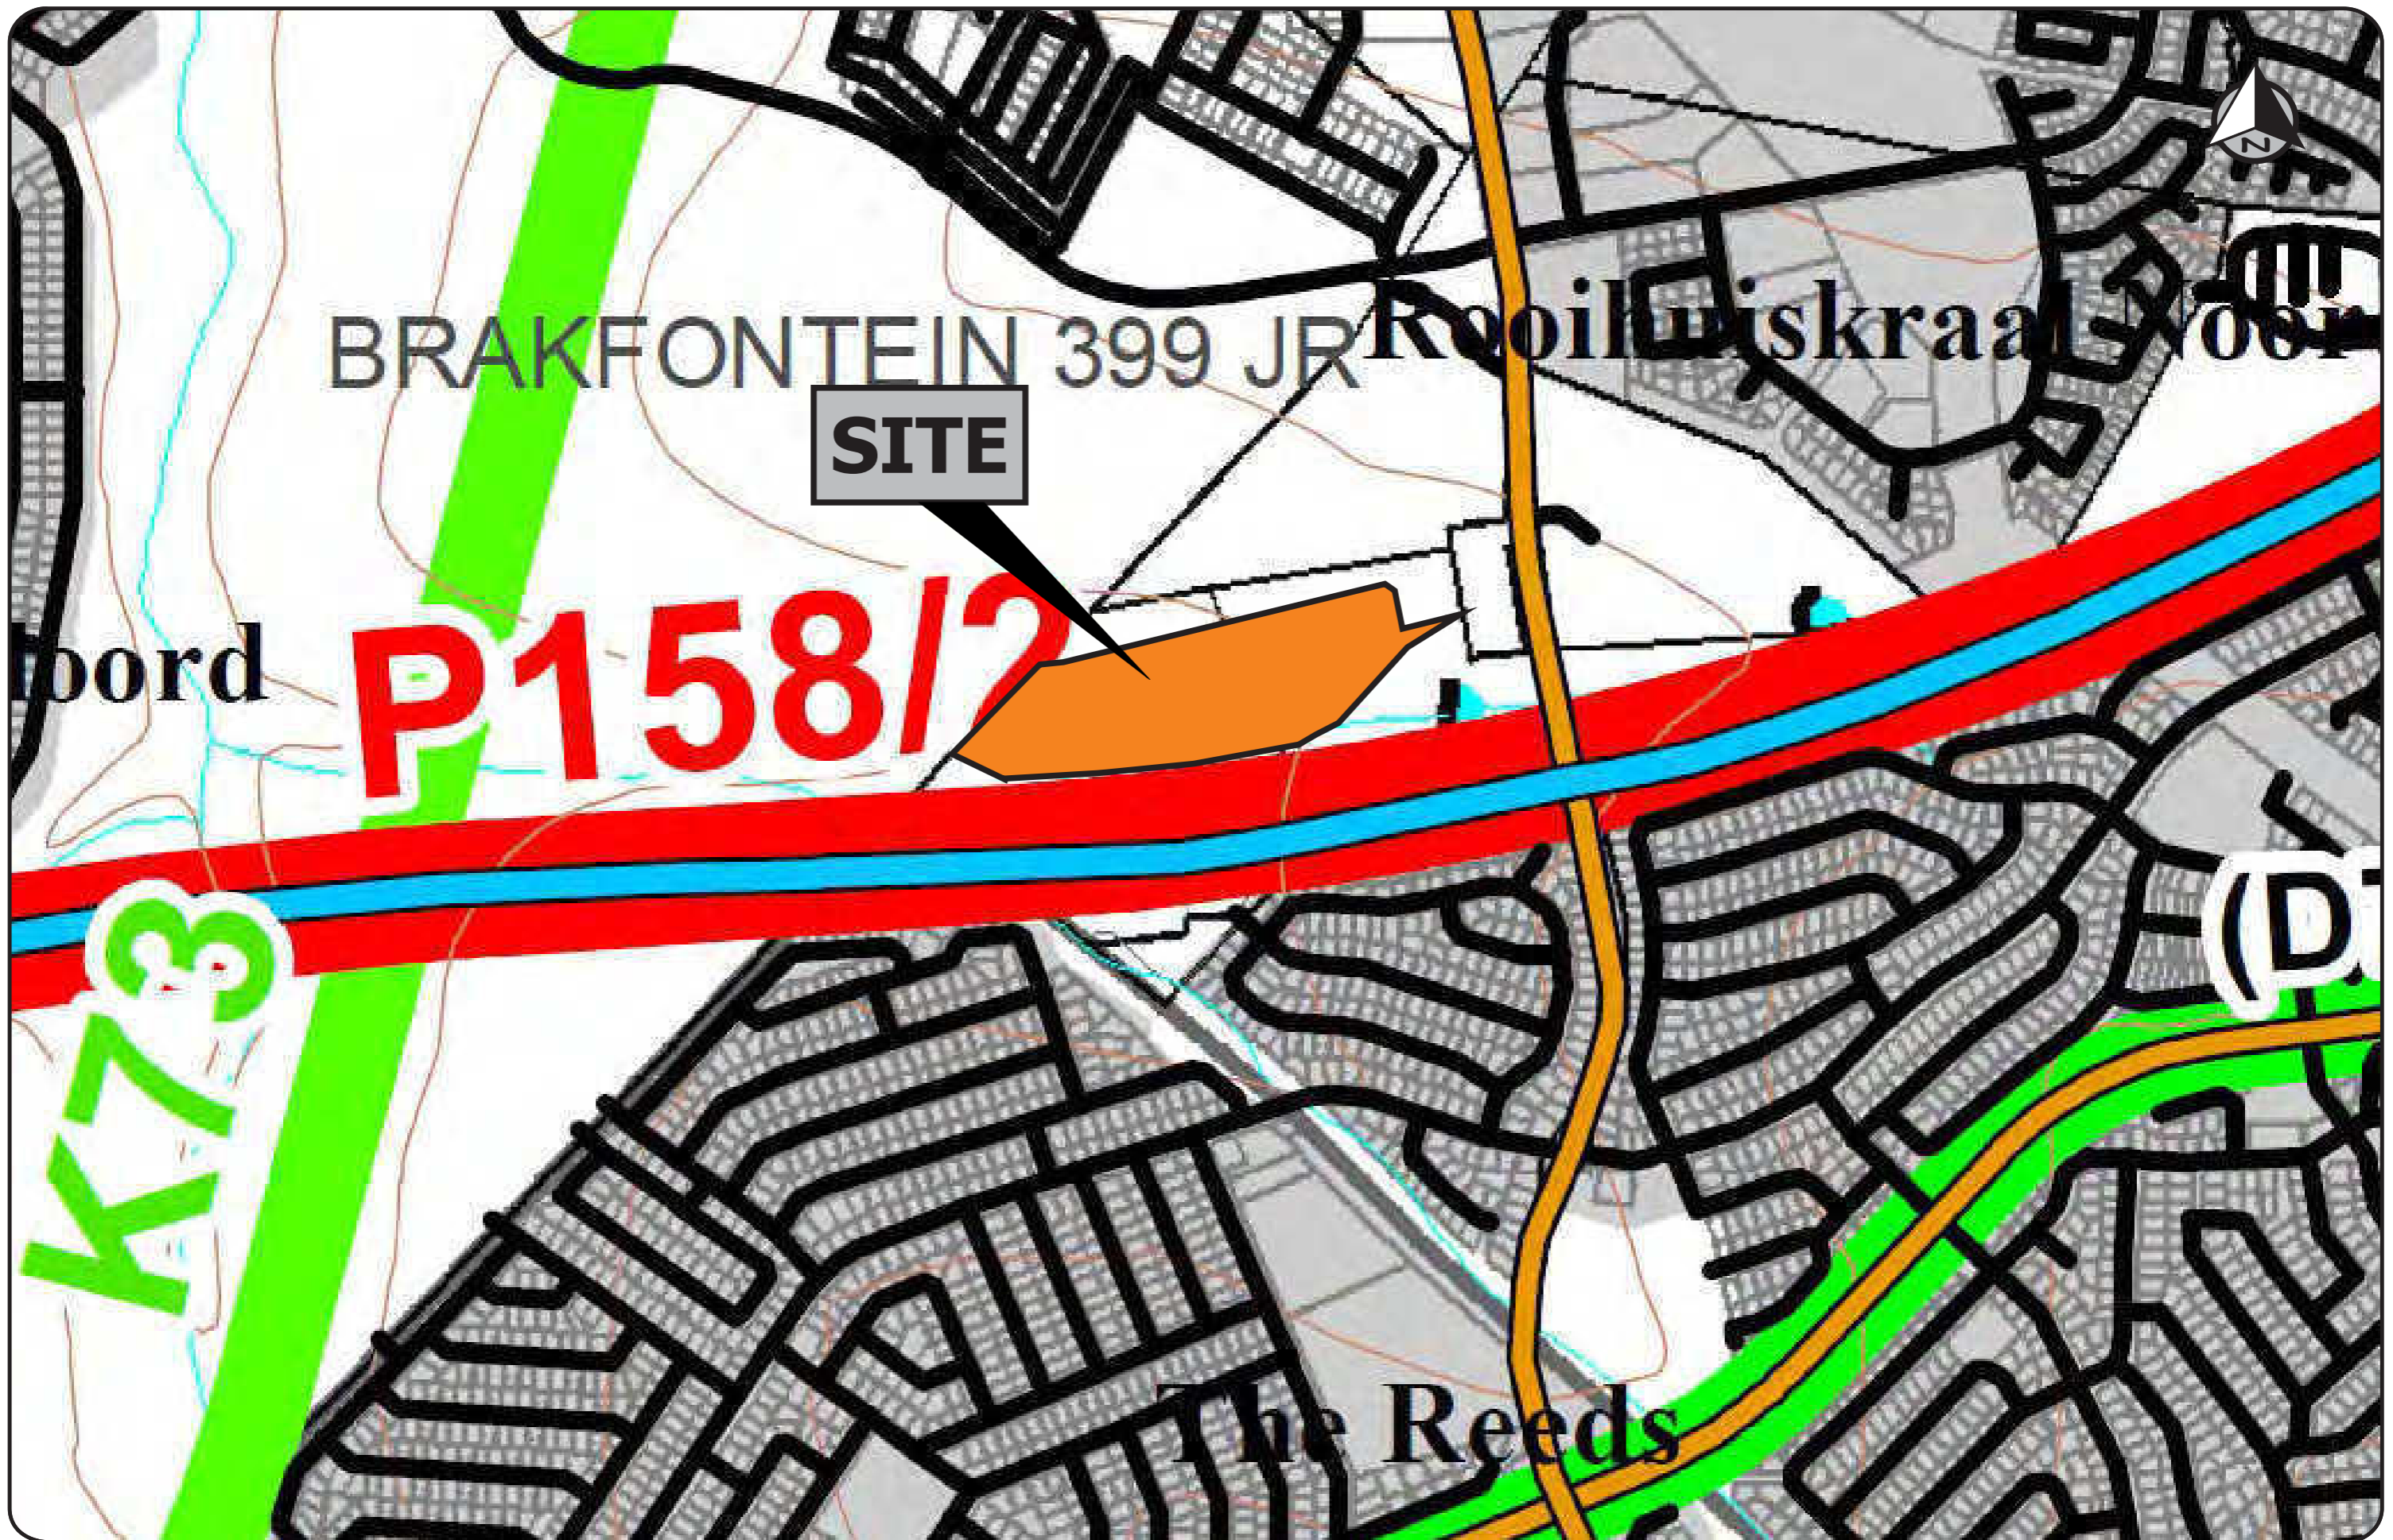
Proj Ref.	P0213
Figure	2

Project Name	Rooihuiskraal Noord Ext 29
Description	Site Aerial View & Key Plan

Access to the site itself will be provided via Kraalnaboom Avenue. To provide access to the erven on which the residential units are proposed, i.e. erven 1 to 4, the extension of Kraalnaboom Avenue will be required as shown in **Figure 2** and in the township layout in **Annexure A**. It also implies that the road will have to cross the wetland by means of a bridge structure.

3. **ACCESS:** Access to the site itself will be provided via Kraalnaboom Avenue. To provide access to the erven on which the residential units are proposed, an extension of Kraalnaboom Avenue will be required as shown in **Figure 2** and in the township layout in **Annexure A**. The proposed extension of the road will also have to cross the wetland by means of a bridge structure.

- 1.3.3 Access:
Access to the site itself will be provided via Kraalnaboom Avenue. To provide access to the erven on which the residential units are proposed, an extension of Kraalnaboom Avenue will be required as shown in Figure 2 and in the township layout in Annexure A. The proposed extension of the road will also have to cross the wetland by means of a bridge structure.

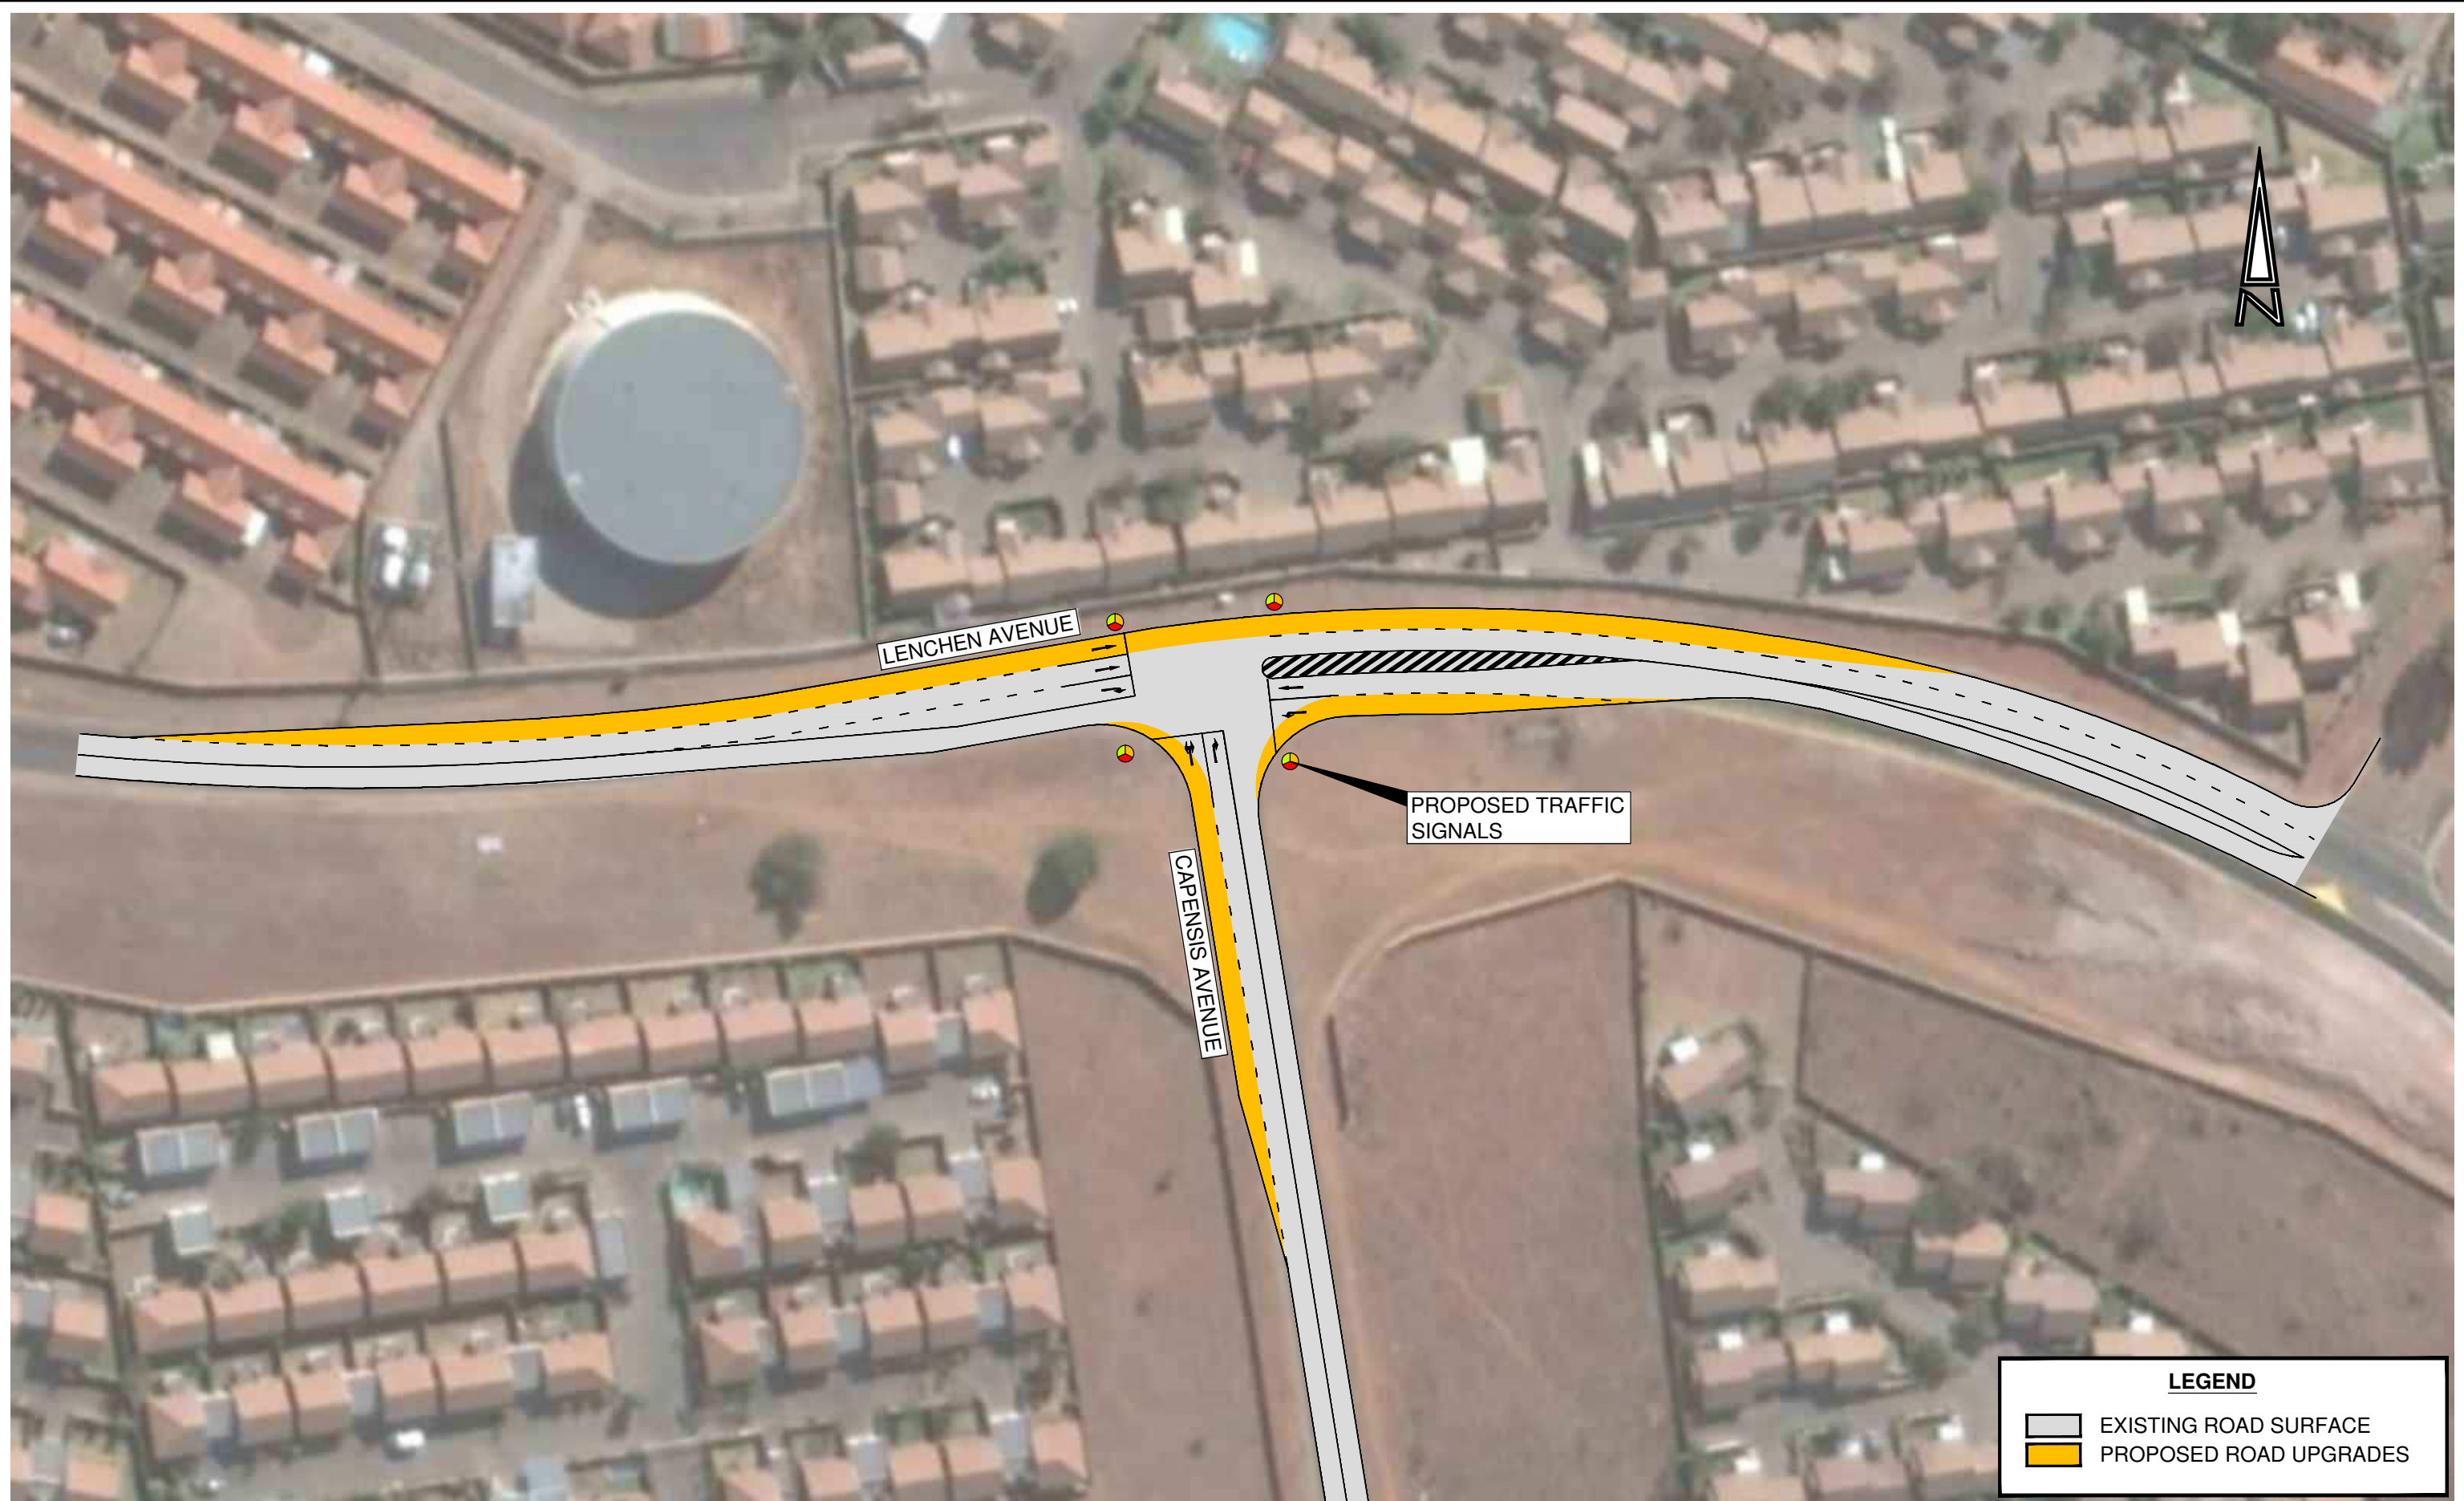
SCALE :	1:500	CHECKED:	D HUNDERMARK	APPROVED:	D HUNDERMARK
DESIGN:	-	DRAWN:	HW BASSON	DATE:	2014/05/28
PROJECT No:	P02013	DRAWING No:	0213/CL/01	REV:	-

PROJECT:	ROOIHUISKRAAL NOORD EXTENSION 29	
TITLE:	PROPOSED INTESECTION UPGRADE : CAPENSIS AVENUE & KRAALNABOOM AVENUE

<p>Proposed Geometry & Control</p> <ul style="list-style-type: none"> • T-intersection • Mini traffic circle • One approach lane on all approaches • Inscribed (outside) diameter approx. 20m • See Drawing No 0213/CL/01

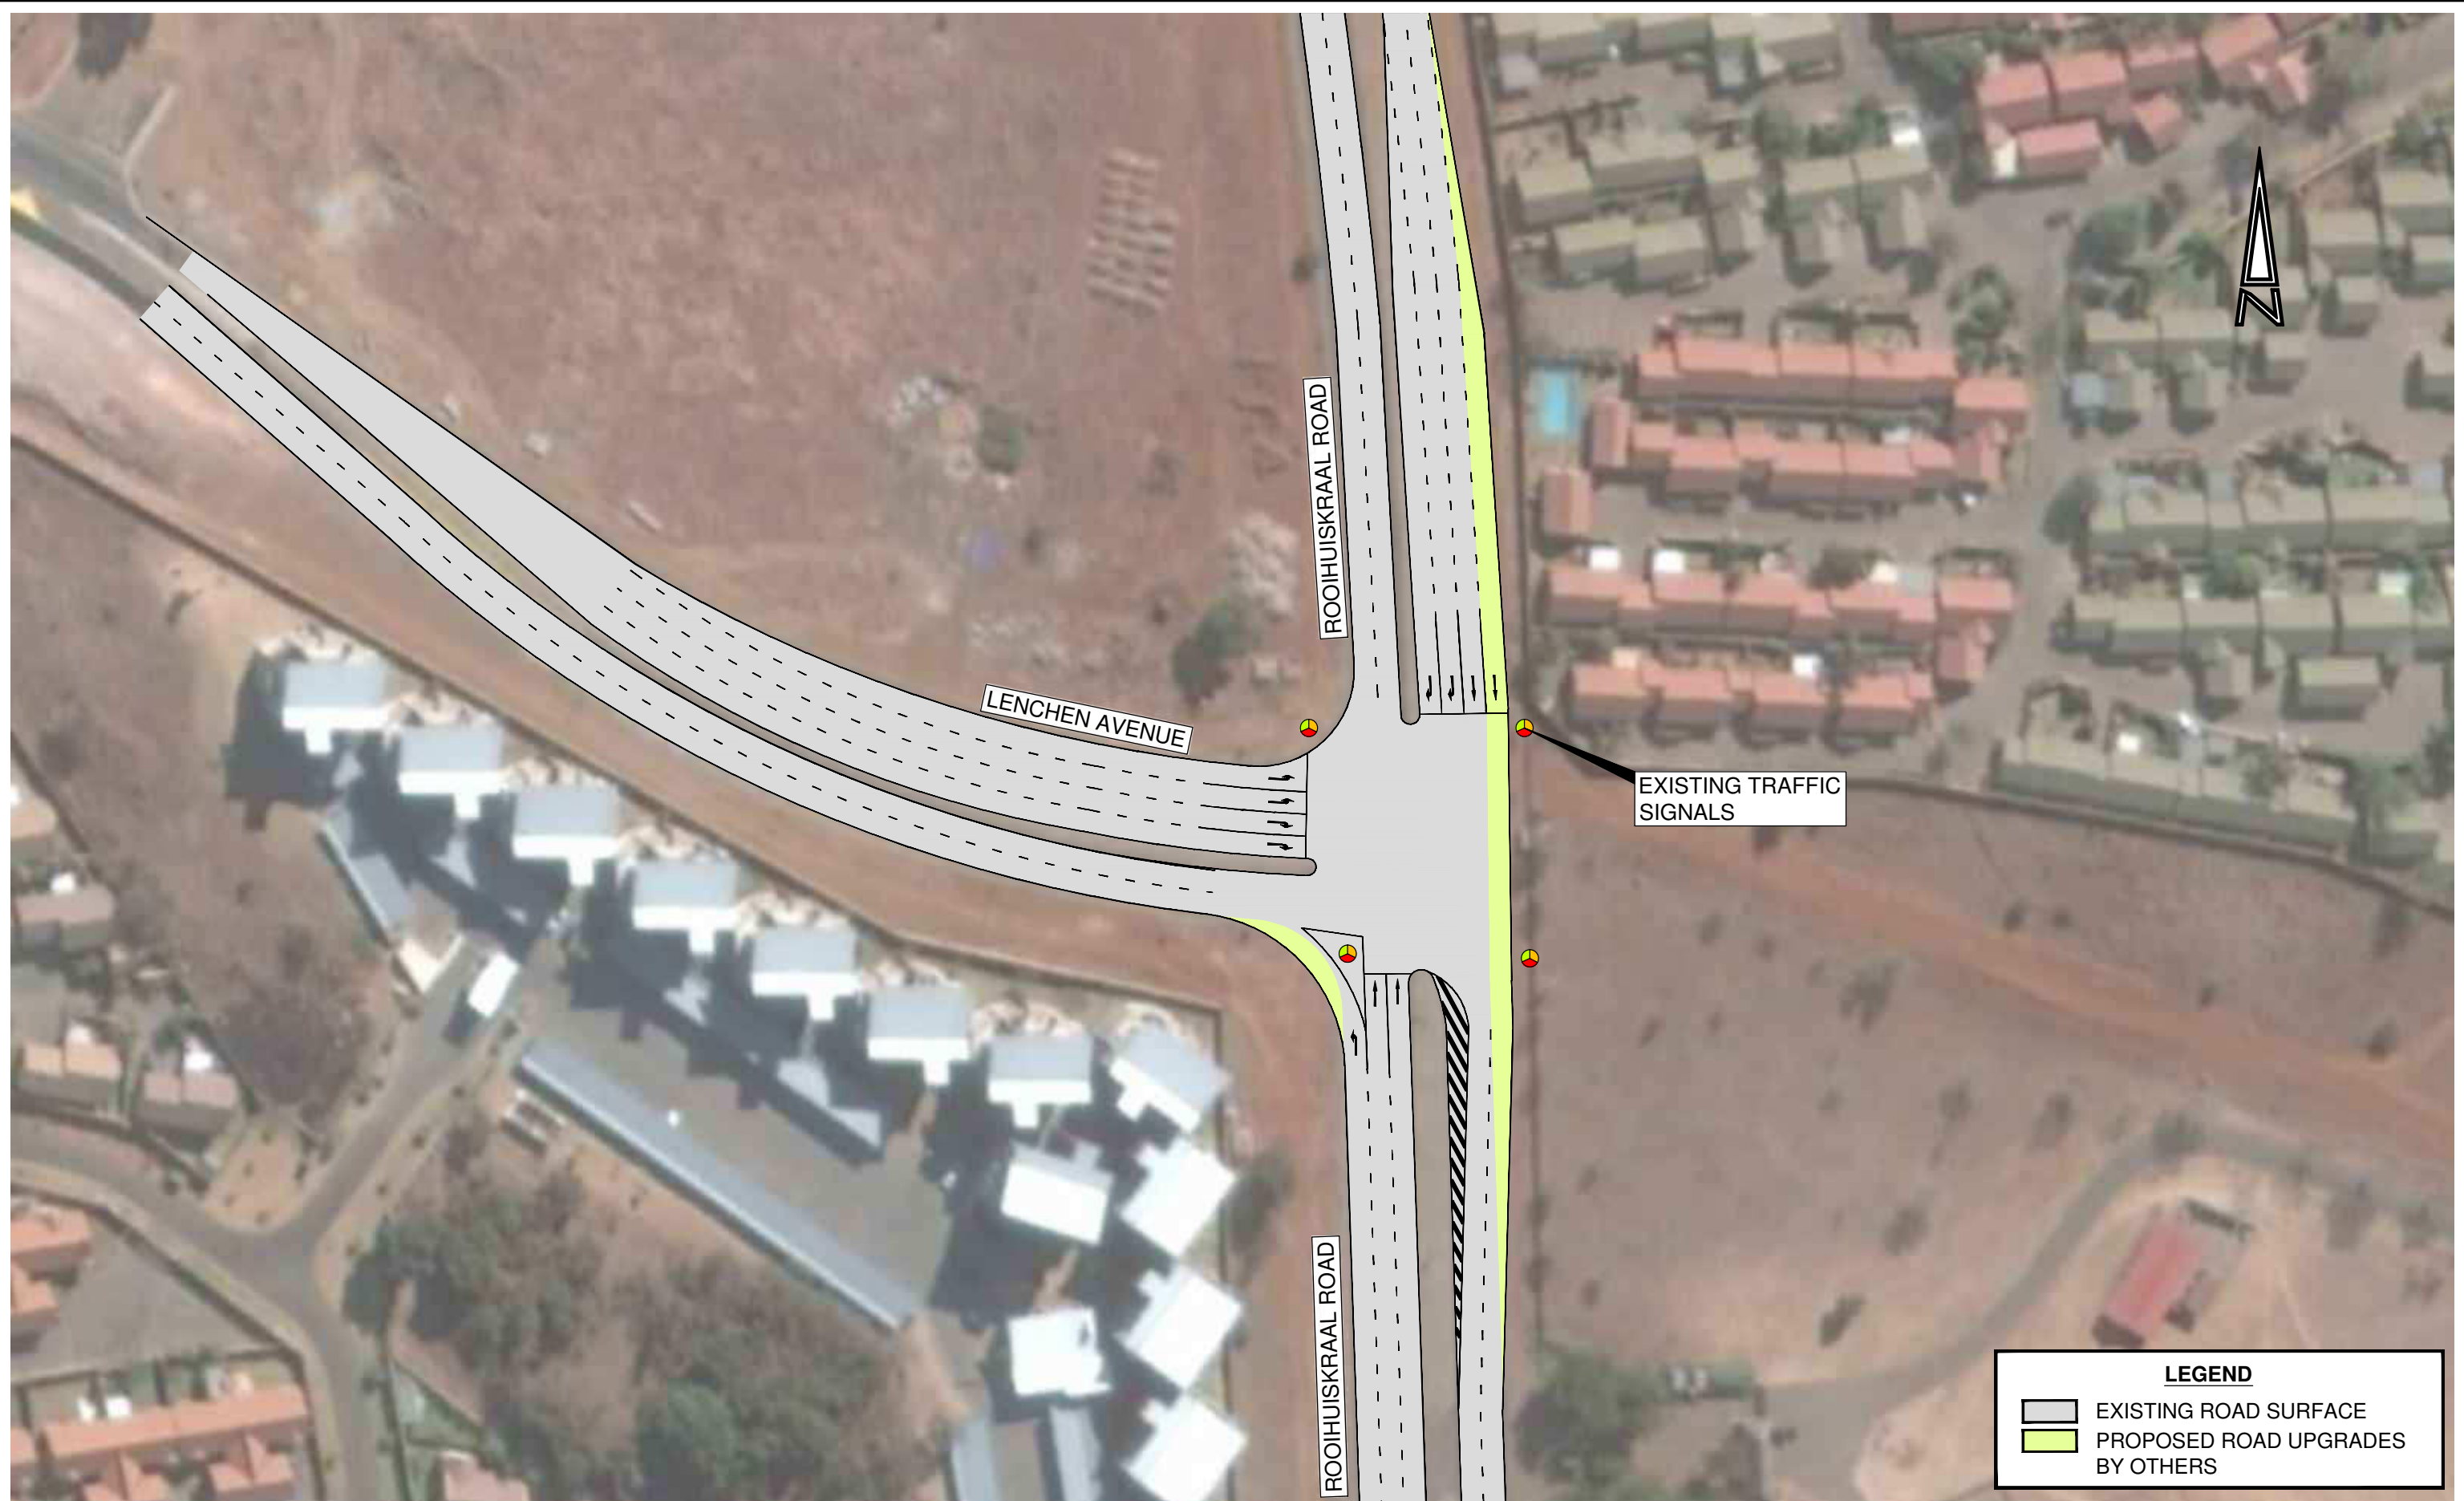
SCALE: 1:1000	CHECKED: D HUNDERMARK	APPROVED: D HUNDERMARK
DESIGN: -	DRAWN: HW BASSON	DATE: 2014/06/02
PROJECT No: P0213	DRAWING No: 0213/CL/02	REV: -

TITLE:
**PROPOSED INTERSECTION UPGRADE:
 LENCHEN AVENUE & CAPENSIS AVENUE**

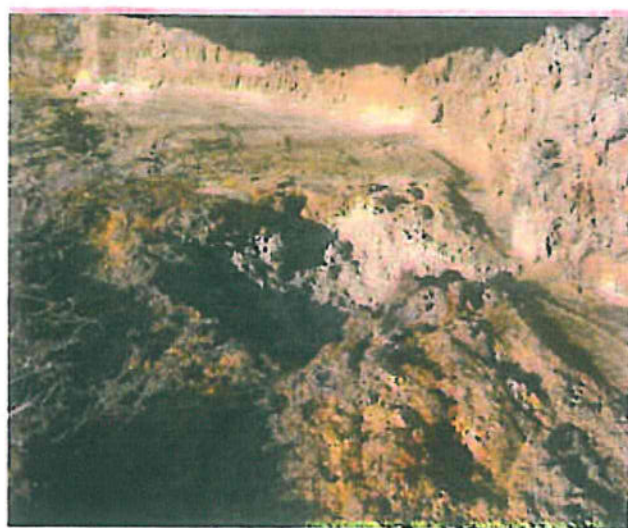
Sample	Unified
	<p>Moist, black, soft, intact clayey silt; Colluvium.</p> <p>Moist, dark brown to black, soft voided silty clay; Colluvium with fine ferricrete nodules and quartz gravel. Pebblemarker?</p> <p>Wet, light grey with orange brown mottling, very soft, slickensided clay; Residual.</p> <p>Wet, orange brown to greenish brown, firm, relic jointed sandy clay; Residual.</p>
<p>0.00</p> <p>0.40</p> <p>0.90</p> <p>1.50</p> <p>2.50</p>	<p>Unified</p> <p>SC LOW heave</p>

NOTES:
1 No refusal.
2 Water seepage at 1.5m
3 Sample taken at TPD/0.8m
