RE : Magobela Gravel Road: Geotechnical Report

PROJECT: LL3335
DATE: July 2019
M Meyer
Pr.Sci.Nat.

REPORT ON A GEOTECHNICAL INVESTIGATION OF MAGOBELA ROAD, UMZINYATHI, NORTHERN KWAZULU-NATAL.

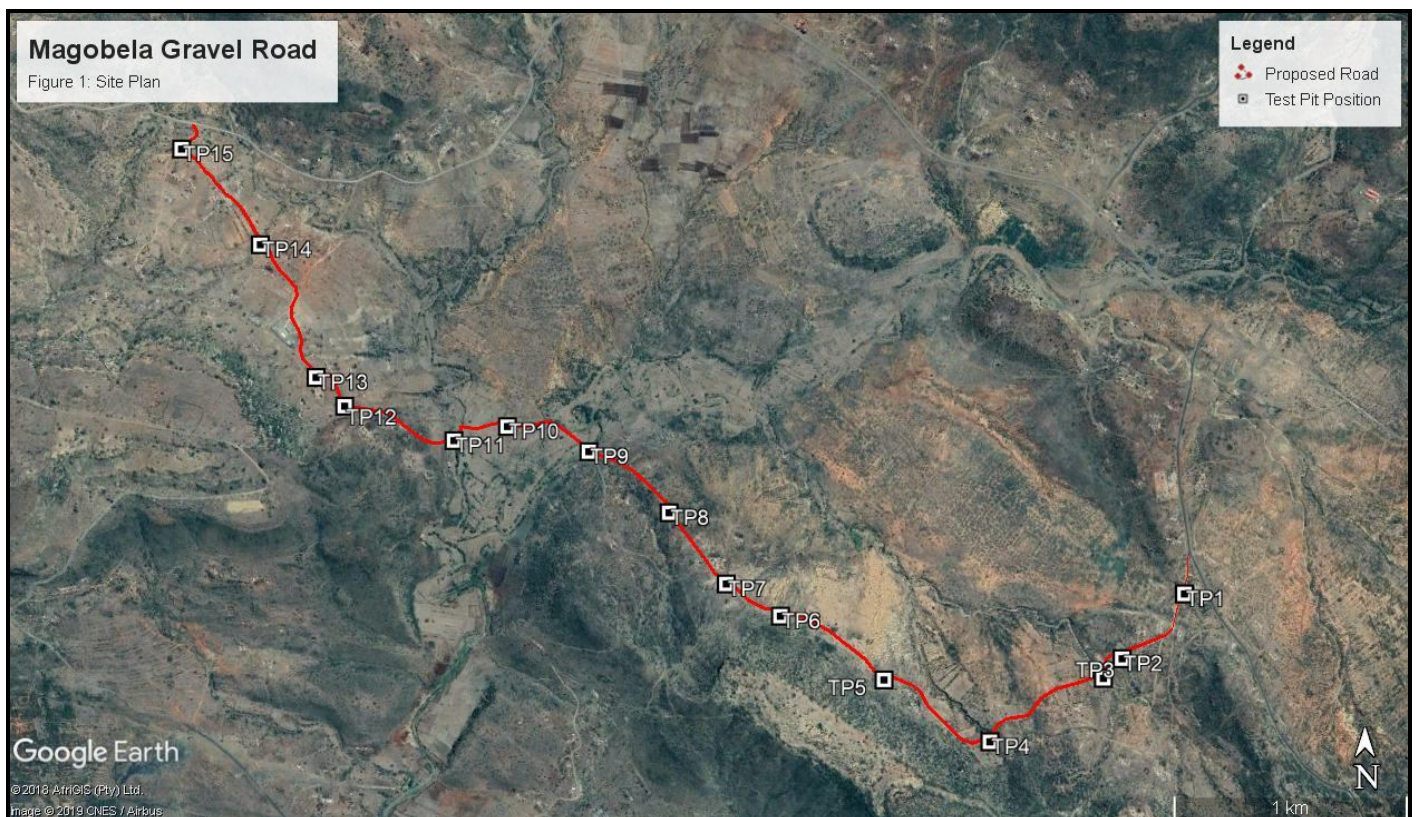
Figure 1: Locality plan, indicating the approximate test pit positions.

The findings of a geotechnical investigation on Magobela Road road roughly 15km north-west of Tugela Ferry are given in this report. The road, as well as the test pit positions are indicated on the *Locality Plan, Figure 1*, below.

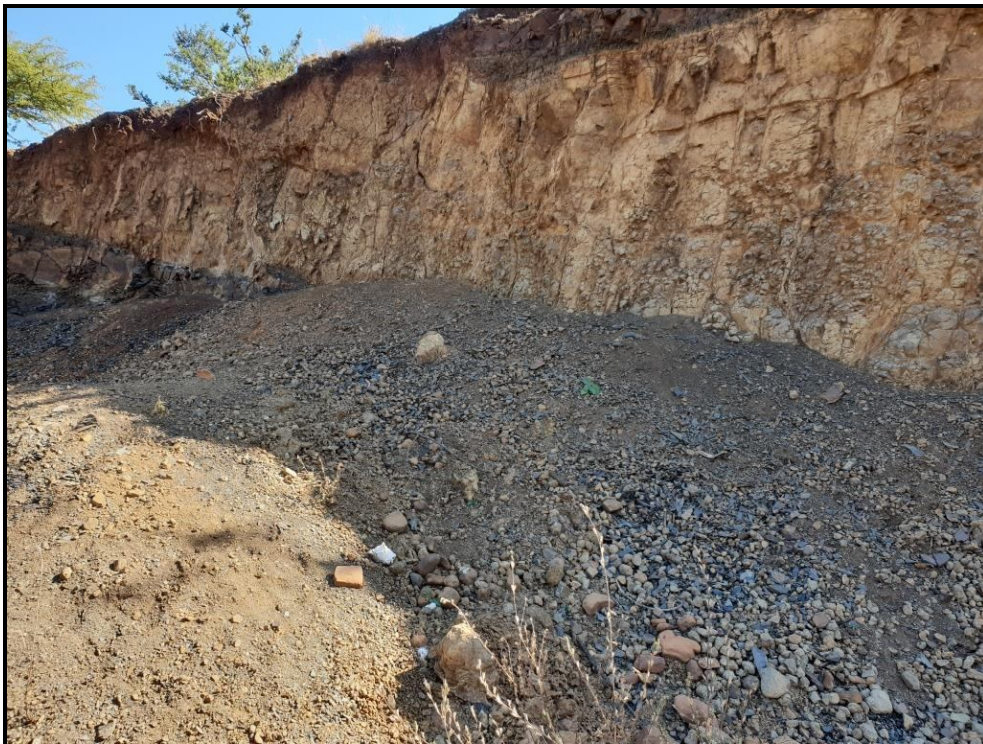
Photo2: View of the western wall of the borrow pit; note both dolerite (yellowish) and shale (dark grey) are present in the borrow pit.

There is an existing borrow-pit roughly 1,5km north of the start of the road. Both shale and dolerite material has been used extensively from this borrow pit but there is still ample room for extension, primarily towards the east. The material from this borrow pit has been used to surface the gravel road accessing the Magobela area and seems to be performing satisfactorily, with minimal dirt in summer but slightly dusty in winter. Erosion channels were noted in some places on the road surfaced with this material, proper drainage measures and a maintenance programme would prevent further degradation. Both the shale and dolerite gravel is most useful, however, the dolerite material does have some oversized hard material that can not be used for surfacing as it is unlikely to be broken to medium gravel.

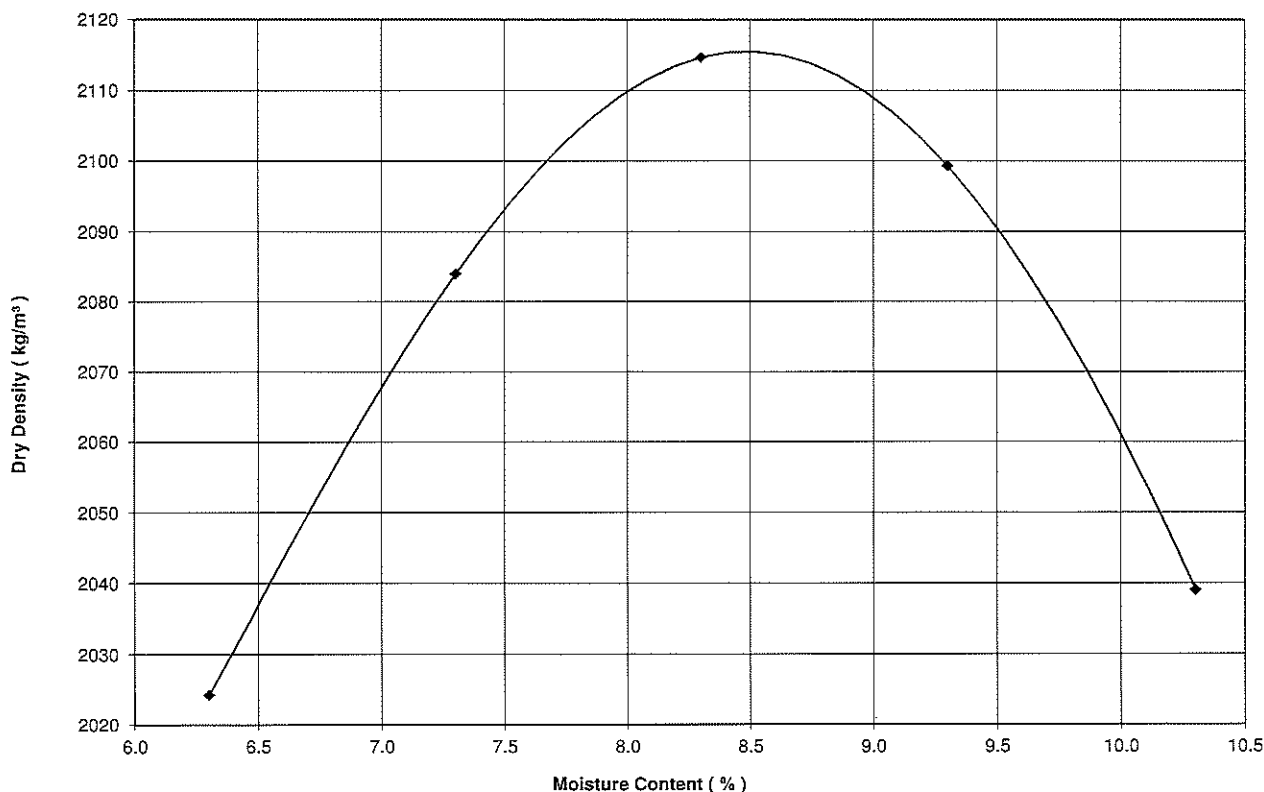
MOISTURE / DENSITY RELATIONSHIP - SANS 3001 - GR30

Moisture Content; (%)	6.3	7.3	8.3	9.3	10.3	Maximum Dry Density	2115 kg/m³
Dry Density (kg/m ³)	2024	2084	2115	2099	2039	Optimum Moisture Content	8.5 %

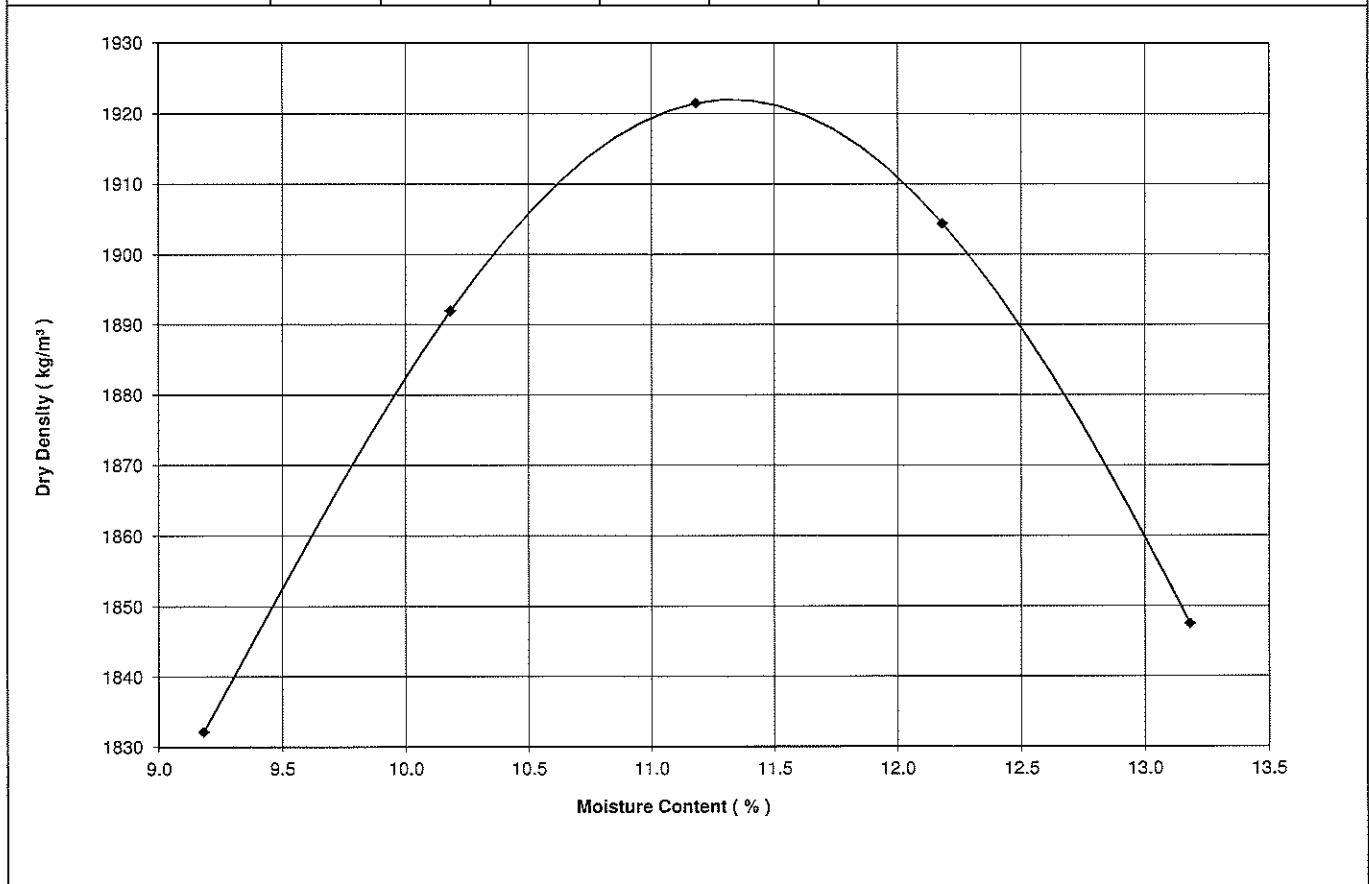
MOISTURE / DENSITY RELATIONSHIP - SANS 3001 - GR30

Moisture Content; (%)	9.2	10.2	11.2	12.2	13.2	Maximum Dry Density	1922 kg/m³
Dry Density (kg/m ³)	1832	1892	1922	1904	1848	Optimum Moisture Content	11.3 %
