Proclaimed Fishing Harbours

Site Specific Maintenance Management Plan
for Lambert's Bay Harbour

Coega Development Corporation

31 August 2017

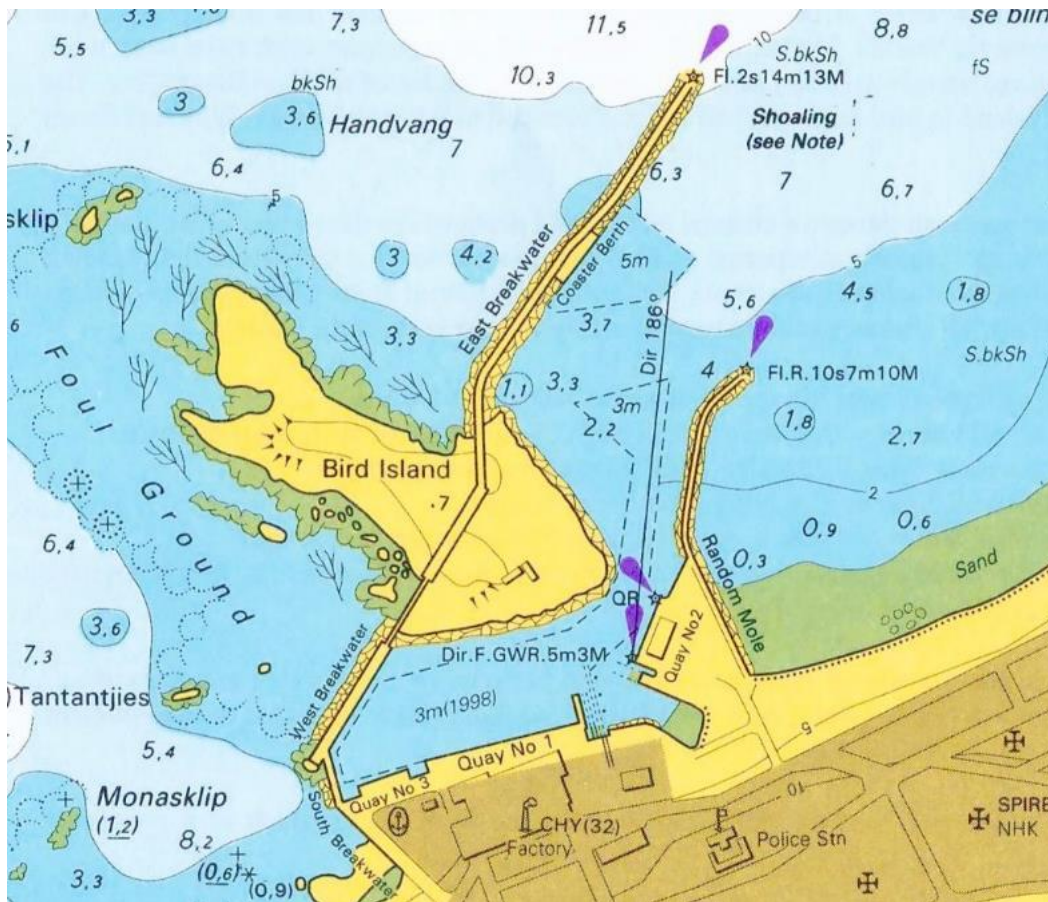
Within Lambert's Bay the charted depth within the main harbour area is -3.0m Chart Datum (CD) whilst a pocket around the Coastal Berth was dredged to -5.0m CD. During Stage 1 the Harbour Master mentioned that no significant maintenance dredging works have been undertaken in the last 15 years which has resulted in the available water depth being significantly reduced and imposing limitations on vessel accessibility.

Figure 2-4 Lambert's Bay Harbour charted depths (Admiralty Chart SAN SC 3)

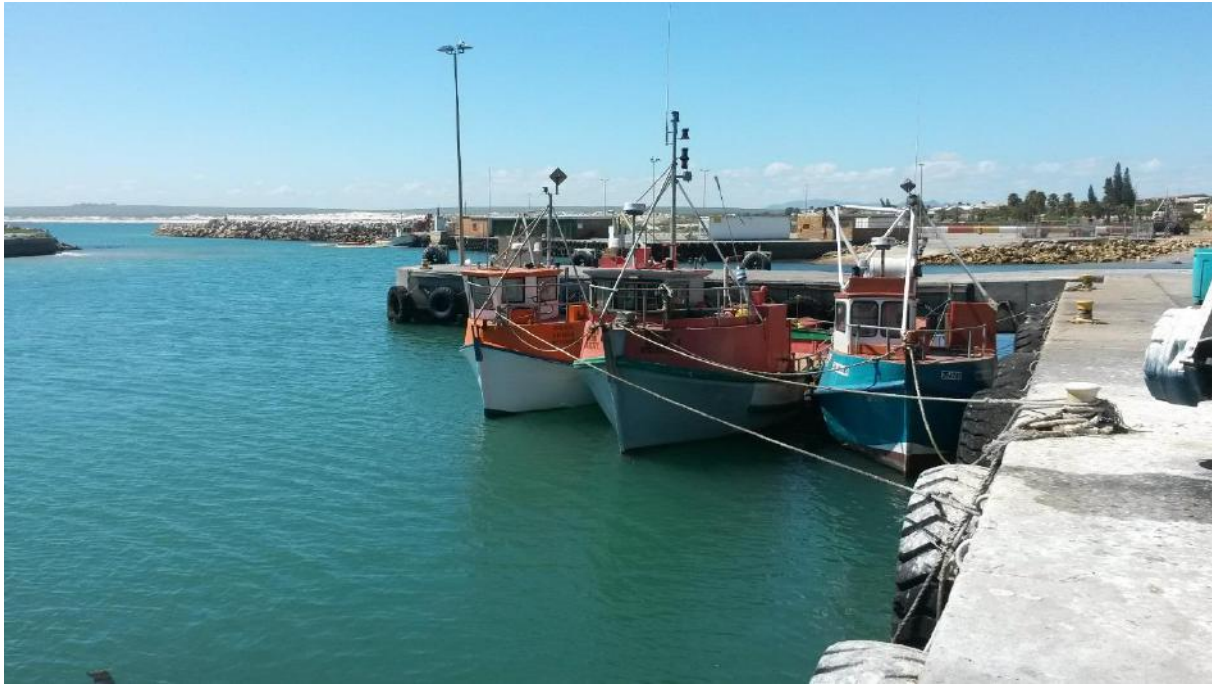
Figure 2-7 Fishing Vessels within the harbour

Lamberts Bay Harbour is now home to only a limited number of small fishing vessels (refer to Figure 2-7). Fishing activities are mostly centred on line fish, West Coast Rock Lobster and small volumes of pelagic species and hake (DELTA, 2013). Subsistence fishing remains important due to the socio-economic profile of the region. Both recreational and commercial West Coast Rock Lobster fisheries are still very active at the harbour, albeit not to the same extent as it was in the past due to the heavily depleted status of West Coast Rock Lobster.

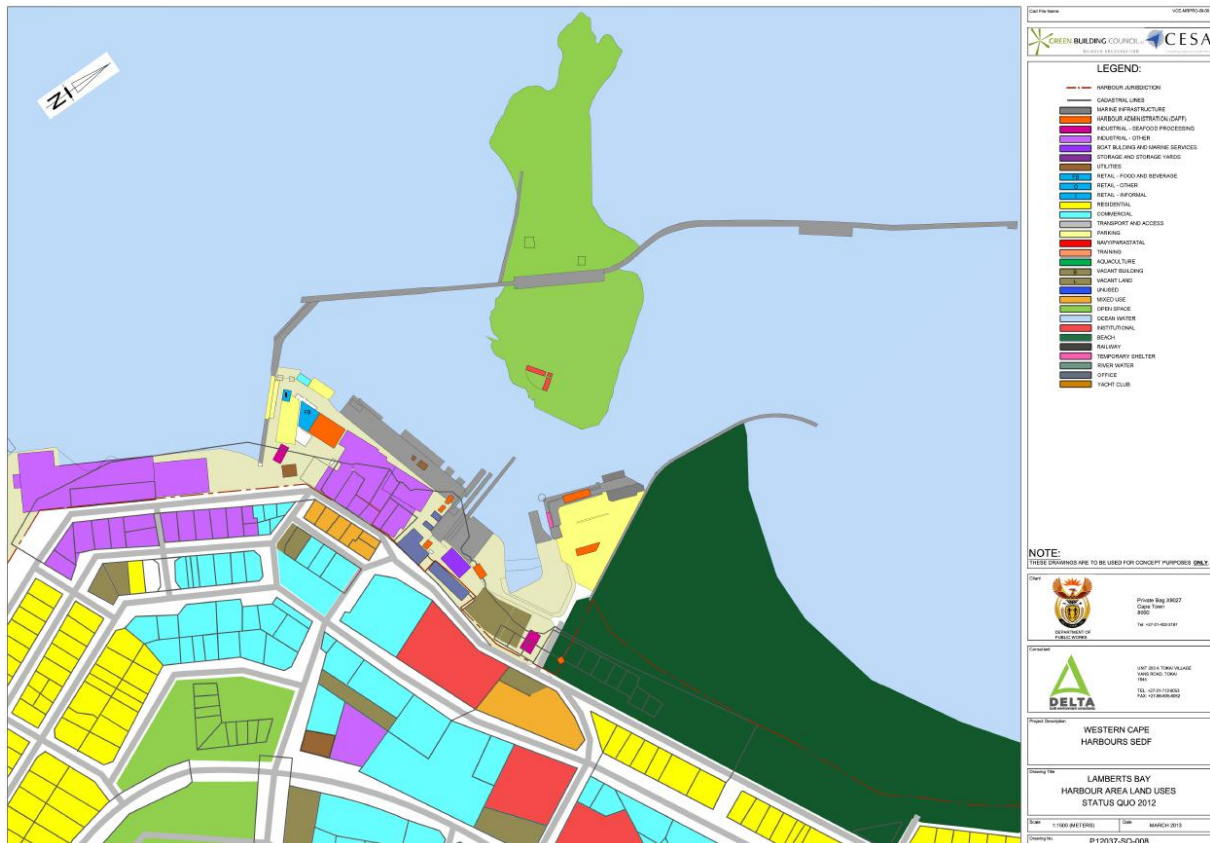
Figure 2-11 Lambert’s Bay Harbour Land Uses (WC Proclaimed Harbours SEDF – Lambert’s Bay, 2013)

Aside from the primary purpose of the property to harbour vessels and support shipping activities, the dominant land-use in Lambert’s Bay Harbour area is industry, with a potato chip factory as the largest industrial activity. Tourist related land-uses include a restaurant, curio shop and boat charter kiosk. The harbour area land-uses are indicated in Figure 2-11.

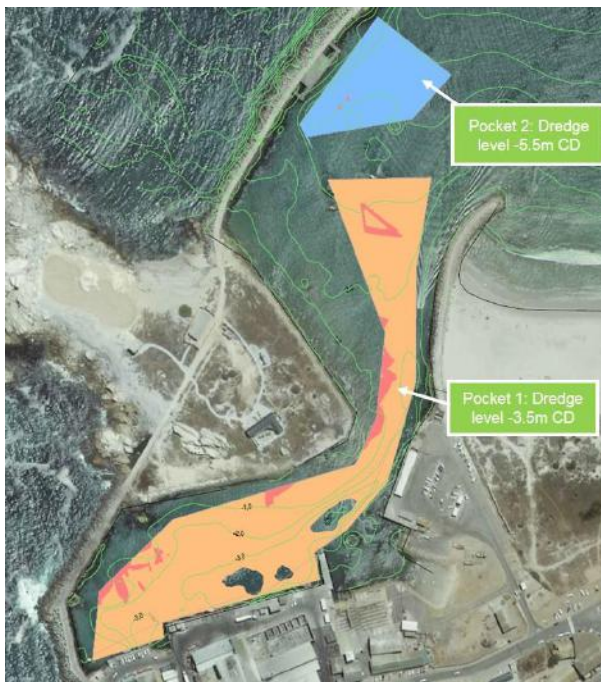
There are two proposed dredging areas within Lamberts Bay Harbour namely the inner harbour basin and entrance channel as well as the berth pocket alongside the Coastal Quay. The dredge areas and associated required dredge depths are illustrated in Figure 3-2.

Figure 3-2 Proposed dredging areas in Lamberts Bay harbour showing presence of rock (in red)

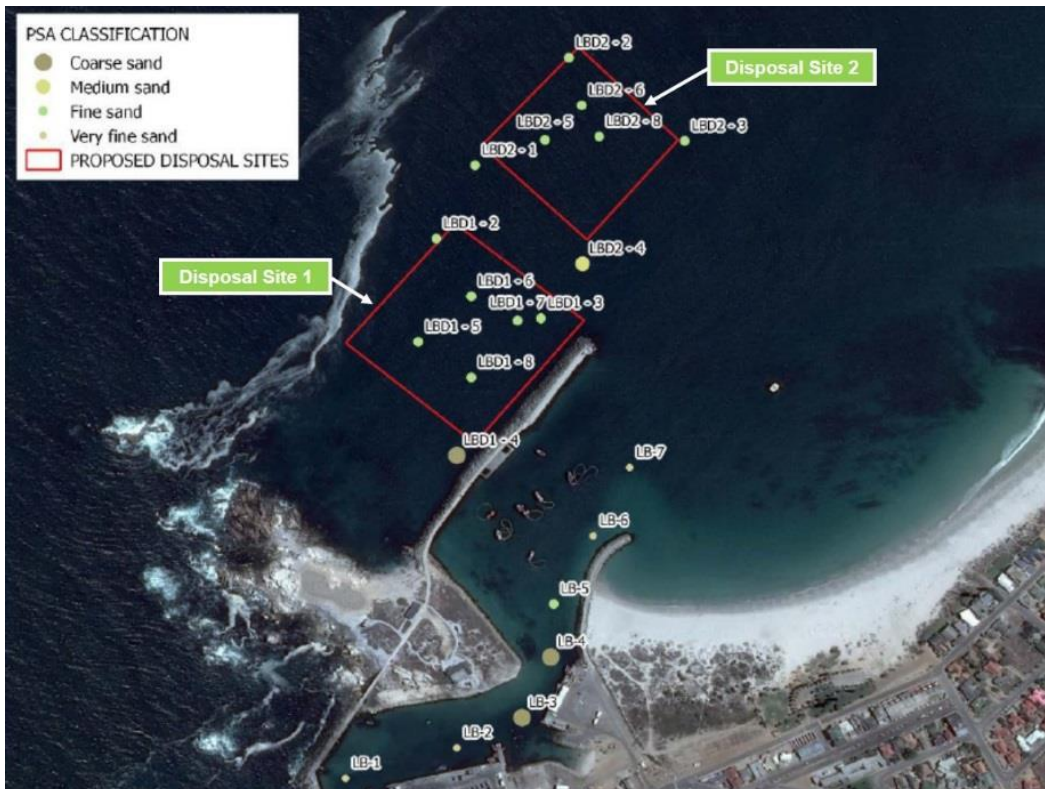
There are two proposed dredging areas within Lamberts Bay Harbour (Figure 3-3) namely the inner harbour basin and entrance channel as well as the berth pocket alongside the Coastal Quay. According to the South African National Action List for the screening of dredged sediment disposal the sediments from Lamberts Bay harbour can be safely disposed of at an authorised location with low probability of associated contaminants generating negative effects on the receiving sediment body. The test samples results revealed that no chemical substances are present at higher than 'normal' concentrations. Although these sediments are safe to be disposed of, a suitable dredge disposal location needs to be identified and disposal should only occur at an authorised site. Potential disposal sites were inspected to assess whether they are suitable for disposal and that there will be limited, mainly physical, detrimental impacts caused by the dumping of sediments. The assessment made on the disposal sites and on the results of the dredged material analysis determined that the marine disposal is the most economical and practical option.

Figure 3-3 Sample sites within the two proposed disposal locations for dredge sediments from Lambert's Bay Harbour

Both disposal sites were investigated and deemed to be adequate for the receiving of the material however Disposal Location 2 is the more suitable disposal location due to its similar sediment characteristics and absence of important biological structures, and also is the site located further away from Bird Island. Disposal in this location is likely to have a low impact on the benthic environment and it is recommended that, if technically and economically possible, the boundaries of Disposal Location 2 should be positioned in order to avoid the area of rocky reef which was identified at site D2-7.

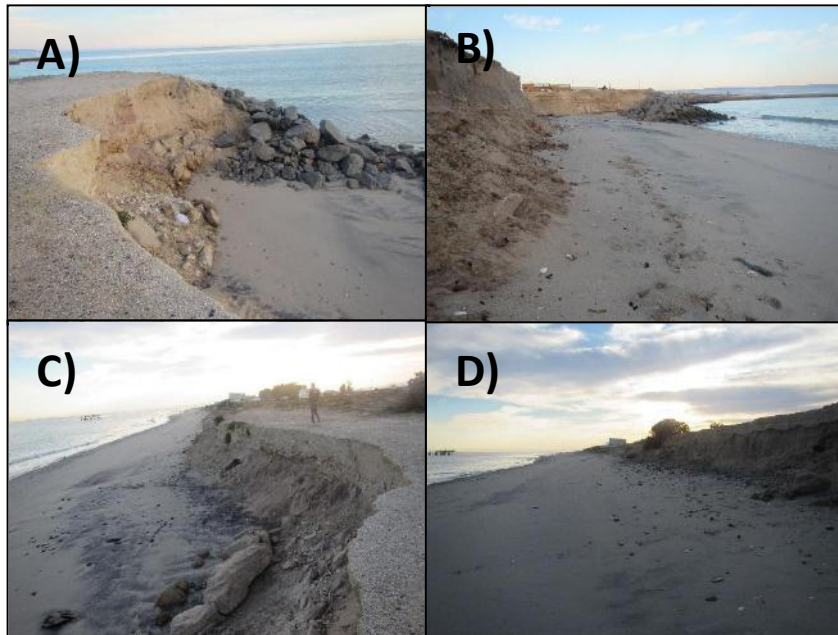
erosion rock armouring was present in some areas. Sand appears to be moving away from the investigated beach in a north easterly direction. Cross shore and down shore beach sediment transects were carried out to determine whether the targeted dredge material was similar in nature to the beach sediment and thus suitable for disposal on the beach. Sediment samples were collected at five sites for particle size analysis for fractions >75 microns (Figure 2-2).

Figure 2-1: Photos taken of the sediment receiving beach (north east of the harbour) just after spring low tide (8 am) on the 23rd May 2017. A) View from the top of the eroded cliffs towards the shore armouring; B) View from site LH 5 looking south west towards the harbour; C & D) Two views of the steeply sloping beach profile, alongshore towards the north east.

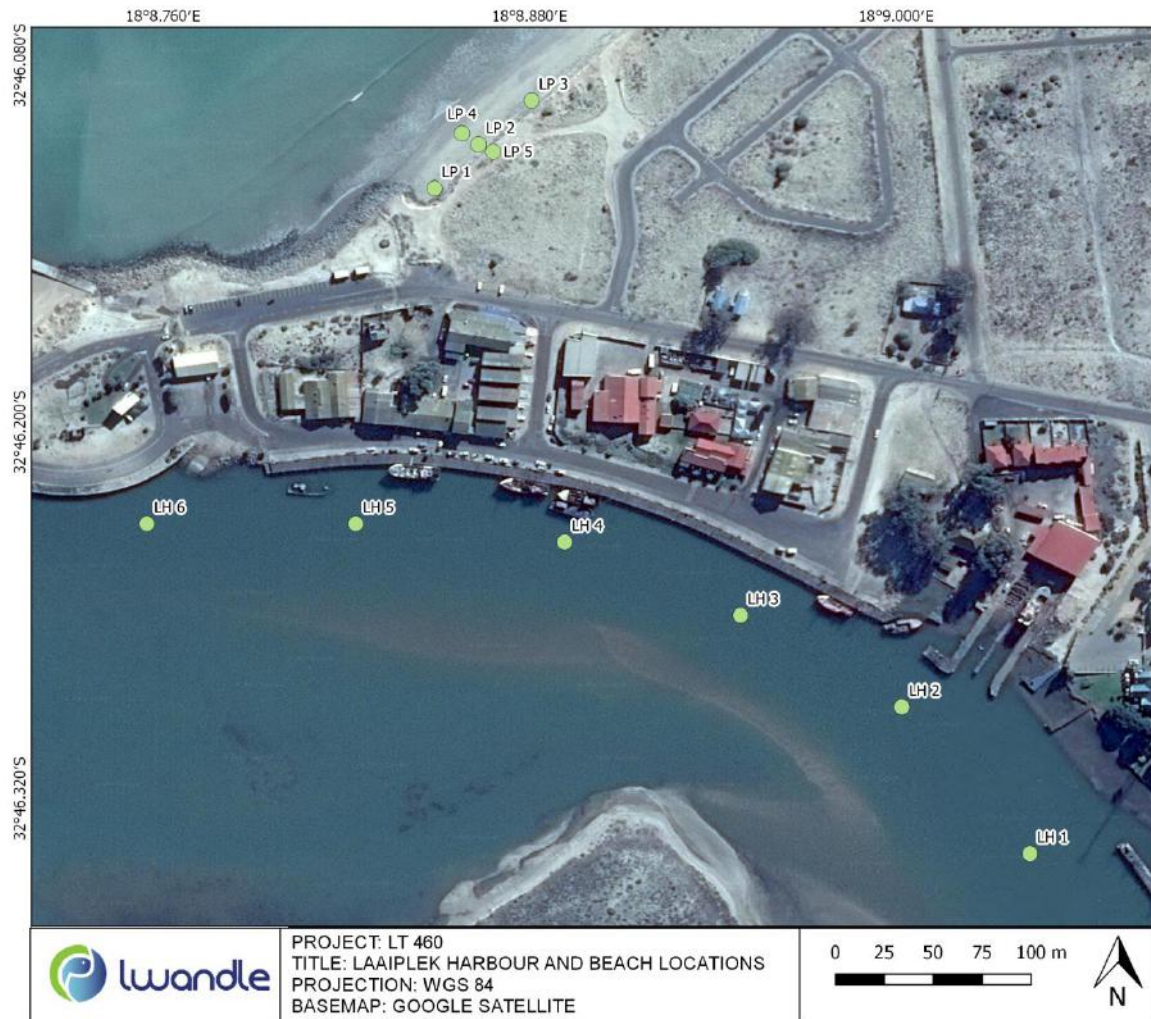
Figure 2-2: Sediment sampling sites in Laaiplek Harbour at the proposed beach nourishment location as well as the proposed dredging sites originally sampled in the November 2016 field survey

Laaiplek harbour is situated at the mouth of the Berg River and to the north east of the harbour there is a long stretch of beach. Beneficial use of the dredge spoil is favoured over disposal in the ocean, and at Laaiplek, Aurecon has identified beach nourishment as the most appropriate disposal option for the proposed 9,300 m³ of dredged sediment. The need for beach nourishment was evident during field investigations where extensive erosion of the existing beach was observed (Figure 2-2). Additionally, the beach exhibited a steep profile (Figure 2-) and anti-

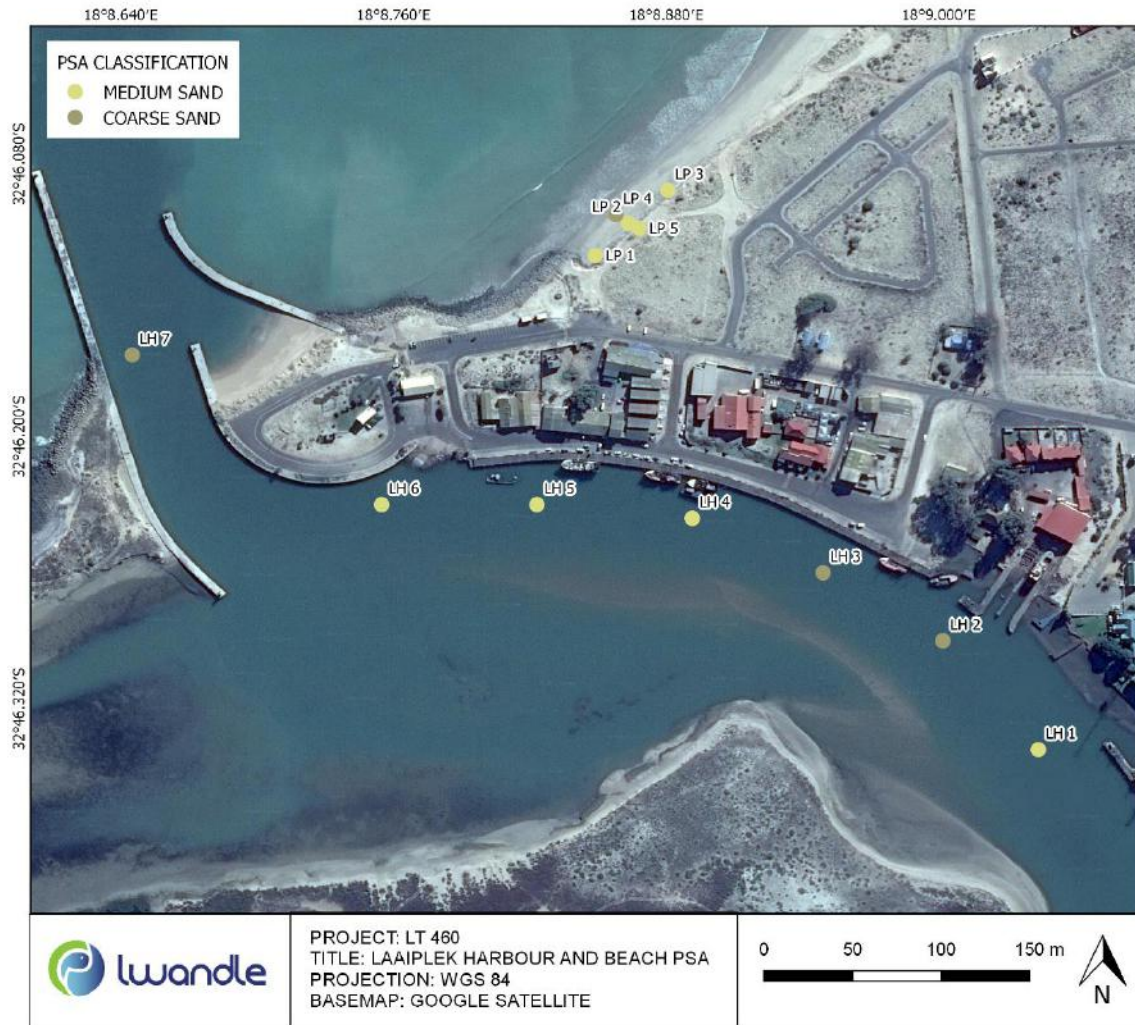
Sand size classes varied in the cross-shore direction (Figure 2-1). Grain size and distribution is relative to the cumulative energy of the coastal processes (wind, wave and currents) acting on the beach, in general resulting in steep beaches having coarser grain sizes (Stauble, 2005). This is evident at Laaiplek, where the beach has a steep profile characterised by medium to coarse grain material and the coarsest sediment were found at the base of the beach. As both the harbour and beach sediments comprise predominately sand, the donor sediments are seen as a good match for nourishment of the beach.

Figure 2-1: Grain size distribution at the dredge sites and the receiving beach north east of the harbour.

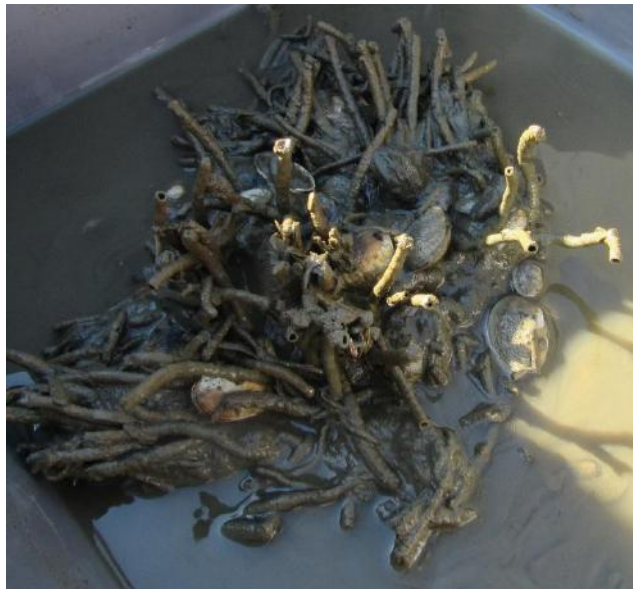
Figure 4-5: Polychaete tubes, polychaetes and molluscs retrieved from the Van Veen grab during sampling at disposal location 2 (site D2-8) in St Helena Bay.

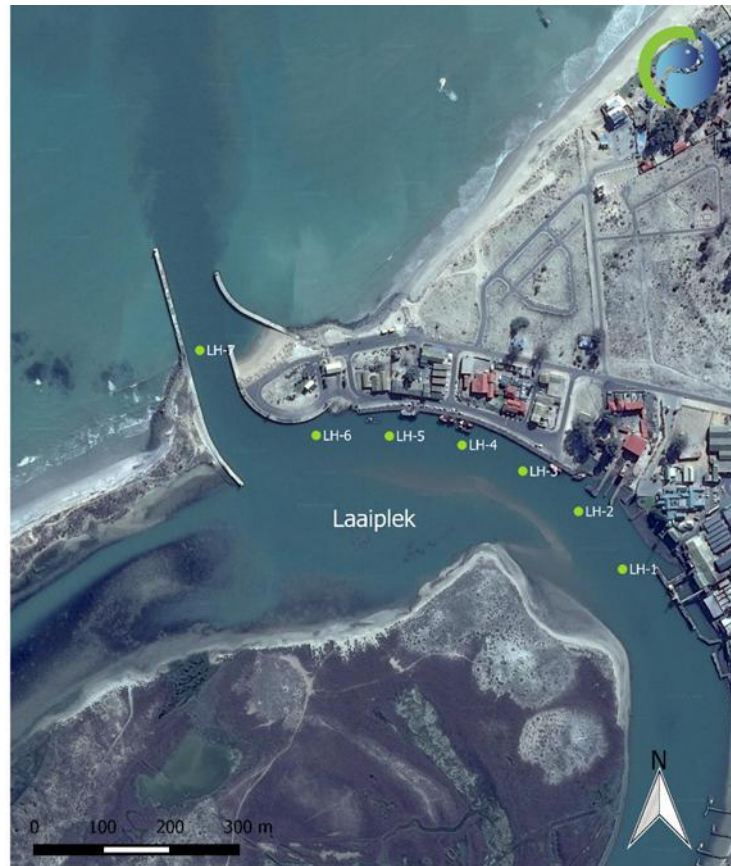
Figure 3-1: Laaiplek Harbour sediment sampling sites for the November 2016 field trip.

Laaipek harbour is situated at the mouth of the Berg River. In total, sediments from seven sampling sites were obtained (Figure 3-1) during the November 2016 field trip. The collected samples were analysed for sediment particle size distribution (PSA) (all sites), and trace metals, total organic carbon content (TOC), and the presence of pesticides (four sites). Results are set out below.

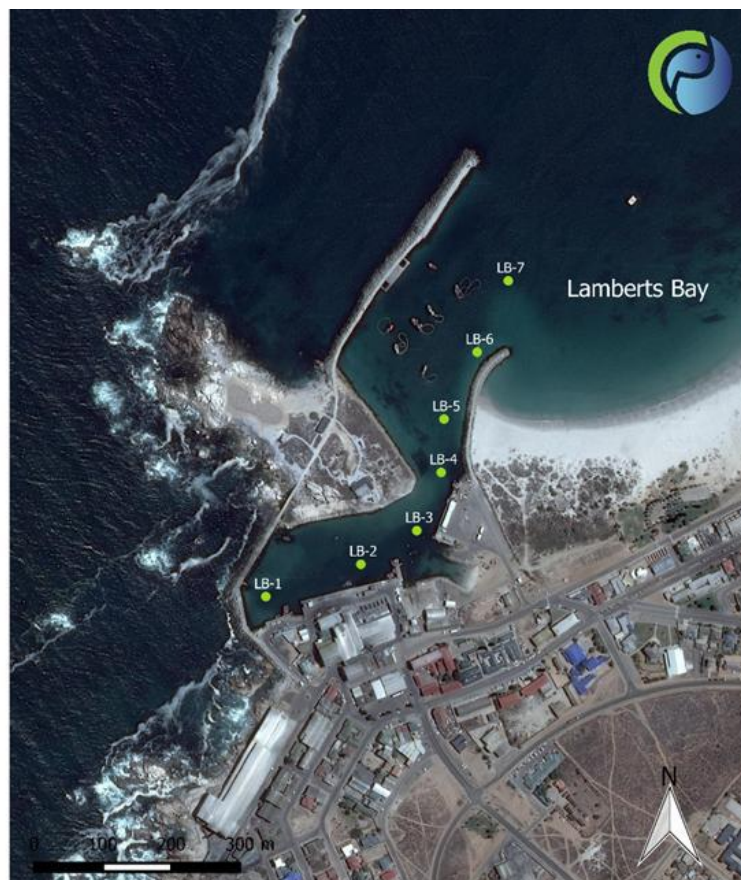
Figure 4-1: Lambert's Bay sediment sampling sites for the November 2016 field trip.

Lamberts Bay Harbour is situated at the north-west side of Lamberts Bay, opposite the Bird Island Reserve. Seven sites were sampled within the harbour during the November 2016 field survey (Figure 4-1). As with Laaiplek, samples for PSA and trace metals and organic content analyses were collected. Pesticides were neglected in this case, as the harbour is not estuarine in nature.
