ZOLA-EMDENI PUBLIC TRANSPORT FACILITY SOWETO, Gauteng Update 2022

Aquatic Ecology Specialist Study

Reference: Larchitect_Zola-Emdeni_Public_Transport_Facility_Soweto_Aquatic_January_2022_Draft
Date: January 2022
Version: Draft

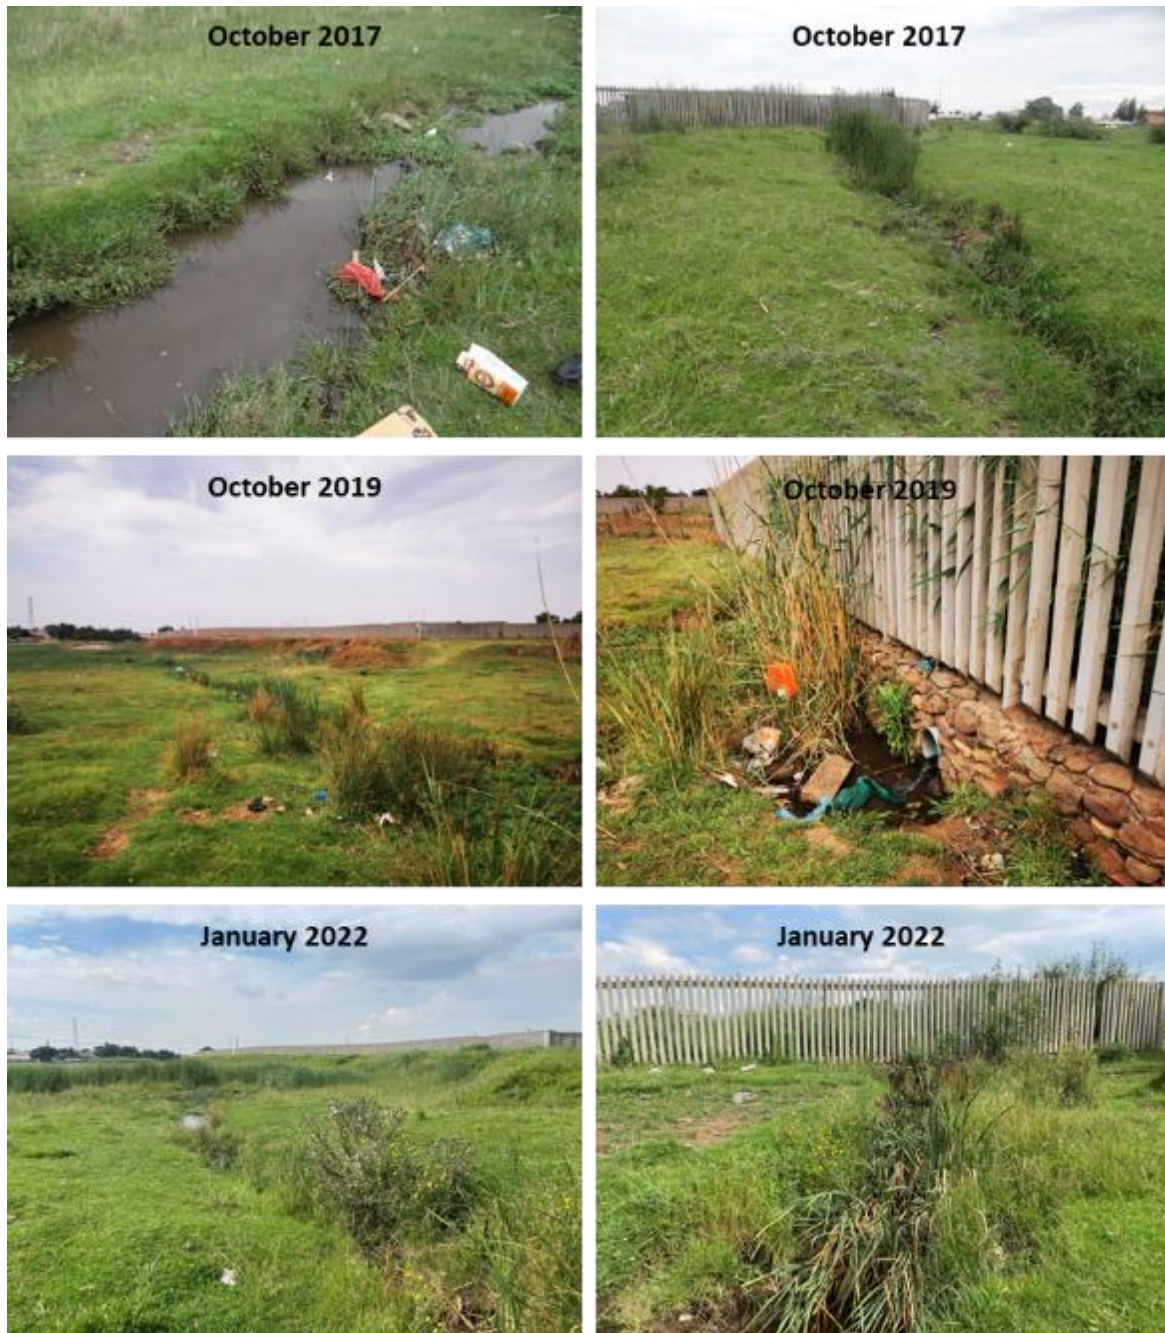
Figure 3-7: Sites photographs taken at site Z1, October 2017, October 2019 and January 2022.

The study area is characterised as a valley bottom system with shallow water and no distinct riparian zone. Site Z1 is situated adjacent to the proposed development, at the source of a drainage line that flows through a wetland area to another drainage line where sites Z2 and Z3 are located (**Figure 2-1**). Evidence of litter and dumping was evident at all three sites during both assessments, as well as run-off from the surrounding urban area (**Figure 3-7, Figure 3-8 and Figure 3-9**). Site Z3 also had sewage leaking into the system.

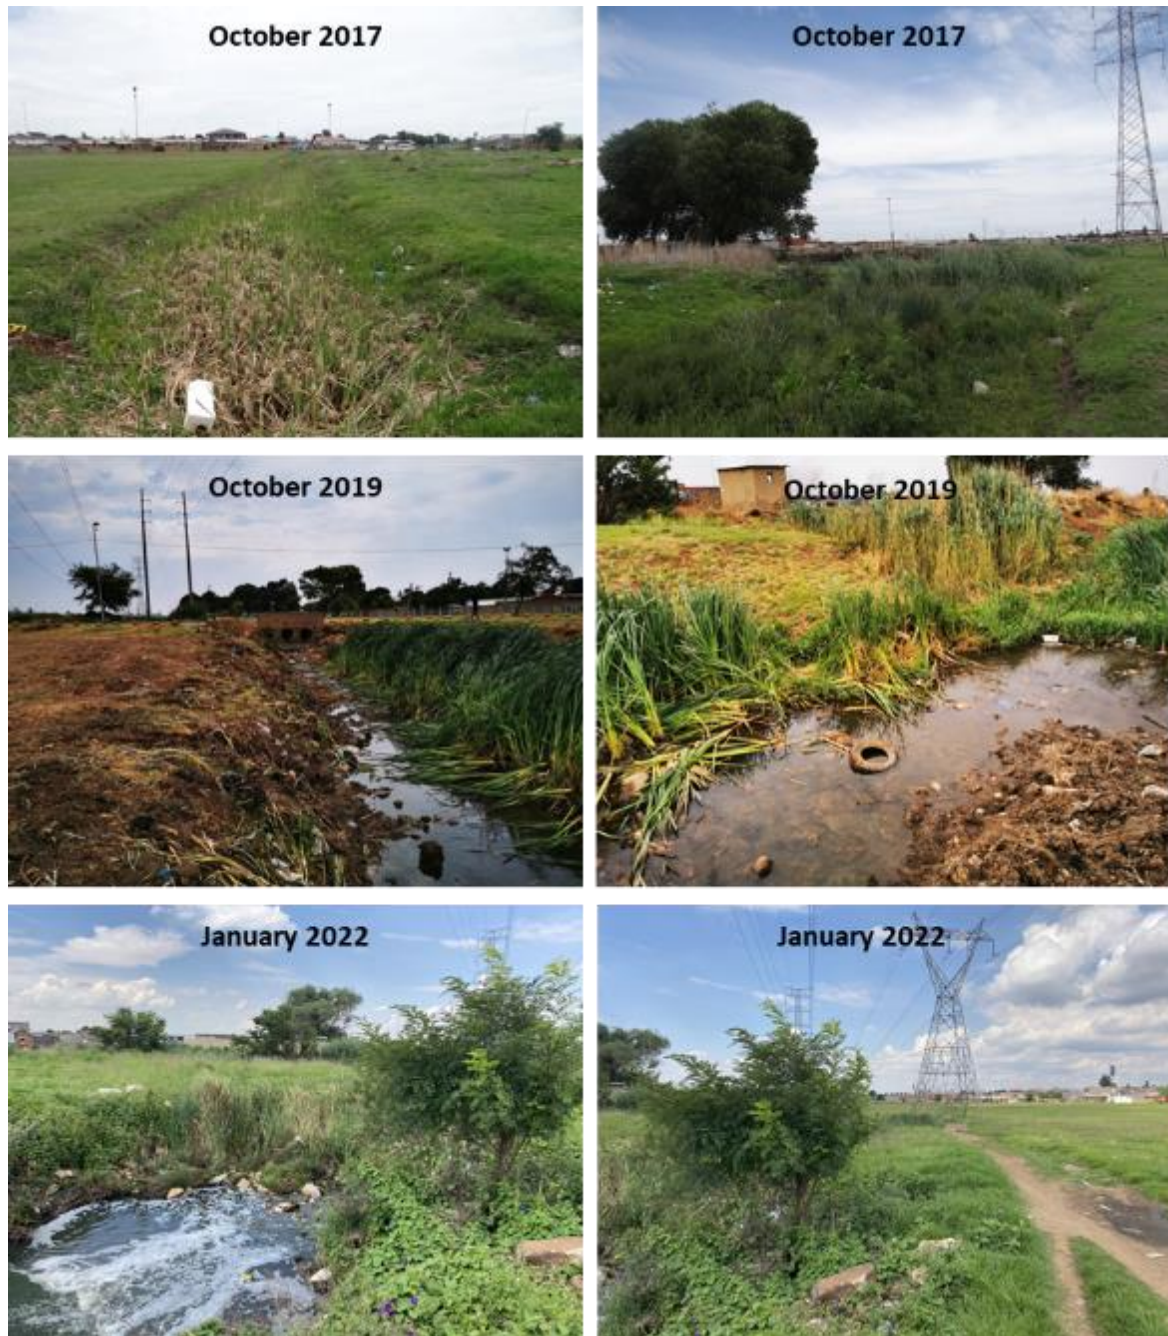
Figure 3-9: Sites photographs taken at site Z3, October 2017, October 2019 and January 2022.

- Evidence of litter and dumping is evident at all three sites as well as run-off from the surrounding urban area. Site Z3 also had sewage leaking into the system.
