DEVELOPMENT OF 3000 BEDS (GEOTECHNICAL INVESTIGATION)

DEVELOPMENT OF 3000 BEDS FOR THE UNIVERSITY OF MPUMALANGA GEOTECHNICAL INVESTIGATION	Internal Doc #	LatGeo	21	001
		Version	000		
		Date	02 February 2021

Description	Information
Document ID:	LatGeo_21_001
Document Name:	UMP Geotechnical Investigation report
Document Revision:	000
Issue Date:	02 February 2021
Electronic File Name:	Geotechnical Investigation report.

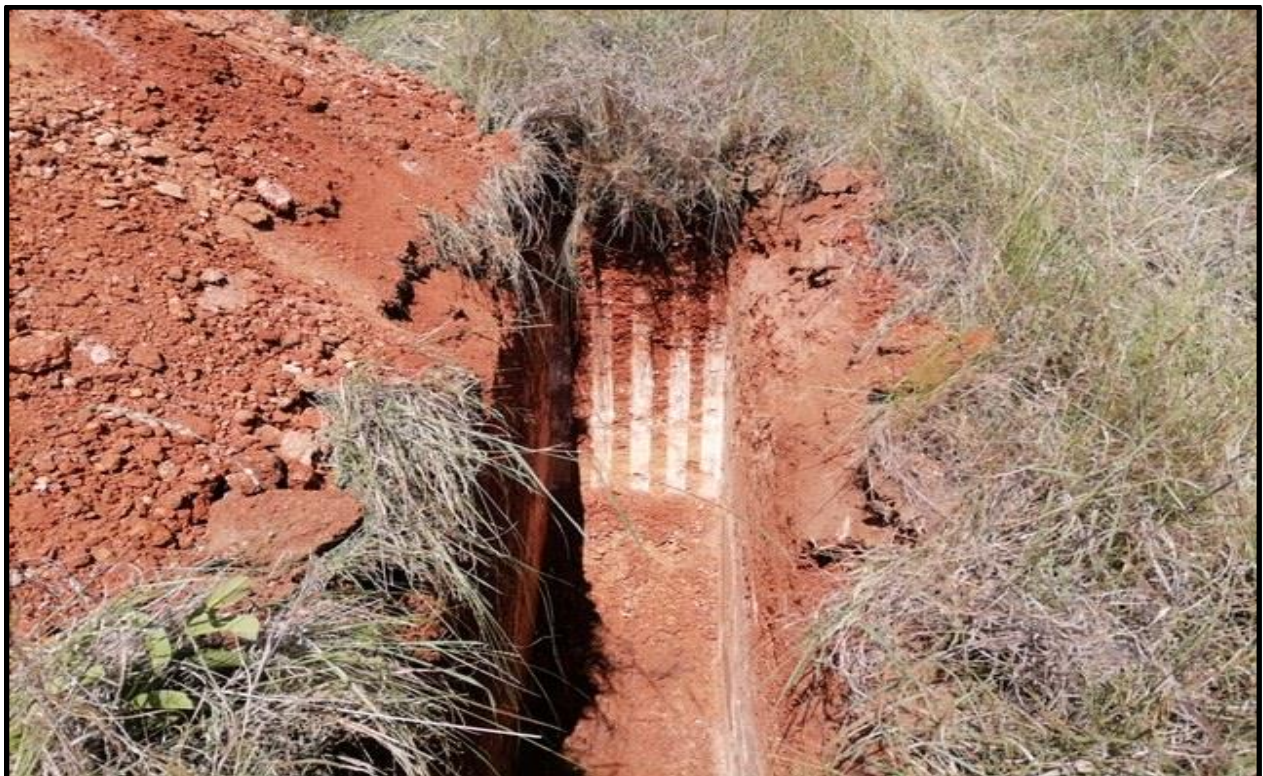
Figure 2: A photograph showing a typical trial pit on site

Disturbed samples of the most prominent soil horizons were taken and submitted to a SANAS accredited soil laboratory for CBR and foundation indicators tests. The trial pits were loosely backfilled after profiling.

The position of the trial pits was determined with the aid of a hand-held GPS, the test holes profile is presented in Appendix A of this report and its approximate location is indicated on a trial pits locality plan attached in Appendix C.

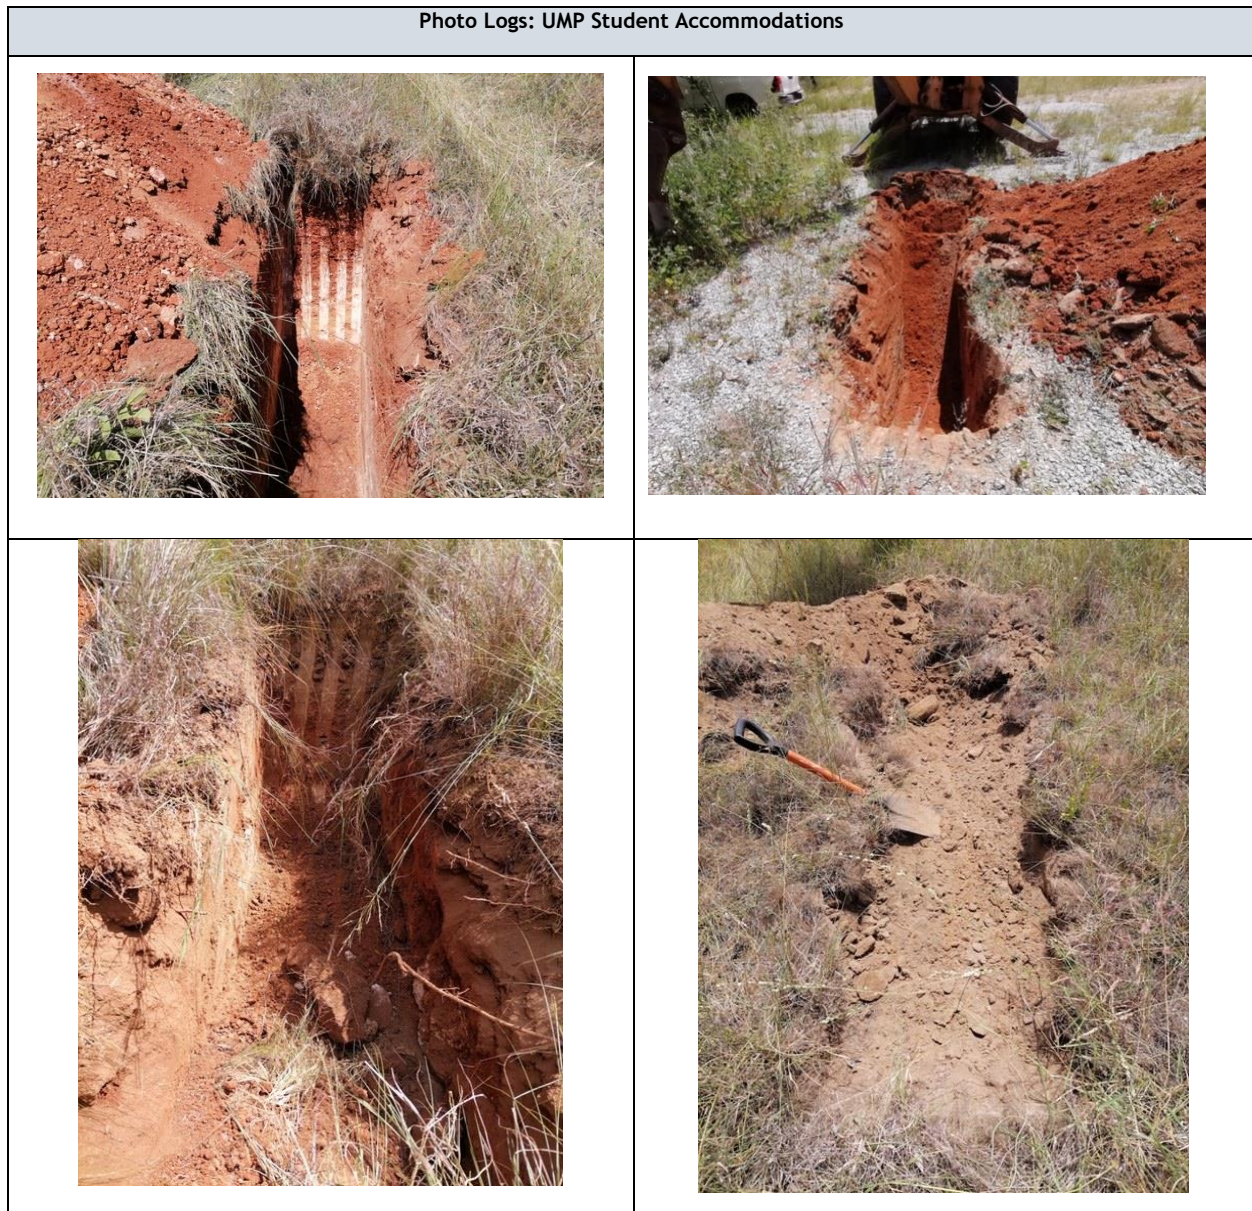
Table 3: Investigated area site photo logs.

Test pits name	End of hole	Depth (m)	Material at base of test pit	Water seepage
UM 14	Refusal	0,8	Granite bedrock	No seepage or groundwater encountered

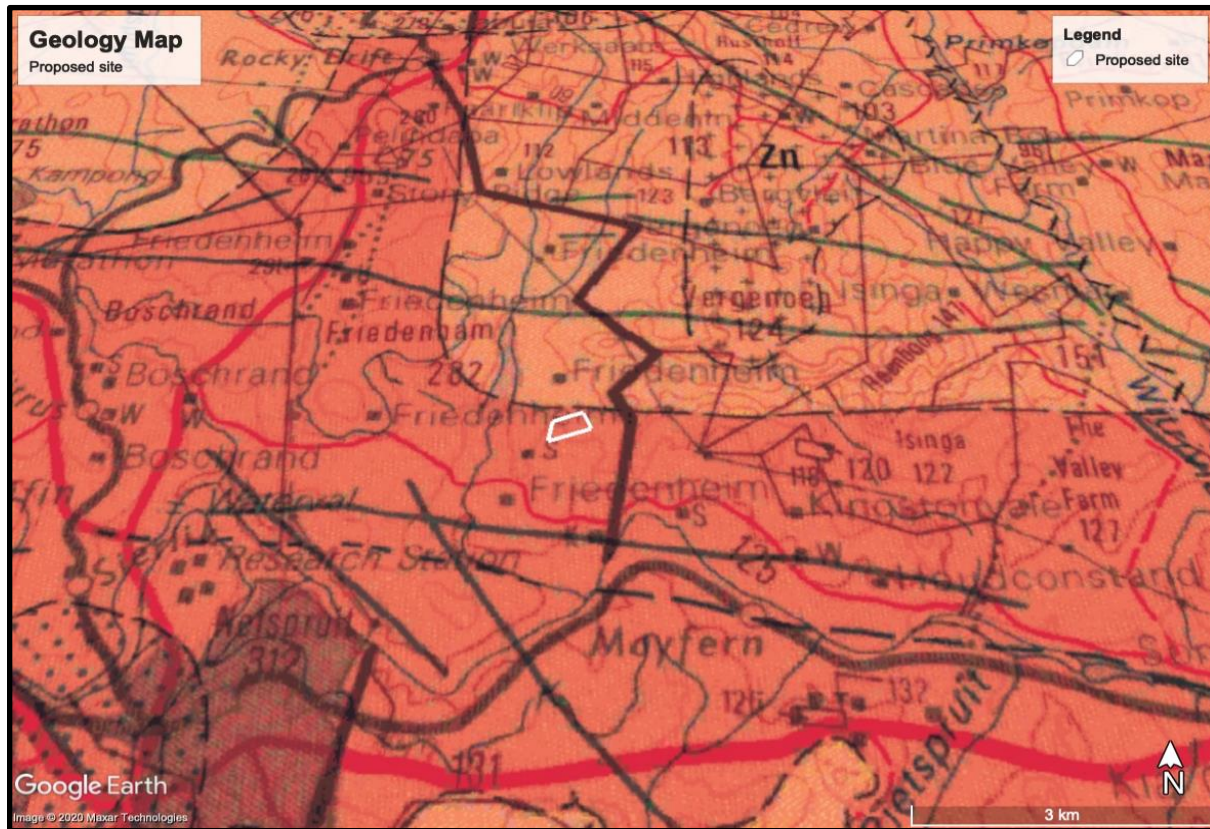
Figure 3: Site geological map.

The soils are predominately sandy in the uplands with a low clay content, with clay soils in the bottom lands (Mucina and Rutherford, 2006). The main underlying rock formation is Quartz-feldspar rocks of the Makhutswi Gneiss (Swazian) domain.

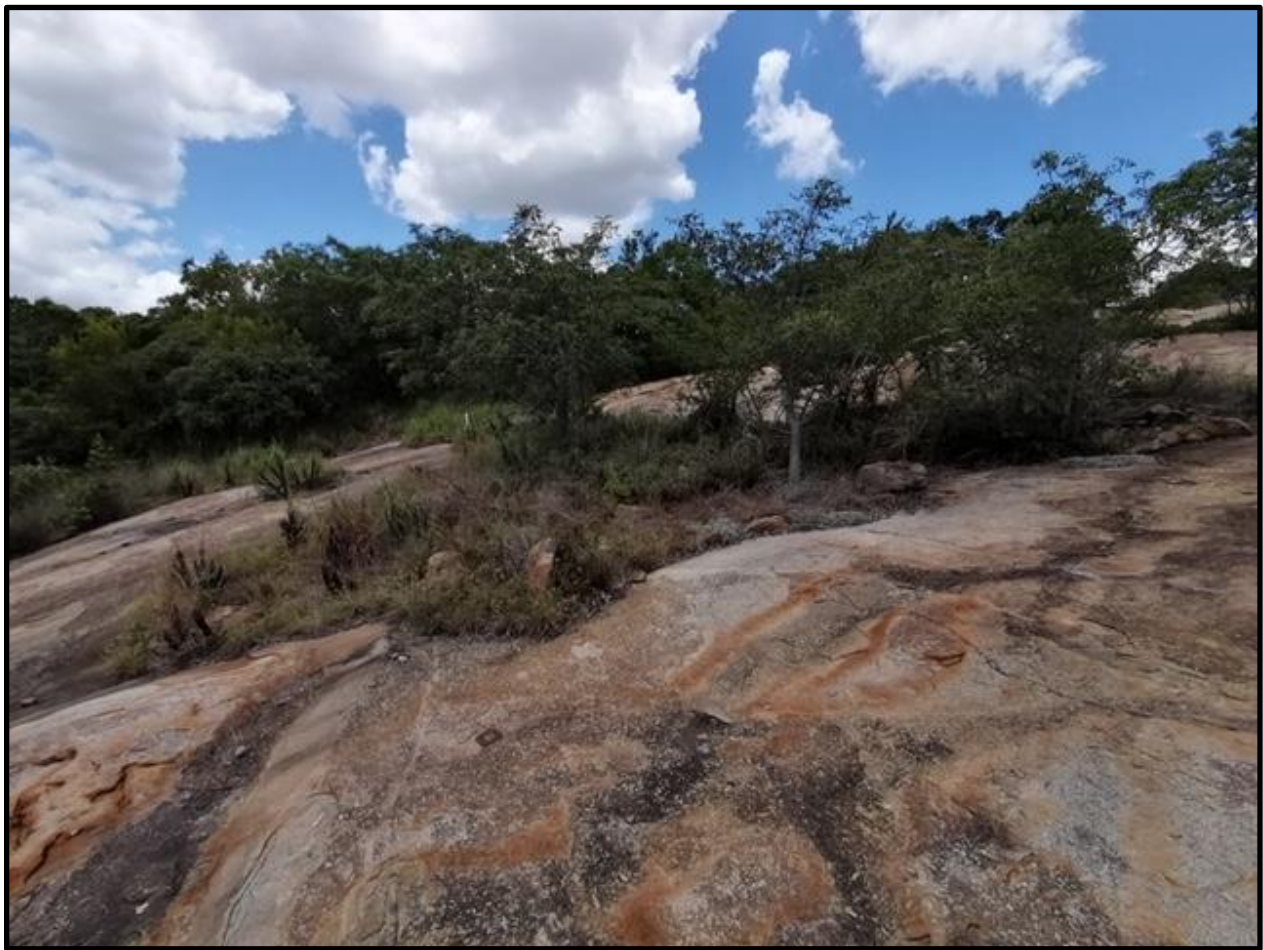
Figure 4: A photographs showing outcrops.

The south eastern part of the site and few patches within the investigated site is covered by boulders and outcrops of granite. The granite found on site was described to be light greyish, coarse grained and very hard granite.

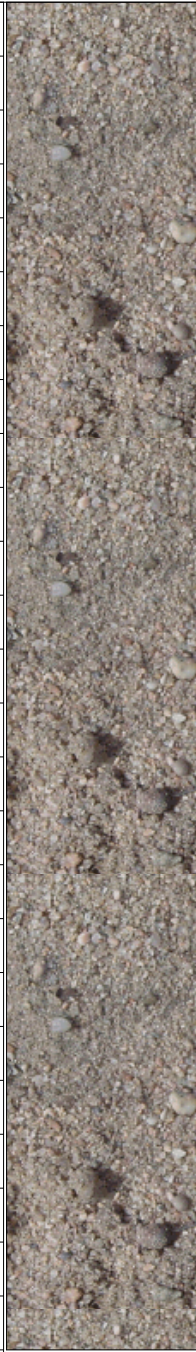
Project: UMP 3000 beds
Profiled: R Maumela
Machine: TLB Machine
Diameter: Trench
Orientation: Vertical
Hole No: UM 07

Slightly moist, dark grey, loose to medium dense, intact, gravelly sand. COLLUVIUM

End of Hole with refusal on a granite bedrock
No seepage or groundwater encountered.
No sample taken
Stable sidewalls.
