Distribution environmental screening document (DESD)
Reticulation Powerlines and Ancillary Services

Project name/Survey

Project number NW-STM-1209-1876-00004 File number

Rural scheme/
Feeder Lindley Munic-De-load Bruwerskraal 22kV Feeder from Burma Rural and refurbish.

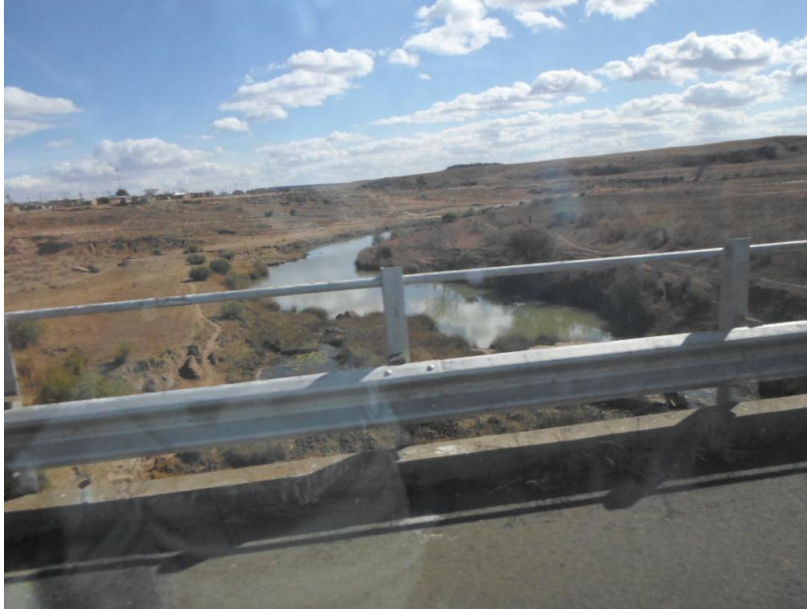
The line crosses the perennial Valsriver at farm Brandhoek erf 20 (See image1). There is a non-perennial stream on farm Klipdrift 580 (See image 2). The line also crosses the non-perennial stream on farm Yeomanrykop jes 579. The perennial Tweespruit is present on farm Zaaiplaatje 440. There is a non- perennial Herbstspruit and a marshy area on the farm Zaaiplaatje 440. The line crosses two non-perennial streams on farm Grootkraal 41 portion 1 and a vlei which has water on it. There is a non-perennial stream present on the farm Verval 427. Two non- perennial streams were observed on farm Bloemhoek 306 and farm Henniesrust 853 where the line will be crossing through. A Perennial stream was observed on farm Burma 1040 where the line will go through.

Image 1: The Valsriver crossing

In order to avoid the possible need for a Basic assessment or Water use licence POLES SHOULD IDEALLY BE PLANTED ATLEAST100M AWAY FROM THE EDGE OF A WATERCOURSE OR OUT OF THE 100 YEAR FLOODLINE.

No vehicles or construction trucks should drive within a waterbody or stream. Long powerline spans with higher poles i.e. 11m H-pole structures must be used to cross rivers/streams or vleis. The natural flow of water should not be interrupted without a water use license. Vehicles and oil containing equipment should be serviced to avoid oil contamination of water during construction and maintenance of the powerline.

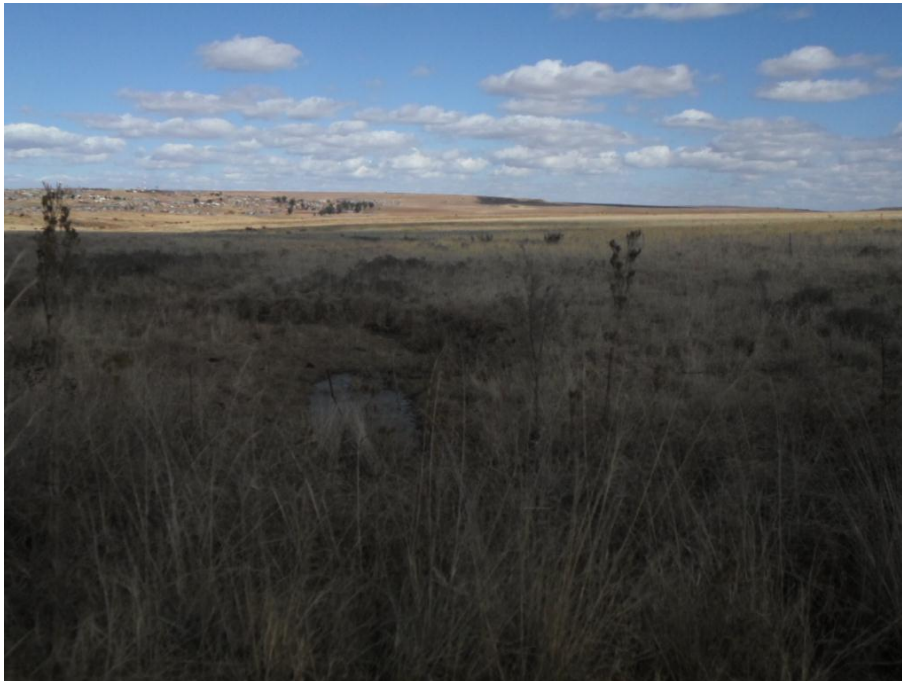
Image 2: Small spruit and wet area at farm Klipdrift 580

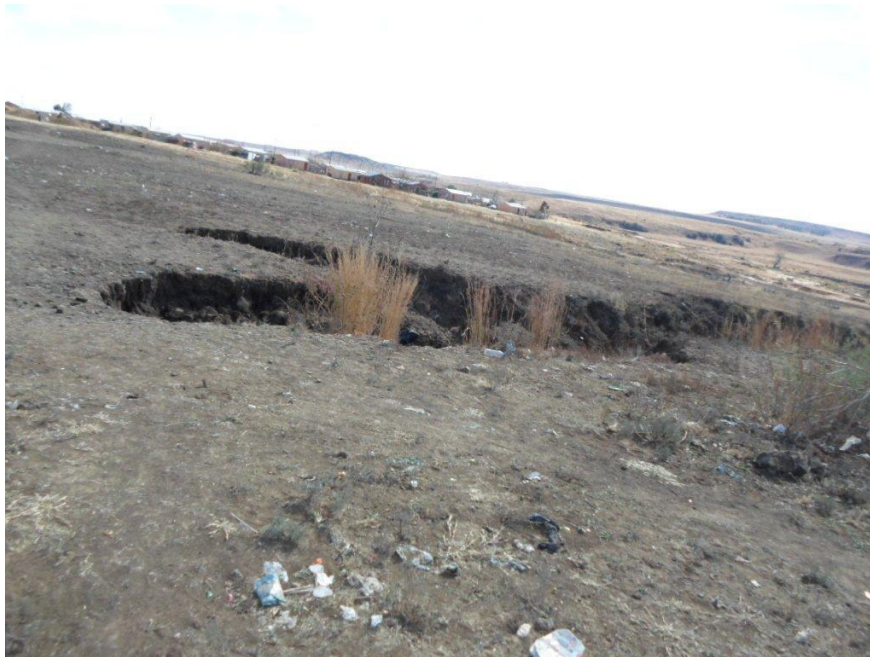
Present condition: The geology falls under the Karoo supergroup which consists of sediments, like sandstone, shale, siltstone and dolomite. The soil type that was observed is wet sandy and rich loam soil, especially where cultivated land were found. The soil is very prone to erosion (as can be seen by dongas in the area) where line goes through farm Brandhoek 20 next to the main tar road 707 (See image3).

Image 3: Gully erosion on farm Brandhoek 20

Present condition: The topography is deeply undulating with hills and ridges are present along the proposed route. Erosion gullies are present where the line goes through farm Brandhoek 20 close to the Valsrivier (See image 3). Small valleys were observed at rivers and steep slopes. Ant hills of termites present in most areas along the proposed powerline route.....

Comments/ Mitigating measures: Vegetation clearance should be kept to a minimum. The movement of vehicles should be kept to a minimum in wet areas and the eroded area on farm Brandhoek 20 next to the main road 707.

Comments/mitigating measures: The current vegetation should be left in its original state. The creation of multiple access routes to the construction point should be avoided. Vehicles must drive at a moderate speed and avoid driving on steep slopes.

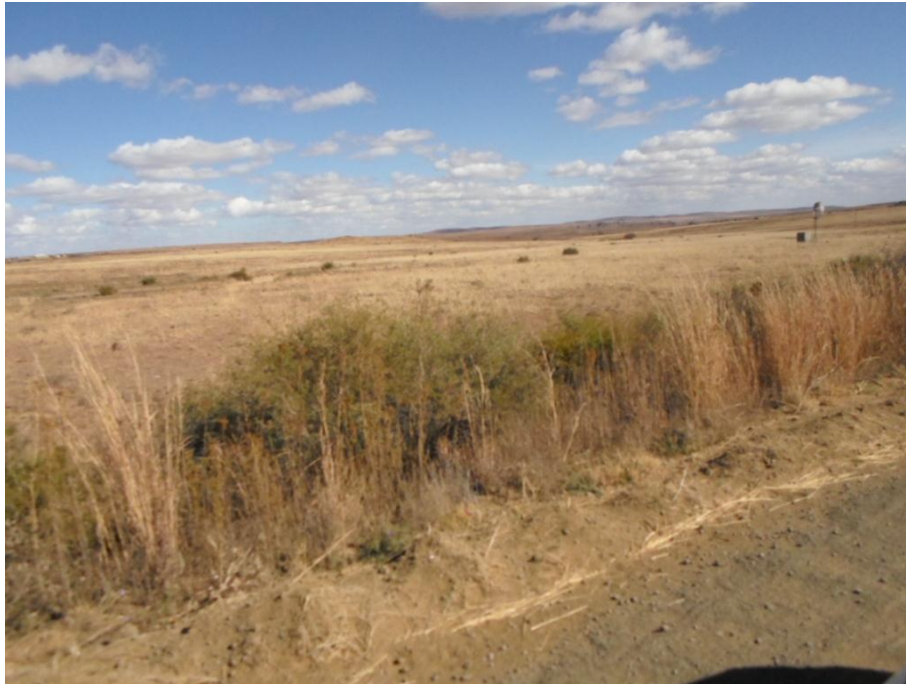
The vegetation cover is mainly moist cold Highveld grassland with *Themeda thiandra* (red grass). Spikelets (grass flower) were also observed in the grasslands (See Image 4). Bluegum trees were also observed on farms Grootkraal 41 portion 12, 8, Gilead 40 and Burma 1040 (See image 5). A weeping willow tree (*Salix babylonica*) was observed on farm Zaaiplaatsje 440 on the bank of the Herbstspruit. There are also dense bushes on farm Gilead 40 along the stream where the line will be crossing the farm. There is cultivated land with mielie crops on farms Yeomanrykopjes 570, Sunnyside 581, Grootkraal 41 portion 13, 5, Verval 427.

Image 4: Grassland with red grass and grassplants

Comments/ mitigating measure: Minimal removal of vegetation. No fires should be made in the veld or on cultivated lands.

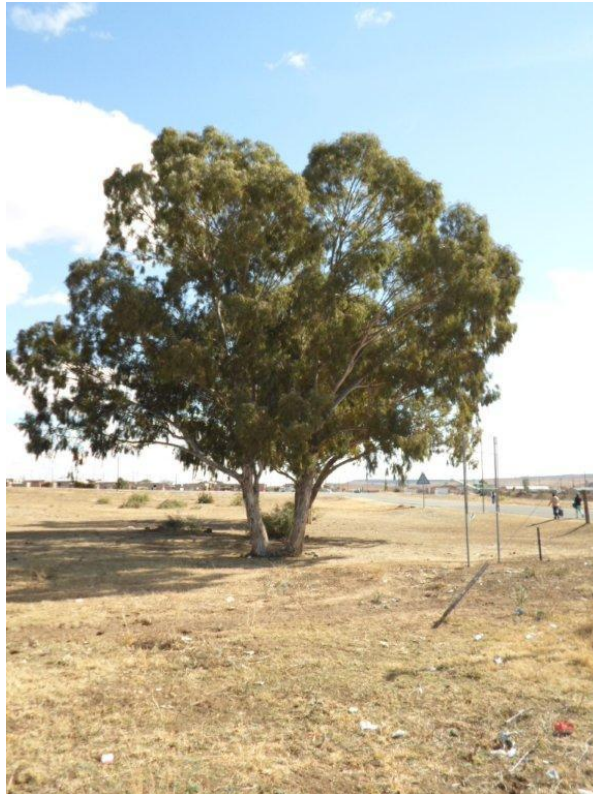
Image 5: Bluegum tree on Brandhoek 20 close to the township and next to the main road.

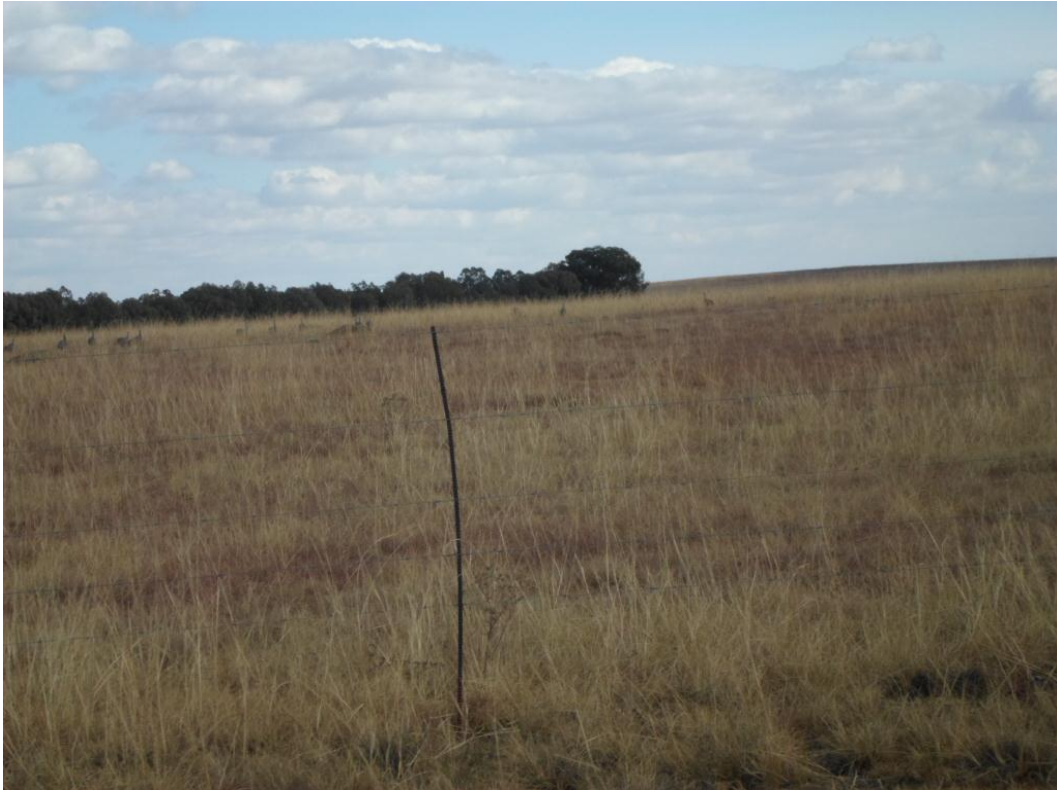
Small weavers were seen on farm Klipdrift 580, a flock of Guinea fowls was observed on the grassland on farm Smaldeel 492 (See image 7).

Image 6: Guinea fowls in the area

Comments/mitigating measures: Minimal vegetation clearance in this area should take place. No poaching of guinea fowls or any other bird species should take place. Bird flappers should be installed on the powerline where it crosses wet areas and/or where collision/electrocution prone birds were observed.
