CONSULTATION IN TERMS OF SECTION 43 OF THE MINERAL AND PETROLEUM RESOURCES DEVELOPMENT ACT 2002, (ACT 28 OF 2002) IN RESPECT OF A CLOSURE APPLICATION FOR A BORROW PIT AT LOOP 8 ON THE SISHEN SALDANHA ORELIN SITUATED ON THE REMAINDER OF THE FARMS AAN DE KAREE DOORNPAN AND SOUS 226 IN THE ADMINISTRATIVE DISTRICT OF CALVINIA, NORTHERN CAPE REGION.

Re: Closure of the Borrow Pit at Loop 8 on the Sishen-Saldanha Oreline, situated on the remainder of the farms Aan de Karee Doornpan 213 and Sous 226, in the Calvinia District.

Oreline Loop Extension Project

Borrow Pit Closure Report - Loop 8

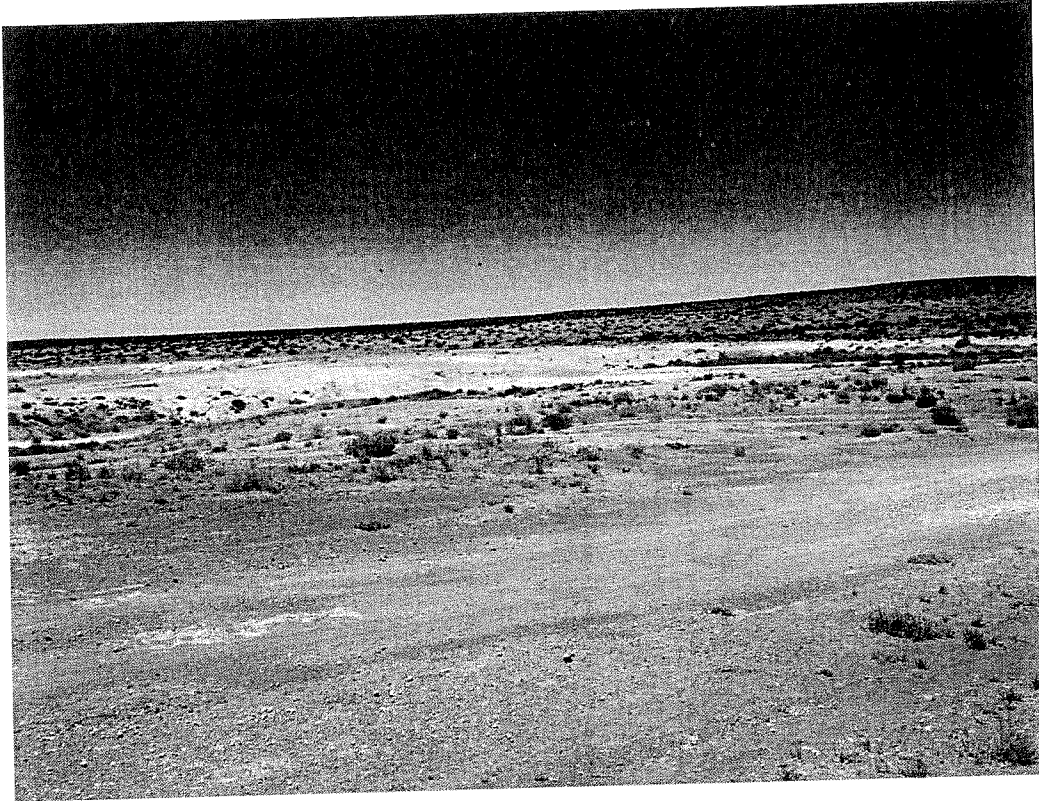
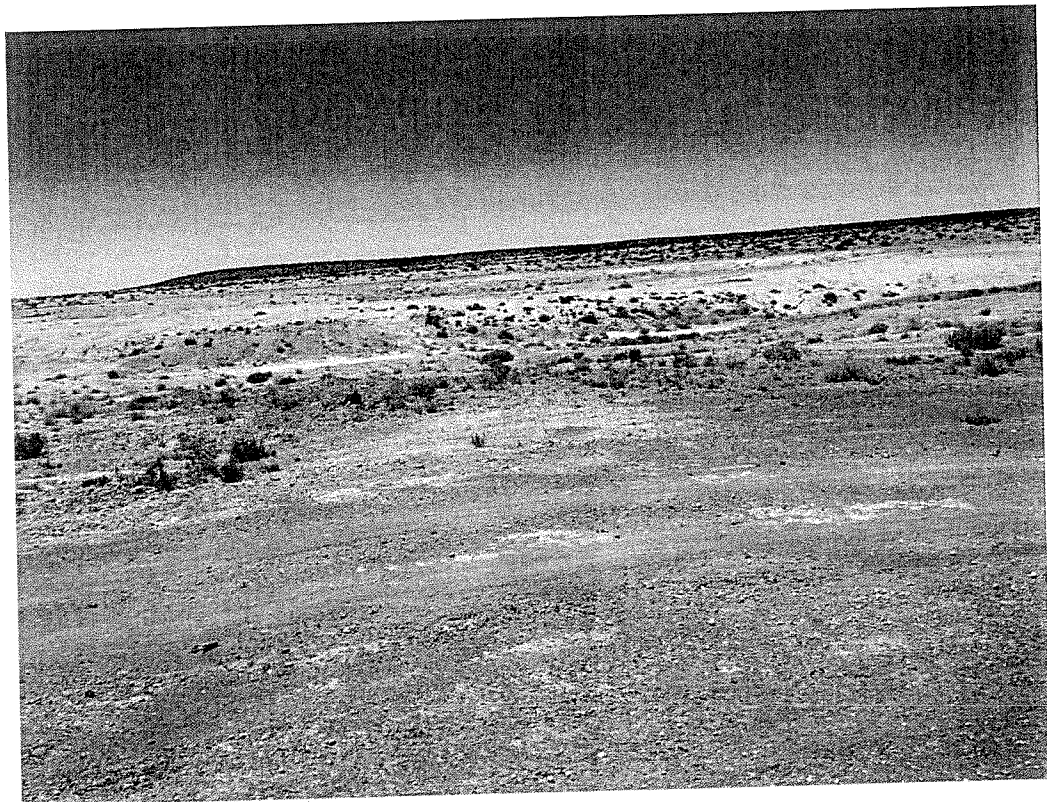
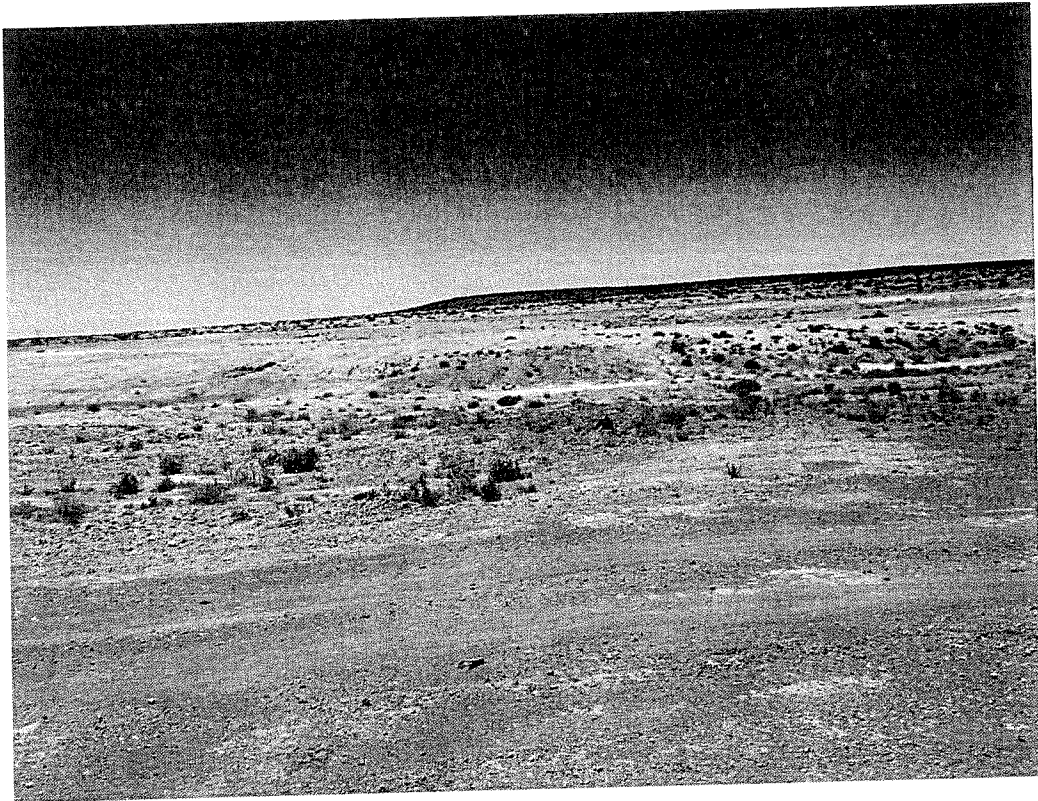
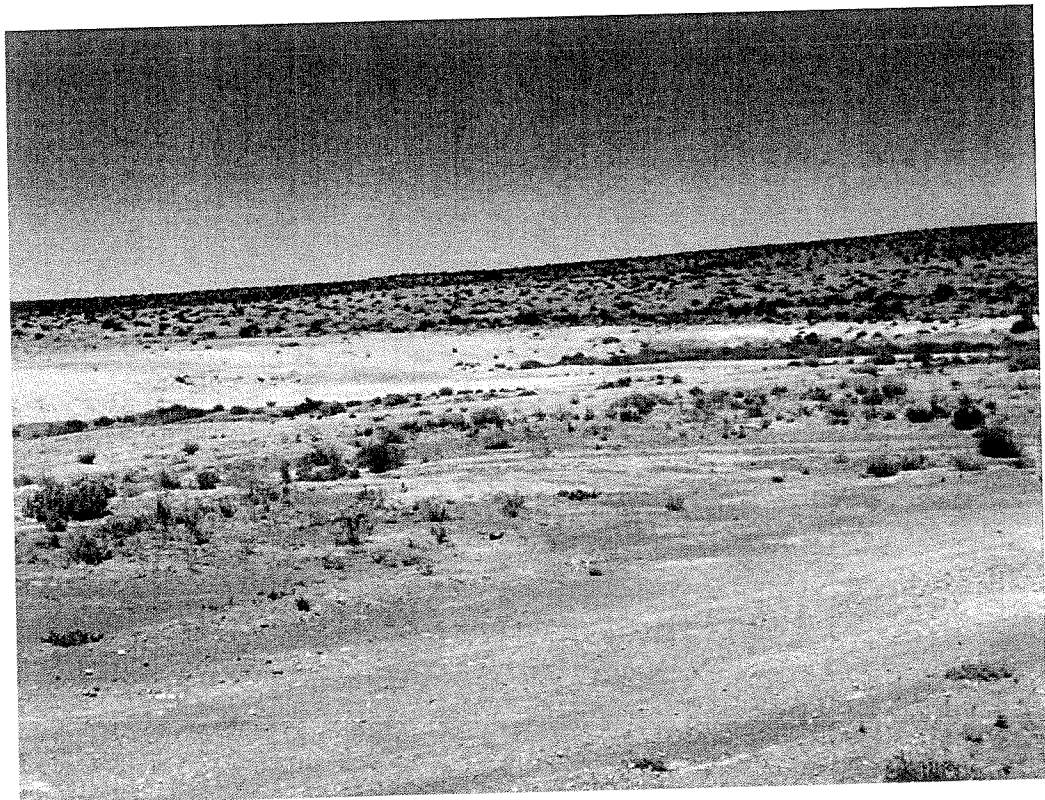
Annexure 4: Site Photographs

A site visit was undertaken to the site on 23 November 2010 in order to identify and assess the relevant environmental risks. **Table 3** summarises the findings of the screening level environmental risk assessment. It is evident from the table that all risks are considered to be insignificant without the need for further mitigation measures, monitoring or rehabilitation. Site Photographs in **Annexure 4** provide a visual basis for some of the conclusions reached in the risk assessment.

The mining operation undertaken by Transnet Limited on the Remainder of the farm Aan de Karee Doornpan 213 in terms of permit reference no: 30/5/1/3/3/2/1/642 has been satisfactorily rehabilitated. The site is not considered to be unsafe or unsightly. There is good vegetative growth of indigenous grass species and the area of operations blends in with the surrounding environment. No further consequences or impacts to the environment are envisaged as a result of the mining operations.
