Preliminary skeletal report by

Esor Construction (Pty) Ltd

I was contacted by Mr. JP Celliers, to assist in identifying several bones that were exposed during the excavation of a trench in Steelpoort Industrial Park, Steelpoort as part of the Spitskop pump station and to the Mototolo mine water pipeline project.

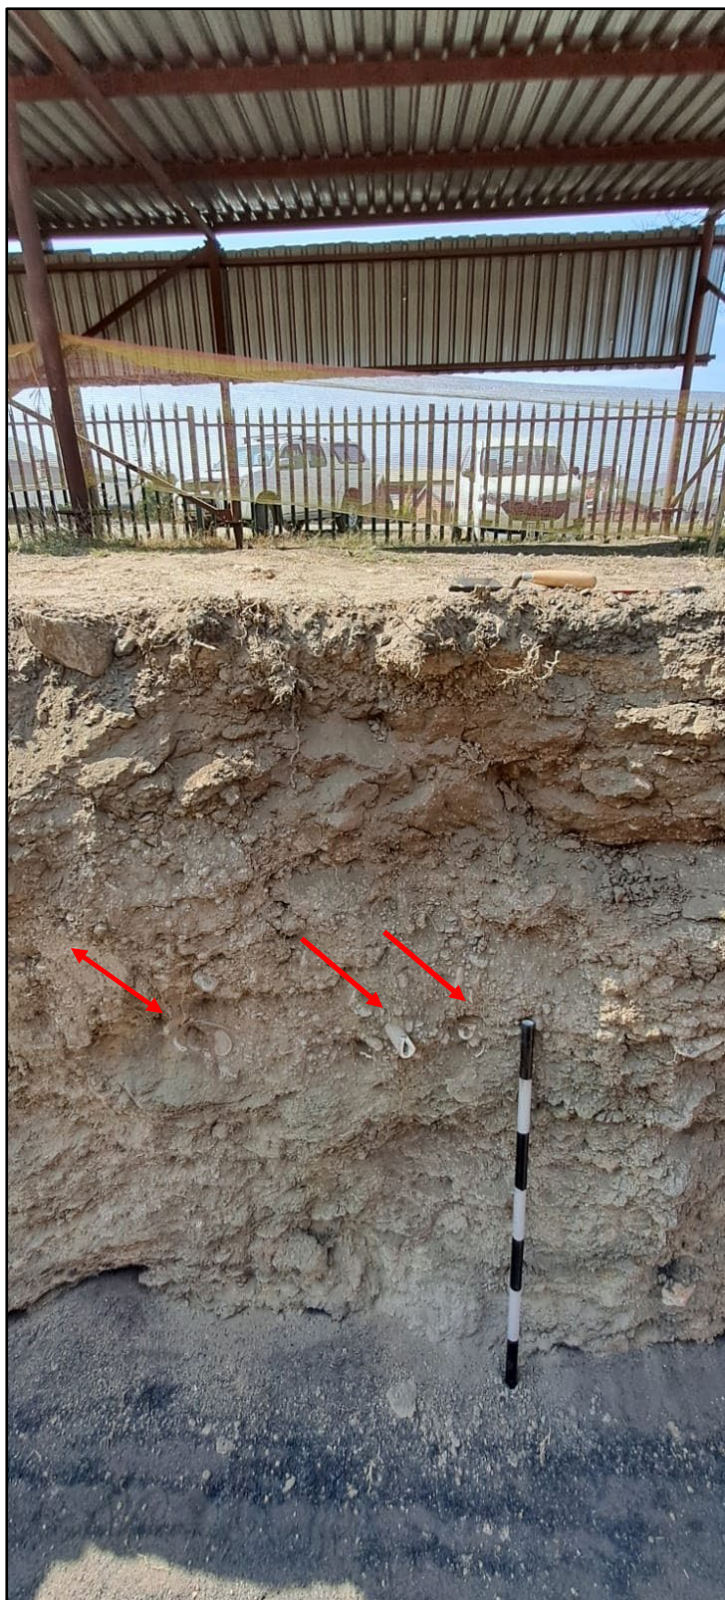
Figure 1. Exposed human remains – ribs, vertebra, femur, and possible tibia fragments.

In Figure 1 the arrows indicate the identified human remains that are all on the same level. Figures 2. and Figure 3., indicate the different bones. In Figure 2. the number 1 indicates the femur and number 2 indicates a possible tibia.

Firstly, I recommend that the area is left undisturbed and an alternative route for the pipeline is excavated. If this is not a viable option, the remains should be exhumed, analysed and then reburied or sent to a formal repository for human remains.

The South African Heritage Recourses Agency (SAHRA) must be informed of the accidental discovery of human remains. Should it be deemed necessary for the development of the pipeline

to continue along the same route, the archaeologist must apply for a rescue permit to retrieve all the human remains from this burial.

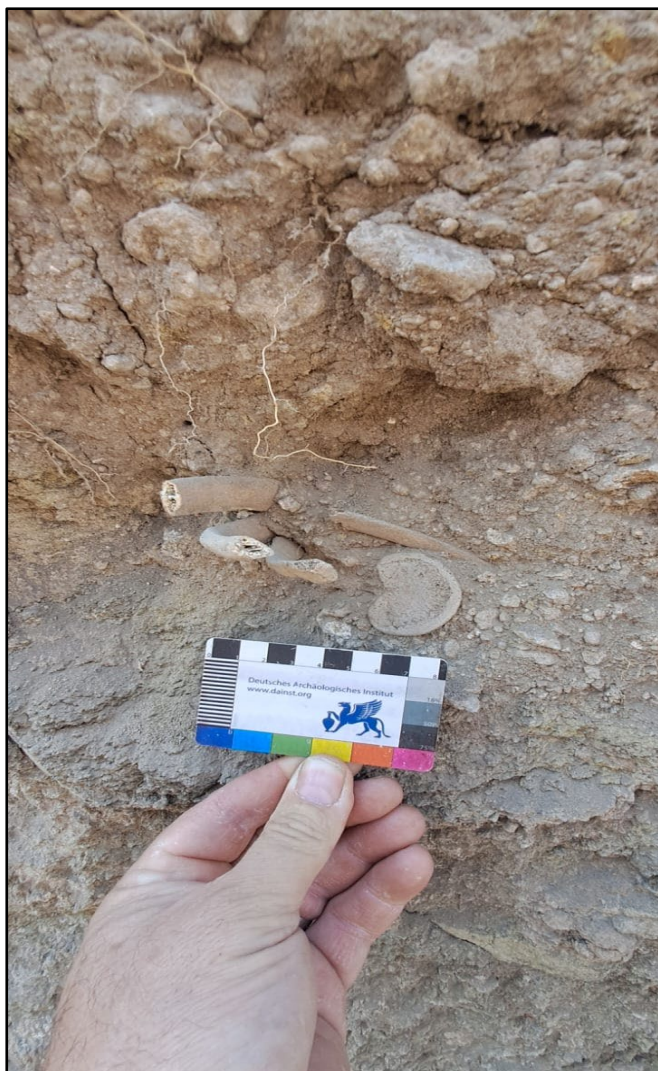
Figure 3. indicates the human ribs protruding from the excavation profile.

Figure 3. Some ribs and vertebrae protruding out of the trench wall.
