SITE INVESTIGATION REPORT

MPAMENI ROAD UPGRADE

OKHAHLAMBA LOCAL MUNICIPALITY

11 June 2018

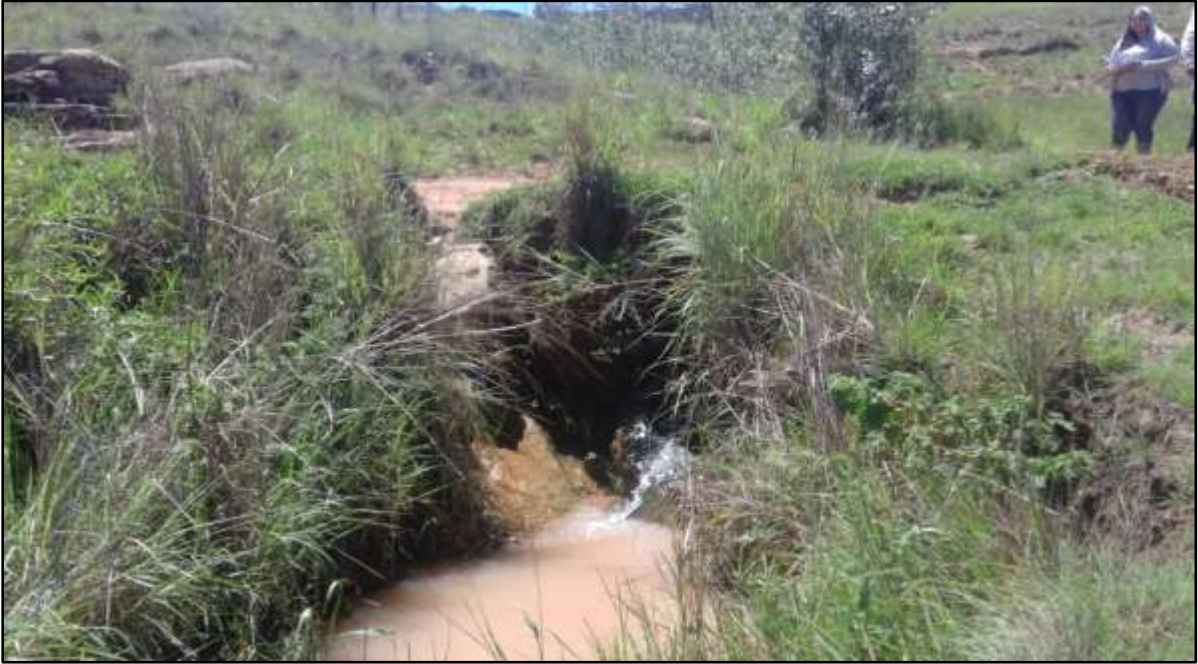
The proposed route traverses No. 04 watercourses. There is an existing pipe culvert structure at water crossing No.01, however this is eroded. There are no structures present at water crossing points No. 02, 03 & 04. Watercourses No. 01 to No.04 were flowing and visible bedrock was observed at watercourses No. 03 & 04. **Refer to Photo 4 showing the watercourses which were encountered.** There is also specific riparian vegetation present along the identified watercourses. **Refer to Photo 5 showing the riparian vegetation.**

Photo 1: Showing the existing structure at Watercourse No.01

There are currently no existing structures present at 3 of the 4 water crossing points. The proposed upgrade aims to install the relevant structures at the water crossing points. Water crossing point No.02 has an existing No.01 x 600mm pipe culvert structure, however, this has been severely eroded over time (**Refer to Photo 1**). Due to the presence of the watercourses, gaining access to the area is extremely difficult for individuals with motor vehicles. The upgrade aims to further facilitate the development of the area by providing a sustainable road/access network.

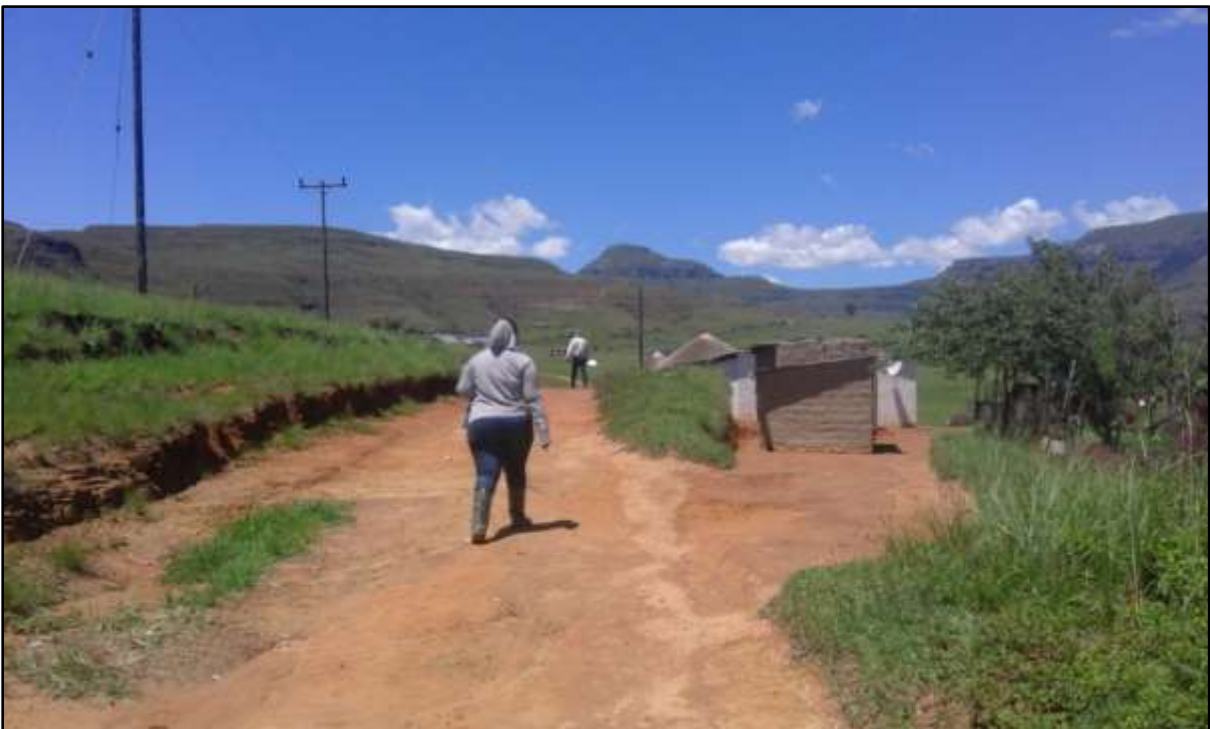
The Mpameni road can be accessed via District Road D1623. There are homesteads situated in close proximity to the road (**Refer to Photo 1 showing the close proximity of homesteads in relation to the road.**). Furthermore, there are fence lines and electricity poles which lie within the existing road reserve. These would have to be moved and realigned in order to cater for the road upgrade.

Photo 2: Showing the proximity of homesteads in relation to the road edge.

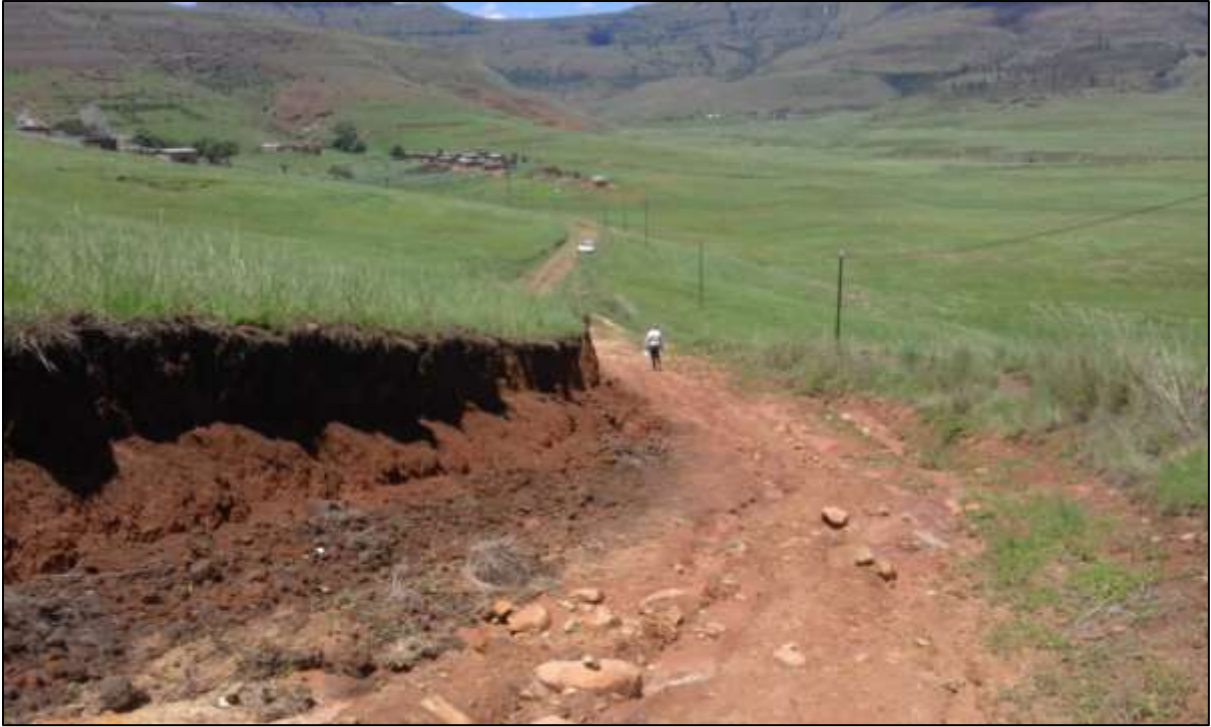
Due to the insufficient drainage along the route, there are portions which are heavily eroded. This is more evident along the banks which run parallel to the route (as the undercutting can be clearly seen). Sufficient drainage systems will have to be installed at certain portions of the route to help reduce the effects of erosion. **Refer to Photo 2 showing erosion and undercutting of banks.** Furthermore, dense vegetation is present along the entire track. **Refer to Photo 3 showing the vegetation encountered along the track.**

Photo 3: Showing the undercutting of slopes and the erosion along the existing route.

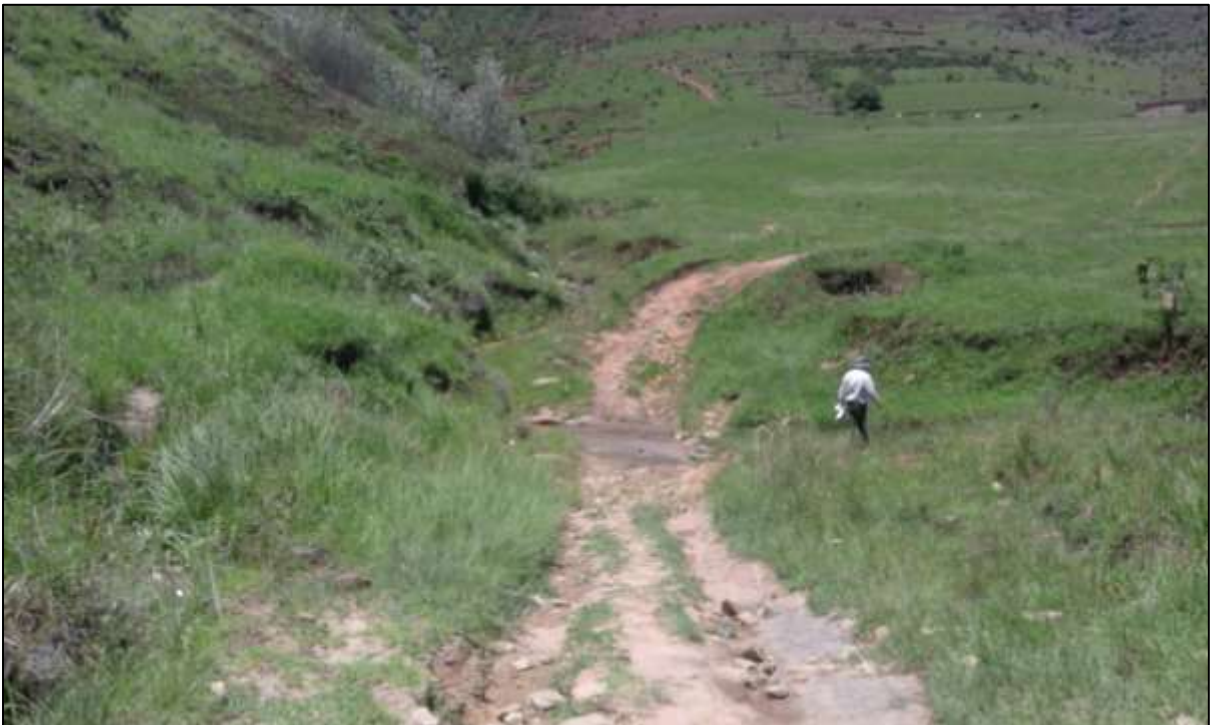
Photo 4: Showing the vegetation present along the route.

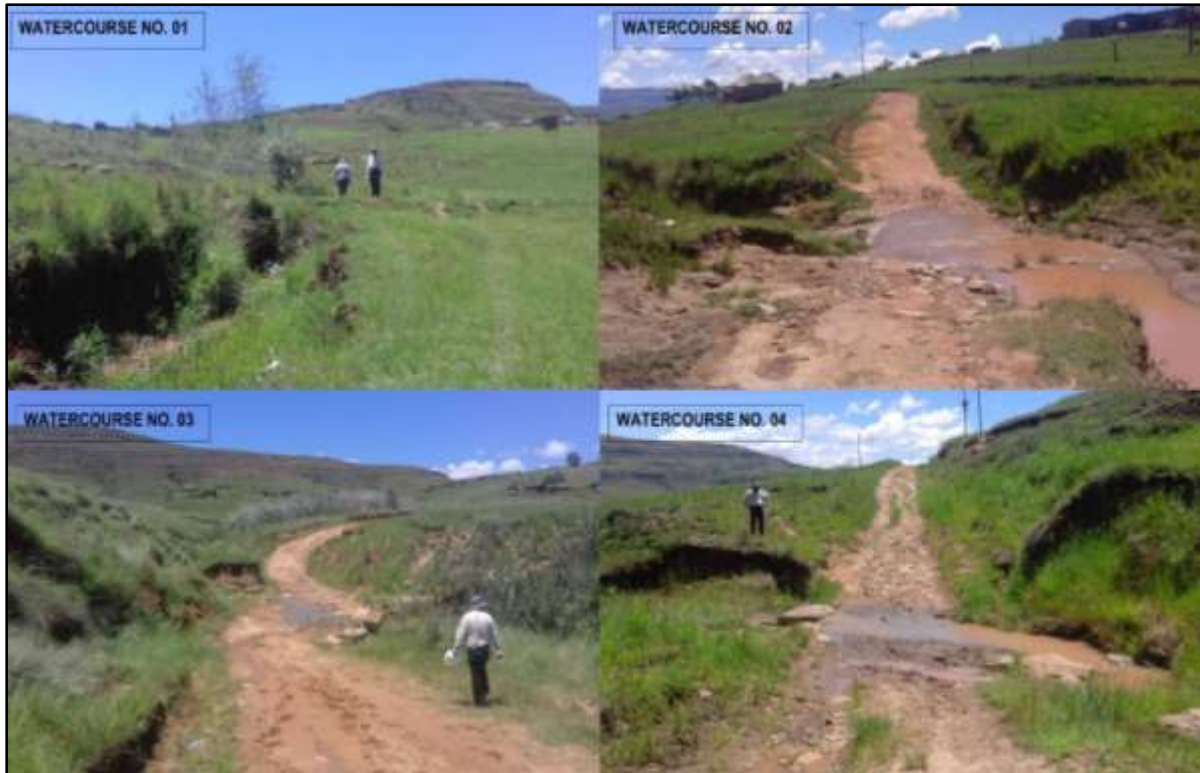
Photo 5: Showing the watercourses along the route.

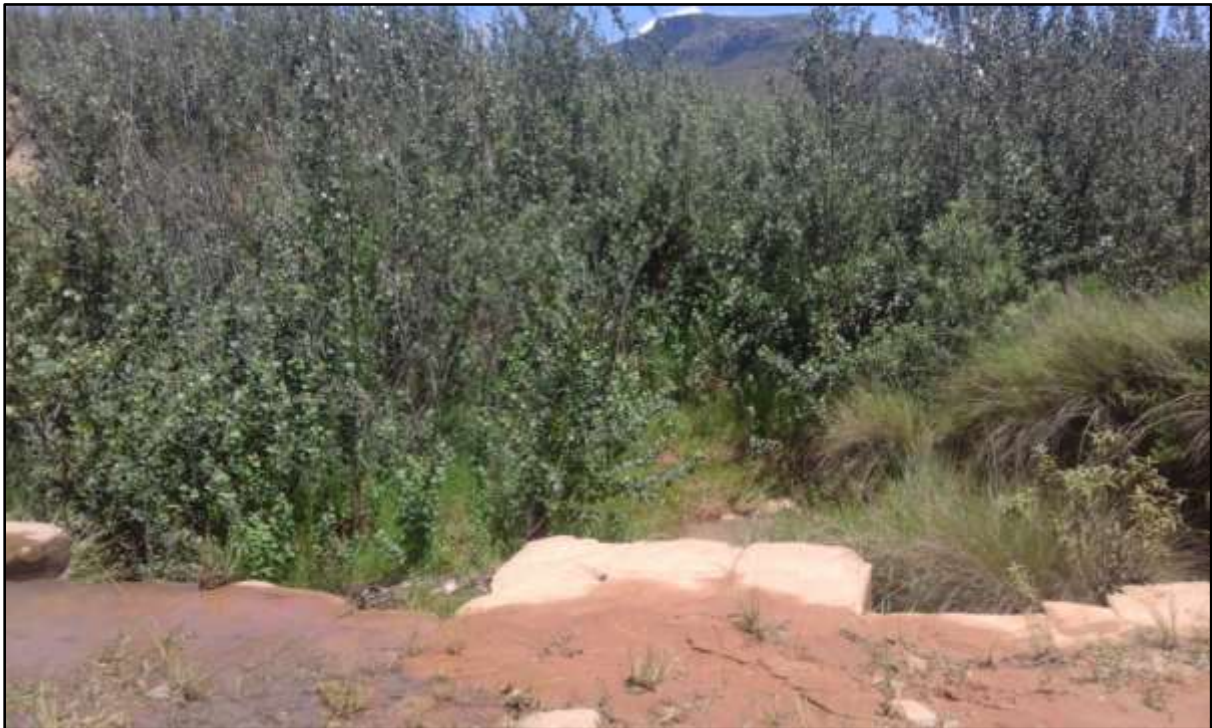
Photo 6: Showing the riparian zone vegetation.
