**GEO-TECHNICAL INVESTIGATION FOR THE FOUNDATION DESIGN OF A  
PROPOSED PUBLIC TRANSPORT FACILITY ON ERF RE/7/239-IQ IN  
EMDENI, SOWETO, GAUTENG PROVINCE.**

**FINAL REPORT**

**Report No. JOB MS201714**

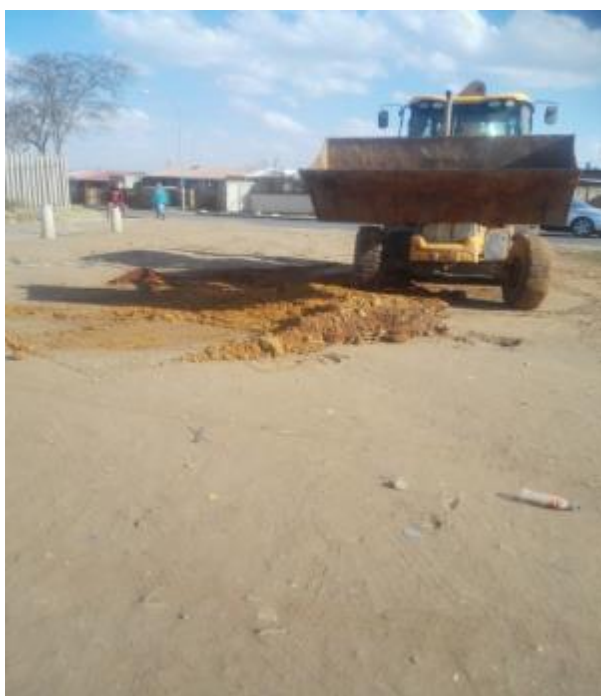
PIC A: The TLB used to excavate test pits

The field investigation was conducted on the 28<sup>th</sup> of June 2017 comprising of a site visit, excavation of three test pits and three DCP tests in areas reflecting different soil horizons. All sites were profiled along the vertical excavation face by the author using the MCCSSO soil profiling technique advocated by Jennings, 1963 (see Appendix A). The rock faces were profiled according to current methods and procedures, (Brink ABA and Bruin RMH); “Guidelines for Soil and Rock Logging” (SAIEG, AEG & SAICE, 1994). Representative samples were submitted for testing to a commercial soils laboratory for the determination of the CBR, MOD and foundation indicator tests.

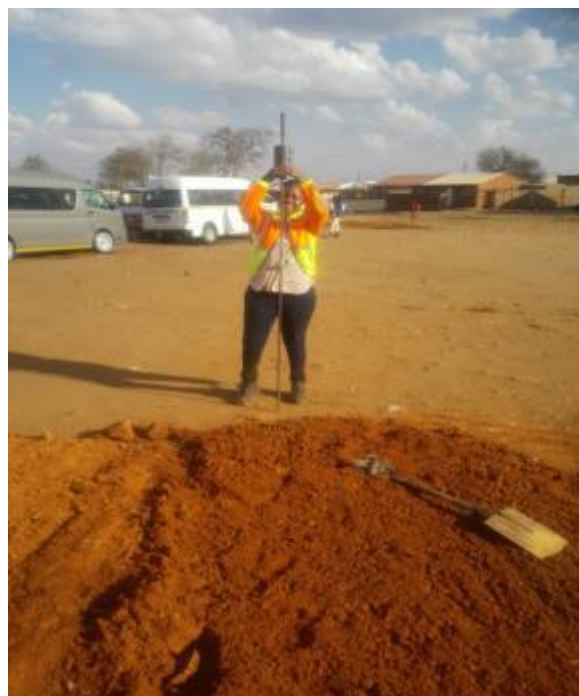
PIC B: DCP test underway

Three DCP tests were conducted (as shown in figure 1. below) to obtain an indication of the densities and CBR values for the subsoil. Measurements were taken at depths varying from surface to refusal. The results for the DCP tests are included in Appendix A.

In summary, the site average CBR values of the soil layers are **34%** at an average depth of **0.4m**, with an allowable soil bearing average pressure range of **271 kPa**. DCP results deeper than 1.5m cannot be relied on due to increased frictional resistance of the testing rods hence the tests were limited to 1.0m.
