**WETLAND IDENTIFICATION, DELINEATION AND ECOLOGICAL
ASSESSMENT ASSOCIATED WITH THE FARM DAM ON THE FARM
THE BREEZE NO. 6921 NEAR RAMSGATE IN KWAZULU-NATAL**

July 2020

Prepared by: **Terratest (Pty) Ltd**

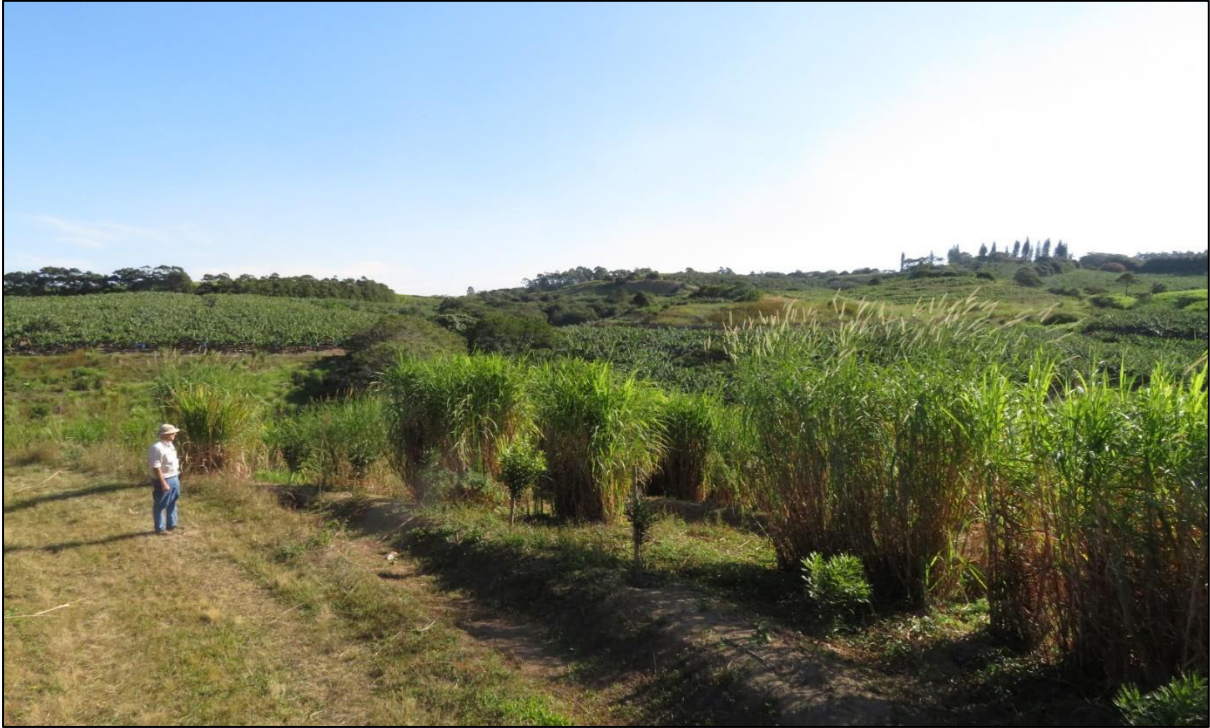
Plate 4: View of the old Sugar Cane fields now planted to Macadamia orchards

The landuse within and surrounding the study area is dominated by commercial agricultural activities. These activities relate to the growing of Banana plantations and Macadamia nut orchards on land previously used for the growing of Sugar Cane. The areas to the south and northeast of the study area consists of the residential areas associated with Ramsgate.

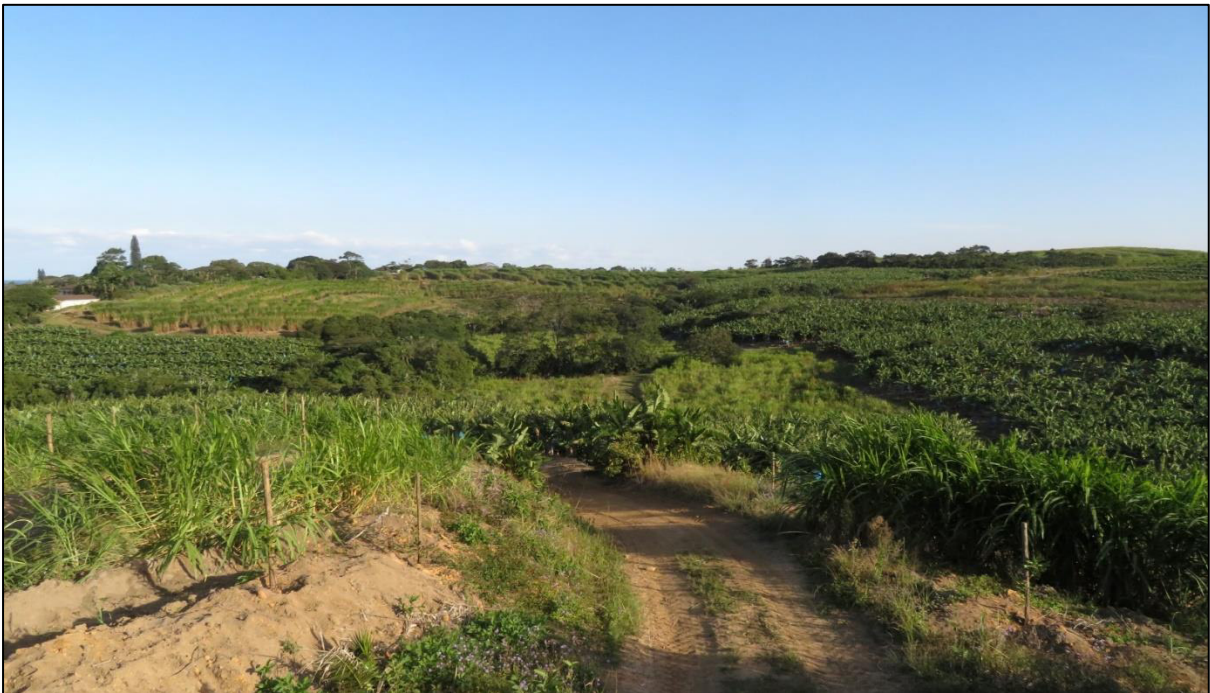
Plate 5: View of the Banana plantations in the study area

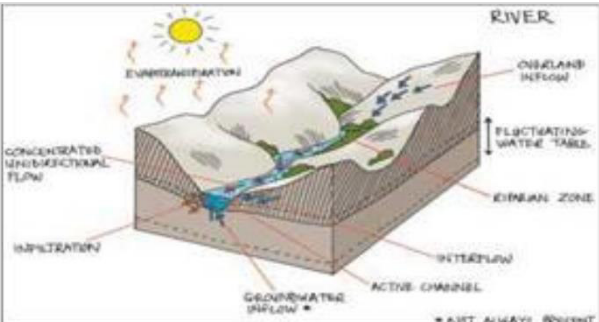
Rivers are linear landforms with clearly discernible banks and a channel, which permanently or periodically, carries a contained and defined flow of water. A river is taken to include both the active channel and the riparian zone.

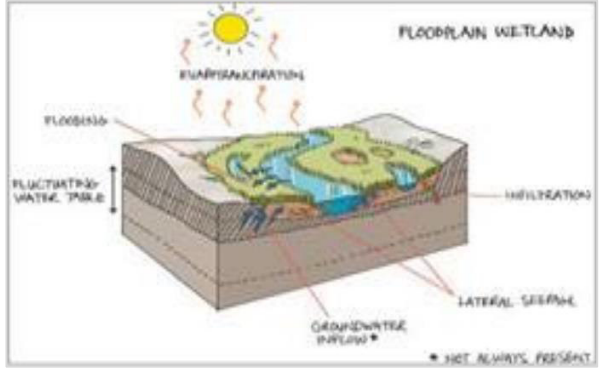
Valley bottom areas with a well-defined stream channel, gently sloped and characterised by floodplain features such as oxbow depressions and natural levees and the alluvial (by water) transport and deposition of sediment, usually leading to a net accumulation of sediment. Water inputs from main channel (when channel banks overspill) and from adjacent slopes.
Valley bottom with channel

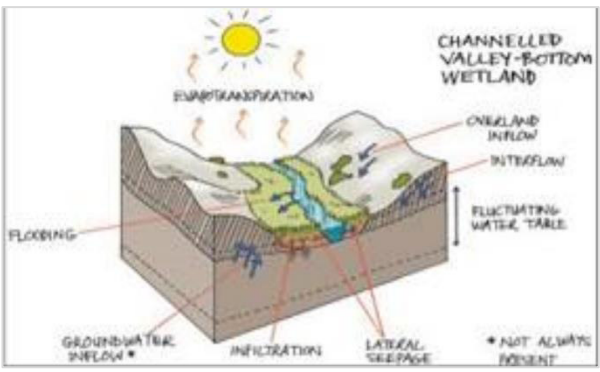
Valley bottom areas with a well-defined stream channel but lacking characteristic floodplain features. May be gently sloped and characterised by the net accumulation of alluvial deposits or may have steeper slopes and be characterised by the net loss of sediment. Water inputs from main channel (when channel banks overspill) and from adjacent slopes.
Valley bottom without a channel

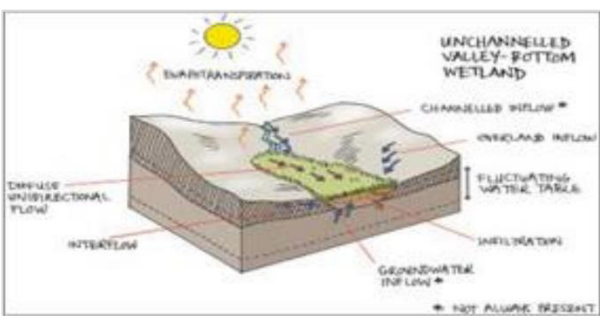
Valley bottom areas with no clearly defined stream channel, usually gently sloped and characterised by alluvial sediment deposition generally leading to a net accumulation of sediment. Water inputs mainly from channel entering the wetland and also from adjacent slopes.

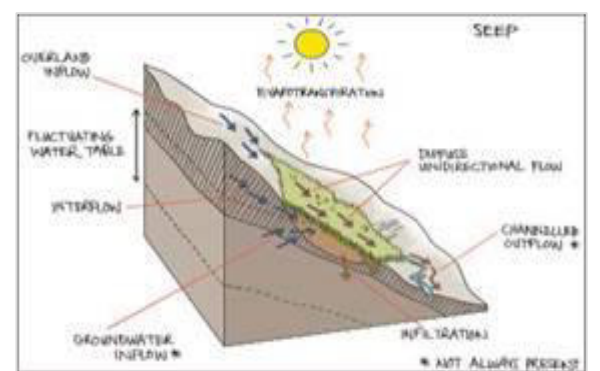
Slopes on hillsides, which are characterised by the colluvial (transported by gravity) movement of materials. Water inputs are mainly sub-surface flow and outflow is usually via a well-defined stream channel connecting the area directly to a stream channel.

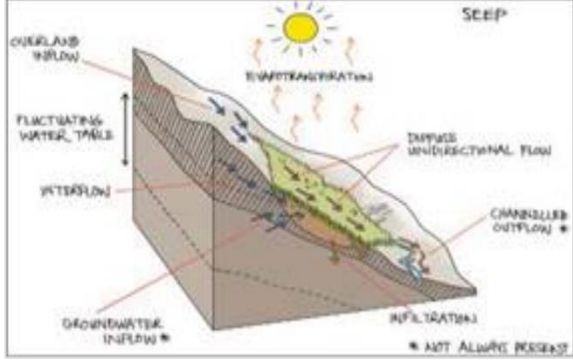
<p>Similar to other hillslope seeps but with no direct surface water connection to a stream channel. Slopes on hillsides, which are characterised by the colluvial (transported by gravity) movement of materials. Water inputs mainly from sub-surface flow and outflow primarily by diffuse sub-surface and/or limited surface flow.</p>
Depression (includes Pans)

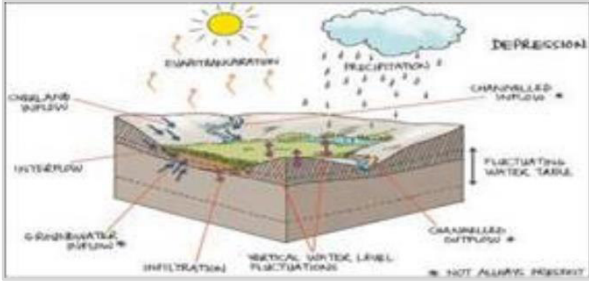
<p>A basin shaped area with a closed elevation contour that allows for the accumulation of surface water (i.e. it is inward draining). It may also receive sub-surface water. An outlet is usually absent, and therefore this type is usually isolated from the stream channel network.</p>
Wetland Flat

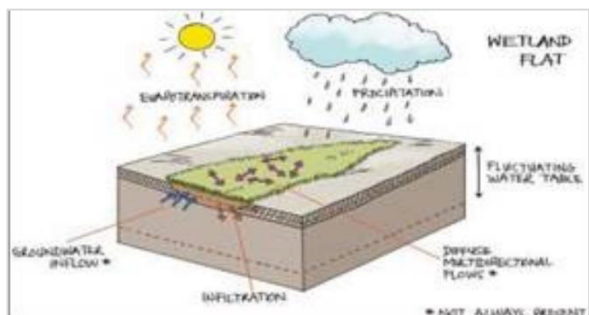
<p>A flat wetland with no apparent inlet or outlet points. Water is obtained from surface or near surface flows and is lost either by downward percolation or evapotranspiration. May be only seasonal in terms of its wetness and hydromorphic soils may be only weakly developed or else be absent. Vegetation may be the strongest indicator.</p>

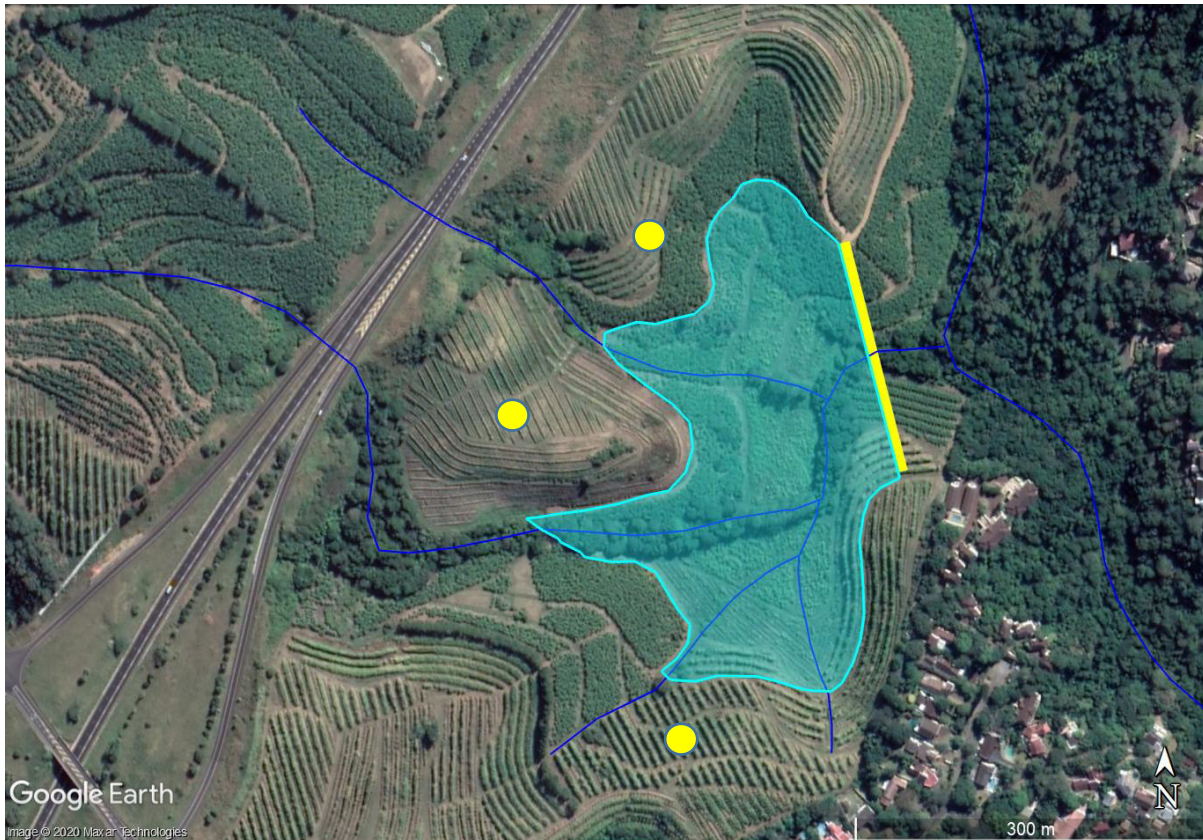
Figure 6: Location of the auger sites (shown in yellow) in relation to the pedestrian bridge crossing

A total of 3 locations were augered above the proposed dam impoundment, with a hand auger to determine the soil physical properties and the soil morphology. The depth of the sampling was to a depth of 1.5m (or to refusal on the underlying dolerite) with all hydropedological features being recorded.

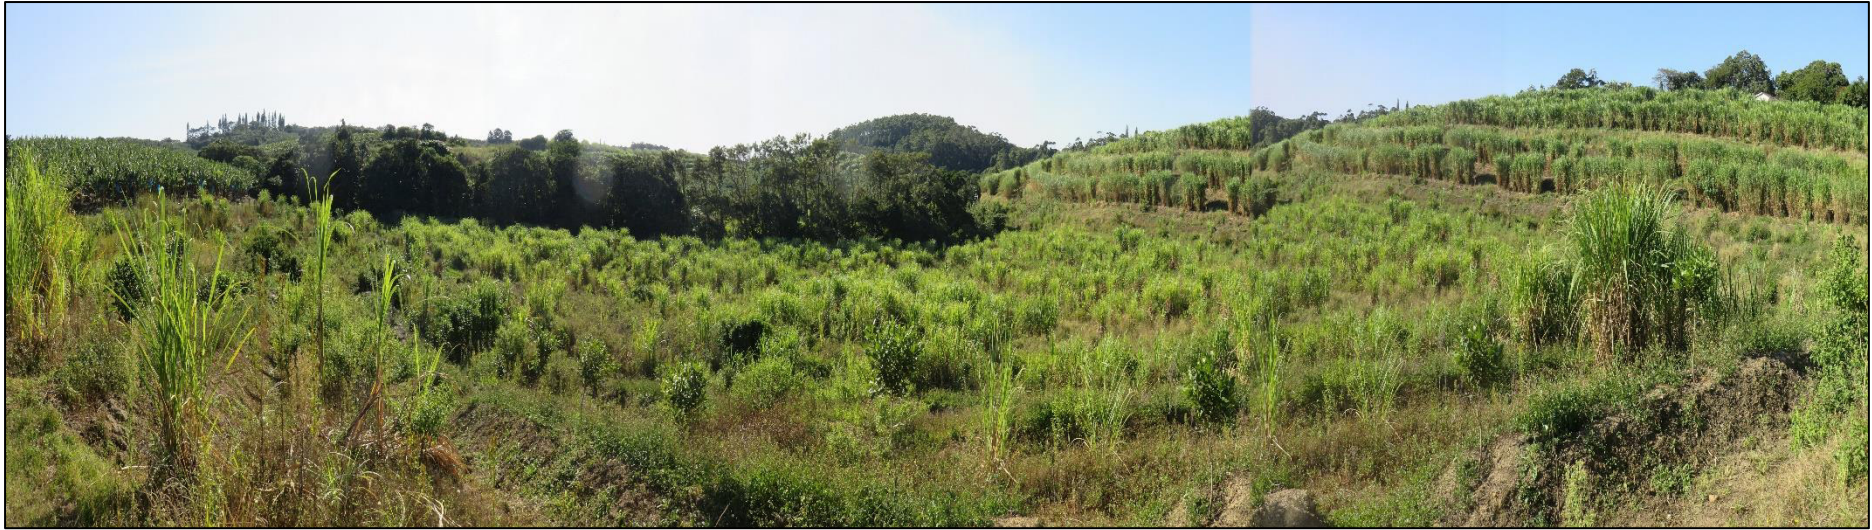
Plate 6: View of the southern wetland segment.

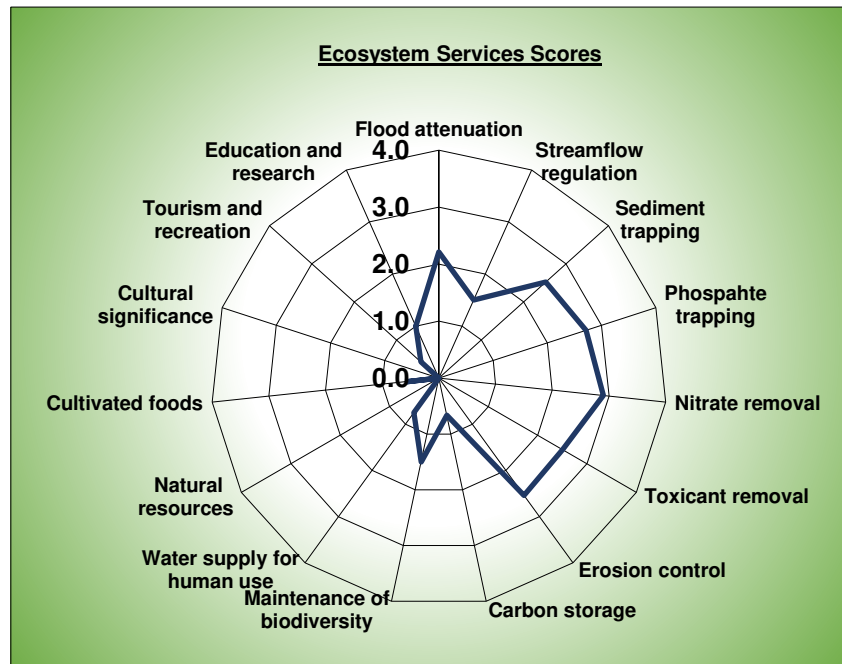
Figure 11: Spider graph showing the ecosystem services provided by the wetland

Wetland Unit	CVB*	
Ecosystem Services Supplied by Wetlands	Indirect Benefits	Regulating and supporting benefits	Flood attenuation	2.2	
			Streamflow regulation	1.5	
			Water Quality enhancement benefits	Sediment trapping	2.5
				Phosphate assimilation	2.7
				Nitrate assimilation	2.9
				Toxicant assimilation	2.5
				Erosion control	2.5
	Carbon storage	0.7			
	Direct Benefits	Provisioning benefits	Biodiversity maintenance	1.5	
			Provisioning of water for human use	0.8	
			Provisioning of harvestable resources	0.0	
		Cultural benefits	Provisioning of cultivated foods	0.6	
			Cultural heritage	0.0	
			Tourism and recreation	0.4	
			Education and research	1.0	
Overall Total Score				21.8	
Average Ecosystem Service Score				1.5	
Threats to Existing Ecosystem Services				4.0	
Opportunities for Enhancing Ecosystem Services				0.0
