# DRAFT BASIC ASSESSMENT REPORT

### PROPOSED UPGRADE OF MAIN ROAD P278 AND ASSOCIATED BORROW PITS, LOCATED ON VARIOUS PROPERTIES WITHIN UMSHWATI LOCAL MUNICIPALITY, UMGUNGUNDLOVU DISTRICT, KWAZULU-NATAL

**EDTEA Reference: DC22/0007/2021 KZN/EIA/0001532/2021**

**March 2021**

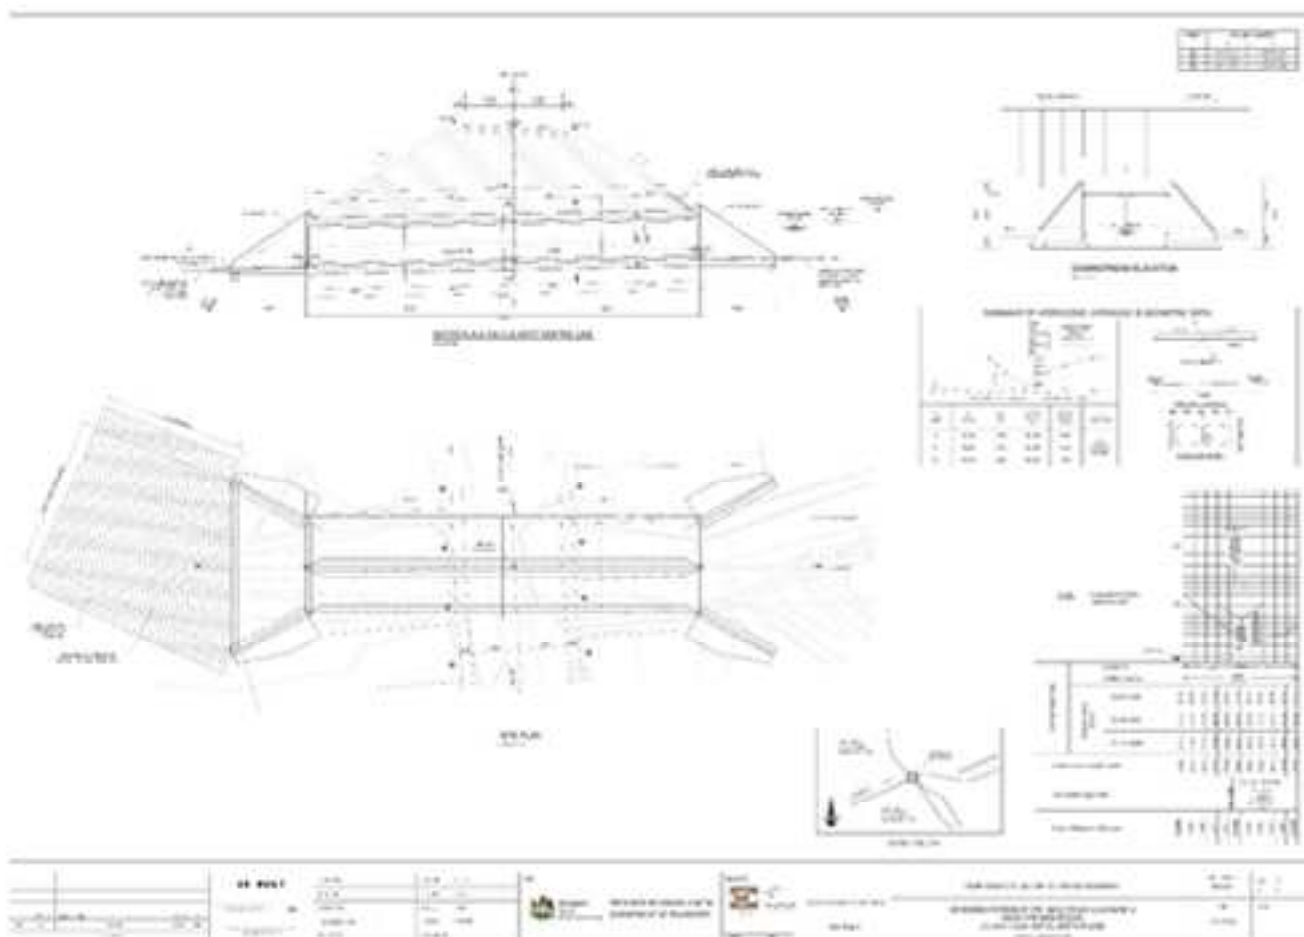
**Figure 1 : Watercourse Crossing 1 - Layout**

The new type 4 black top road will cross over above the new concrete portal culvert structure on compacted base material with 1:1.5 slopes on either side. The total dimensions of the concrete portal culvert structure will be 8,95m wide x 34,45m long x 4,9m height with 6,468m wing walls at each end, trapezoidal shaped apron slab and reno mattress details on either end.

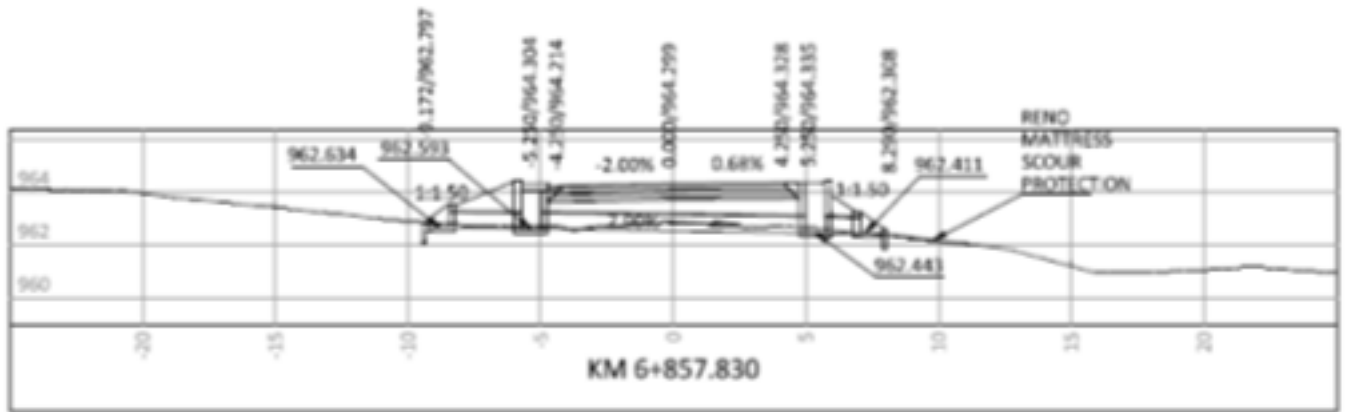
Figure 3: Watercourse Crossing 2 - Detail

Watercourse Crossing 2 proposed pipe culvert comprises 2 x 900mm Ø x 15m length concrete pipes with headwalls and gabions to suit and reno mattress as scour protection at outlet.

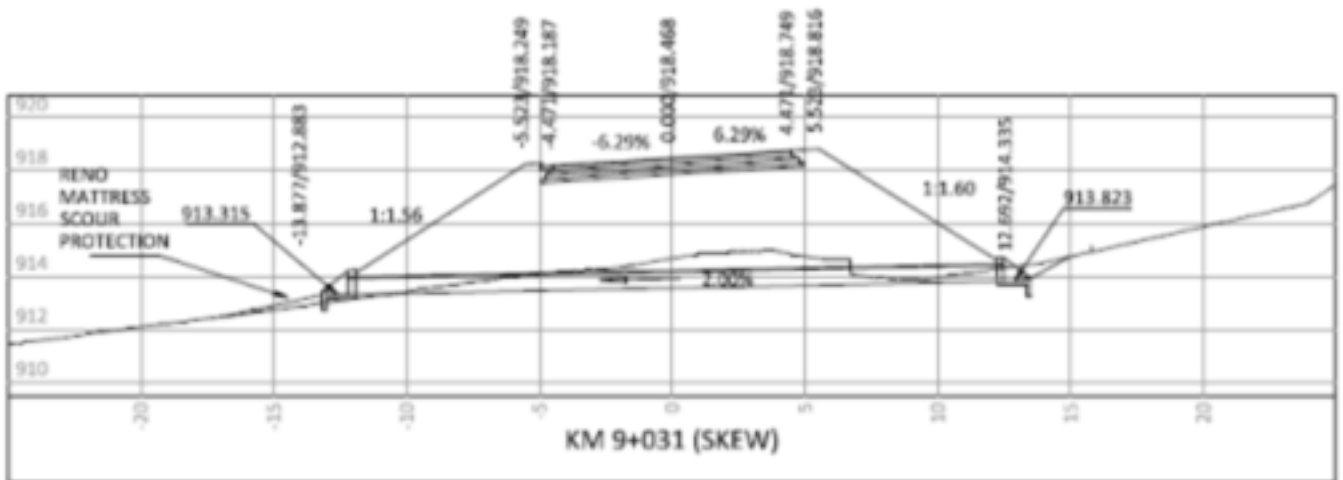
Figure 4: Watercourse Crossing 4 - Detail

**Watercourse Crossing 4** proposed pipe culvert comprises 2 x 900mm Ø x 15m length concrete pipes with headwalls and gabions to suit and reno mattress as scour protection at outlet.

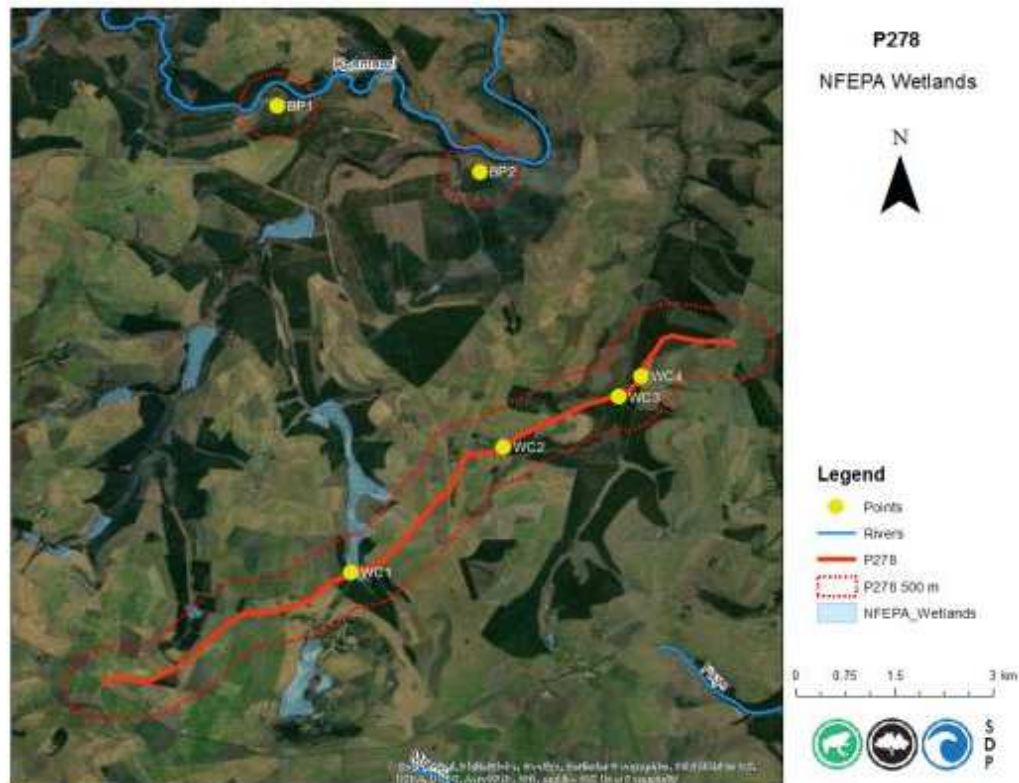
National Freshwater Ecosystem Priority Areas, (NFEPA), and watercourses are present within 500m of the P278 and the watercourse/wetland associated with WC1 has been identified by the NFEPA data. The NFEPA wetland data indicates the presence of channelled valley bottom wetlands and seep wetlands in the vicinity of the project area. The channelled valley bottom wetlands indicated are dams that are located on a channelled/unchannelled valley bottom wetland systems. The seep wetlands near the Noodsberg Sugar Mill are also associated with a dam. No wetland systems are identified by the NFEPA data for WC 2, 3 and 4.

**Figure 5. NFEPA wetlands within the study area.** The watercourse/wetland associated with WC1 has been identified by the NFEPA data. No wetland systems are identified by the NFEPA data for WC 2, 3 and 4. (Wetland & Surface Water Assessment Report, Whitehead, SDP, October 2020)

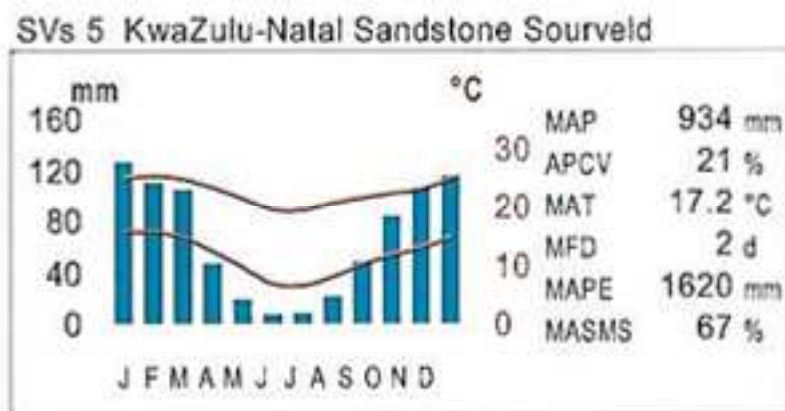
Blue bars - median monthly precipitation.

Upper and lower red lines – mean daily maximum and minimum temperature

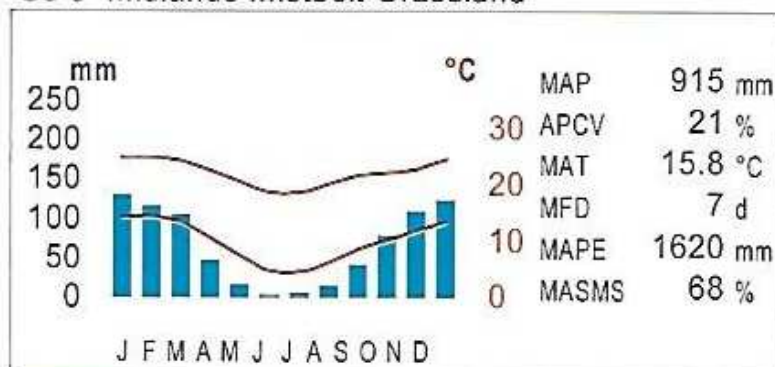
**Gs 9 Midlands Mistbelt Grassland**

Blue bars - median monthly precipitation.

Upper and lower red lines – mean daily maximum and minimum temperature

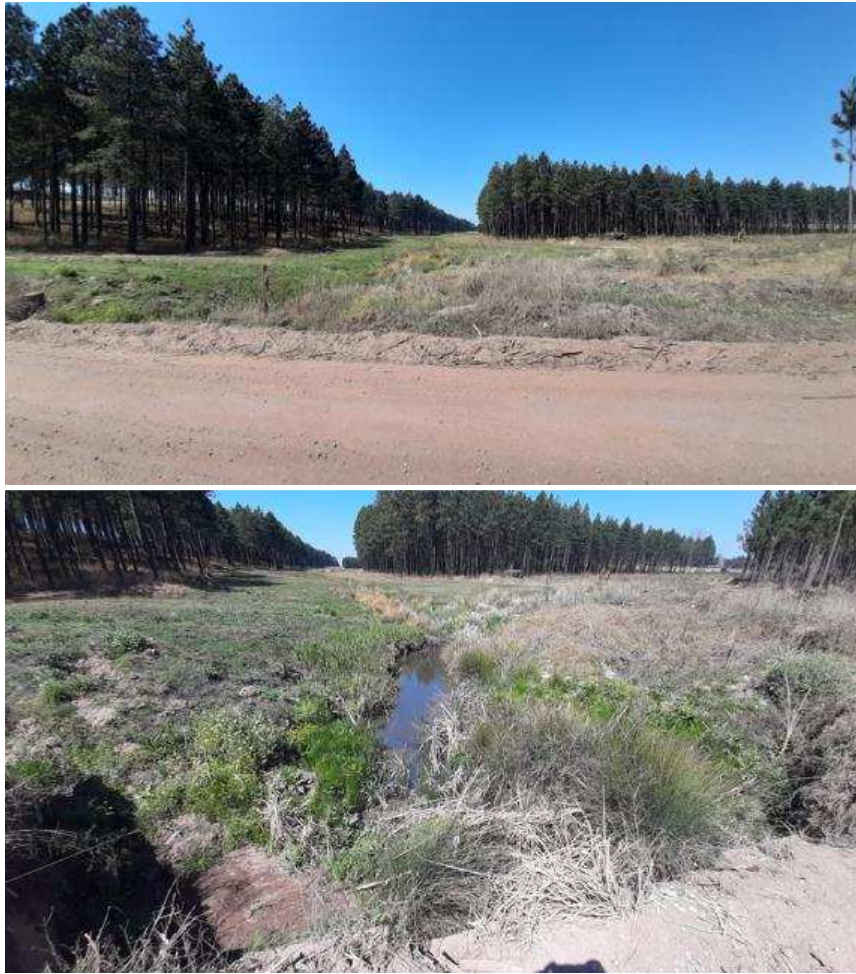
**Figure 9. Top and bottom: The upstream portion of HGM unit 4 and the lower portion of HGM unit 3. Note the distinct channel and open water. Timber (*Pinus patula*) is a dominant land use within the catchment of HGM unit 4. (Wetland & Surface Water Assessment Report, Whitehead, SDP, October 2020)**

There are two HGM units present at WC 1 – HGM units 3 and 4. HGM units 3 and 4 are both channelled valley bottom wetland units, (Figure 9 overleaf). HGM unit 4 is split by the P278, while HGM unit 3 joins HGM 4 close to the P278. The channels of each unit are well defined. The channel associated with HGM unit 3 supports seasonal flow, while that associated with the lower portion of HGM unit 4 holds surface water permanently, (flow may not necessarily be present). During the site visit, the channels of both units were waterlogged, (Figure 10 overleaf). Hygrophilous vegetation is well established in the channel area of HGM unit 4. *Cyperus latifolius*, *Typha capensis*, *Juncus effusus* and *Phragmites australis* are dominant. The outer extent of both HGM units is consistent with temporary wetland conditions. Hygrophilous vegetation is limited to depressions (*Juncus effusus*) while the remainder of the area, (where not under plantation), supports facultative plant species. These include *Trifolium repens* (exotic), *Plantago lanceolata* (exotic), *Chenopodium album* (exotic), *Erucastrum austroafricanum*, *Cyperus esculentus* and *Paspalum urvillei*. The channel of HGM unit 3 supports clusters of *J. effusus* and *Zantedeschia aethiopica*. The outer temporary zone was under plantation. Due to the past shading, the vegetation cover is sparse and has not fully recovered. The upper extent of HGM unit 3 is not affected by plantation and vegetation cover within the outer temporary zone is dense. Invasion by *Rubus cuneifolius* is present and an informal road crossing separates the upper and lower portions of the unit, (Figure 11 overleaf).

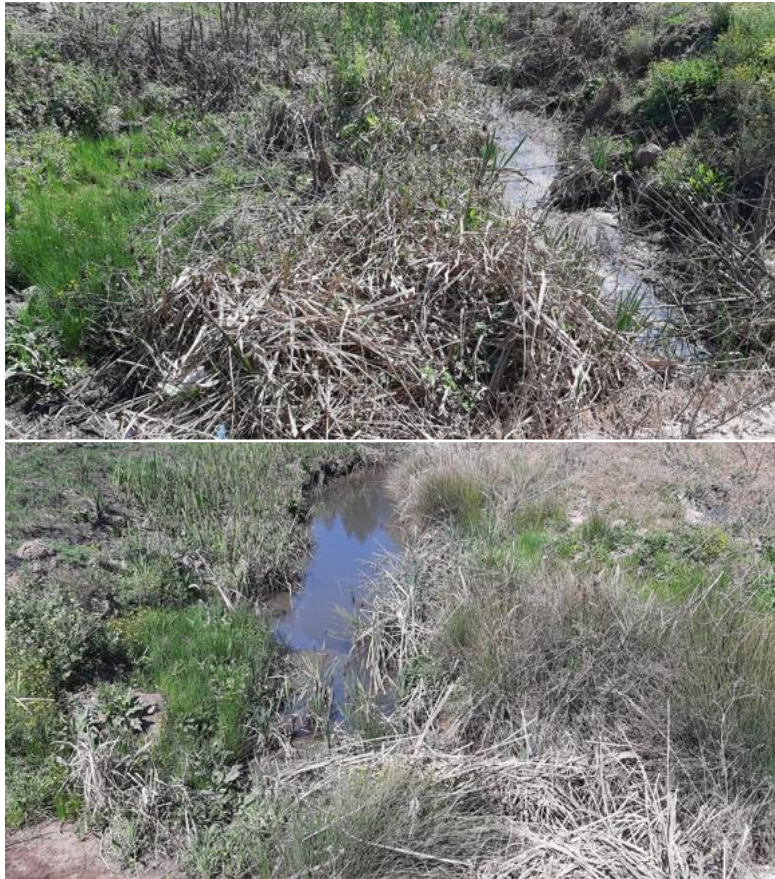
**Figure 10. Top: Hygrophilous vegetation associated with the channel area of HGM unit 4 immediately downstream of the existing crossing.**

**Bottom: Hygrophilous vegetation associated with the channel upstream of the existing crossing.**

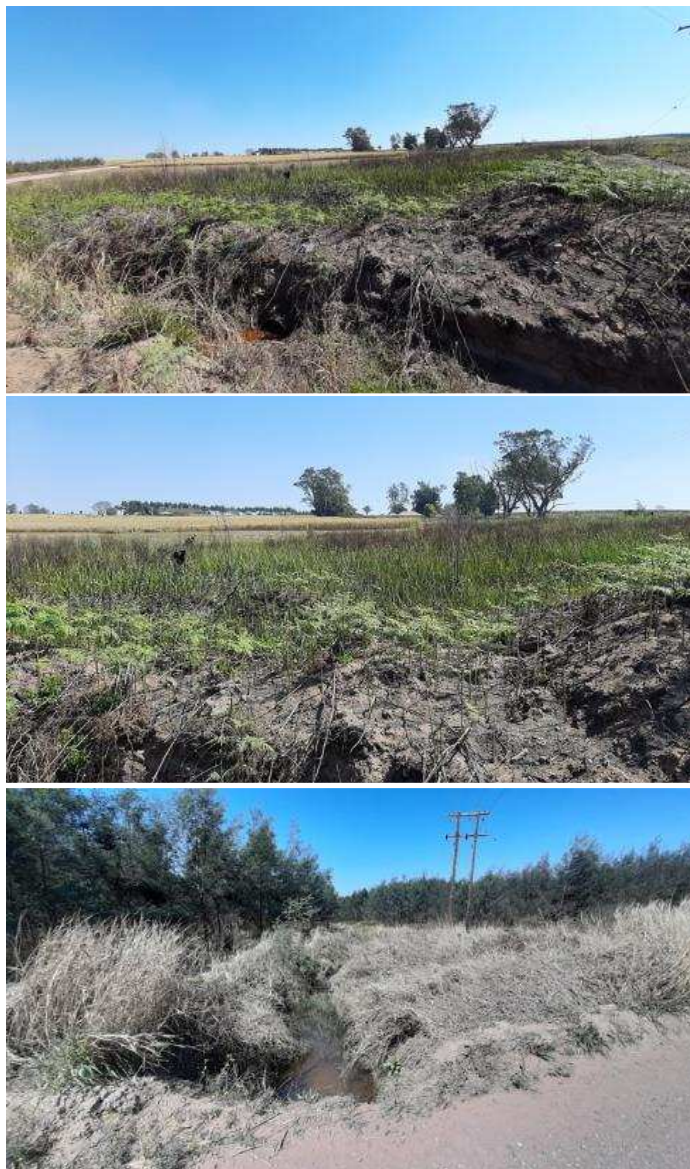
**Figure 12. Top: HGM unit 5 upstream of the crossing at WC 2. Middle: The vegetation present in HGM unit 5 – *Cyperus latifolius* and *Pteridium aquilinum*. Bottom: The nature of WC 2 downstream of the crossing. Note the *A. mearnsii* plantation and narrow, trench like channel. (Wetland & Surface Water Assessment Report, Whitehead, SDP, October 2020)**

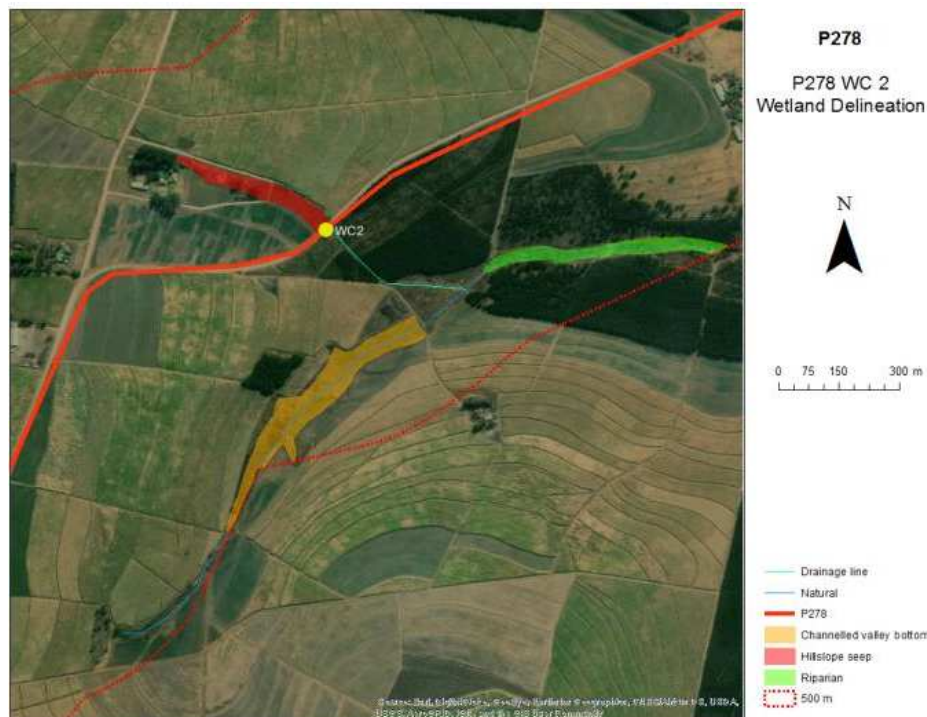
**Figure 13. The nature and extent of the wetland units in the vicinity of WC 2. HGM unit 5 is located immediately upstream of the P278. HGM unit 6 is the unaffected channel valley bottom wetland visible to the south. (Wetland & Surface Water Assessment Report, Whitehead, SDP, October 2020)**

The drainage channel downstream of the P278 crossing follows a formal path, as is clearly evident in Figure 13 overleaf. It appears as if the alteration was made to facilitate the establishment of the adjacent *Acacia mearnsii* plantations. This wetland and drainage line system feed into the upper Mtizane River, which drains towards the P278 (WC 3).

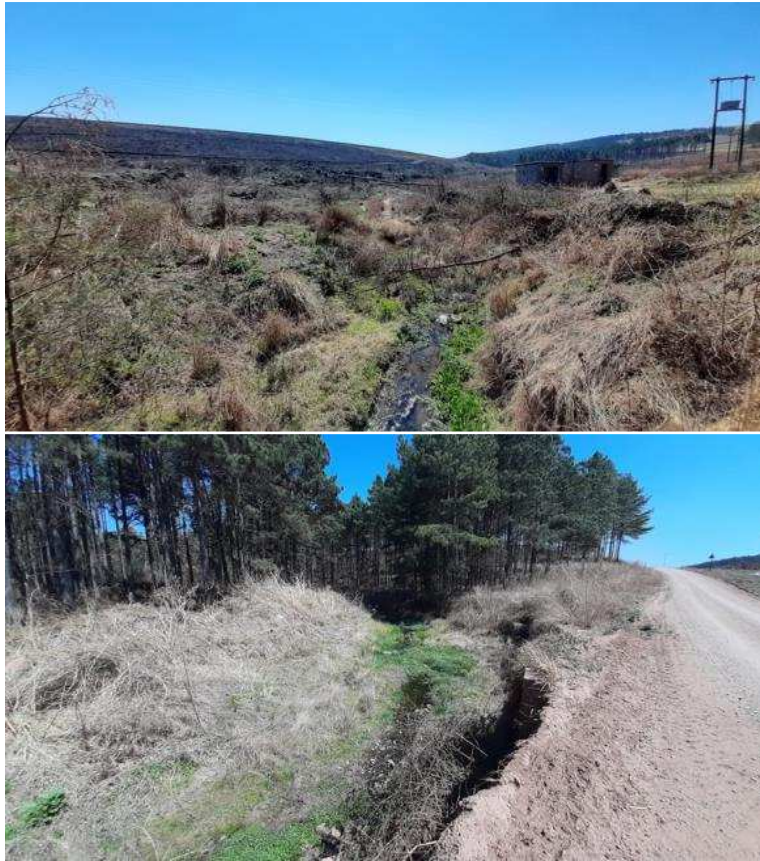
**Figure 14. Top: The nature of the riparian habitat downstream of the WC 4 crossing. The vegetation has been disturbed by recent agricultural activities and burning. Bottom: The nature of the active channel and riparian habitat upstream of the WC 4 crossing. The active channel is incised and *P. patula* plantation is present adjacent to the channel. (Wetland & Surface Water Assessment Report, Whitehead, SDP, October 2020)**

At WC 3, the P278 crosses the Mtizane River, a perennial stream, (channel width <2m, Figure 14). The channel is incised and a clear macro bank is present. The vegetation present is riparian in nature, although large portions of the riparian zone has been transformed to timber. Downstream of the crossing, the riparian zone and remaining terrestrial vegetation had been burned. Remaining riparian vegetation consists of tall grasses and exotic invasion. *Rubus cuneifolius* is prominent downstream of the crossing. New growth of *Anredera cordifolia* was observed during the site visit. Marginal vegetation is short and consists of herbs such as *Plantago lanceolata*, sedges such as *Juncus effusus* and grasses such as *Paspalum urvillei*. Downstream of the crossing, a broad alluvial terrace along the eastern bank is present (Figure 15). This has been ploughed and no natural vegetation remains. Germination of *Cyperus esculenta* was apparent.

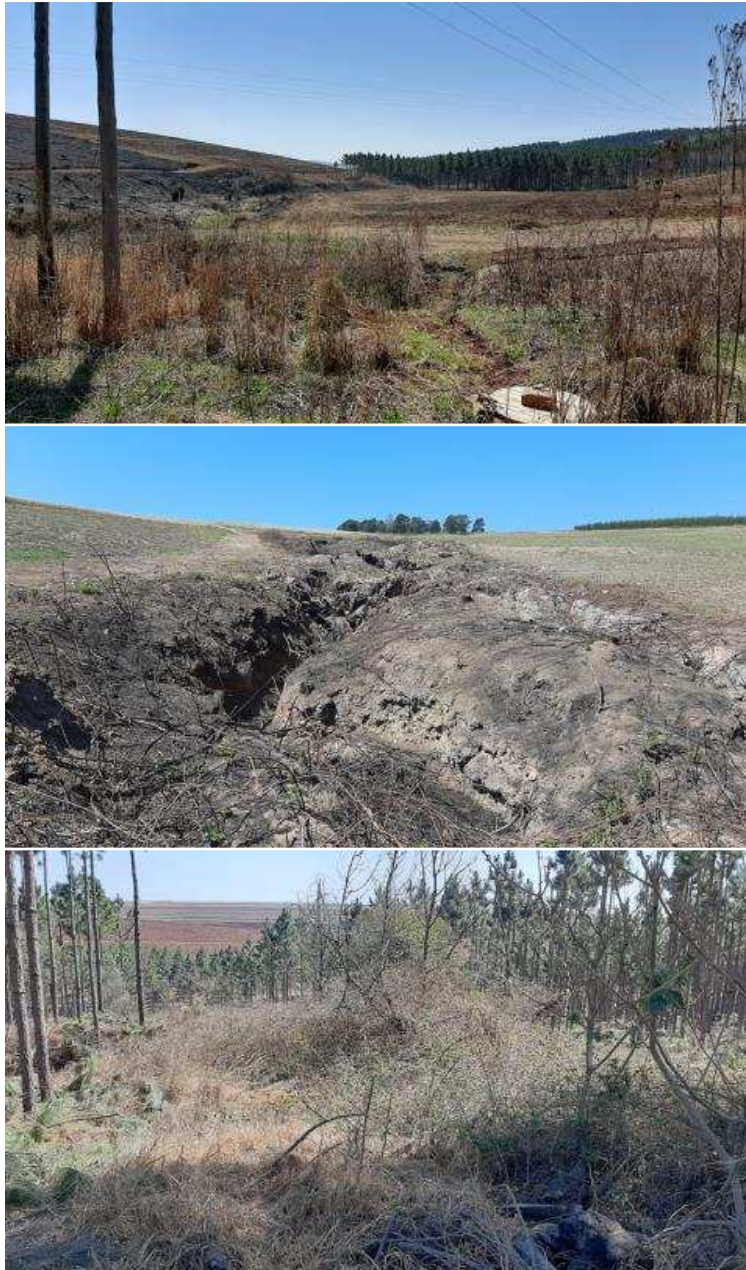
**Figure 15. Top: A broad alluvial floodplain is present downstream of the WC 4 crossing. The floodplain has been transformed by agriculture.**

**Middle: The upper portion of WC 4. No riparian vegetation is present due to clearing and burning. This is assumed to have occurred during the harvesting of the adjacent sugar cane.**

The watercourse at WC 4 is a drainage line that has been substantially affected by agricultural activities and exotic invasion (Figure 15). The upper portion has been completely cleared and burned and the regrowth of *R. cuneifolius* was observed. *Acacia mearnsii* stumps were observed. The channel area is incised and flow is ephemeral. The lower section, within the plantation area, is choked with *R. cuneifolius*, with the occasional *Solanum mauritianum*.

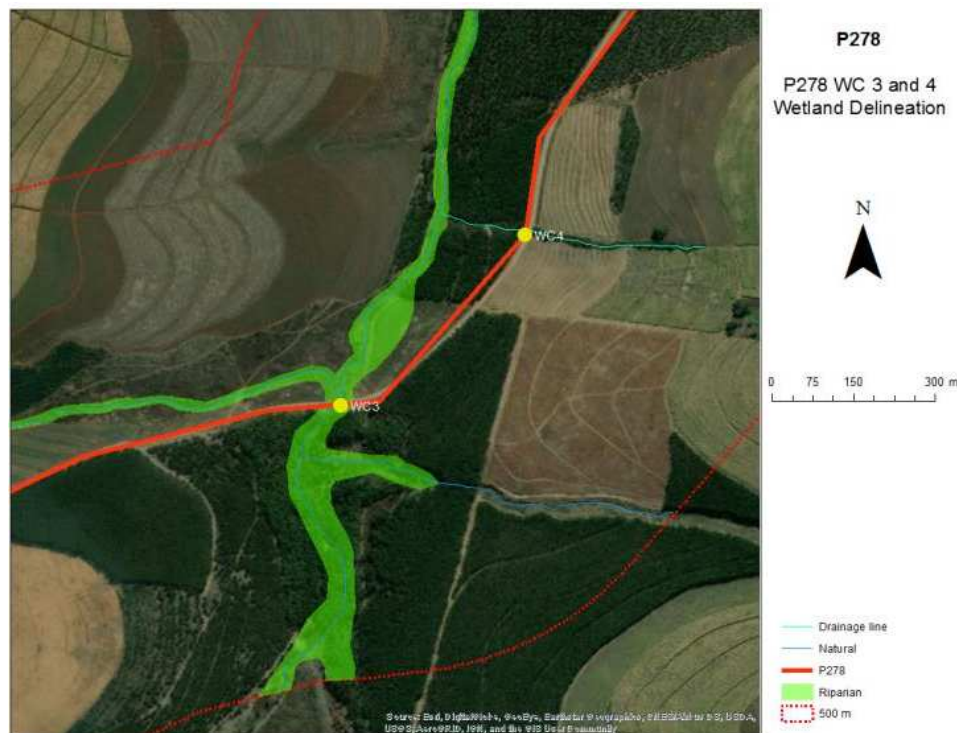
**Figure 16. The extent of the riparian habitat associated with the Mtizane River at WC 3 and the drainage line at WC 4.**  
(Wetland & Surface Water Assessment Report, Whitehead, SDP, October 2020)

The extent of the riparian habitat associated with the WC 3 and 4 crossings is shown in Figure 16 overleaf.

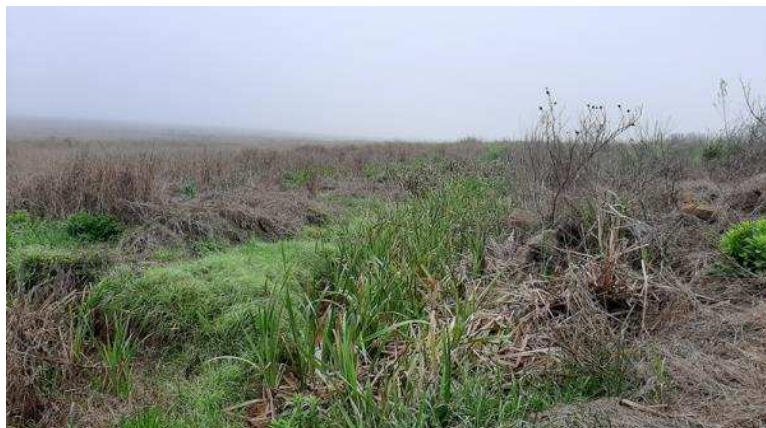
**Figure 17. HGM unit 1. *Cyperus latifolius* is visible within a channel, while the surrounding seasonal and temporary wetland portions support dense *P. urvillei* and *P. clandestinum* cover.**  
(Wetland & Surface Water Assessment Report, Whitehead, SDP, October 2020)
