Report on a Geohydrological Investigation General Waste (Witkoppies) Landfill Site, ESKOM Majuba Power Station

Project Title: Geohydrological Investigation - Majuba General Waste Landfill Site, ESKOM Majuba Power Station

Engeolab Reference: LL3821

Date: June 2022

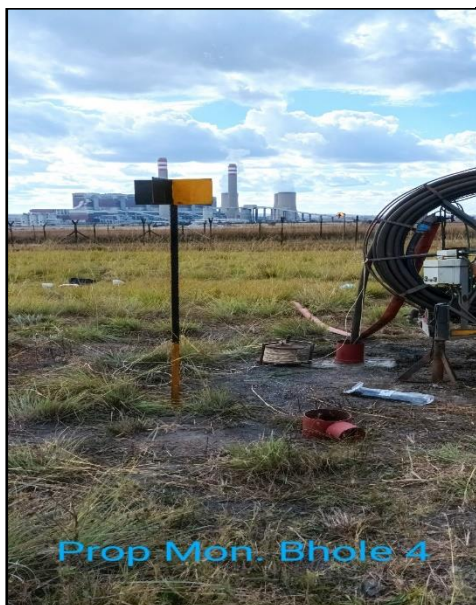
PLATE 3

Using a submersible pump capable of pumping small volumes of water, the yields of the boreholes BH2, BH3 and BH4 were tested – refer to Plate 3.

The yield tests were carried out in accordance with SANS 10299-4:2003: PART 4 – Test-pumping of Water Boreholes. The data was captured and analysed using Theiss and Cooper methods. Copies of the field test data and analyses are attached as Appendix B and for convenience, a summary of the results is presented by Table 4.3.1.

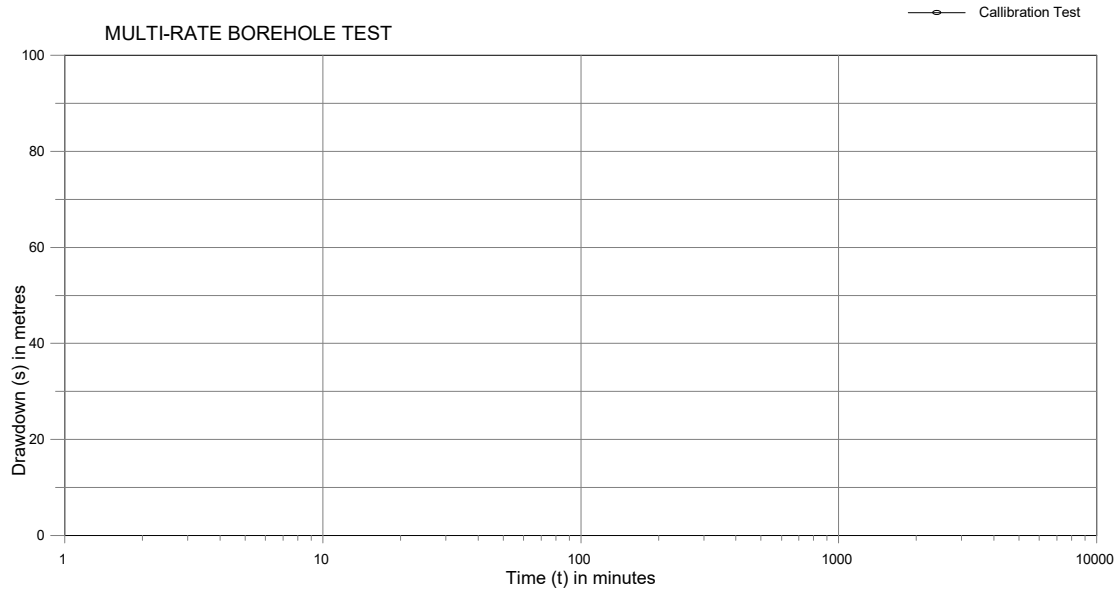
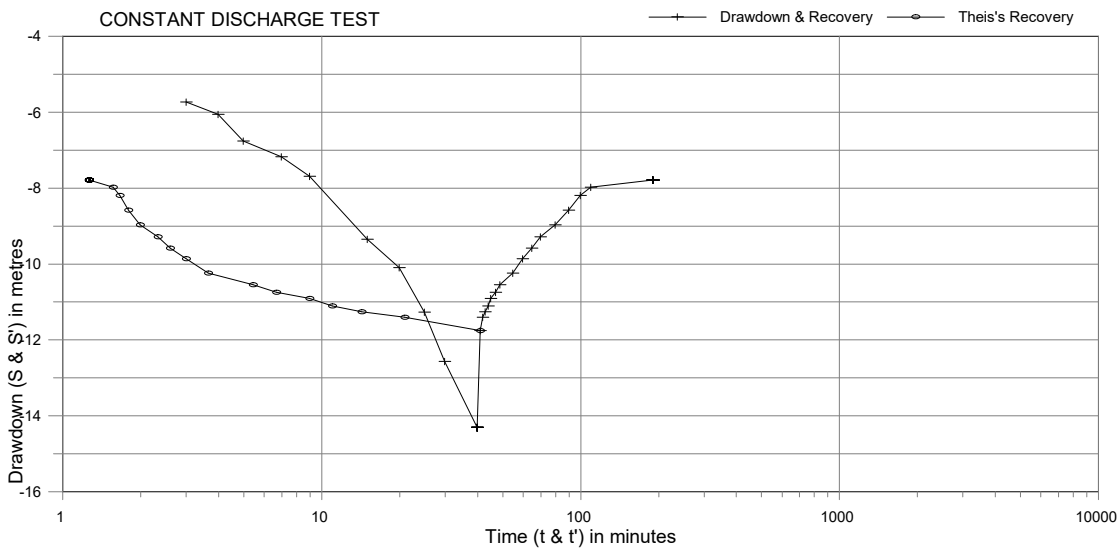
TOTAL TIME PUMPED (min)		t' = total time since pumping started.
AVERAGE YIELD (l/s):	0,08	t" = time since pumping stopped.

REGION :		BOREHOLE NO :	BH 02	MAP REFERENCE :		
DISTRICT :		DEPTH :	20	LATITUDE :		
SITE NAME :		WATER LEVEL :	3,7	LONGITUDE :		
VILLAGE :		DEPTH OF PUMP :	18	Lo SYSTEM :		
Mahikeng Provincial Hospital						
MULTI-RATE BOREHOLE TEST				DATE TESTED : 18/05/2022		
TEST Nr	YIELD (l/s)	DURATION (min)	DRAWDOWN (m)	RECOVERY (min)	RECOVERY (m)	Q/st (l/s/m)
1						
2						
3						
4						
5						
CALIBRATION		0,00/0,00				
CONSTANT-RATE DISCHARGE TEST				DATE TESTED : 18/05/2022		
AVE. YIELD (l/s)	DURATION (min)	DRAWDOWN (m)	RECOVERY (min)	RECOVERY (m)	kD (m ² /day)	S
0,08	40	14,30	150	7,78	0,0	1,00E-03
OBS. HOLE 1						
OBS. HOLE 2						
OBS. HOLE 3

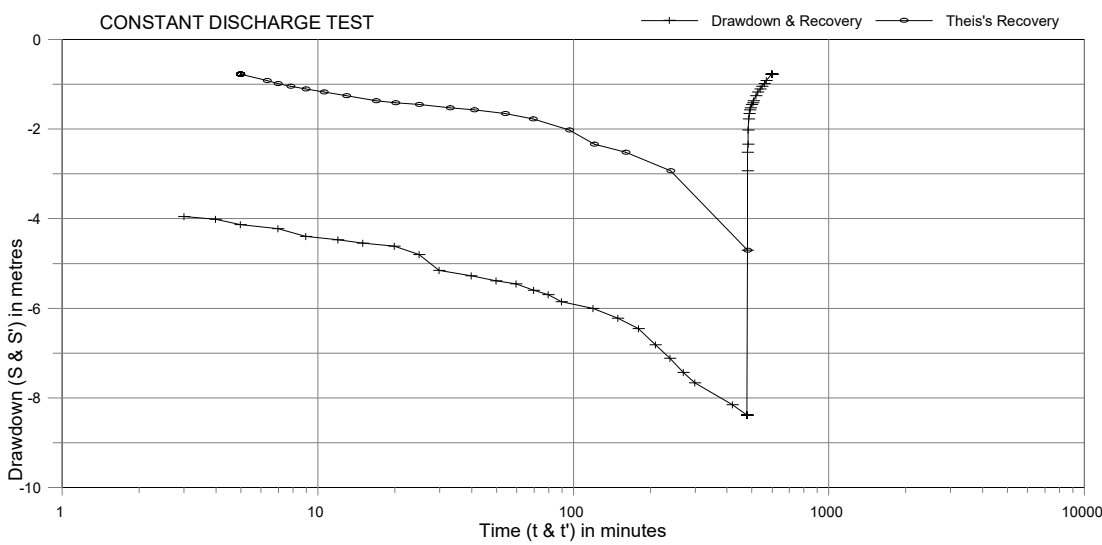
TOTAL TIME PUMPED (min)		t' = total time since pumping started.
AVERAGE YIELD (l/s):	0,20	t" = time since pumping stopped.

REGION :		BOREHOLE NO :	BH 04	MAP REFERENCE :		
DISTRICT :		DEPTH :	20	LATITUDE :		
SITE NAME :		WATER LEVEL :	4,43	LONGITUDE :		
VILLAGE :		DEPTH OF PUMP :	18	Lo SYSTEM :		
Mahikeng Provincial Hospital						
MULTI-RATE BOREHOLE TEST				DATE TESTED : 25/02/2022		
TEST Nr	YIELD (l/s)	DURATION (min)	DRAWDOWN (m)	RECOVERY (min)	RECOVERY (m)	Q/st (l/s/m)
1						
2						
3						
4						
5						
CALIBRATION	0,00/0,00					
CONSTANT-RATE DISCHARGE TEST				DATE TESTED : 26/02/2022		
AVE. YIELD (l/s)	DURATION (min)	DRAWDOWN (m)	RECOVERY (min)	RECOVERY (m)	kD (m ² /day)	S
0,20	480	8,38	120	0,77	2,5	1,00E-03
OBS. HOLE 1						
OBS. HOLE 2						
OBS. HOLE 3

- 1.) A monitoring facility must be installed for this borehole and the waterlevel of the borehole must be measured regularly.
- 2.) The maximum abstraction rate for the borehole is the yield indicated for the 8 hour pumping cycle resting for the remainder of the time (16 hours).
- 3.) It is recommended that the 8 hour pumping cycle be used and the borehole be allowed to recover 16 hours.
- 4.) If the demand is more than 5,7m3/d the borehole can be pumped using the 8hour pump cycle twice a day, resting 4 hours between cycles.
- 5.) Do not over pump initially!!
- 6.) Water quality monitoring should take place to ensure good water quality.

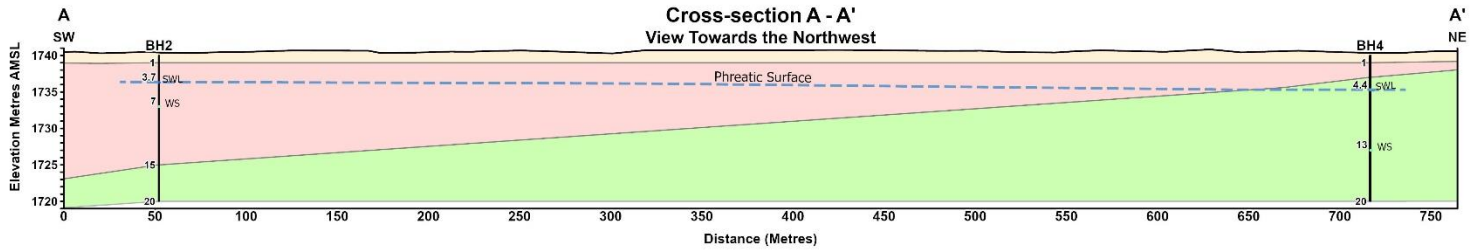
- Colluvium
- Dolerite
- Carbonaceous Shale

Vertical Exaggeration 4X
