Report on a Geohydrological Investigation General Waste (Witkoppies) Landfill Site, ESKOM Majuba Power Station

DATE: June 2022

Project Title: Geohydrological Investigation - Majuba General Waste Landfill Site, ESKOM Majuba Power Station

Engeolab Reference: LL3821

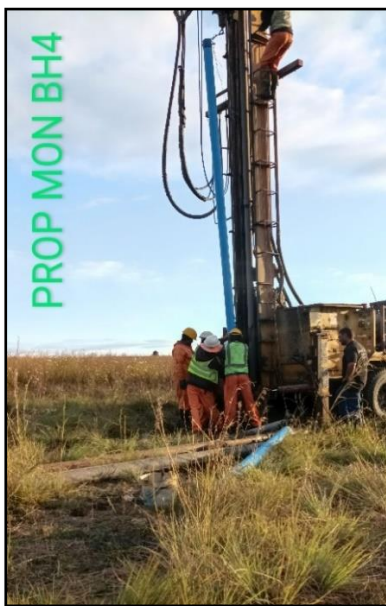
PLATE 1

The three 165mm diameter monitor boreholes were drilled using the rotary air flush percussion drilling method. Each borehole was drilled to 20m with the top 6m of the boreholes reamed to 219mm and subsequently sleeved from surface to 6m depth with solid mild steel casing – refer to Plate 1 below and Appendix A – Borehole Profiles. To ensure the long term serviceability of the boreholes, 140mm diameter uPVC casing was installed from surface to the end of the hole (with the lower 3m perforated) and the borehole annulus backfilled with graded filter sand. A lockable lid was welded onto the steel casing and a concrete collar was cast around the casing. To ensure that the borehole position is visible, a 2,5m high yellow and black steel marker was installed as close as possible to the borehole - refer to Plate 2 below. The master key of the lockable borehole lids was handed over to ESKOM’s Environmental Manager at Majuba Power Station.

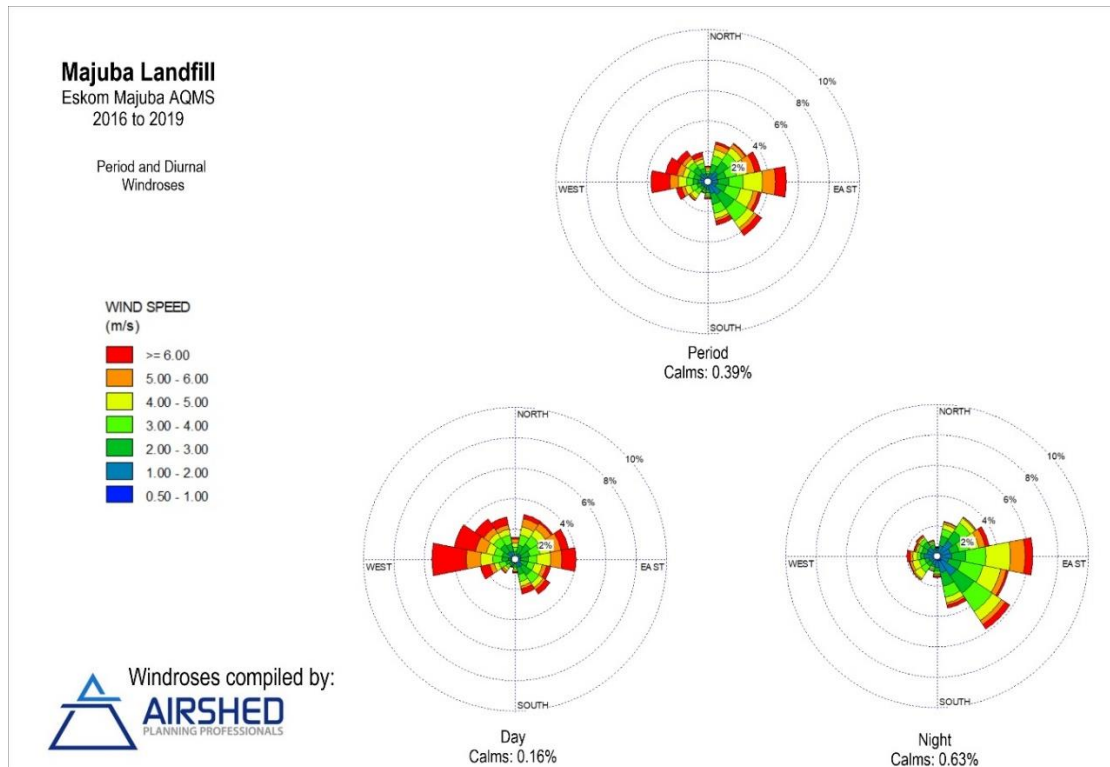
FIGURE 8.2.1: PERIOD & DIURNAL WIND ROSES FOR THE ESKOM MAJUBA AQMS, 2016 - 2019

The wind field for the study area is described with the use of wind roses. Wind roses comprise 16 spokes which represent the directions from which winds blew during the period. The period and diurnal for the Eskom Majuba AQMS for the period 2016 to 2019 are shown in Figure 8.2.1. The colours reflect the different categories of wind speeds; the yellow area for example, representing winds of 4 m/s to 5 m/s. The dotted circles provide information regarding the frequency of occurrence of wind speed and direction categories. The figure given for calm conditions represents the frequency with which the calms occurred, i.e. periods during which the wind speed was below 0.5 m/s.

During the day the wind is predominantly from the west, with a secondary component from the east, with fairly strong wind speeds and little calms. During the night the wind field shifts to be mainly from the east and southeast. The wind is generally stronger during the day with more frequent calms during the night.

It must be taken into account that the area is rather wind-swept (see Chapter 8.2) and although there are calm tendencies during the night, there are no structures on site or in close proximity to which the gas can migrate to where it could accumulate and represent an explosion hazard. Typical methane gas migration paths such as through porous rock – which do not occur on site as the sediments and intrusive dolerite are solid and the absence of subsurface services which may create paths make gas migration highly unlikely.

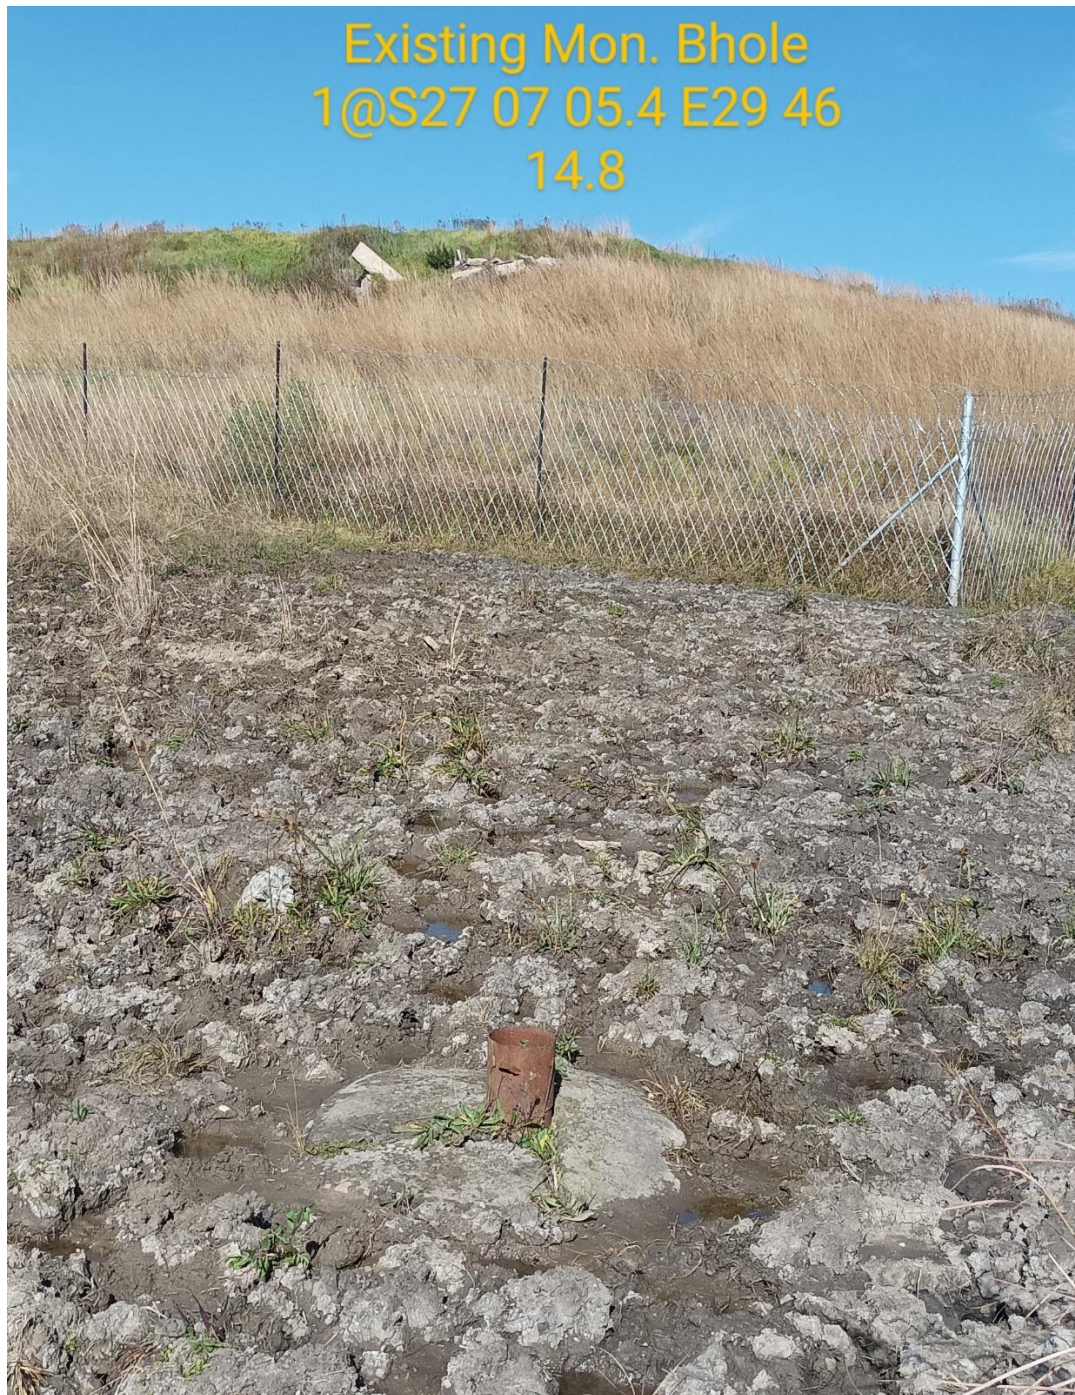
EXISTING MON BOREHOLE - BH1

CLIENT:	Savannah Environmental	PROJECT NAME:	ESKOM MAJUBA PS LFS
PROJECT REF:	LL3821	HOLE No.	Existing Mon Borehole - BH1
X-COORD:	S 27 07'5.41"	Y-COORD:	E 029 46'14.80"

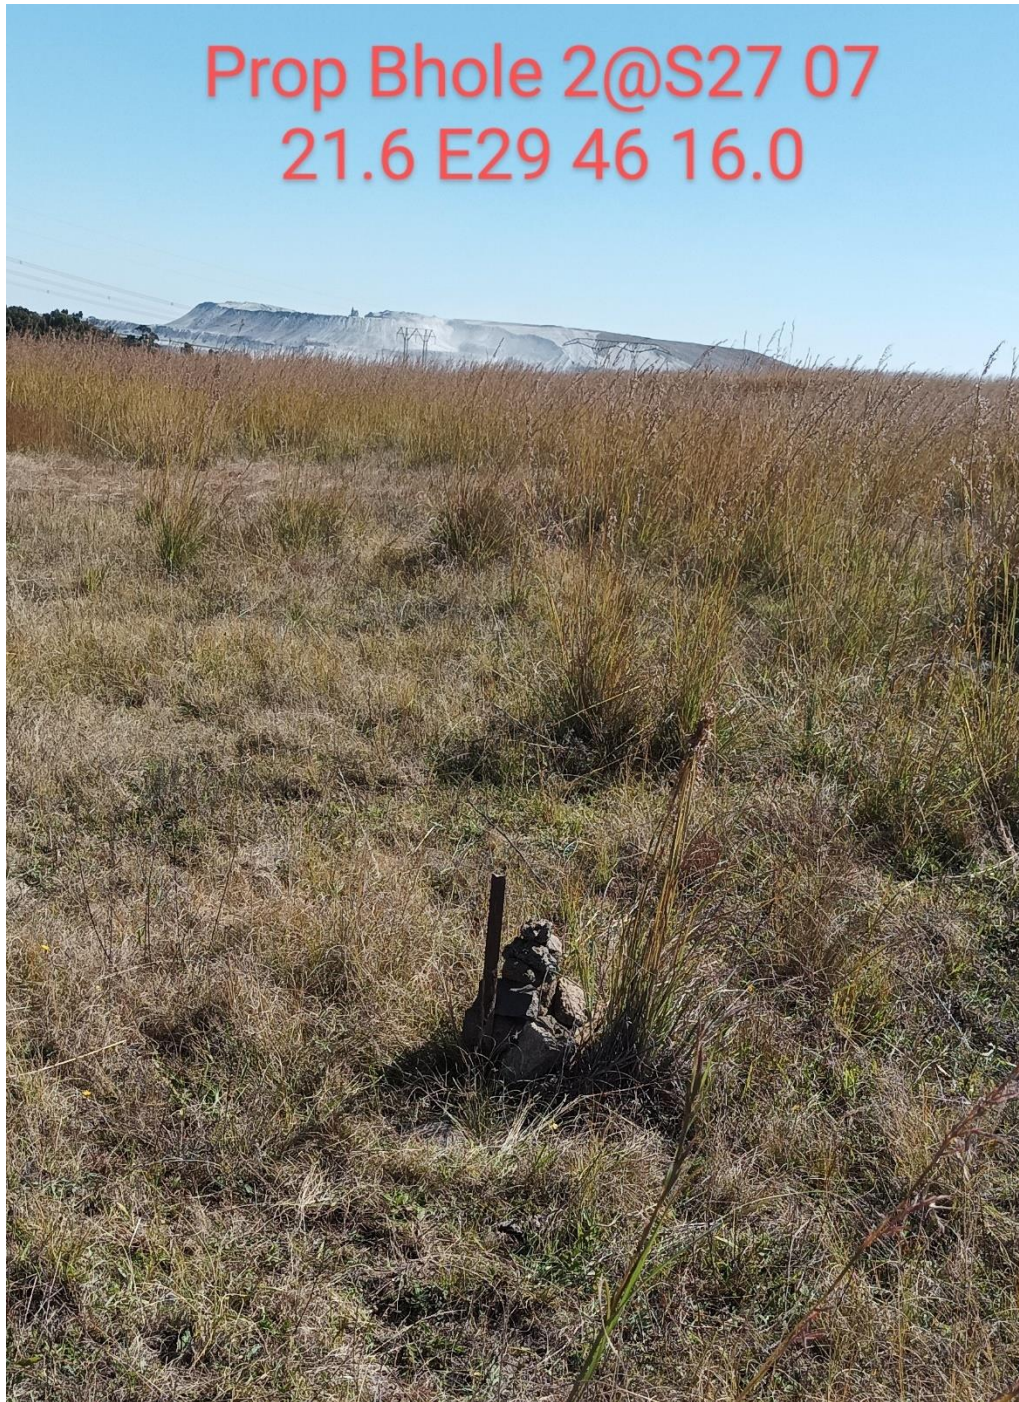
PROP MON BOREHOLE - BH2

CLIENT:	Savannah Environmental	PROJECT NAME:	ESKOM MAJUBA PS LFS
PROJECT REF:	LL38121	HOLE No.	Prop Mon Borehole - BH2
X-COORD:	S 27 07' 21.6"	Y-COORD:	E 029 46' 16.0"

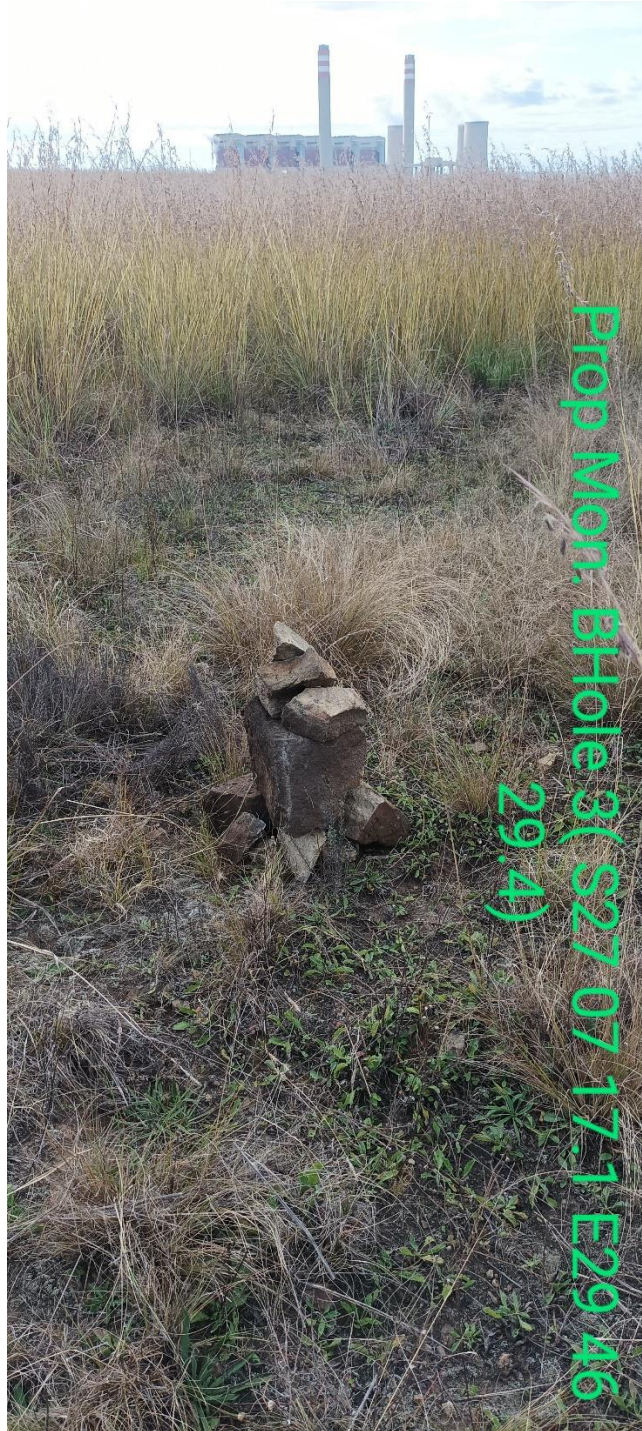
PROP MON BOREHOLE - BH3

CLIENT:	Savannah Environmental	PROJECT NAME:	ESKOM MAJUBA PS LFS
PROJECT REF:	LL38121	HOLE No.	Prop Mon Borehole - BH3
X-COORD:	S 27 07' 17.1"	Y-COORD:	E 029 46' 29.4"

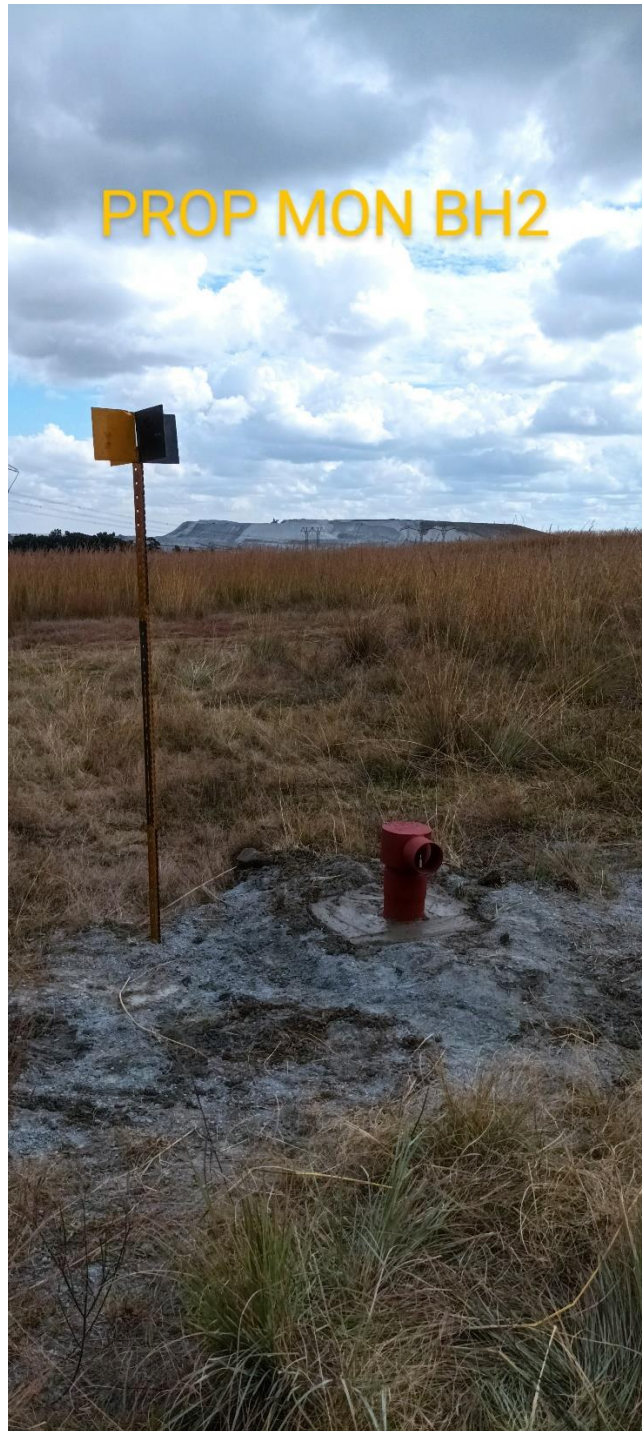
BOREHOLE _ Mon BH2

CLIENT:	Savannah Environmental	PROJECT NAME:	ESKOM MAJUBA PS LFS
PROJECT REF:	LL38121	HOLE No.	Mon BH2
X-COORD:	S 27 07'21.6"	Y-COORD:	E 029 46'16.0"

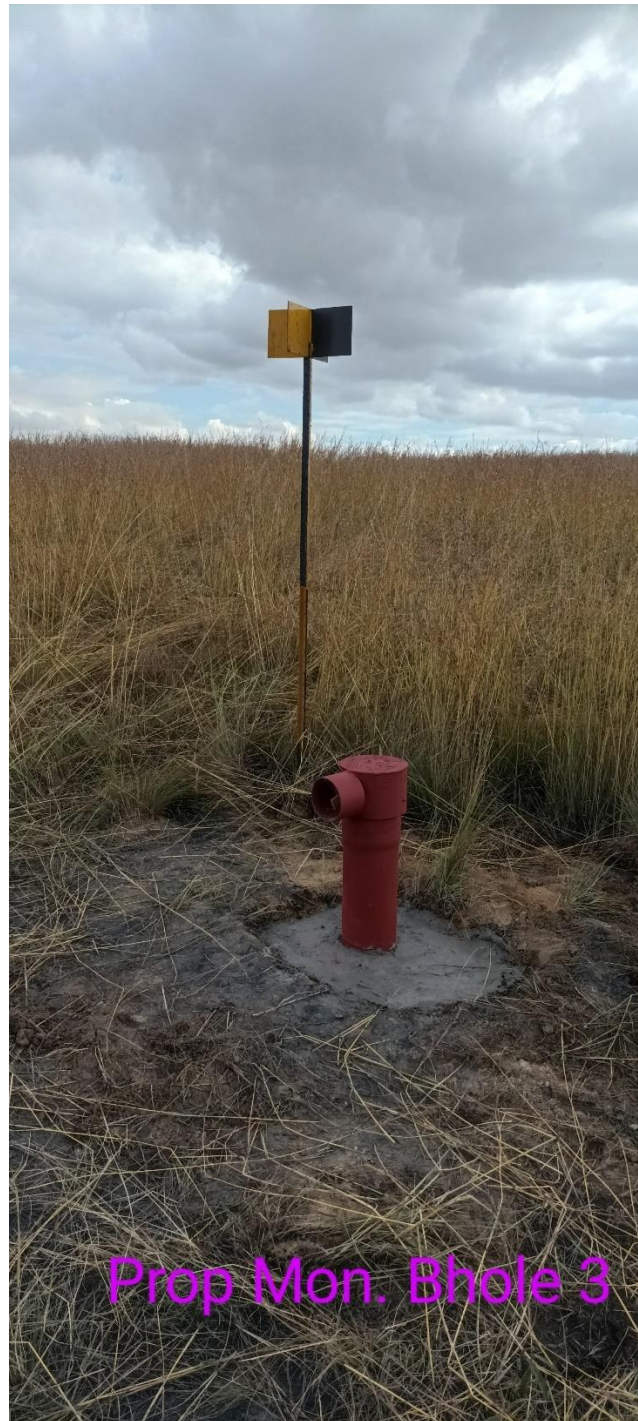
BOREHOLE _ Mon BH3

CLIENT:	Savannah Environmental	PROJECT NAME:	ESKOM MAJUBA PS LFS
PROJECT REF:	LL38121	HOLE No.	Mon BH3
X-COORD:	S 27 07' 13.0"	Y-COORD:	E 029 46' 29.9"

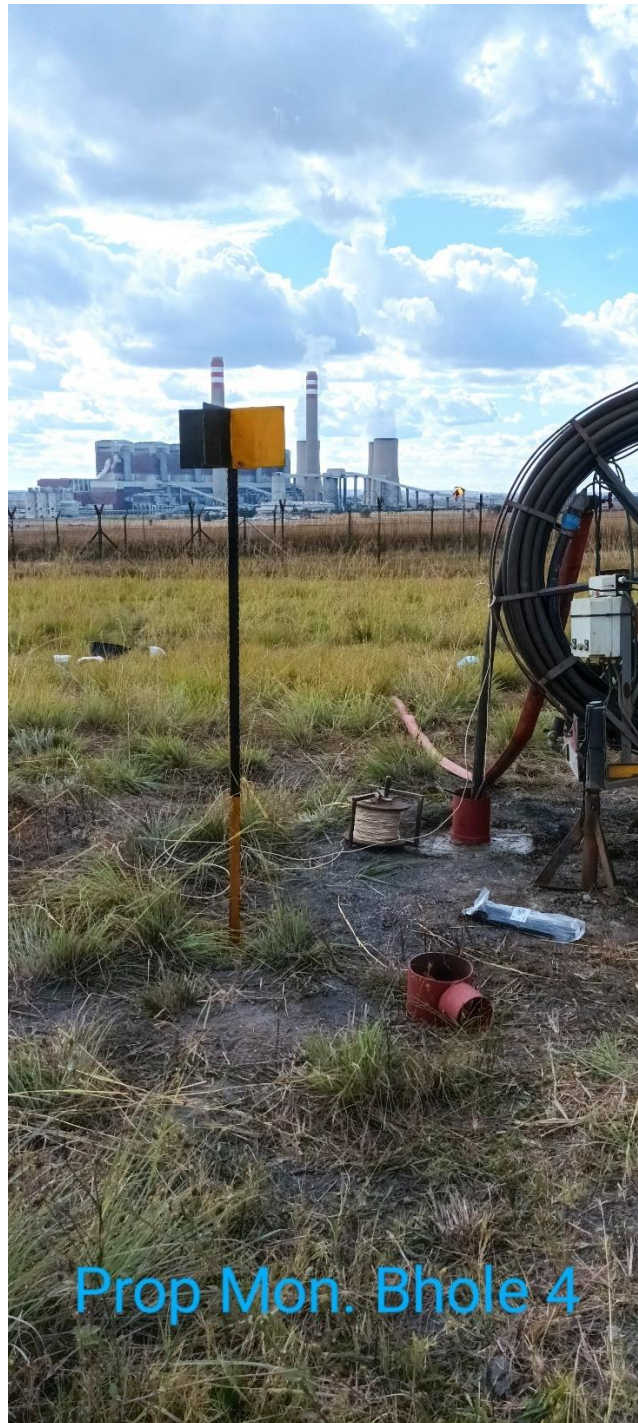
BOREHOLE _ Mon BH4

CLIENT:	Savannah Environmental	PROJECT NAME:	ESKOM MAJUBA PS LFS
PROJECT REF:	LL3821	HOLE No.	Mon BH4
X-COORD:	S 27 07' 03.4"	Y-COORD:	E 029 46' 27.5"

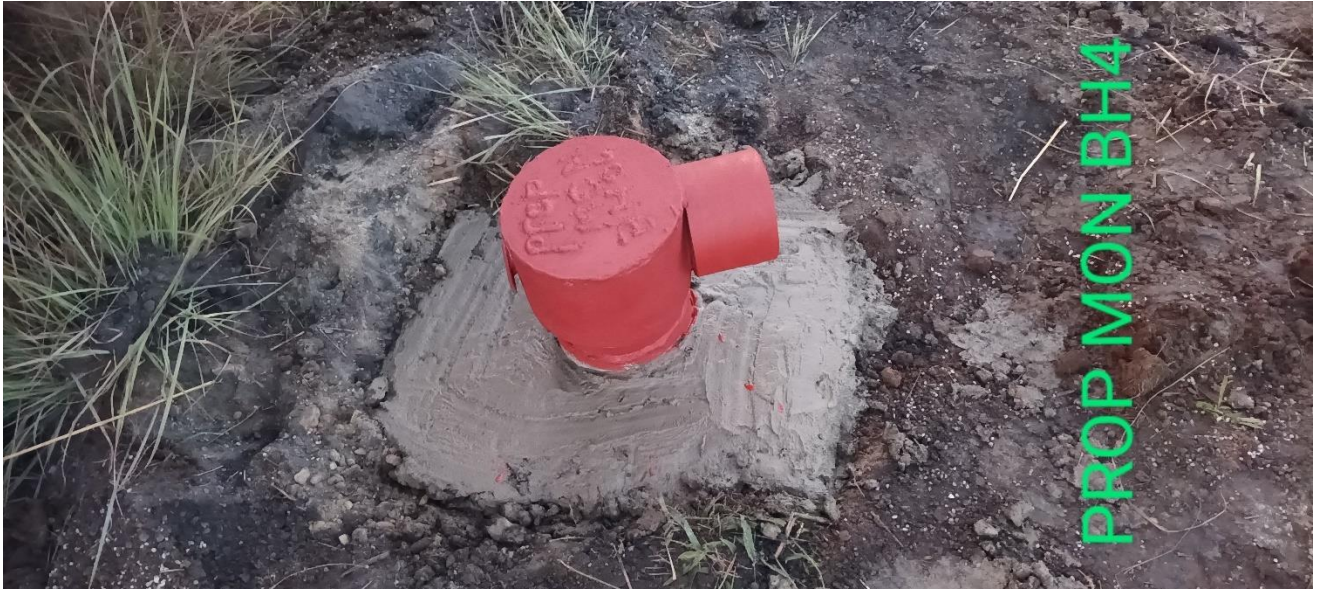
CAPPED BOREHOLE _ Mon BH4

CLIENT:	Savannah Environmental	PROJECT NAME:	ESKOM MAJUBA PS LFS
PROJECT REF:	LL38121	HOLE No.	Mon BH4A
X-COORD:	S 27 07' 03.4"	Y-COORD:	E 029 46' 27.5"
