Geotechnical Investigation Report

Majuba

General Waste Landfill Site,

ESKOM Majuba Power Station

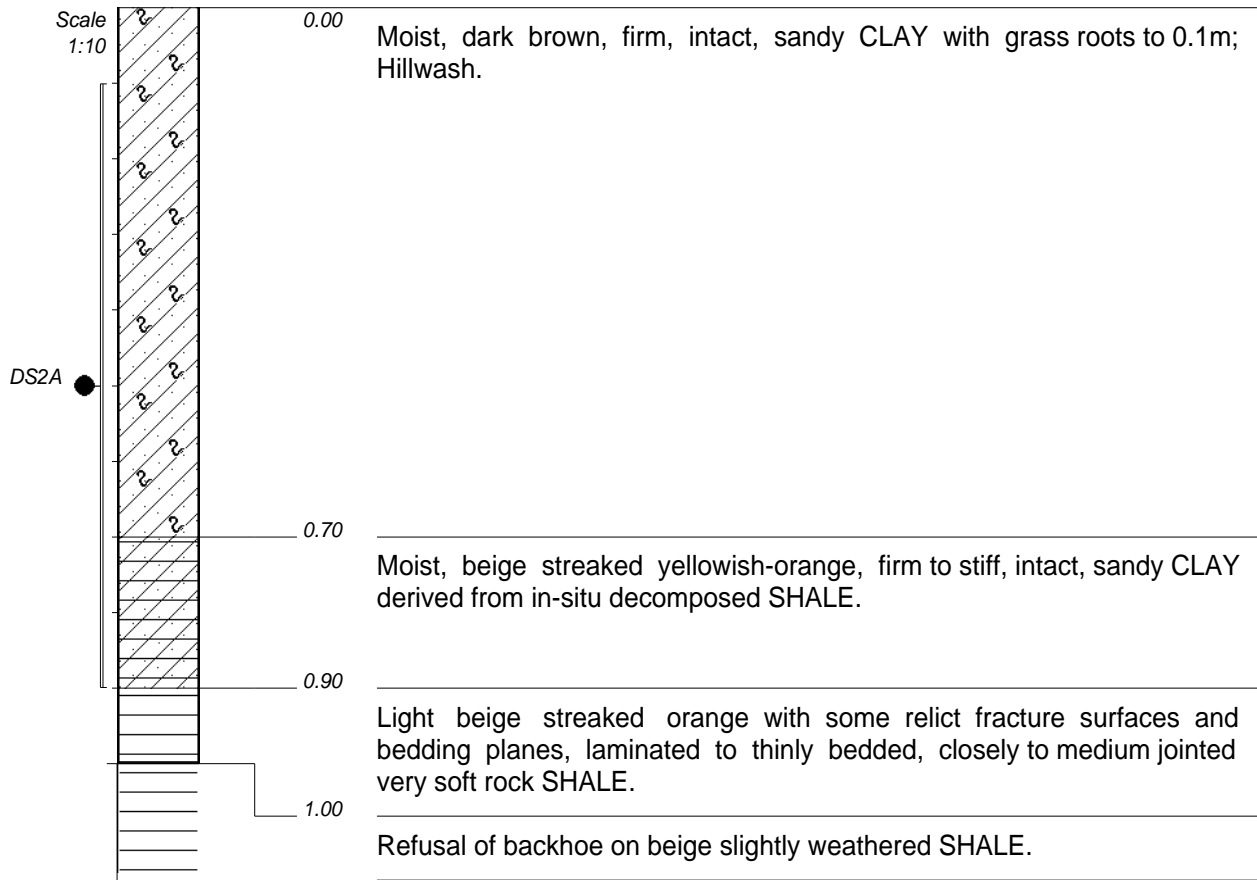
- 1) No seepage
- 2) Sampled as follows: DS2A 0.1m--0.9m

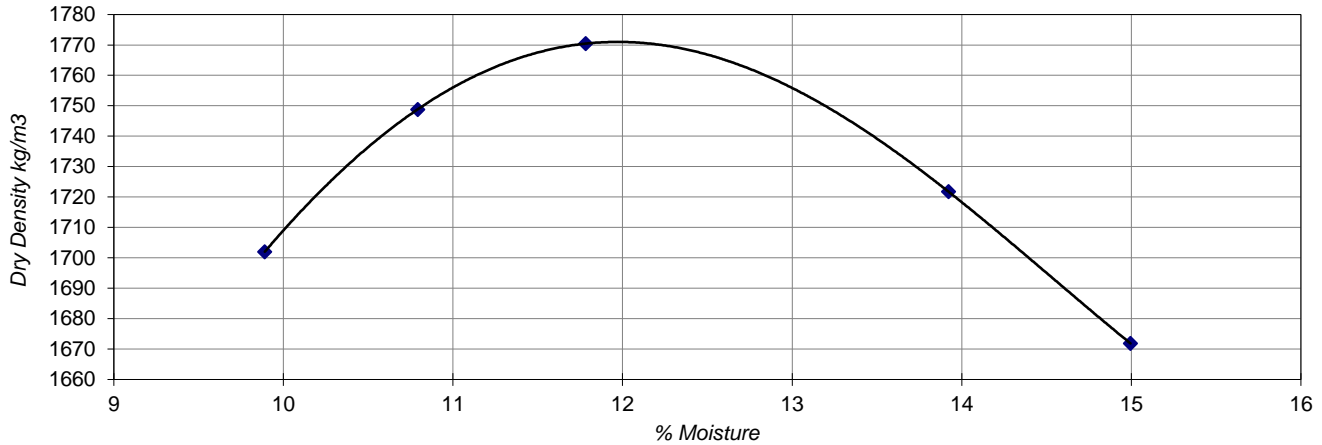
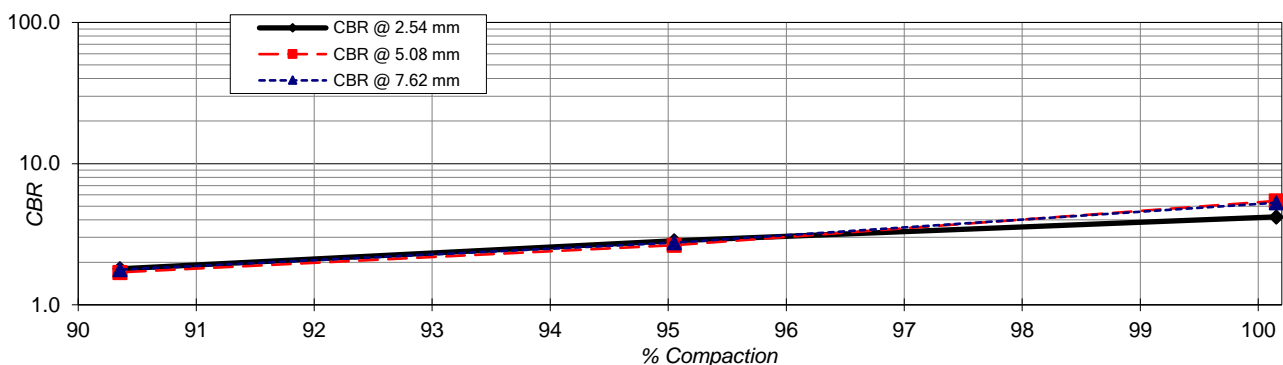
California Bearing Ratio (readings)

Maximum dry density =	1771 kg/m³
Optimum moisture content =	12.0 %

% Compaction	100	98	97	95	93	90
CBR of 13.344 kN	4	4	3	3	2	2
Briquette Info	Mod		N.R.B.		Proc.	
Dry Density (kg/m ³)	1774		1683		1600	
Compaction Moisture (%)	11.8		11.8		11.8	
Compaction (%)	100.2		95.1		90.4	
% Swell	0.94		1.51		2.19

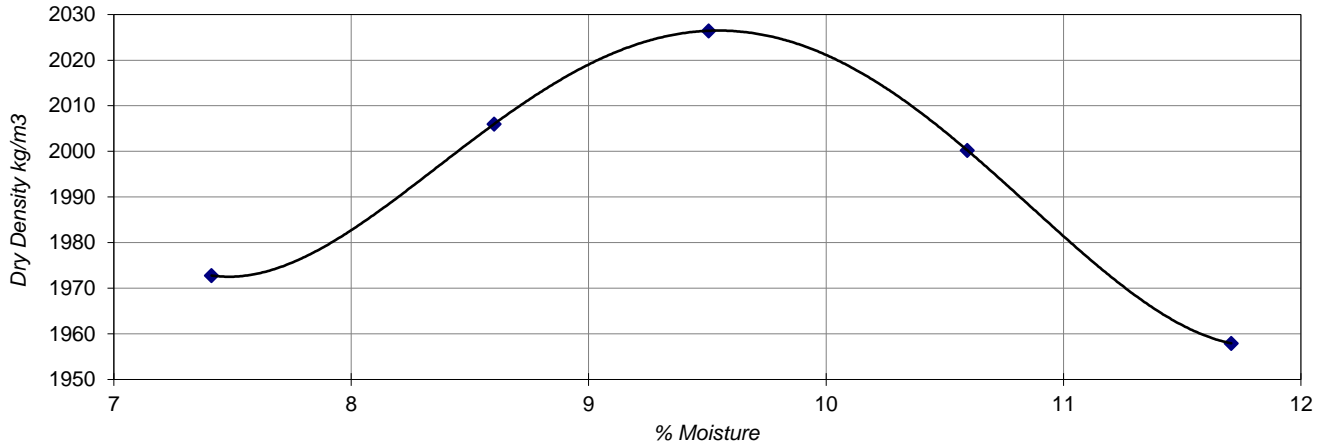
California Bearing Ratio (readings)

Maximum dry density =	2026 kg/m³
Optimum moisture content =	9.5 %

% Compaction	100	98	97	95	93	90
CBR of 13.344 kN	33	25	22	17	12	7
Briquette Info	Mod		N.R.B.		Proc.	
Dry Density (kg/m ³)	2033		1929		1835	
Compaction Moisture (%)	9.5		9.4		9.4	
Compaction (%)	100.3		95.2		90.6	
% Swell	0.38		0.71		1.21

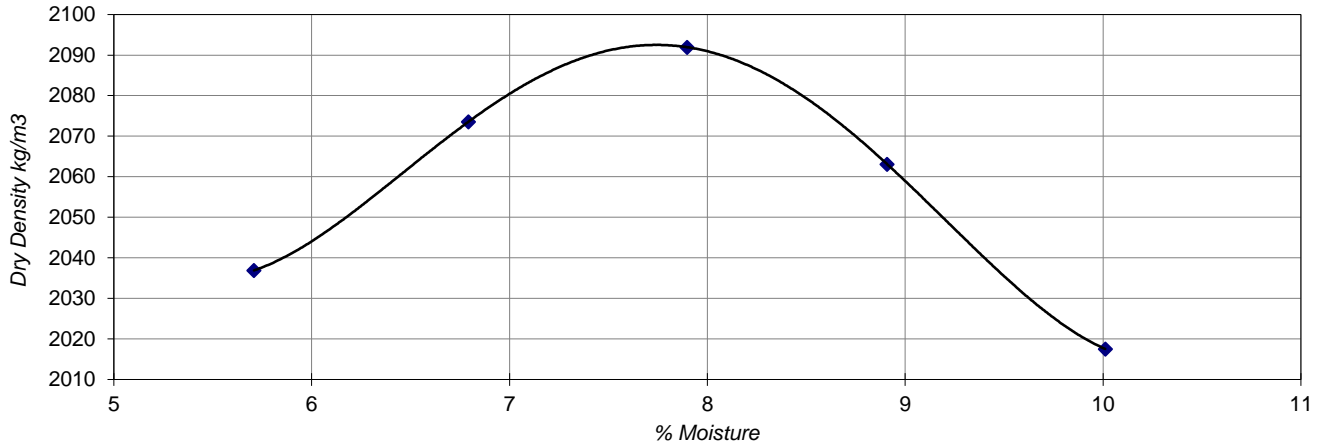
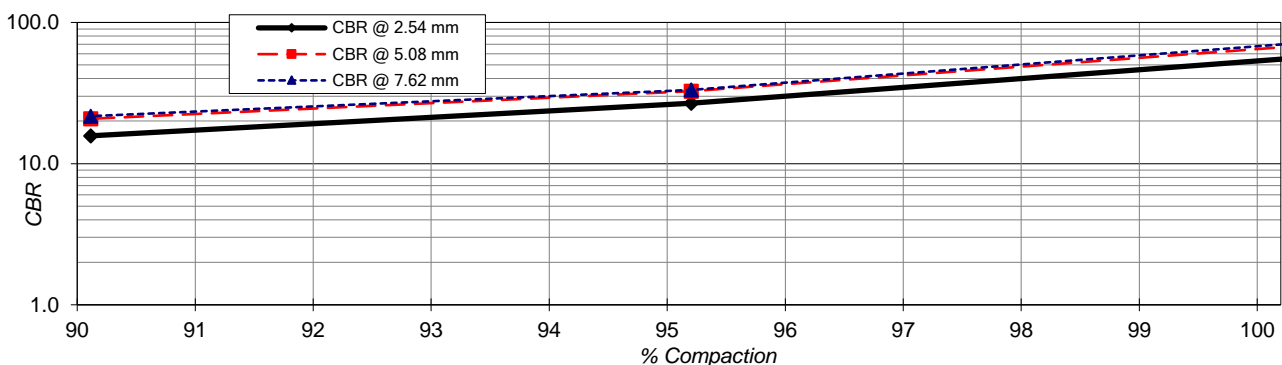
California Bearing Ratio (readings)

Maximum dry density =	2092 kg/m³
Optimum moisture content =	7.8 %

% Compaction	100	98	97	95	93	90
CBR of 13.344 kN	53	40	35	26	21	16
Briquette Info	Mod		N.R.B.		Proc.	
Dry Density (kg/m ³)	2100		1992		1885	
Compaction Moisture (%)	7.9		8.0		8.0	
Compaction (%)	100.4		95.2		90.1	
% Swell	0.19		0.33		0.63

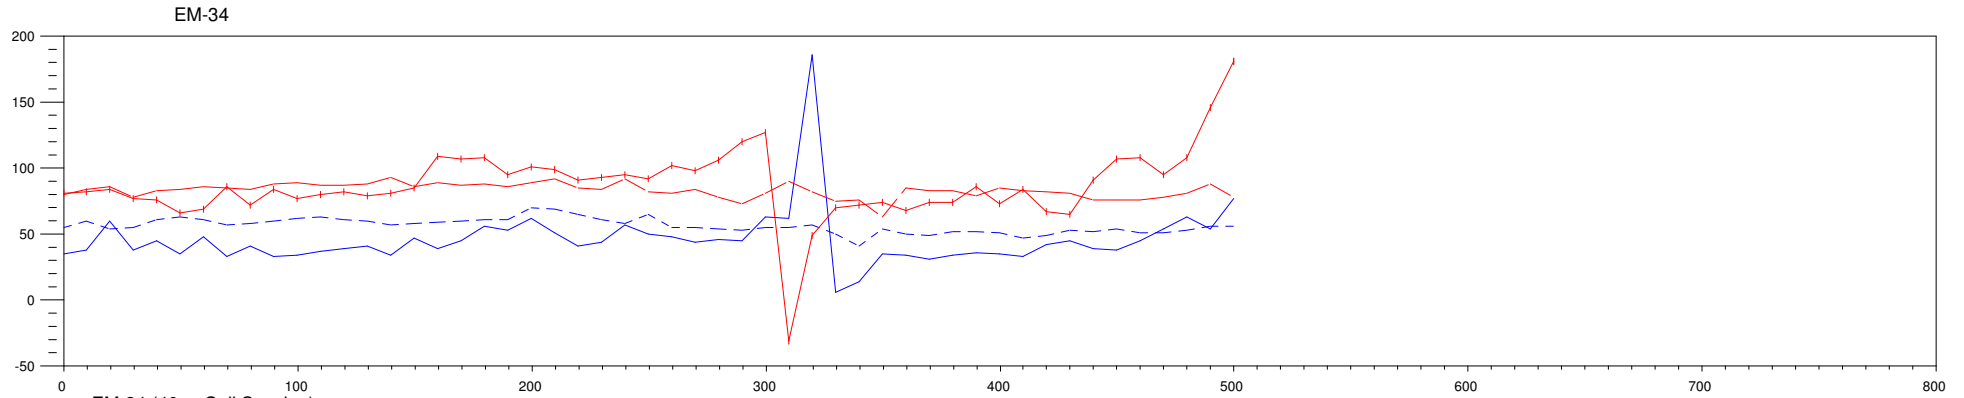
CLIENT:			
BOREHOLE NO:	MAJUBA PS-1	DISTRICT :	SW-NE
REGION:	MPUMALANGA	VILLAGE:	LINE START S27 07' 09.3" E29 46' 09.5"
		SITE:	500
			LINE END S27 07' 02.1" E29 46' 25.5"
			DRILL SITE: MAJUBA PS-1

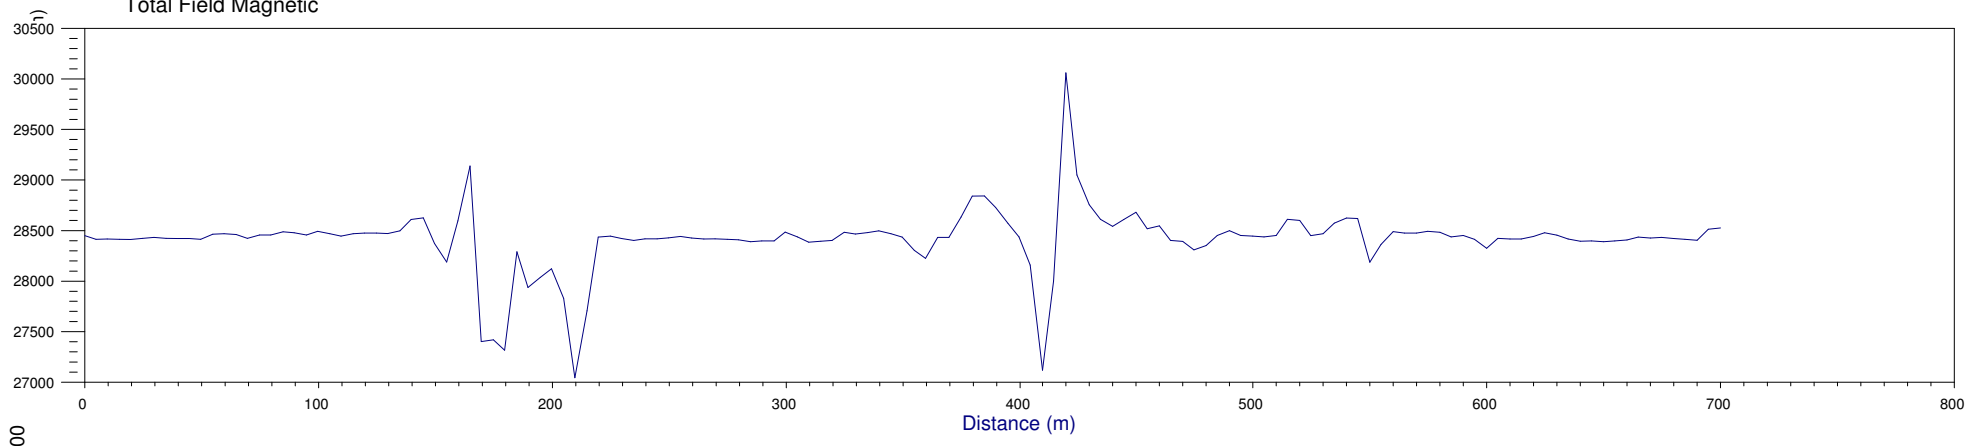
CLIENT:			
BOREHOLE NO:	MAJUBA PS-3	DISTRICT :	E-W
REGION:	MPUMALANGA	VILLAGE:	LINE START S27 07' 15.0" E29 46' 33.8"
		SITE:	660
			LINE END S27 07' 15.6" E29 46' 09.5"
			DRILL SITE: MAJUBA PS-3

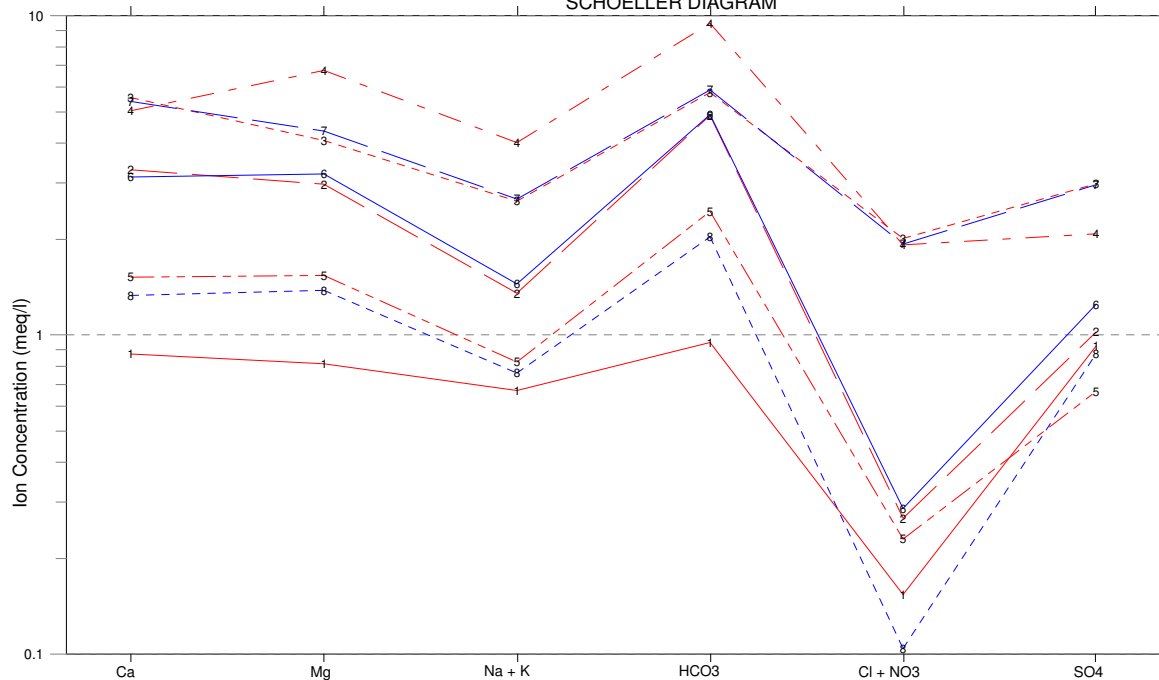
SCHOELLER DIAGRAM

Plot ID	Sample ID
1	Spring Water (SpEngeo 1)
2	Spring Water (SpEngeo 2)
3	Borehole (SpEngeo 3)
4	Dam Water (SpEngeo 4)
5	Spring Water (SpEngeo 5)
6	Spring Water (SpEngeo 6)
7	Spring Water (SpEngeo 7)
8	Spring Water (SpEngeo 8)
