The Proposed Construction of a 15ML concrete reservoir, elevated tower and pump station at the existing Masetjaba View reservoir site, located in Nigel, Gauteng Province

Ecological Impact Assessment Report

January 2019

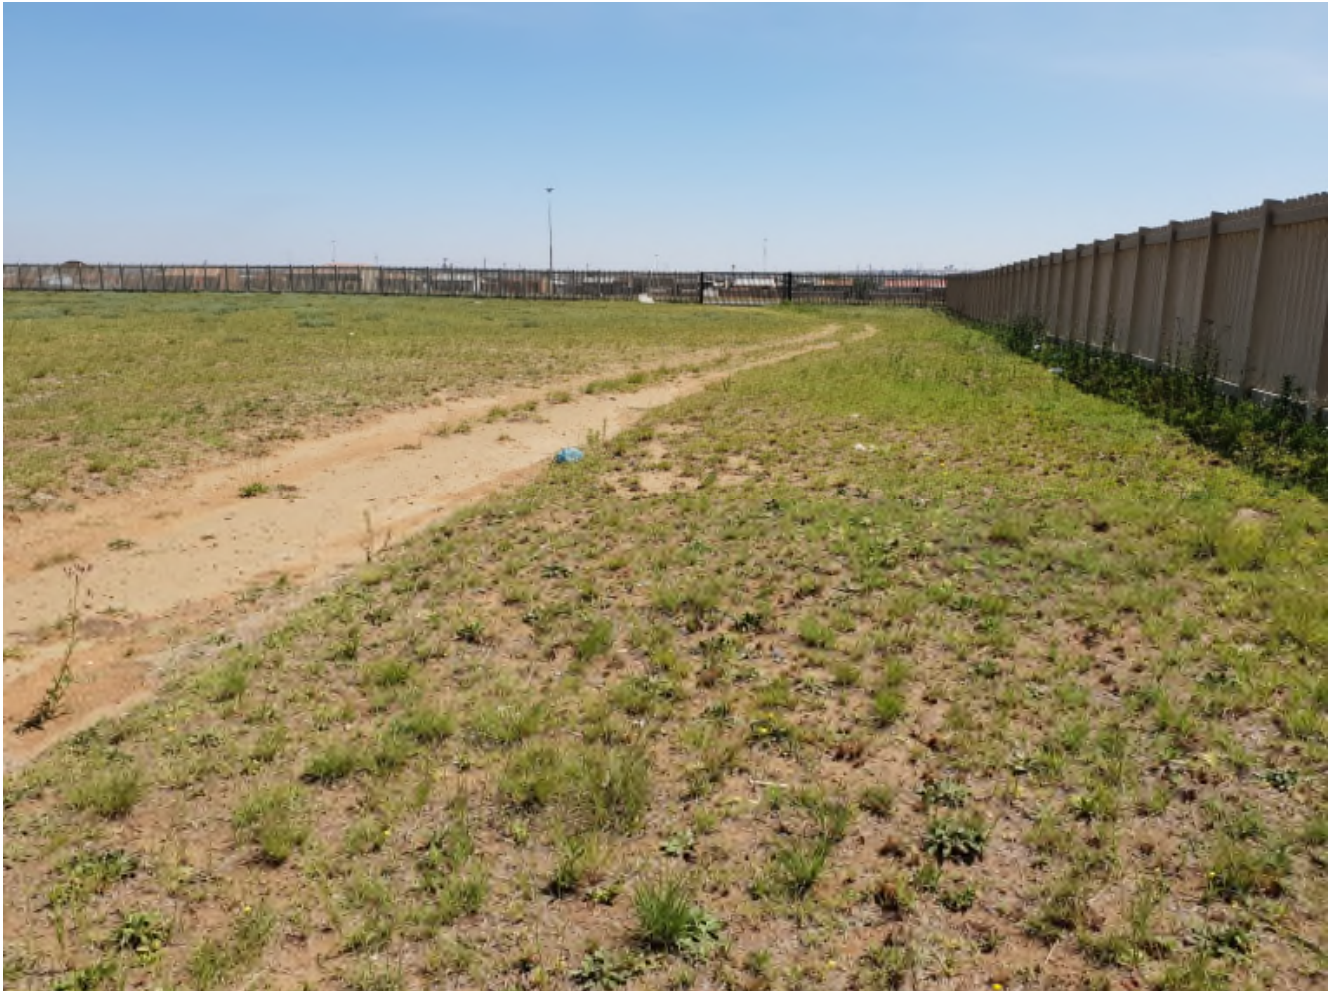
Plate 4.1: Topography of the project site, showing flat terrain features throughout the project site.

The entire site is flat with no distinct topographical features, within a broader context of slightly undulating hills with intermittent small valleys in which drainage lines are common. Plate 4.1 below illustrates the overall topography of the site. The elevation of the site is approximately 1 600 m above mean sea level.

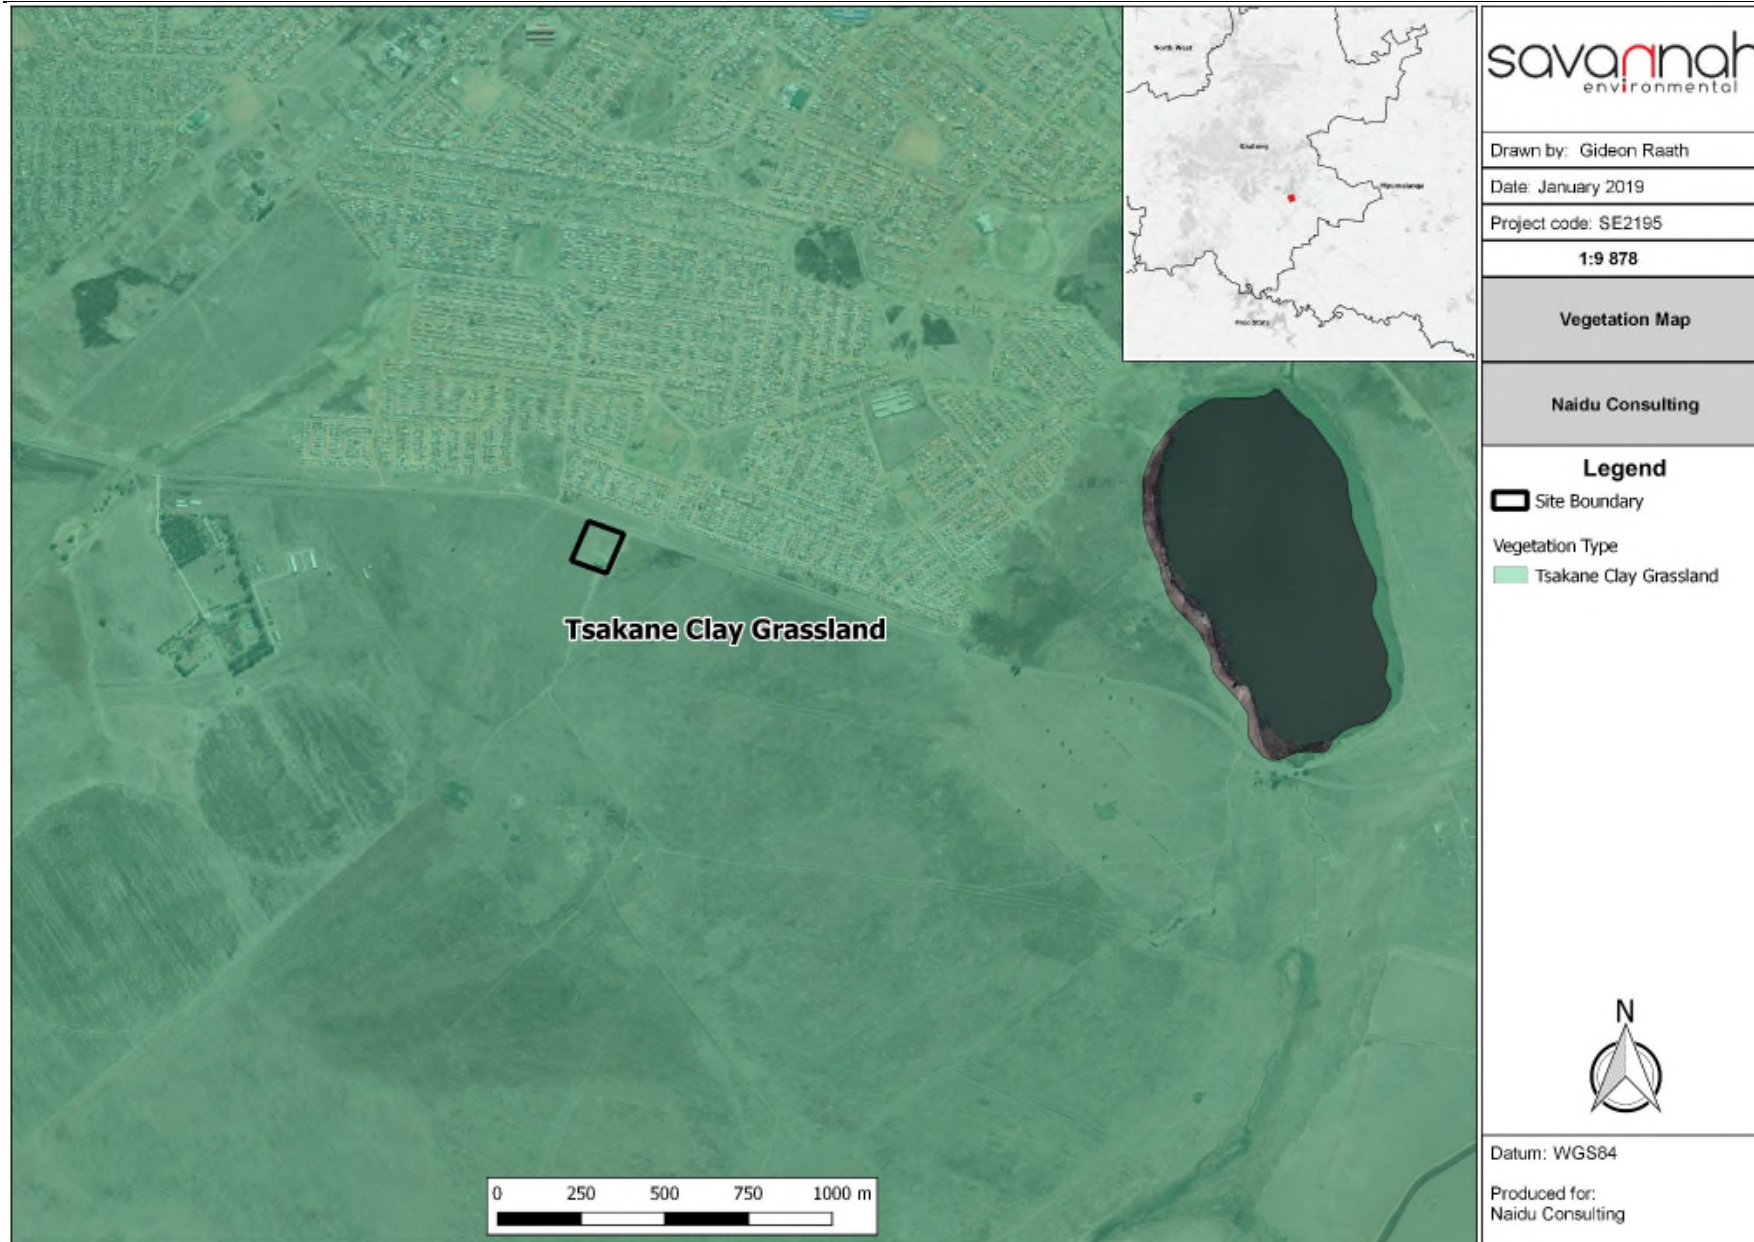
Figure 5.1: Mucina and Rutherford (2012) vegetation map of the study site.

The project occurs entirely within the Grassland Biome (Mucina & Rutherford, 2012) (Figure 5.1), which occurs from just north of Bisho in the Eastern Cape, to the Free-State border near Kimberley, to Pretoria in the north and Pietermaritzburg in the East. The bioregion within this biome – the Mesic Highveld Grassland Bioregion – furthermore occurs mainly in eastern, wetter areas of the Highveld, reaching towards the northern escarpment, straddling the border of the Grassland and Savanna Biome in the north. This Bioregion are comprised of 'sour' grasslands, with the various vegetation units generally distinguished by geology and substrate, elevation, topography and rainfall characteristics.

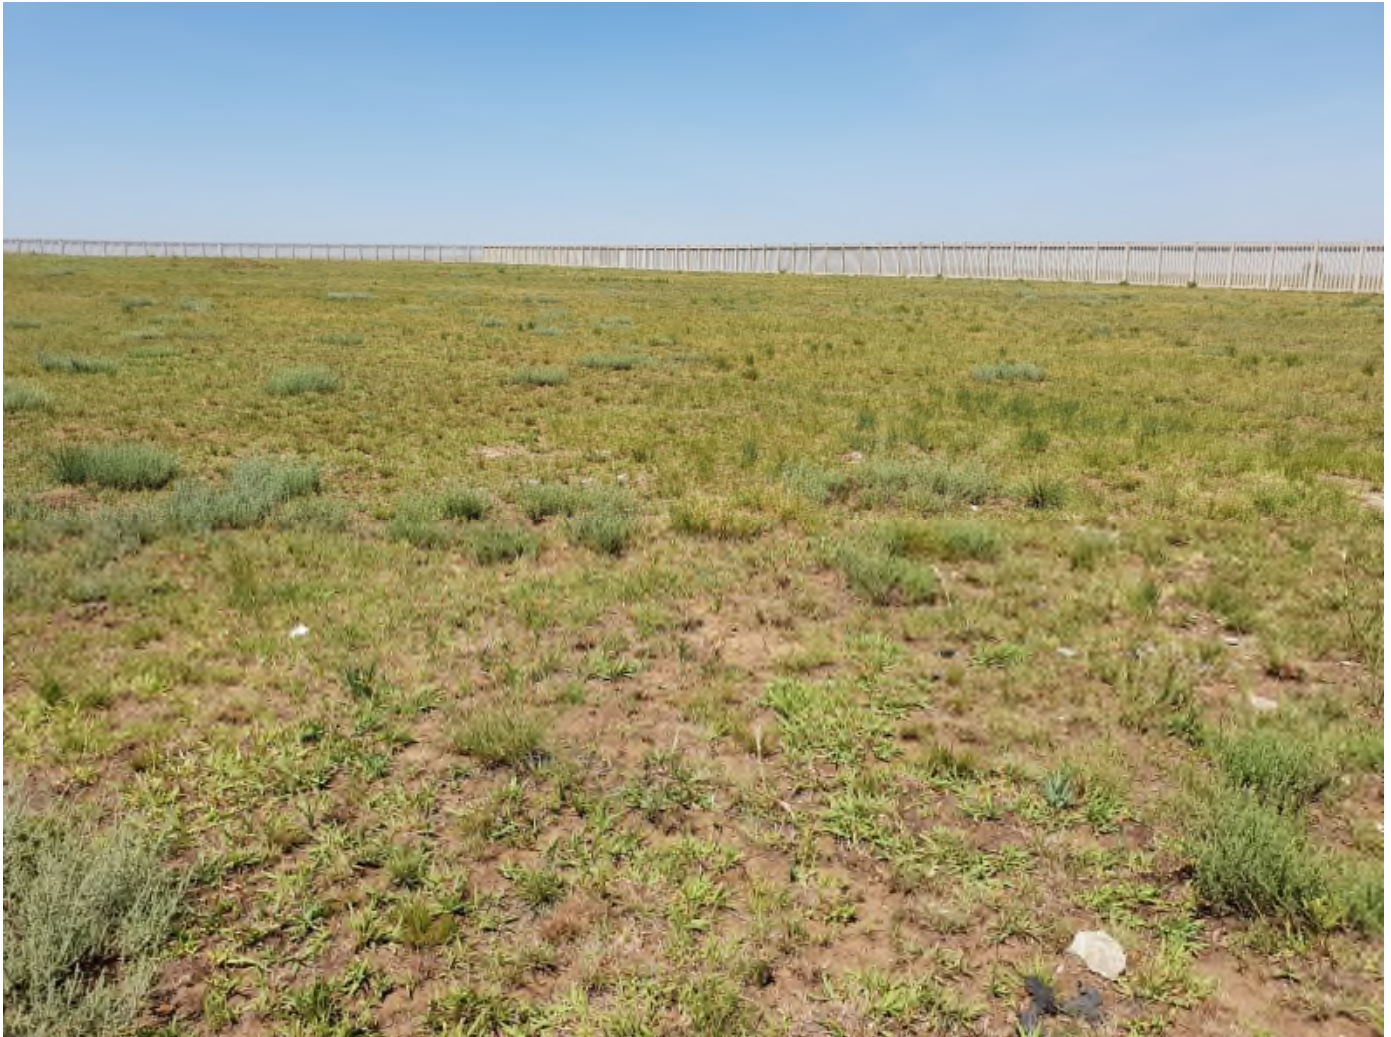
Plate 6.1: Highly degraded Tsakane Clay Grassland present onsite.

Due to the small size of the site (1.6 ha), only one vegetation unit was identified within the project area - highly degraded Tsakane Clay Grassland (Plate 6.1, and Figure 6.1 below).

This vegetation unit covered the entire site uniformly, and consisted of predominantly grass species, with no tree or shrub forms present. The species composition identified onsite conformed to a minor degree to that of the Mucina & Rutherford (2012) descriptions, and thus represented the Tsakane Clay Grassland vegetation type described in the SANBI Vegetation Map, albeit in a highly degraded condition. In particular, the relatively high abundance of *Hyparrhenia hirta* (thatching grass) and low species richness indicated the high levels of disturbance experienced on site historically.

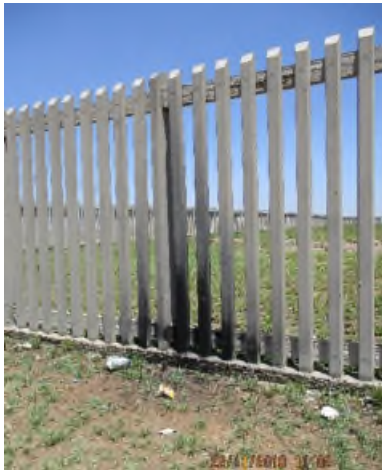
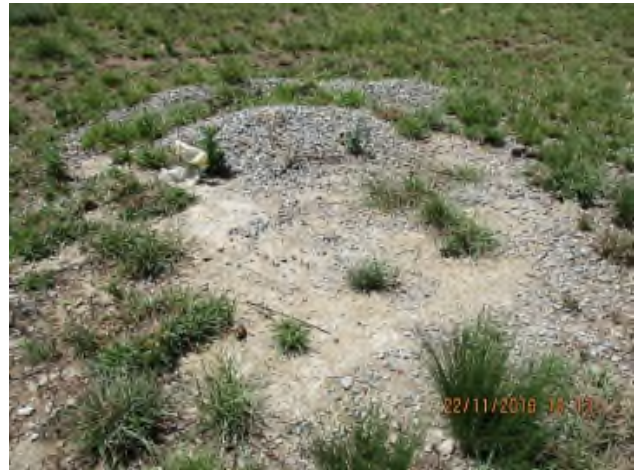
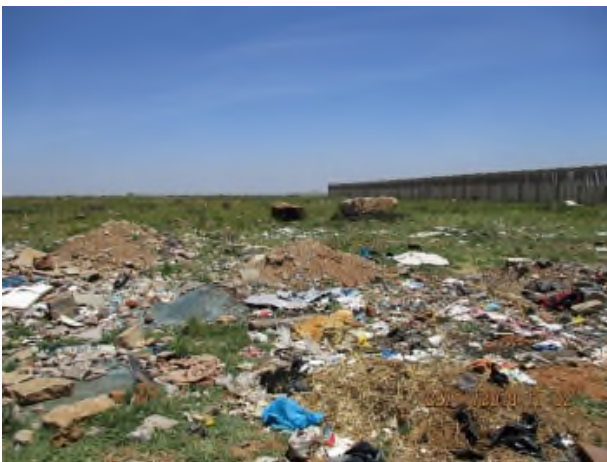
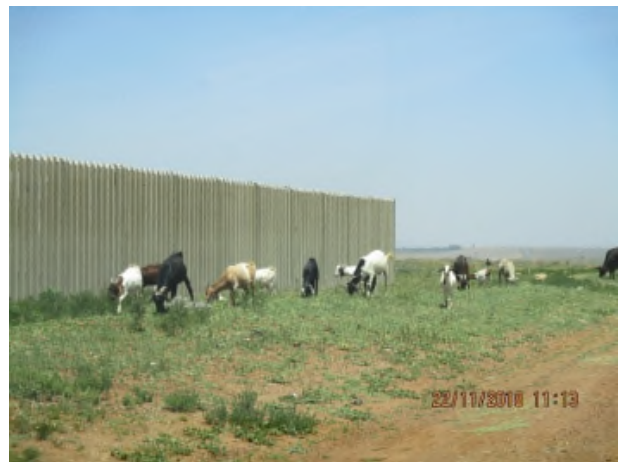
Plate 6.2: Evidence of current and historic disturbance on site.

The site is fenced (concrete palisading), with one entrance and a small gravel road leading to the existing water infrastructure. Evidence of disturbance (Plate 6.2) was evident throughout the site with illegal dumping observed adjacent to the site as well as along the boundary fence. In addition, grazing was observed nearby (2m away from the existing fence line, and surrounding the proposed site). As the fence was only constructed recently, both grazing and illegal dumping would historically have occurred on site contributing to the low species diversity and the disturbance of the site (visible from the aerial imagery for approximately 10 years leading up to the fence being erected).

Burning and litter along the fencelines

Set concrete, building material and packaging present on site

Illegal dumping adjacent to the site

Grazing adjacent to the site

Evidence of historical construction (set concrete and trench lines visible), with minor invasive species occurrence, was also noted near the north western corner of the site (facing the current water infrastructure), where the laydown areas for the existing water infrastructure may have been. The burning of waste adjacent the site contributes to ongoing fires occurring on site, with evidence of recent burning observed during the site assessment. As the site is presently fenced, no other land use occurs apart from the operation of the existing water infrastructure.
