**MIDDELBURG WATER RECLAMATION PROJECT**

**HAZARD RATING OF MODELLED IMPACTED MINE WATER  
AND GYPSUM WASTE**

Report No.: JW119/10/B478/B

**SPECIALIST STUDY: HERITAGE IMPACT ASSESSMENT REVISION 2 IN  
CONNECTION WITH AMENDMENTS TO THE MIDDELBURG WATER RECLAMATION  
PROJECT, STEVE TSHWETE LOCAL MUNICIPALITY, MPUMALANGA**

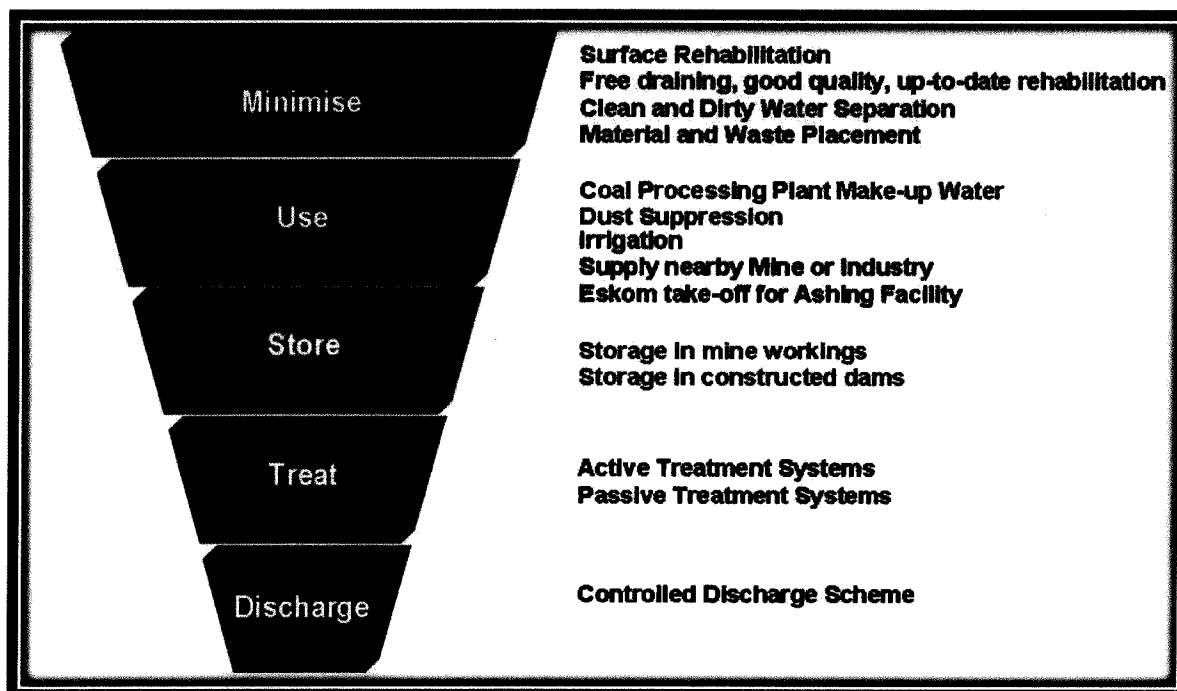
Figure 4: Hierarchy of Mine Water Management

The fundamental criteria used in screening of the identified water management alternatives are encapsulated in the mine water management hierarchy as depicted **Figure 5**. This hierarchy is core to integrated water management at mining sites and essentially states that mines must, in the first instance seek to optimally implement pollution prevention measures. If these measures do not address all the water management issues then the mine should secondly develop and implement appropriate water reuse and reclamation strategies, which may include a greater or lesser degree of water treatment in order to render the water suitable for reuse. If there is still a residual water management problem, then the mine could evaluate and negotiate options with the DWA for the discharge of untreated water to the water resource. It is, however, understood that the latter option will no longer be allowed by the DWA.

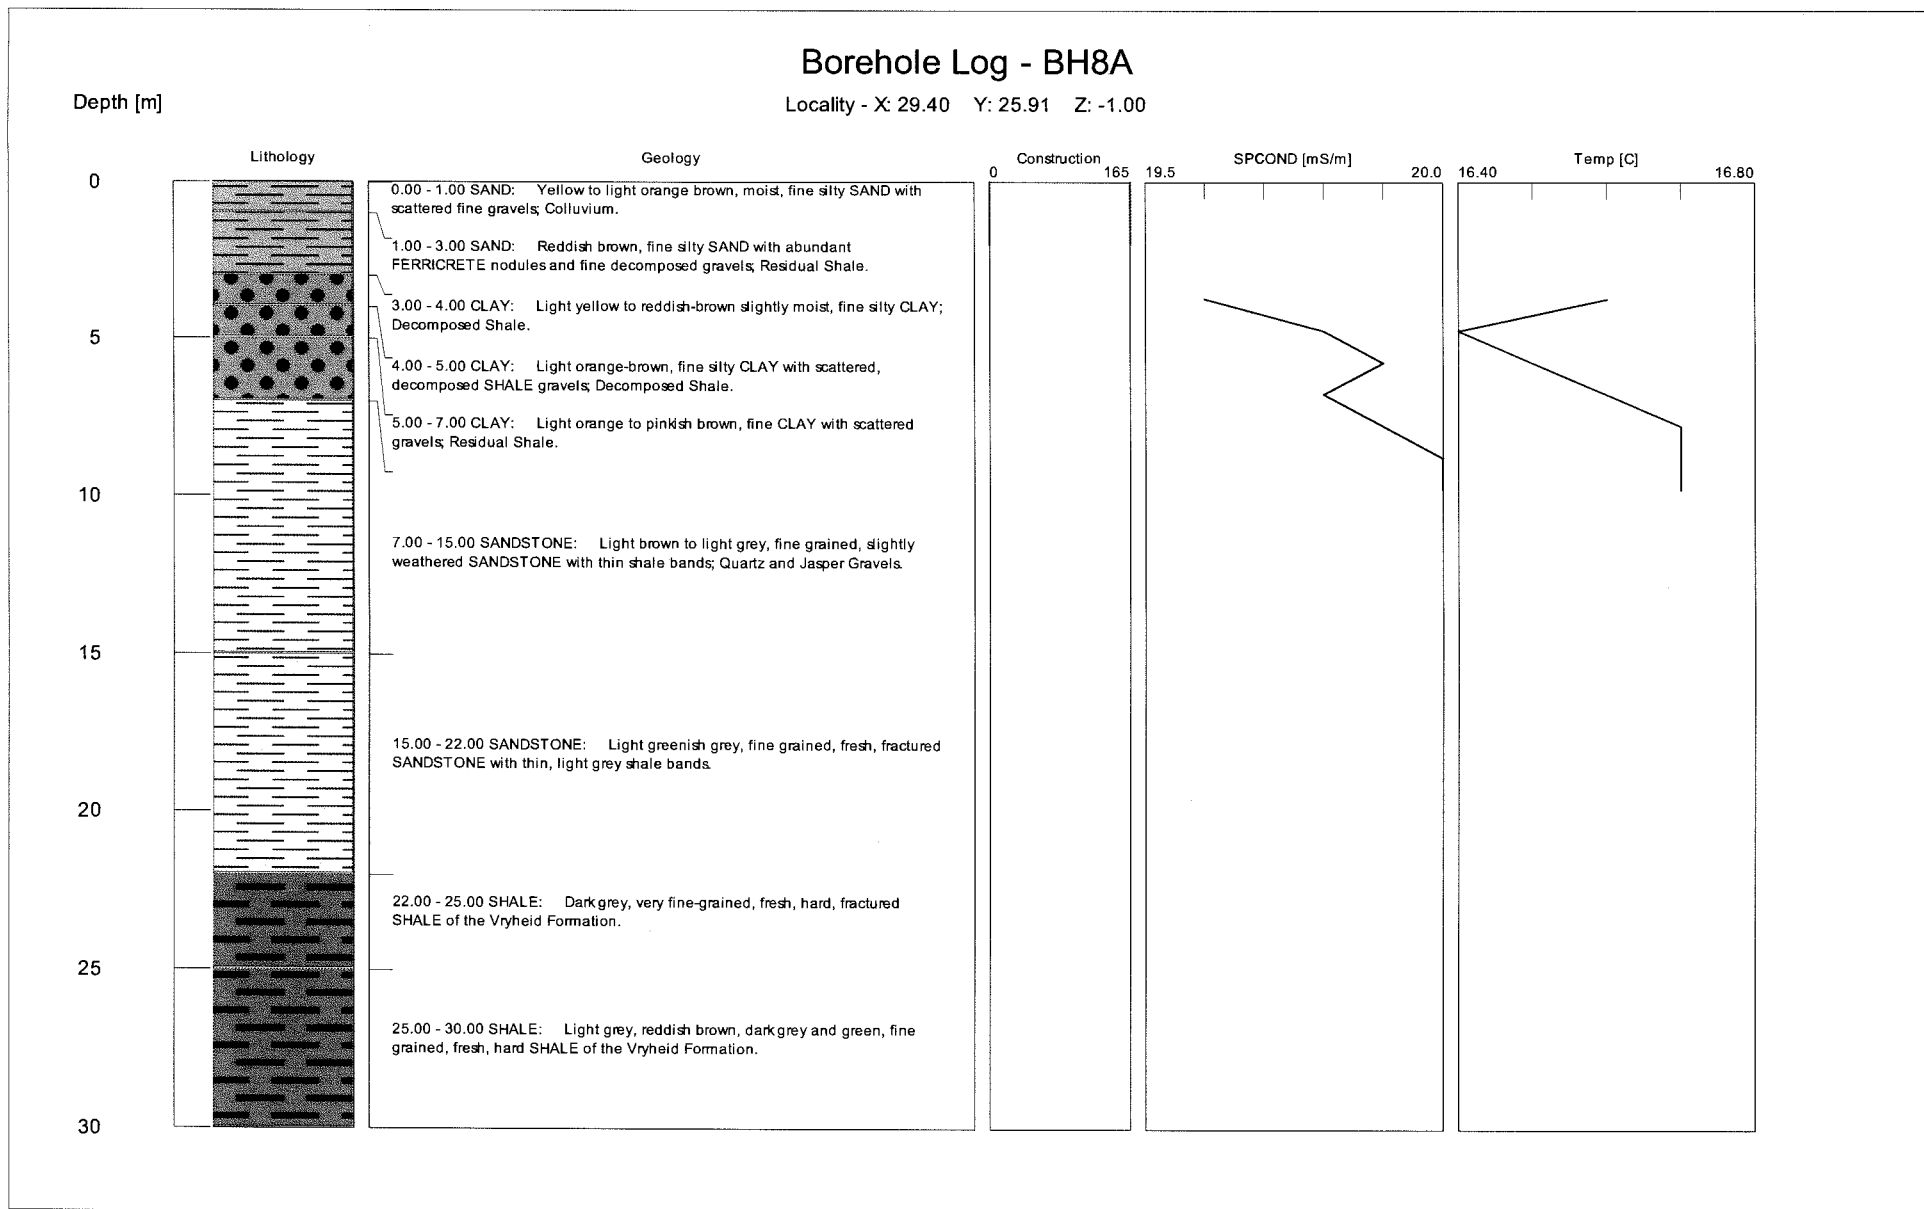
APPENDIX A – Figure 13: Borehole parameters BH8A

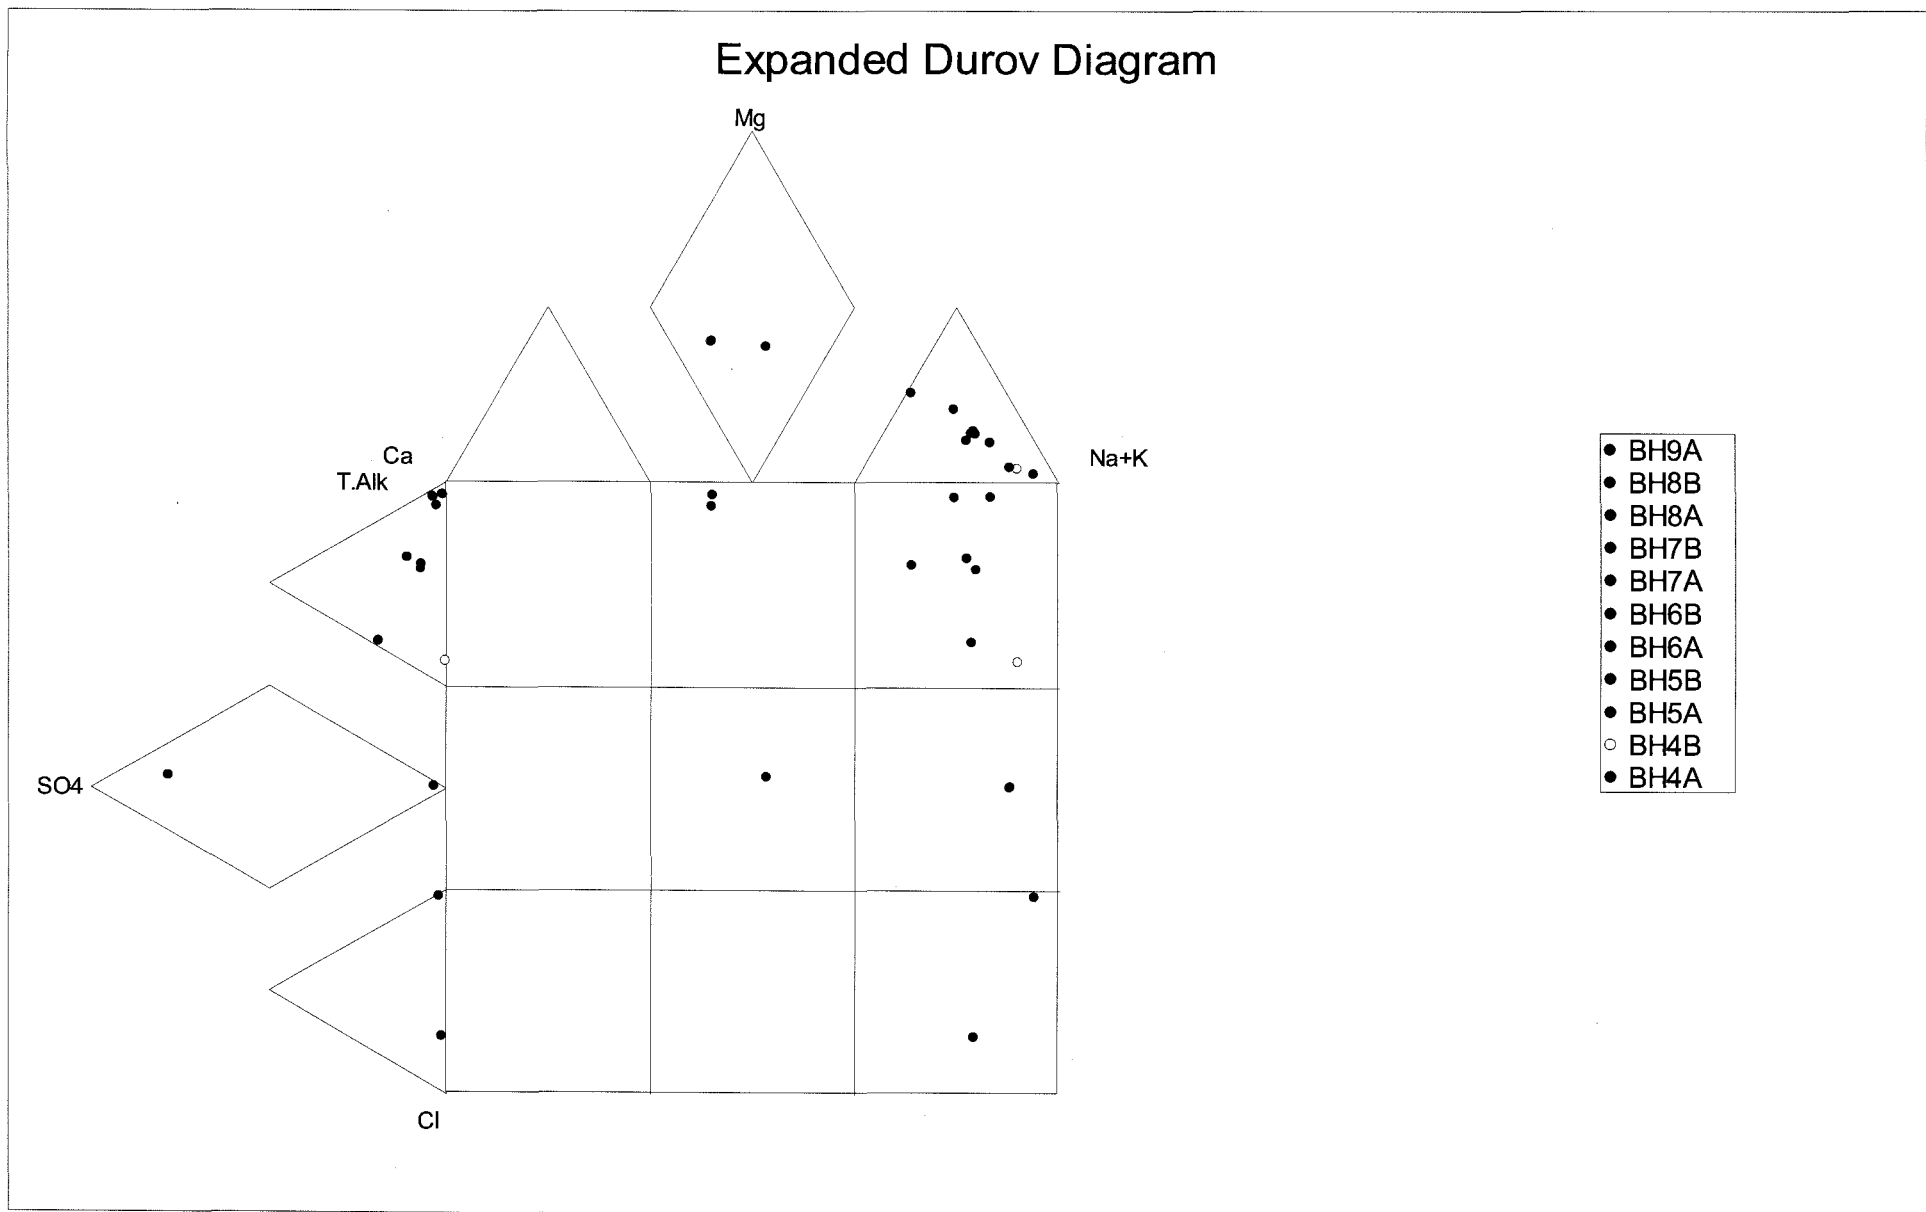
APPENDIX B - Figure 1: Expanded Durov diagram of ground water samples
