Re: Motivation for a waiver on the full HIA

HILTON SIDING Development
on Erf 1500 Hilton – Pietermaritzburg

ARCHAEOLOGICAL IMPACT ASSESSMENT REPORT ON PROPOSED SIDING DEVELOPMENT ERF 1500, HILTON, UMGENI LOCAL MUNICIPALITY, UMGUNGUNDLOVU DISTRICT MUNICIPALITY, KWAZULU-NATAL

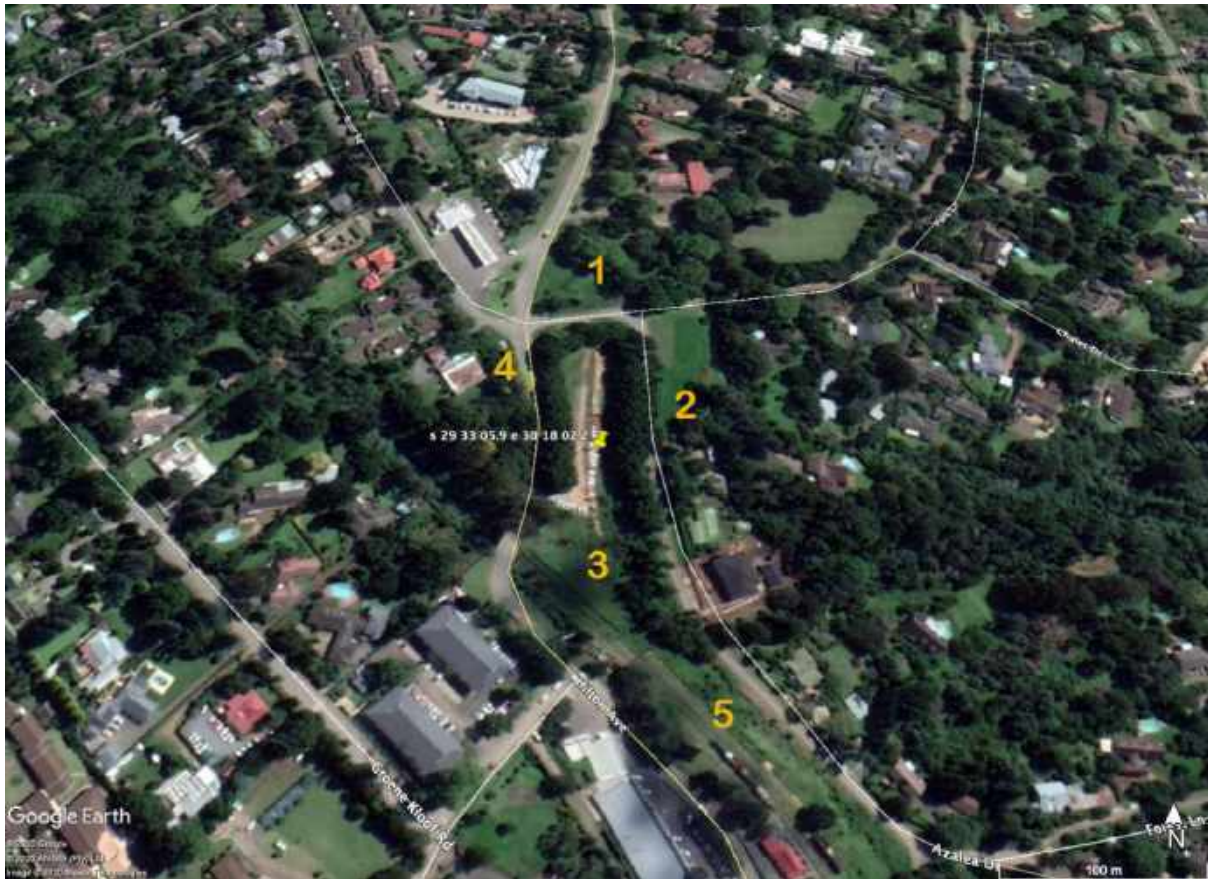
Figure 1. The location of Erf 1500, Hilton. The site is a disused railway siding. The rectangular shaped property is oriented with the long side along a roughly N-S axis. It is bounded by densely planted trees on three sides (1, 2 & 4) while on the southern side (3) it adjoins the railway servitude. 1 = Park Lane; 2 = Azalea Drive; 3 = Railway servitude; 4 = Hilton Drive. Map acknowledgement: Google Maps.

Erf 1500, Hilton (Figure 1) in Hilton falls under the uMngeni Local Municipality, uMgungundlovu District Municipality, KwaZulu-Natal. It is a roughly rectangular area of land of approximately 8000 m² that is bounded on the north side by Park Lane, on the east by Azalea Drive, on the west side by Hilton Avenue. To the south is the railway servitude.

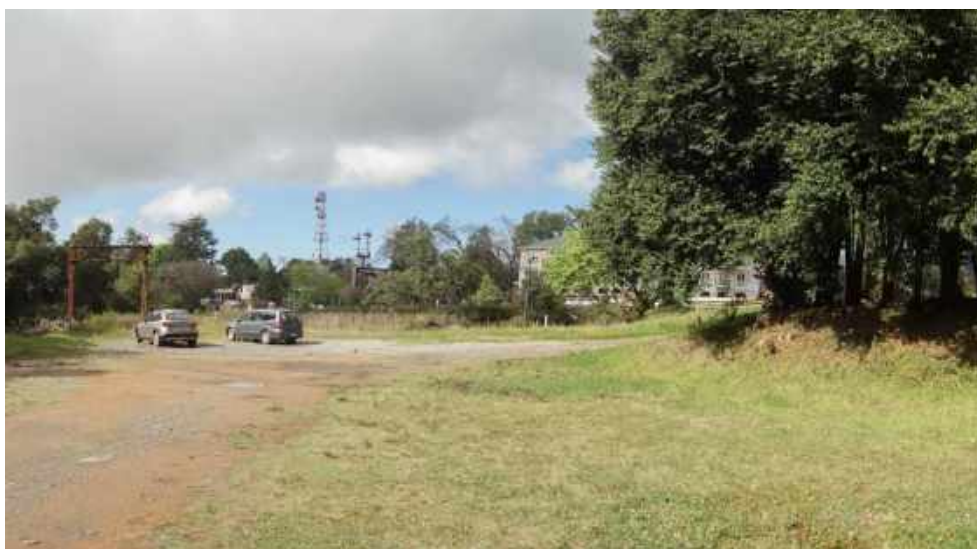
Figure 2. Erf 1500, Hilton. Looking south towards the railway line

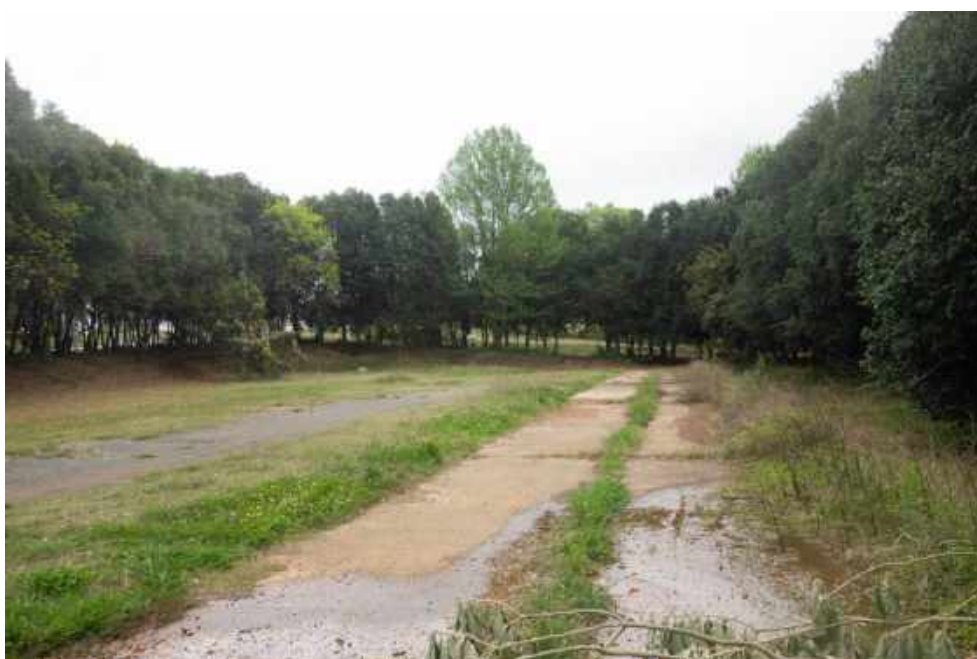
Figure 3. Erf 1500, Hilton. Looking north to Park Lane (centre) and Hilton Drive (left). Azalea Drive is to the right but not visible in the picture

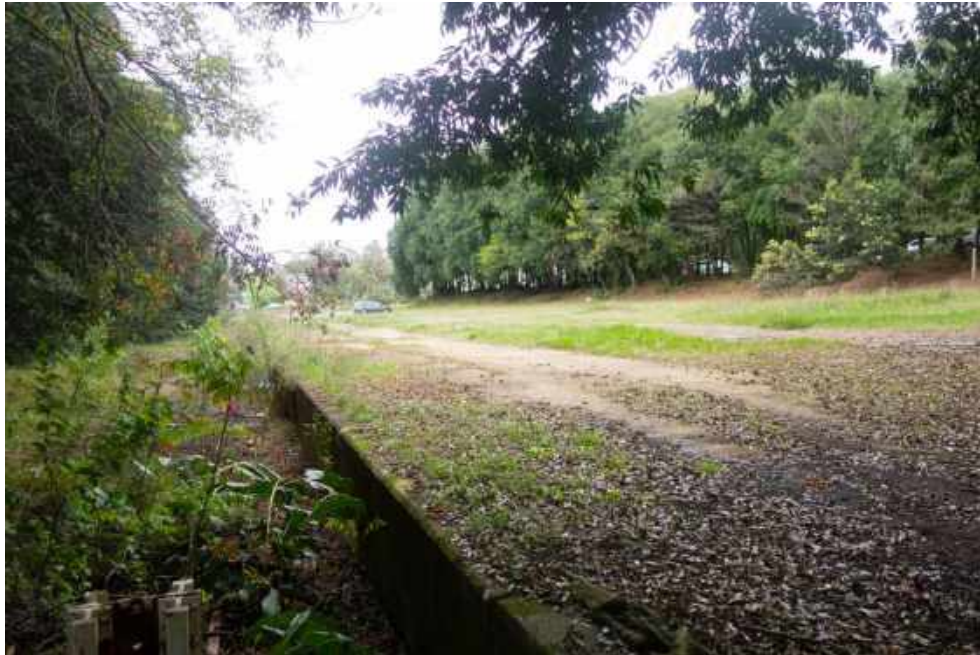
The area was developed decades ago as a railway siding and is now disused. It comprises a single set of rails and a gantry alongside a concrete platform. These are oriented roughly along a north-south axis. The area west of the concrete platform has been levelled and surfaced and the site is terraced down from Hilton Avenue to Azalea Drive. On the western side along the edge of Hilton Avenue there is 2-3 m slope down to the levelled and surfaced area. On the eastern side of the property is a 2 to 3 m slope down to Azalea Drive. The property is bordered on the east, west and north sides by rows of well-established trees 10 m and more in height. Besides the terrace slope along the edge of Hilton Drive, it appears that there is a second embankment that has been pushed up against the pre-existing slope. The site may have been scraped or bulldozed at some and the debris was pushed up against portions

Figure 4. The railway siding, looking to the south. The railway lines (at left but not visible) are still in place. The concrete surfaced platform and adjacent hard surfaces cover most of the property

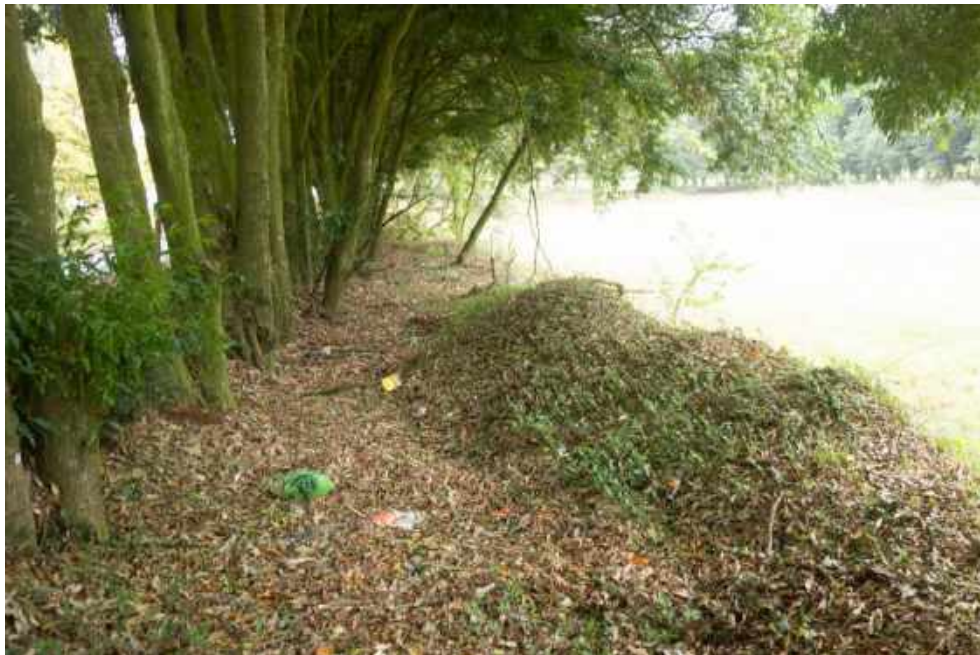
of the slopes on north and north west edges of the property (along Hilton Avenue and Azalea Drive) (Figure 5).

Figure 5. Along the western side of the property adjacent to Hilton Ave, piles of earth and rubble have been pushed to one side

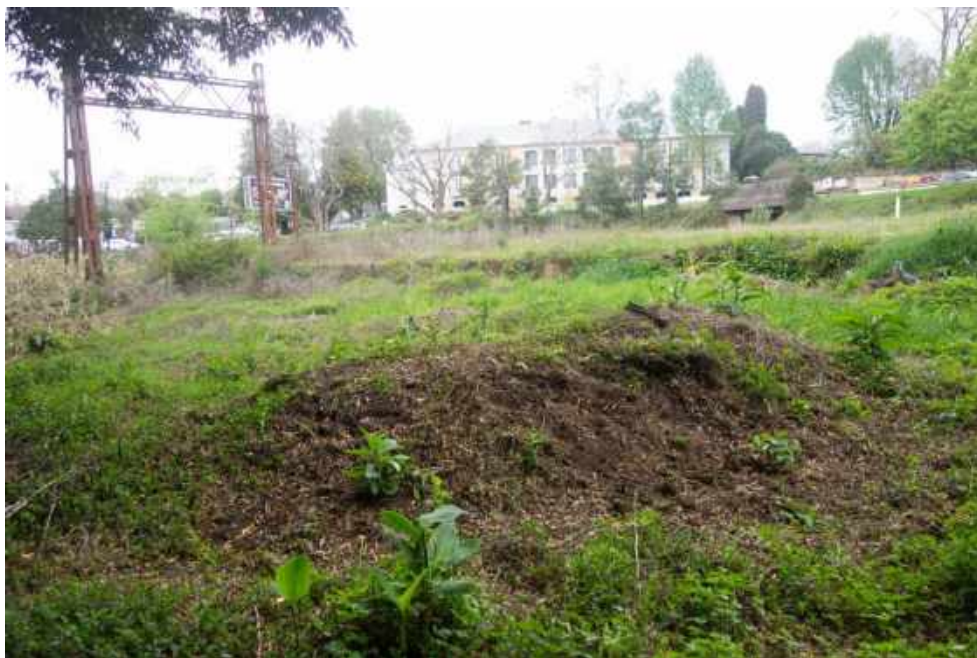
Figure 6. A mound of earth and rubble surrounded by disturbed ground

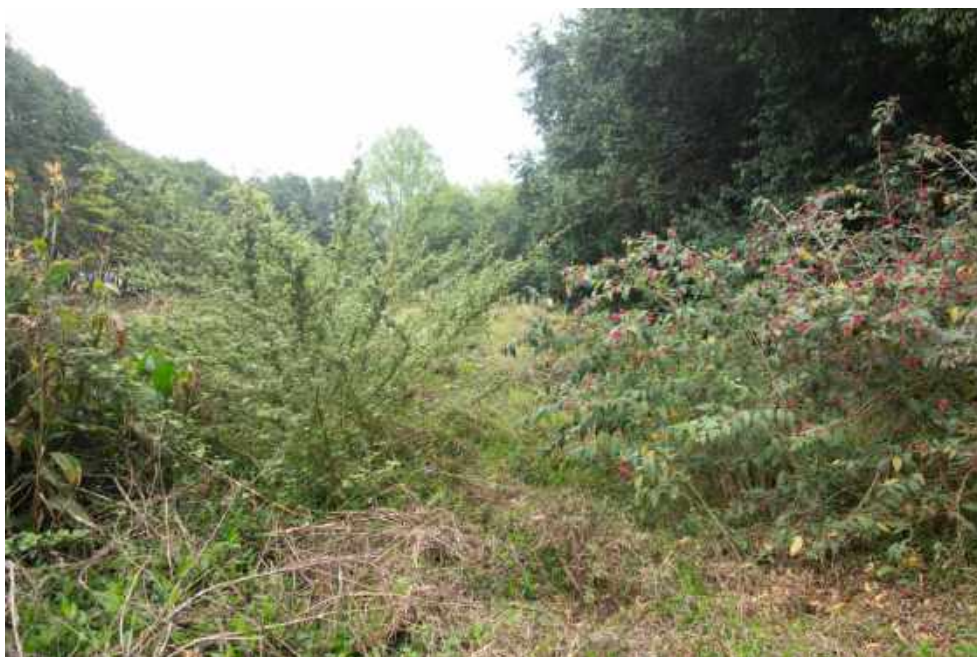
Figure 7. Dense overgrowth on disused areas of the property

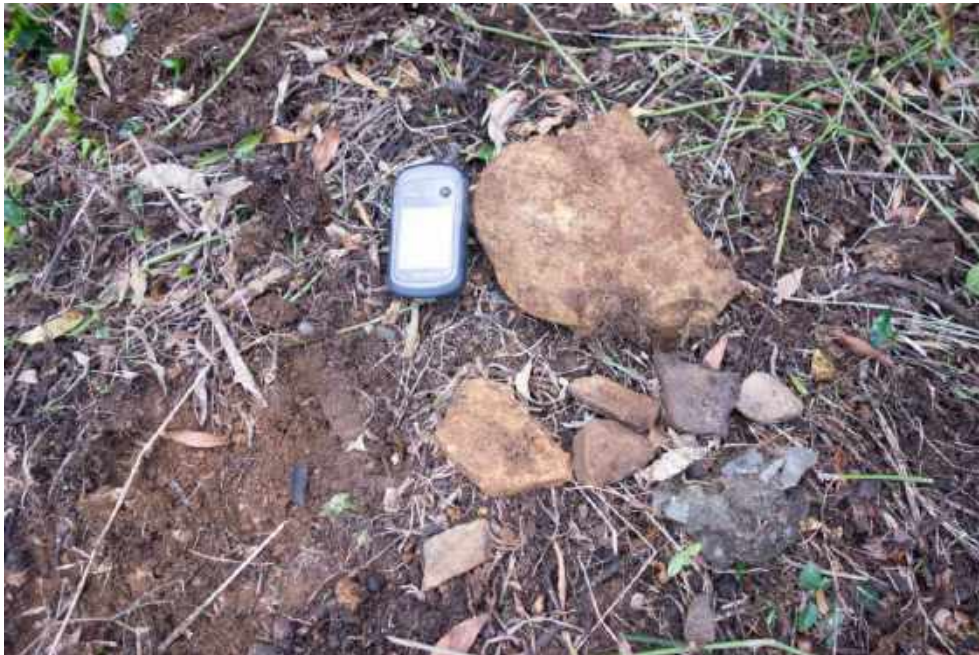
roots. There are a few thickets and piles of felled bushes which were not accessed in the inspection. The terraced slopes were inspected for signs of artefacts eroding out and at intervals small patches in the undergrowth were cleared and inspected (e.g. Figure 12). Some of several small mounds covered with vegetation were also probed. The co-ordinates of the localities were recorded. Small areas of the surface layer of soil were opened. It was found that the soils were loose and unconsolidated and contained crushed gravel and chunks of shale (Figure 9). Altogether 13 localities were sampled in this way (Appendices A-C). The composition and consistency of the samples confirms that the slopes and the mounds on the property are not archaeological in nature.

Figure 9. The soil contains chunks of subsurface rock and gravel chips used as ballast on railway lines

From this description it should be clear that the site has been totally transformed by development. All traces of human habitation and the landscape before the construction of the siding have been destroyed and buried.

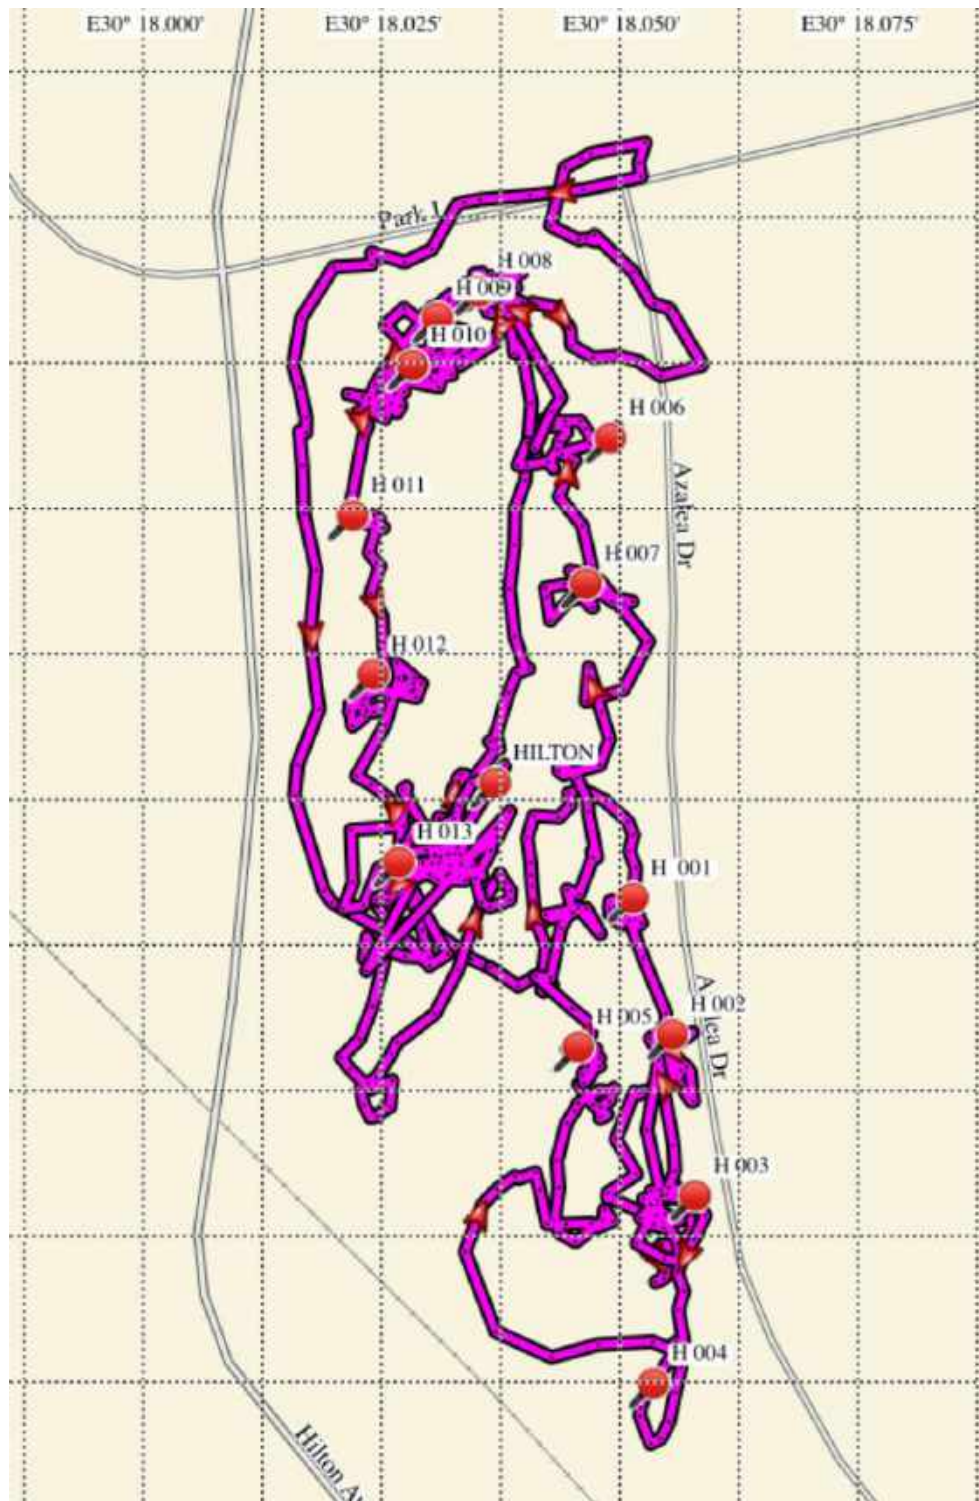
Figure 10. Erf 1500, Hilton: Map showing track walked and points at which the ground was closely inspected for archaeological traces
