# BASIC ASSESSMENT REPORT

## PROPOSED MQHASHELA TO MUNGA PEDESTRIAN BRIDGES, LOCATED ON FARM NO RE/15843 PORTION 0 (REMAINING EXTENT) OF FARM ALFRED LOCATION NO 3, KWAZULU-NATAL, WARD 33, RAY NKONYENI LOCAL MUNICIPALITY, UGU DISTRICT MUNICIPALITY

ENVIROEDGE NO.:  
12 071

DATE:  
March 2019

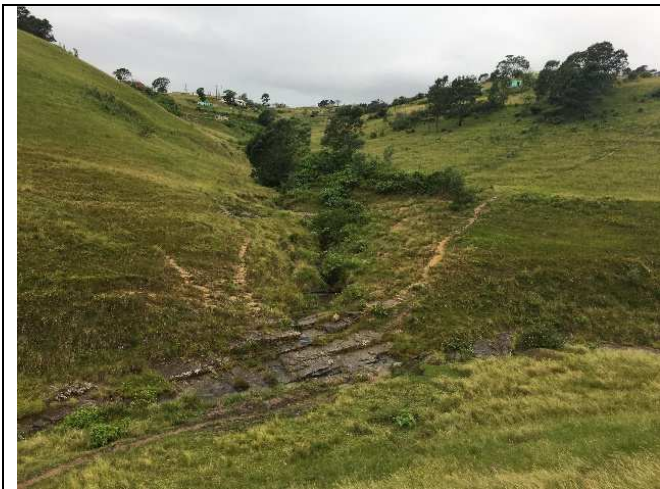
**Image 1.** Image looking south east over the Ncumuse River tributary, towards the eastern pedestrian bridge site.

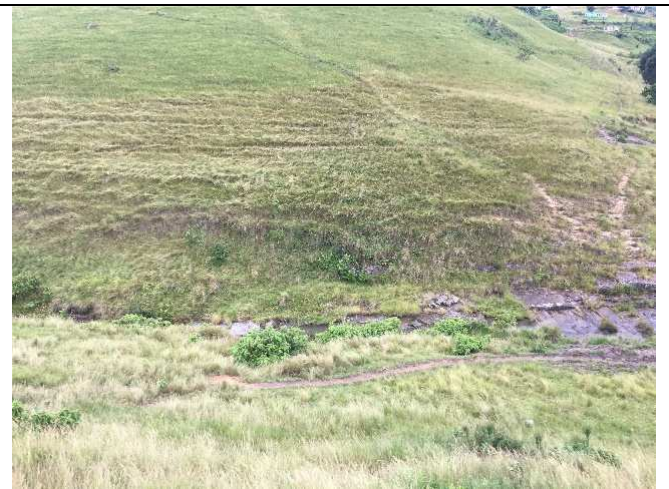
**Image 2.** Image looking east over the Ncumuse River tributary, towards the northern pedestrian bridge site.

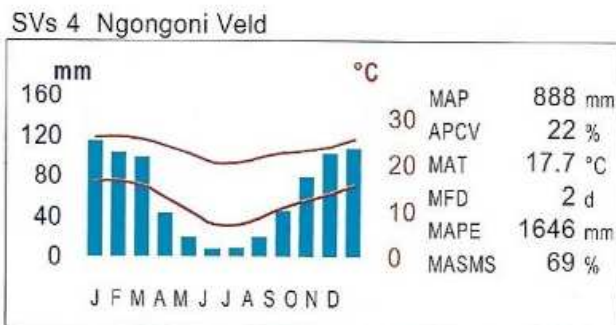
Blue bars - median monthly precipitation.  
 Upper and lower red lines – mean daily maximum and minimum temperature  
 MAP – Mean Annual Precipitation  
 MAT – Mean Annual Temperature

The project site area, Mbeni, receives summer rainfall with some rain in winter, approximately 700-1100mm of rain per year, with most rainfall occurring during summer. Some valleys are sheltered and may show some weak rainshadow effects. Frost is infrequent in the area, occurring mainly where cold air becomes rapidly trapped in valleys. The average temperatures range from a maximum of 37.0°C in summer to a minimum of 4.9°C in winter. The region is the coldest during June/July when the mercury drops to 10°C on average during the night (See figures below).

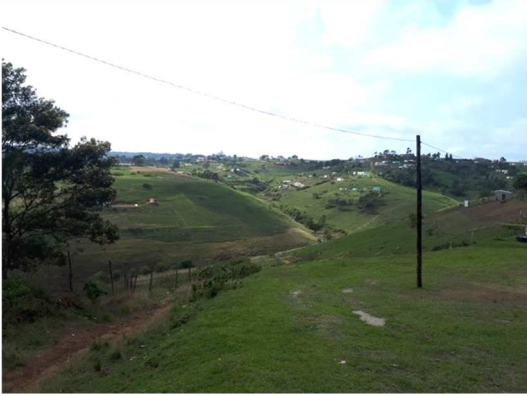
**Image 3.** General view from the top of the slope near the Munga School. Note the steep topography and incised valley.

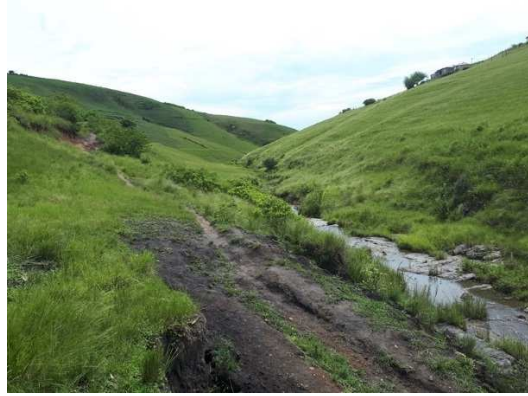
**Image 4.** The incised nature of the valley and narrow riparian zone downstream of the proposed crossing, as viewed from the left bank.

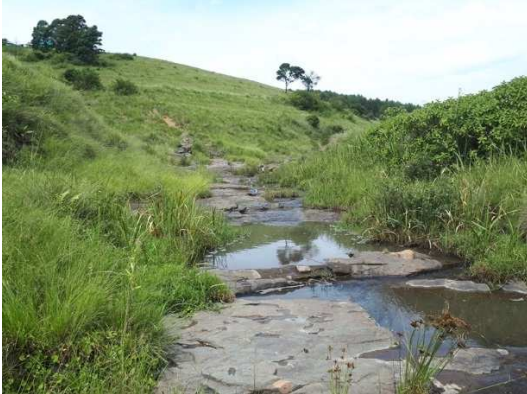
**Image 5.** Low flow conditions and bed rock substrate of the active channel.

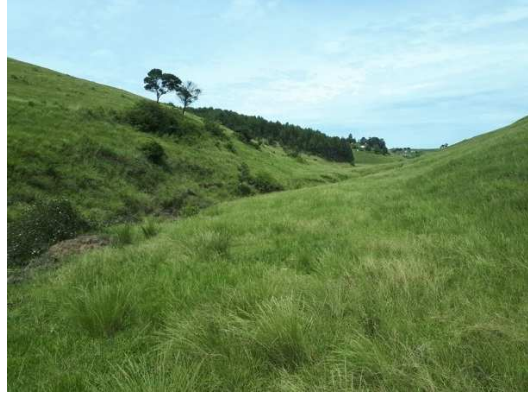
**Image 6.** The nature of the valley upstream of the crossing. Note the dominance of *A. junciformis* within the adjacent grassland.

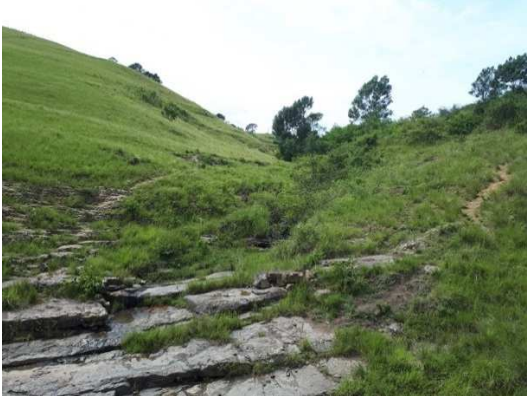
**Image 7.** The lower portion of a seasonal channel that joins the main channel from the east in the vicinity of the proposed crossing.

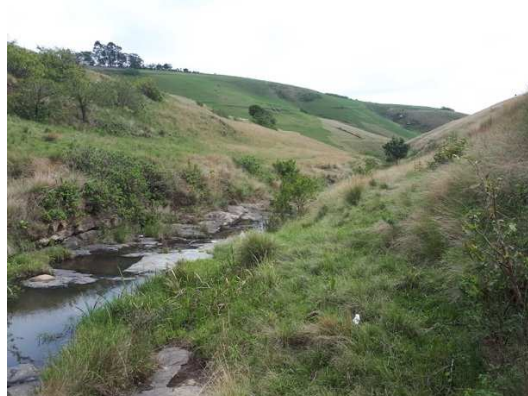
**Image 8.** View of the downstream riparian habitat taken during the subsequent follow up visit, as viewed from the right bank.

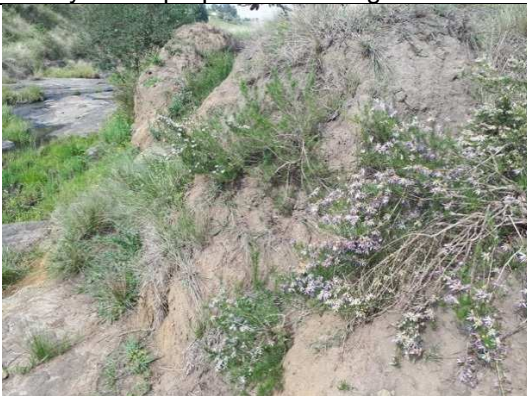
**Image 9.** *Felicia filifolia* growing on an eroded bank adjacent to the active channel near the crossing site.

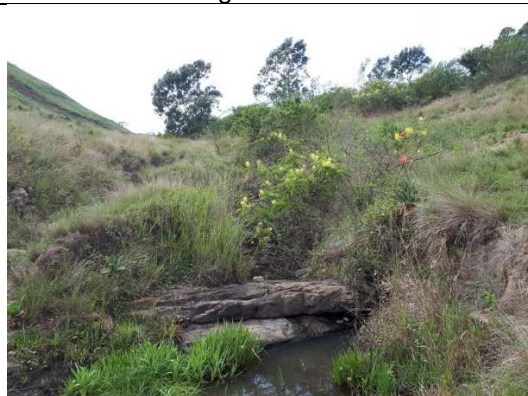
**Image 10.** A smaller seasonal tributary at the crossing site. Note invasion by *A. mearnsii* and *Caesalpinia decapetala*.

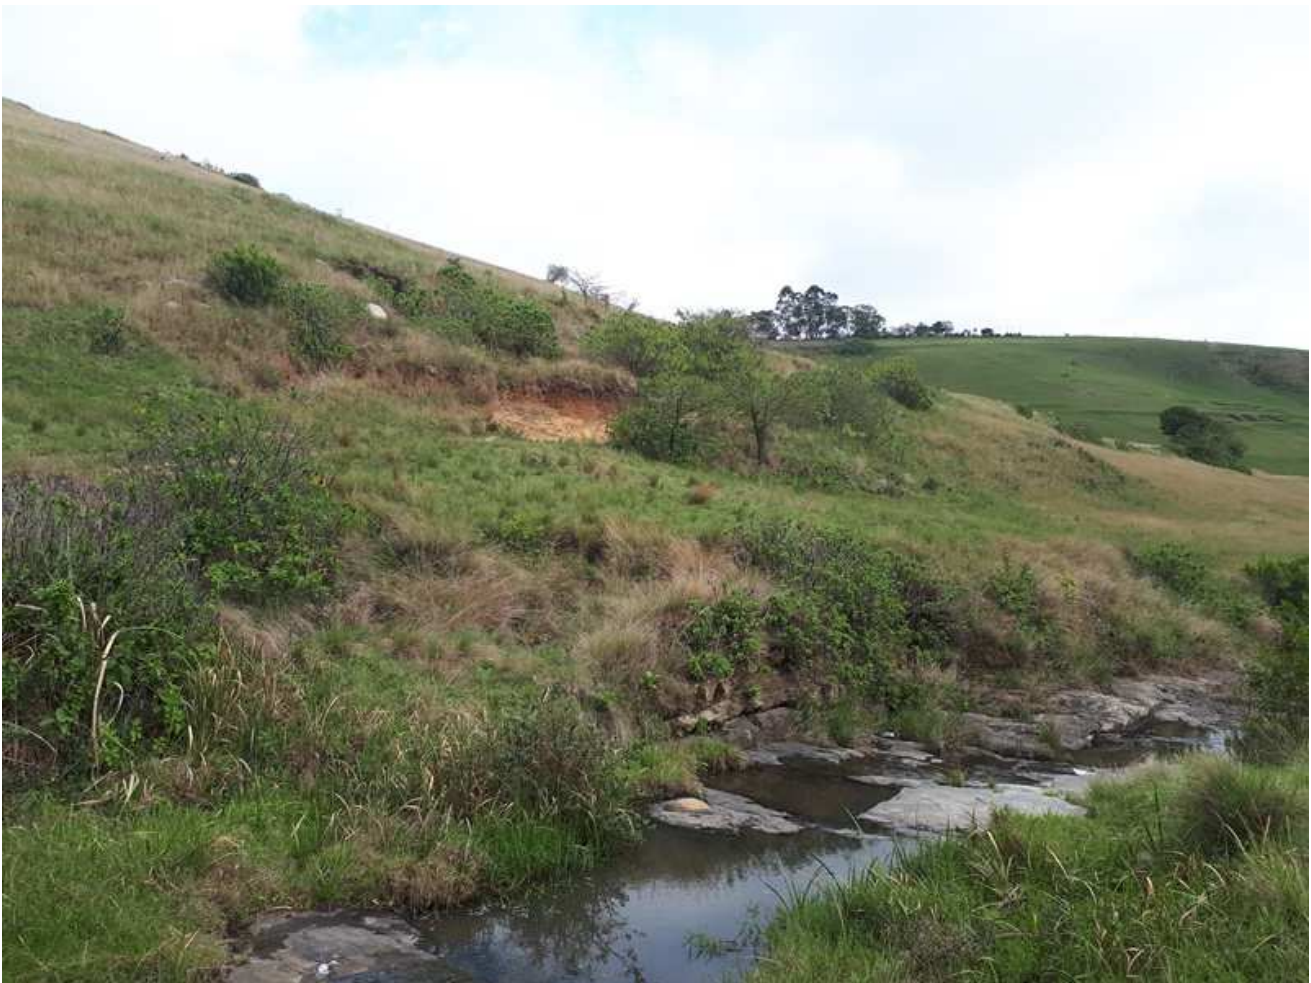
**Image 11.** Riparian vegetation at the crossing site. Note invasion by *S. didymobotrya* and *P. comosus* along upper edge of channel bank.

The marginal zone vegetation along the main watercourse channel was found to be generally intact, with occasional exotic invasion (*Nasturtium officinale*) or disturbance associated with the existing informal crossing. The majority of disturbance and impacts were associated with the non-marginal zone. Exotic invasion was prominent and the following species were noted (Image 11):

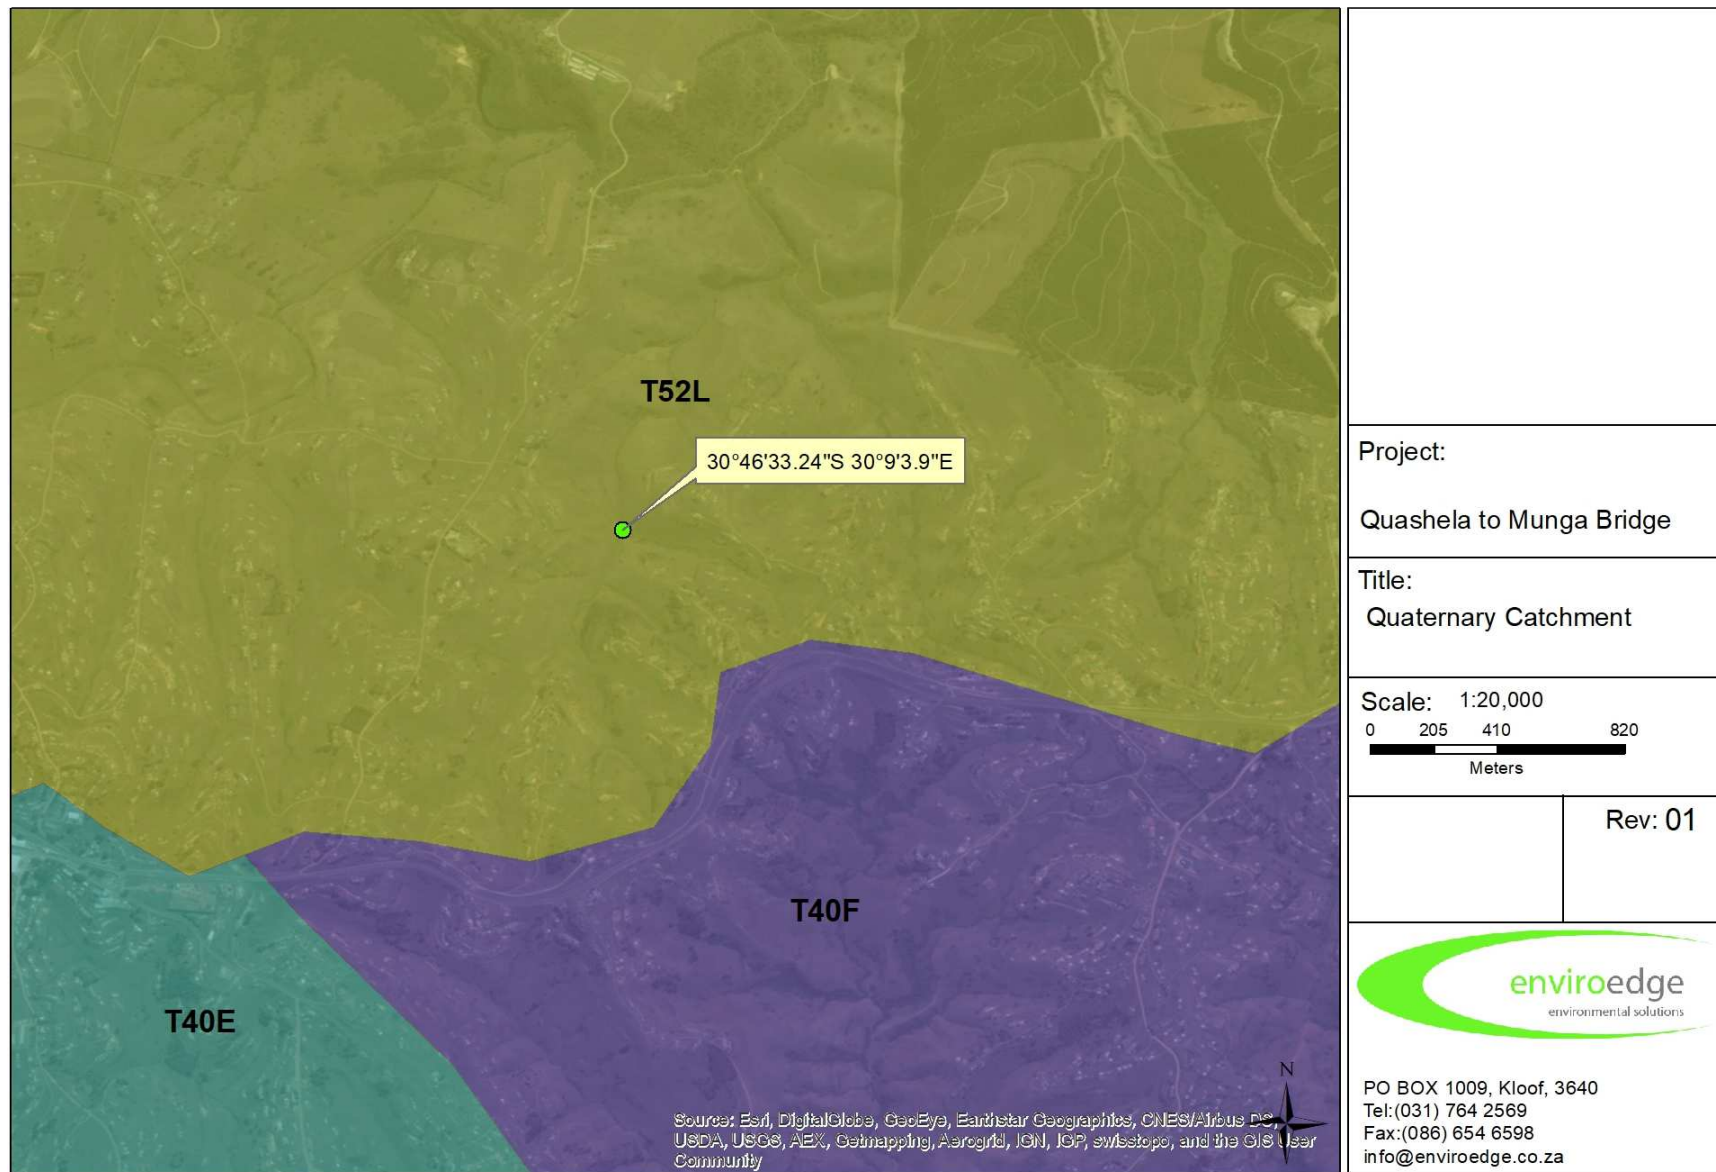
Figure 3: Mqhashela to Munga Pedestrian Bridges – Watercourses

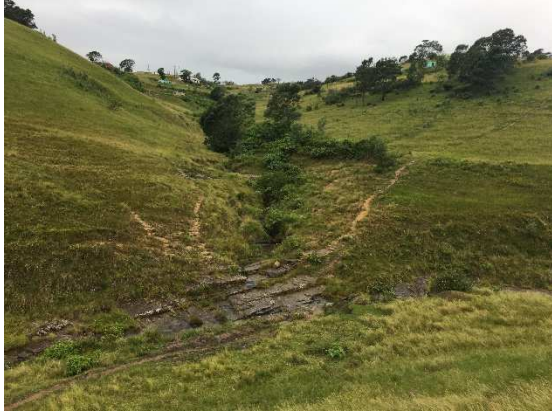
Plate 1. Image looking south east over the Ncumuse River tributary, towards the eastern pedestrian bridge site.

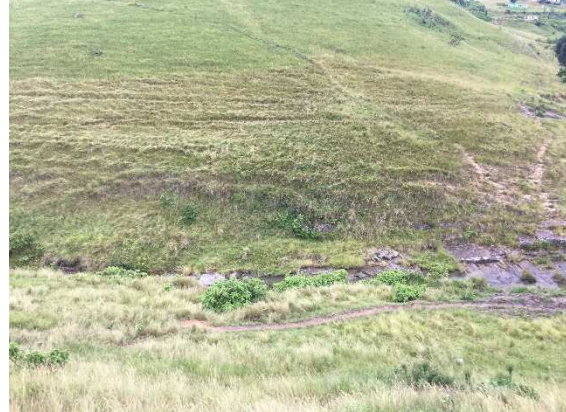
Plate 2. Image looking east over the Ncumuse River tributary, towards the northern pedestrian bridge site.

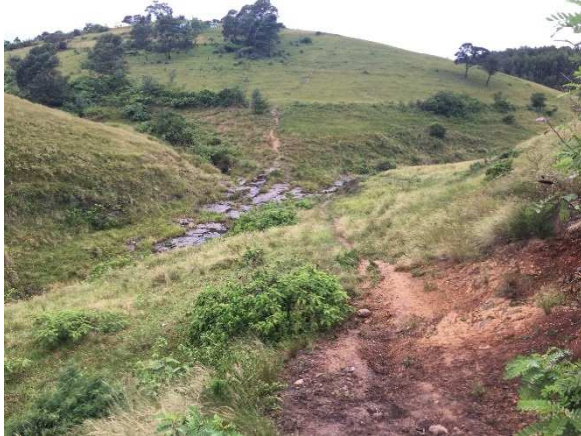
Plate 3. Image looking south-south east, overlooking the study area. Note in the informal pedestrian tracks cross the Ncumuse River tributary.

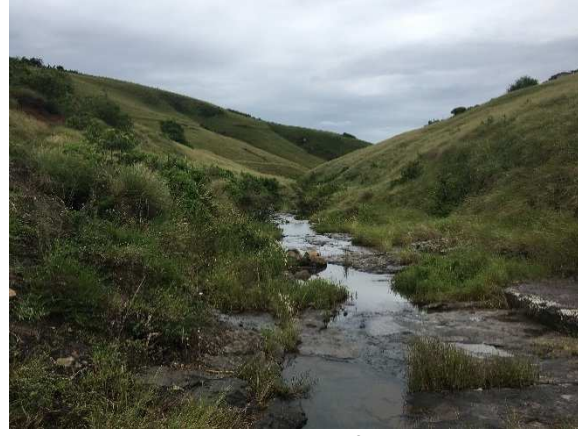
Plate 4. Image looking north from the site downstream along the Ncumuse River.

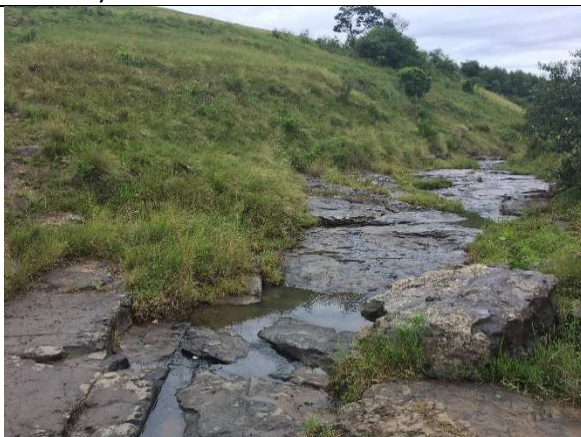
Plate 5. Image looking south from the site upstream of the Ncumuse River tributary.

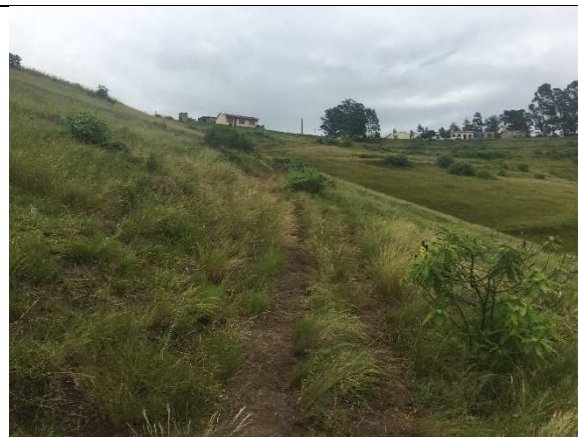
Plate 6. Image looking north west showing existing access track to the proposed site.
