HERITAGE IMPACT ASSESSMENT – PHASE 2
Assessment of Structures and proposed development :
Proposed N3 Key Ridge Upgrade & Viaduct, KZN

Date : 19 September 2023

<i>Client Name :</i>	South African National Roads Agency (SANRAL)
<i>Document Title:</i>	Heritage Impact Assessment Phase 2 of proposed Key Ridge N3 Upgrade & Viaduct Project
<i>Reference :</i>	Phase 1 Heritage Impact Assessment : Key Ridge N3 Upgrade & Viaduct Project, KwaZulu-Natal, Umlando Archaeological Surveys & Heritage Management, April 2013
<i>File Name :</i>	N3_Realignment-HIA-2BE023-09-11
<i>Municipality:</i>	eThekweni Metro

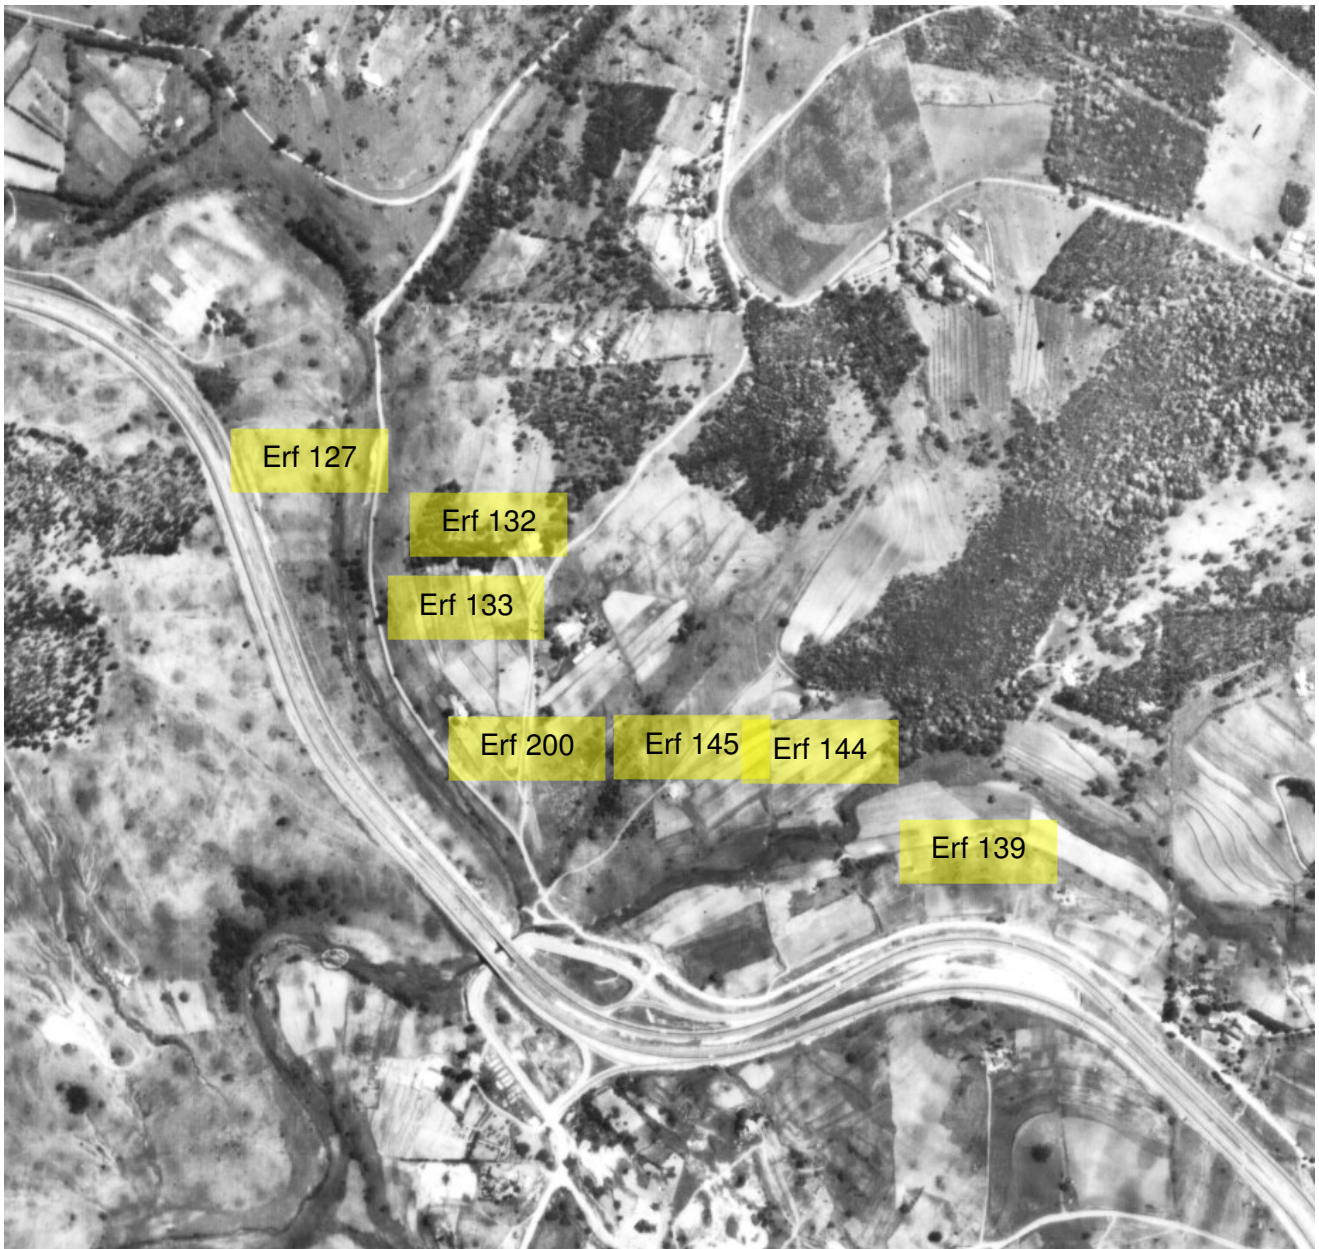
Study area map – Aerial Photo 1968

The locations of the existing structures were overlaid on topographical maps and aerial photographs dating from 1937, 1953 and 1968. The aerial photograph of the area dated 1968 was used as the closest reference for determining the age of the structures, being 5 years after 1963 (60 years ago).

There are a few structures evident on the 1968 aerial photograph that appear to occur within the boundaries of erf 200 (2 structures) and erf 144.

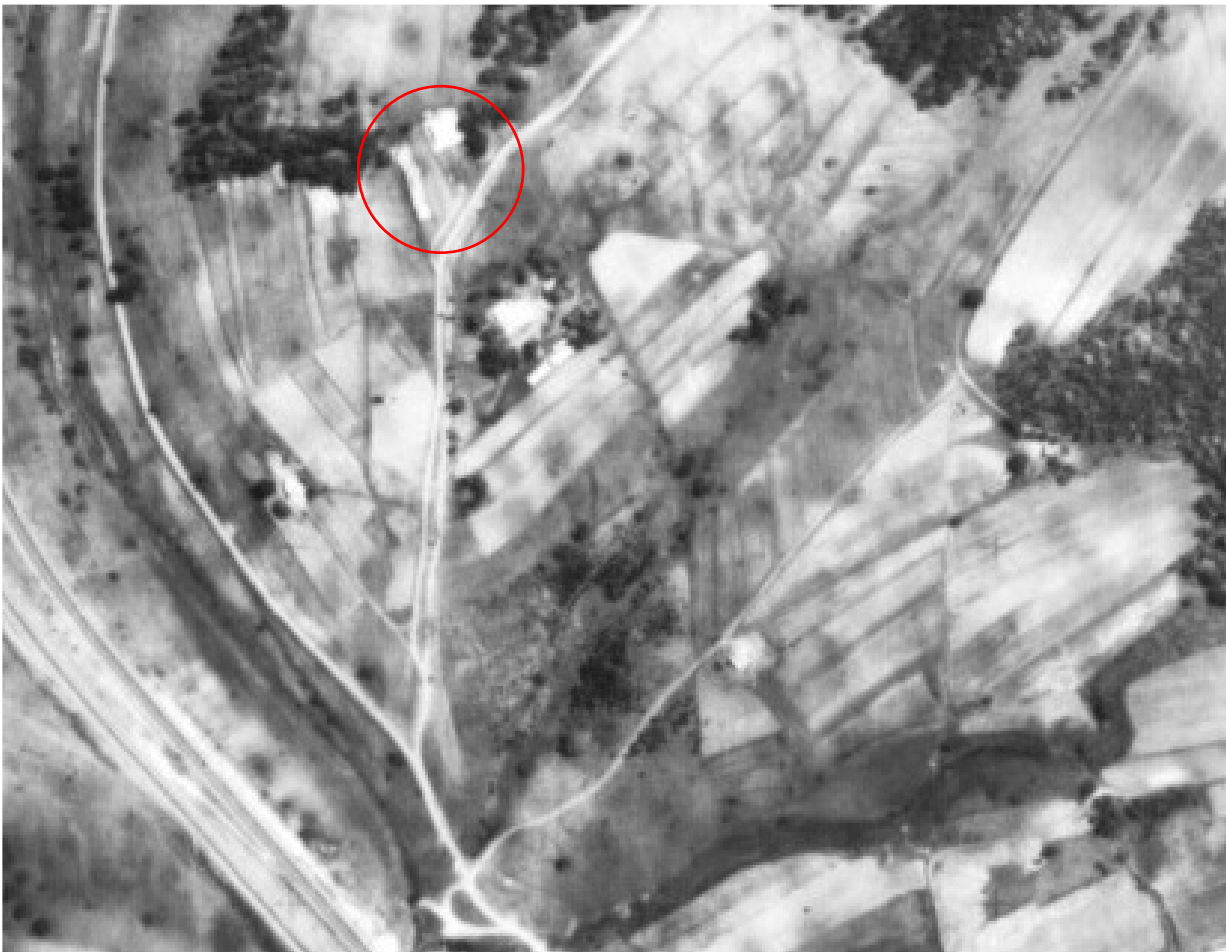
Only two of these structures exist today : SD11 and possibly SD8 (animal shelter) which were buildings used by Peacevale Kennels.

On closer examination of SD11 it appears to be a simple residential building built of concrete block and steel, the roof form appears to have been changed and the building no longer resembles a residence.

A possible structure or clearing is evident on the image close to SD11, it is in the position of the existing kennels.

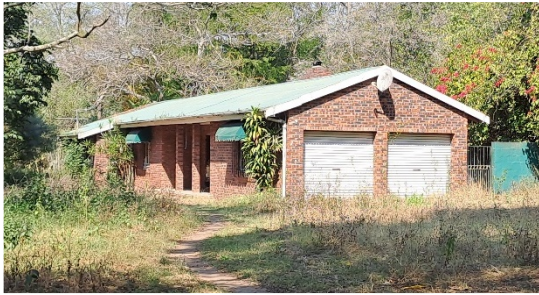
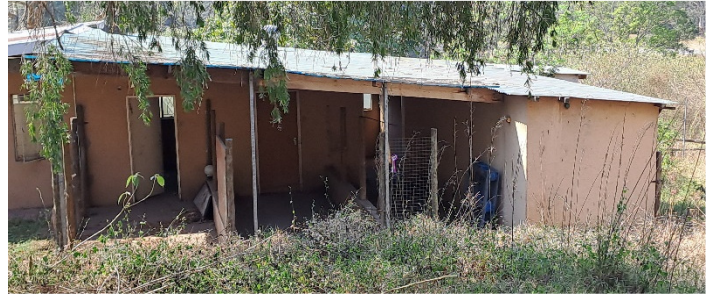
Erf 127 : Structures 1-4

Erf	Ref.	Description	Coordinates	Significance	Mitigation
127	1	Facebrick house and yard	-29.764624, 30.681372	Nil Younger than 60 years	No permit required for demolition
	2	Outbuilding – plastered concrete block construction	-29.764686, 30.681717	Nil Younger than 60 years	No permit required
	3	Outbuilding – plastered concrete block construction	-29.764825, 30.681668	Nil Younger than 60 years	No permit required
	4	Outbuilding – plastered concrete block construction	-29.764865, 30.681793	Nil Younger than 60 years	No permit required
200	5	Animal shelter (kennels)	-29.766466, 30.684299	Nil Younger than 60 years	No permit required
	6	Animal shelter	-29.766675, 30.684377	Nil Younger than 60 years	No permit required
	7	Animal shelter	-29.766851, 30.684470	Nil Younger than 60 years	No permit required
	8	Animal shelter	-29.766750, 30.684599	Nil Younger than 60 years	No permit required
	9	Animal shelter	-29.766792, 30.684902	Nil Younger than 60 years	No permit required

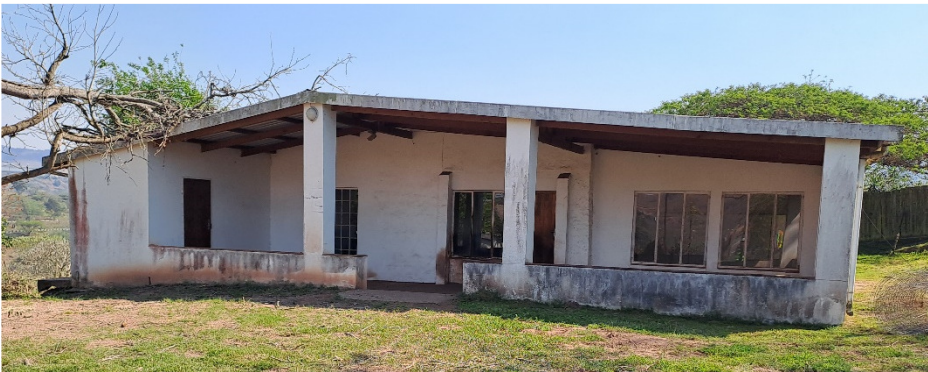
Erf 200 : Structure 11 (Peacevale Kennels)

10	Animal shelter	-29.766214, 30.684685	Nil Younger than 60 years	No permit required
	11	Ex. Residential/ admin building (Peacevale Kennels)	-29.766273, 30.685001	Appears on 1968 aerial photograph. Date of construction is unconfirmed.	Amafa to confirm if a permit is required for demolition

Only one structure (SD11) seems to appear on the 1968 aerial photograph. No structures appear in the same area on the 1953 aerial.

Since there are no building records, the photographic records are the only dating tool available. The age of the existing structure is deduced to be between 55 and 69 years old. The materials and finishes of the building indicate that it is younger than 60 years old.

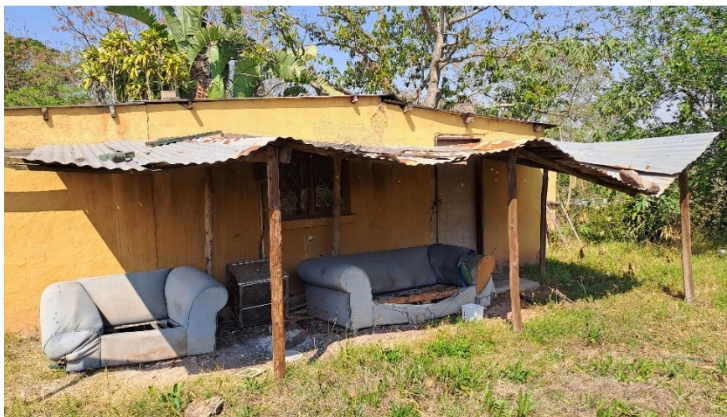
Erf Rem of 133 : structure 15

12	Animal shelter	-29.766181, 30.685220	Nil Younger than 60 years	No permit required
	13	Animal shelter	-29.766337, 30.685189	Nil Younger than 60 years	No permit required
	14	Animal shelter	-29.766653, 30.685348	Nil Younger than 60 years	No permit required
133	15	2 roomed dwelling – concrete block structure	-29.765869, 30.685493	Nil Younger than 60 years	No permit required
132	?			Nil Younger than 60 years	No permit required
145	16	Residential building	-29.767706, 30.687623	Nil Younger than 60 years	No permit required
	17	Residential building	-29.767978, 30.687636	Nil Younger than 60 years	No permit required
	18	Agricultural building	-29.768089, 30.687817	Nil Younger than 60 years	No permit required
	19	Agricultural building	-29.768402, 30.687954	Nil Younger than 60 years	No permit required
144	20	Wooden cabin	-29.768312, 30.688236	Nil Younger than 60 years	No permit required
	21	carport	-29.768328, 30.688309	Nil Younger than 60 years	No permit required

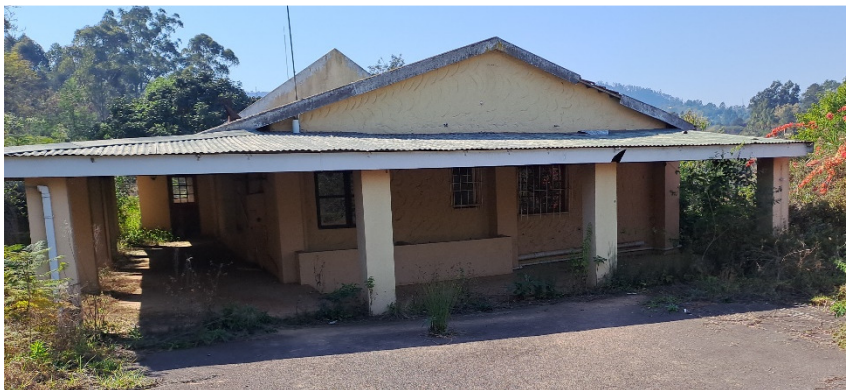
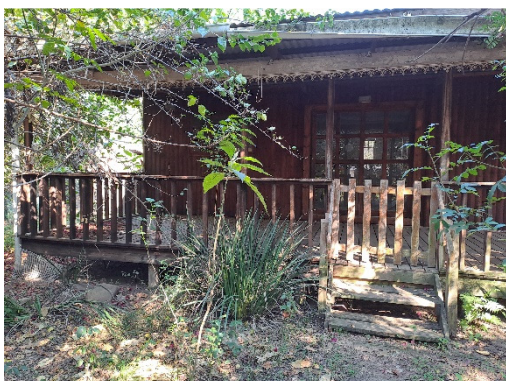
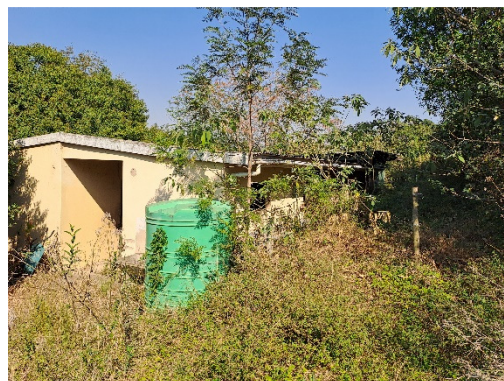
Erf 144 : Structures 20-24

22	Stables	-29.768500, 30.688223	Nil Younger than 60 years	No permit required

23	Residential building	-29.768297, 30.688743	Nil Younger than 60 years	No permit required
	24	garage	-29.768149, 30.688701	Nil Younger than 60 years	No permit required
139	25	Residential building	-29.770283, 30.690370	Nil Younger than 60 years	No permit required
	26	House and farm workshops	-29.770111, 30.690809	Nil Younger than 60 years	No permit required
	27	Outbuilding	-29.770179, 30.691067	Nil Younger than 60 years	No permit required
	28	Outbuilding	-29.770135, 30.691235	Nil Younger than 60 years	No permit required
	29	Outbuilding	-29.769992, 30.691205	Nil Younger than 60 years	No permit required
	30	Outbuilding	-29.770165, 30.691385	Nil Younger than 60 years	No permit required

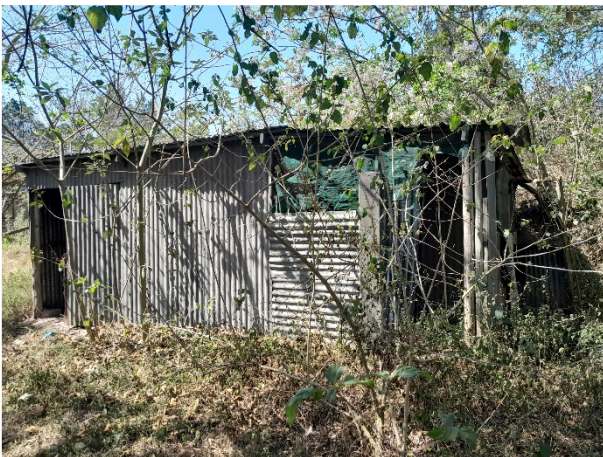
Erf 132

All structures were inspected for any signs of older materials, most were of concrete block construction with fittings and finishes commonly used in the 1970's. No sign of older materials or remains of older structures were found.

All structures and remains of structures are recommended as "Not Conservation Worthy".
