## **APPENDIX H**

Freshwater Impact Assessment

## **Environmental Impact Assessment of Founders Estate 5 Tented Camp, Boschendal Estate**

### **Freshwater ecosystems**

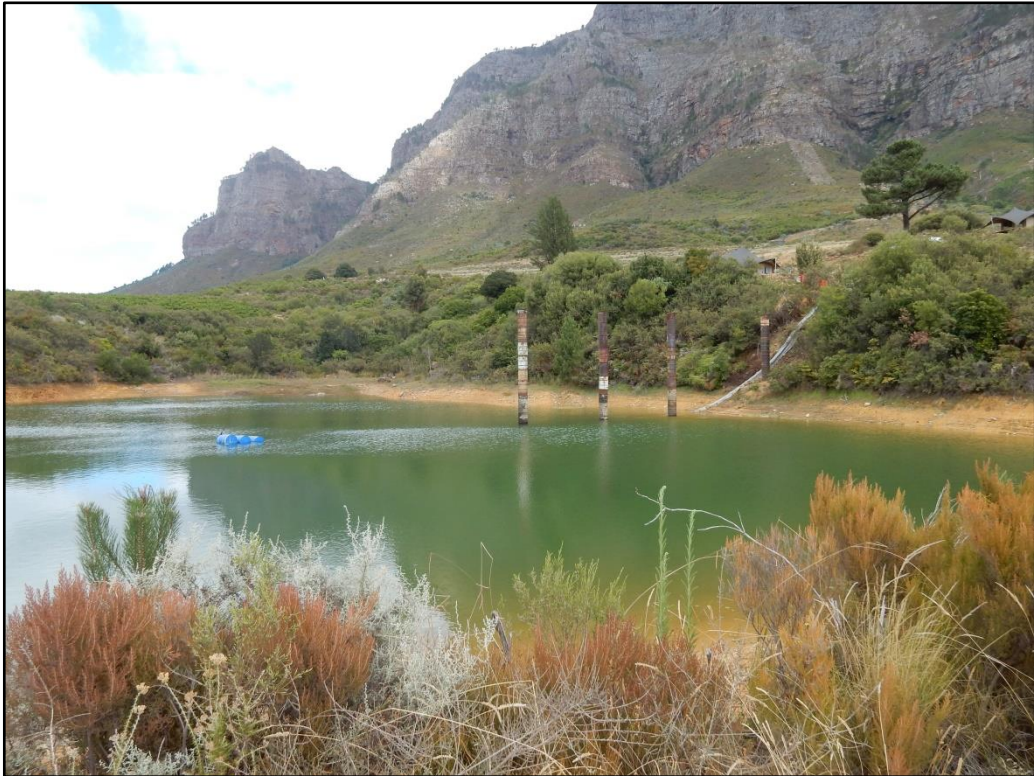
**Figure 2.1** Farm dam into which Stream 1 flows. The riparian vegetation around Stream 1 continues around the margins of the dam, and can be seen here. The Tented Camp can be seen in the background.

The “Tented Camp” site is located adjacent to Stream 1, as mapped in 2007 and 2019. Stream 1 is a tributary of the Werda River, which ultimately flows in the Berg River. The riparian area around Stream 1 is typical of mountain streams in this area (see Section 3 for a description of the plant species characterising the riparian area). Stream 1 has good water quality (visual assessment) and seasonal surface flow.

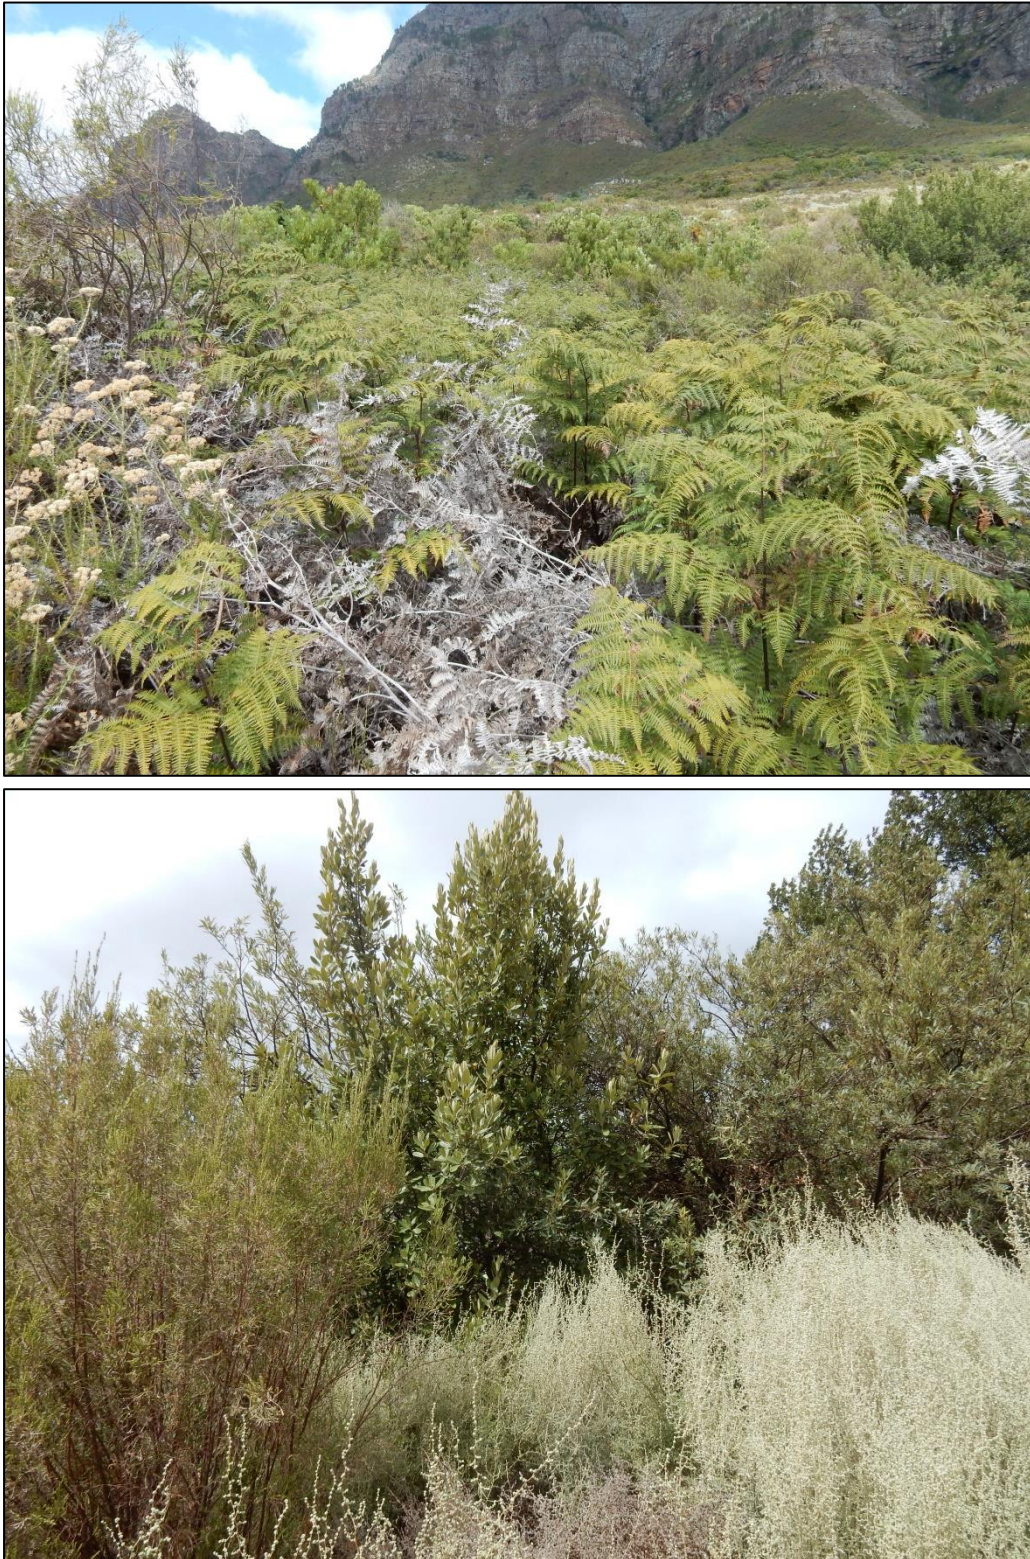
**Figure 3.1** (Top) Bracken and (bottom) tree species – *Kiggelaria africana* (middle), *Olea europaea* subsp. *africana* (right) and *Searsia angustifolia* (left) – typical of the riparian areas on the Tented Camp site, Boschendal Estate. The *Seriphium plumosum* (slangbos) in the foreground is characteristic of the more terrestrial vegetation.

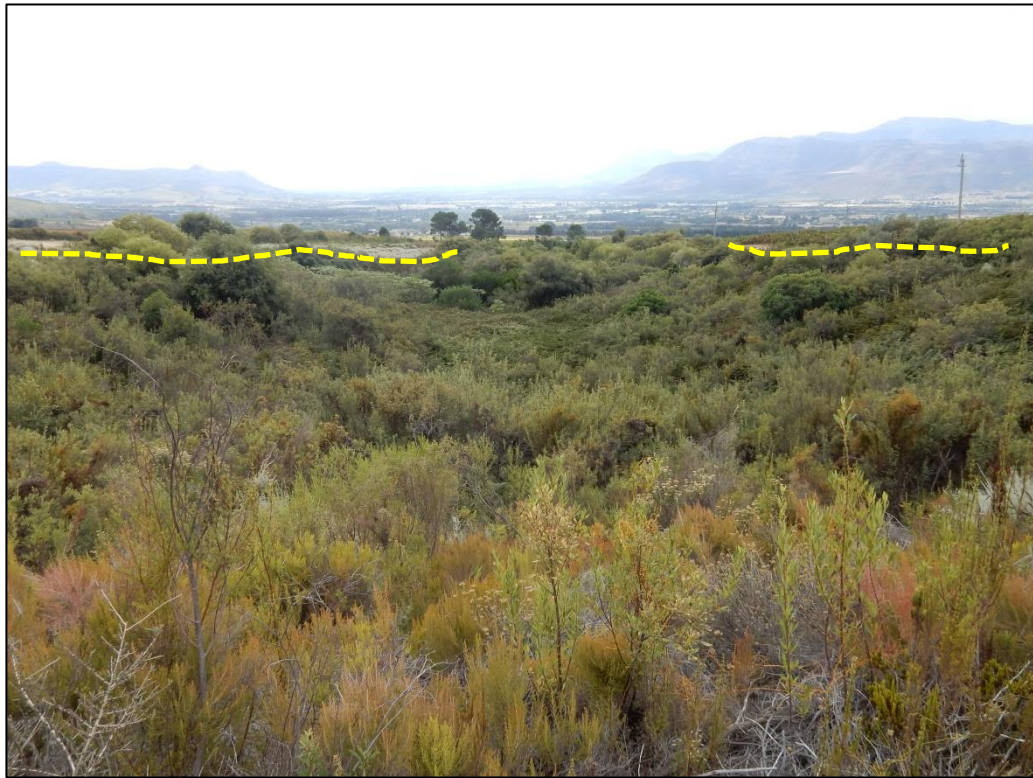
**Figure 3.2** Riparian area below the dam wall at the Tented Camp site, showing the clear boundary between riparian and terrestrial vegetation (the pale grey *Seriphium plumosum*) (yellow dashed line).

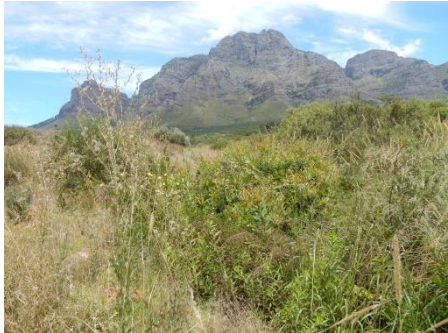
Water-courses <sup>1</sup>	Watercourse type (geomorphological zone)	Comments	Photograph	PES Category	Ecological Sensitivity & Importance Category
Upper Stream 1 (above the farm dam at the Tented Camp site)	Mountain stream with associated riparian area	Stream flows down the slopes of the Simonsberg mountains, with a dense riparian growth of indigenous trees and shrubs with a few alien trees, such as pines. Water quality is good; and flow seasonal to ephemeral.

<p>Riparian area of the upper reaches of Stream 1</p>	A	High
Upper Stream 1 (below the farm dam)	Upper foothill stream with associated riparian area	Stream flows below the farm dam for some distance and then is diverted to flow around agricultural fields.

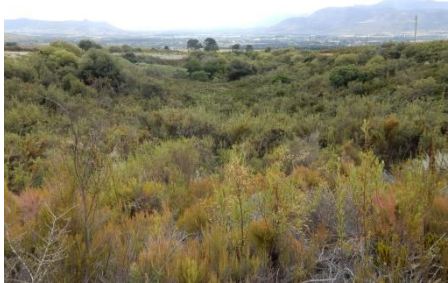
<p>Riparian area in Stream 1 below the farm dam</p>	C	High

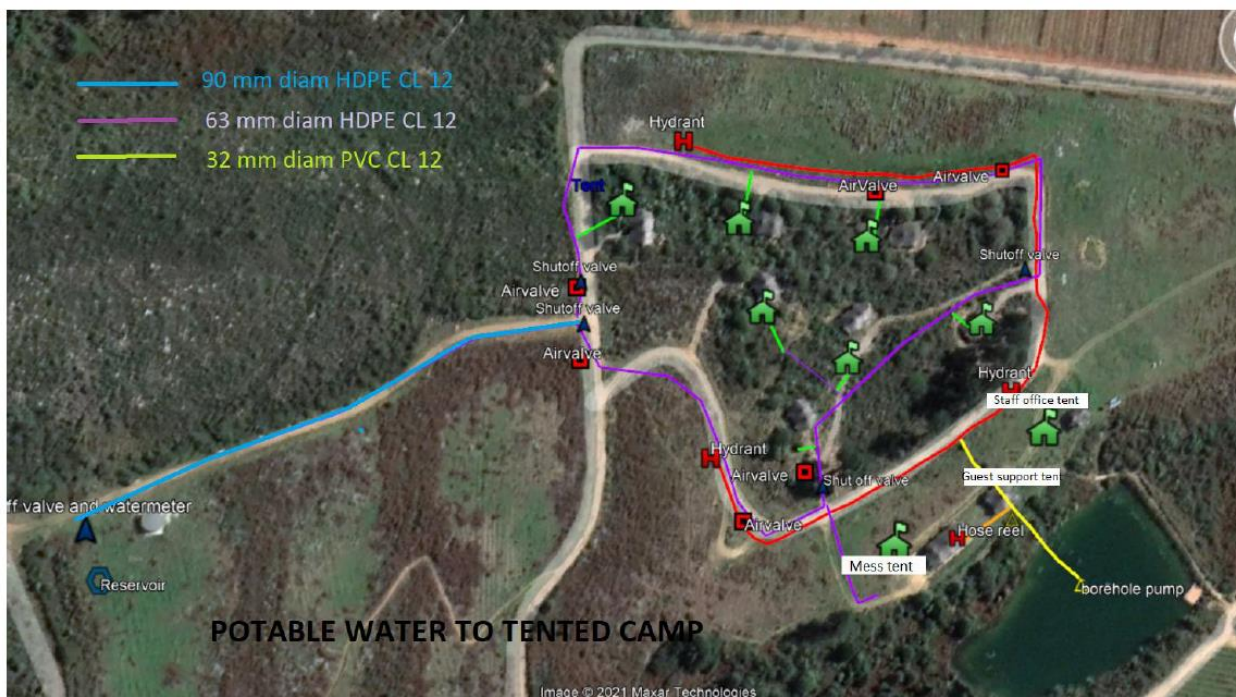
Figure 7.1 Potable water layout for the Tented Camp site.

Potable water is supplied from a reservoir some distance uphill of the site (at 413 mAMSL). A gravity supply line runs from the reservoir to the site, and then splits into the internal network (Figure 7.1). The reservoir and supply line were constructed for the development. Water is supplied to the reservoir from a natural spring close by, that provides a consistent supply of water throughout the year. An in-line aggregate filtration system and water purification system has been installed to improve water quality. A new in-line

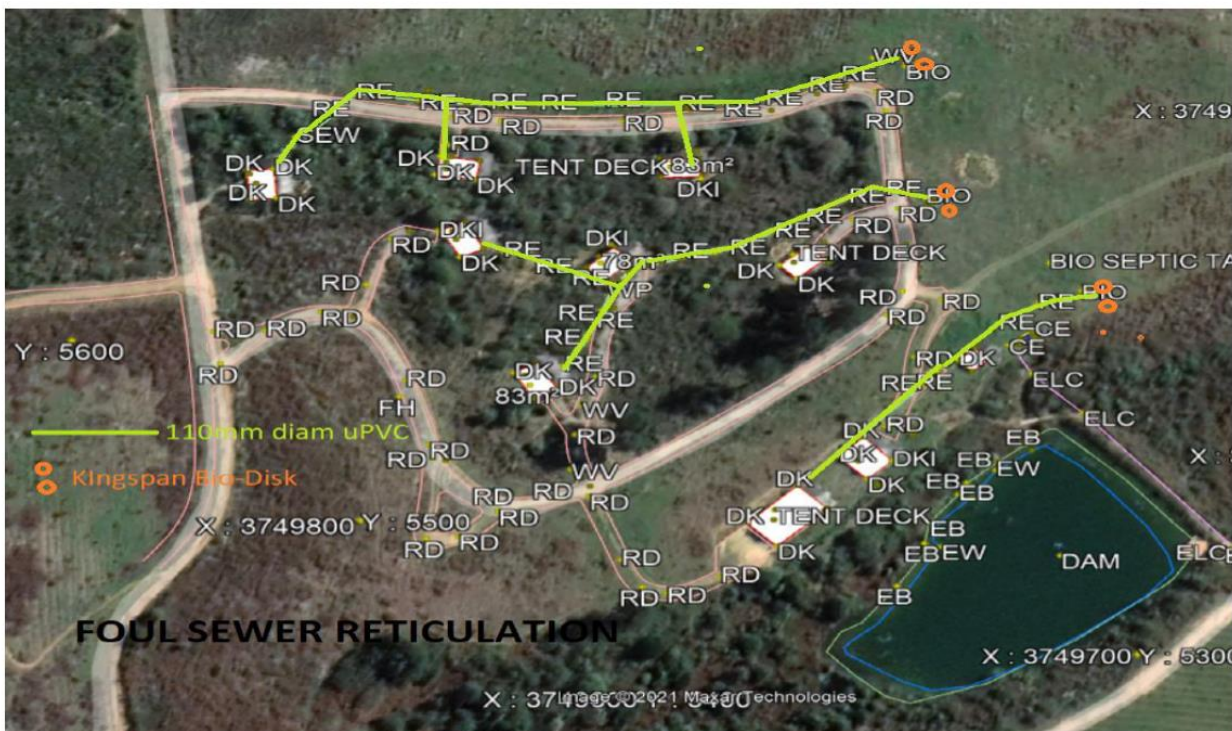
Figure 7.2 Sewer reticulation system at the Tented Camp site.

It is recommended that the treated effluent be discharged to a soakaway below each treatment Unit. This will allow for additional treatment of the effluent before it is allowed to seep into the soil and, finally, the watercourse. The soakaway should be located outside of the ecological buffer around the riparian area. It is not recommended that the effluent be discharged directly into the watercourse, riparian area or the dam.

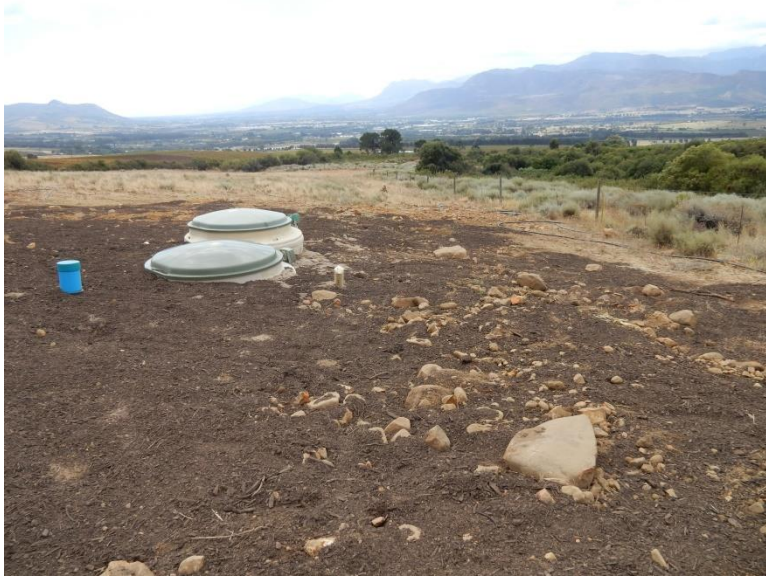
**Figure 7.3** Above ground component of the BioDisc domestic sewage treatment plant (BA model), located at the Tented Camp site.

**Table 7.1** Chemical parameters of the treated effluent discharged to ground or a watercourse from the BioDisc treatment unit.

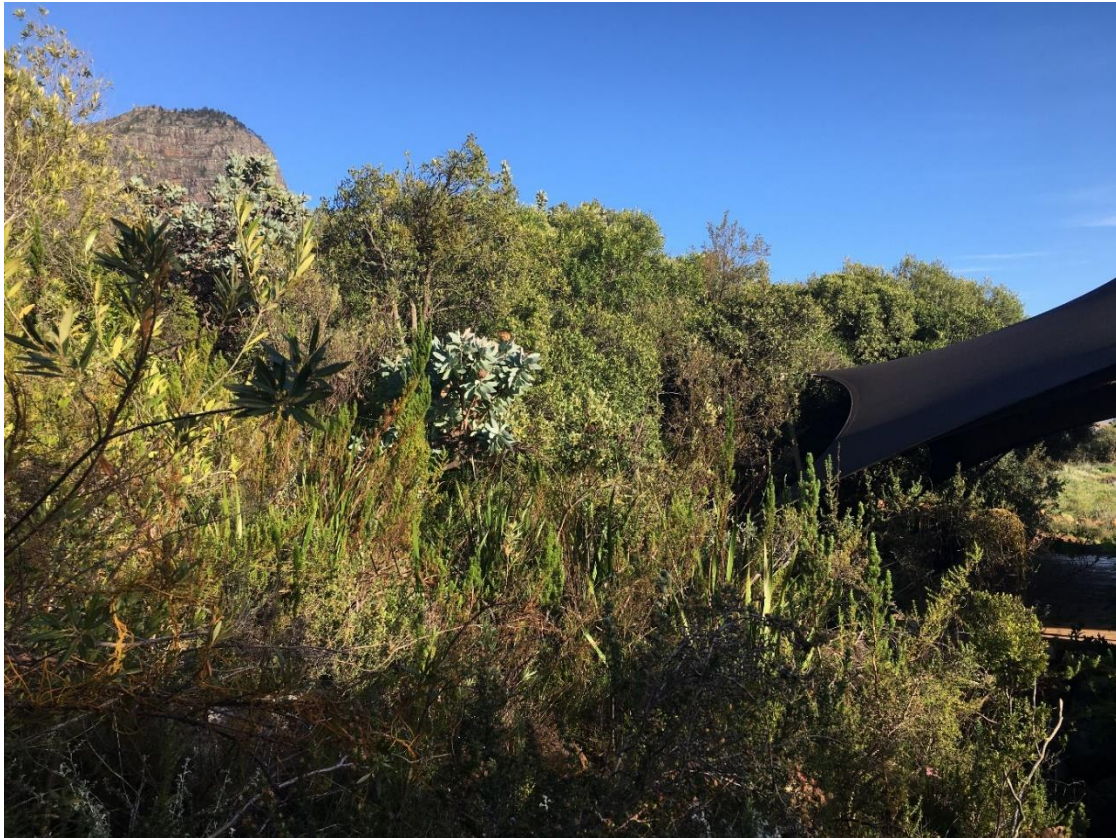
**Figure 4.3: Near intact Boland Granite Fynbos at tent 6**

In the centre of the project area where the seven tent platforms are located, is a patch of Boland Granite Fynbos (referred to as the “impacted patch of Boland Granite Fynbos”) (Figure 4.3). The north-western portion of this patch (where tents 4, 6 and 7 are located) is characterised as near intact with species such as *Cliffortia ruscifolia*, *Hermannia hyssopifolia*, *Leucadendron salicifolium*, *Osteospermum moniliferum*, *Searsia angustifolia* and *Dicerotheramnus rhinocerotis* present. *Searsia angustifolia* (a small tree species) was also present within the patch. The eastern portion of this patch is more degraded and has a higher number of alien invasive species (Figure 4.5 and Figure 4.5). On the eastern edge of this patch is a stand of large pine trees (Figure 4.6). Refer to Figure 4.3 which shows the distribution of the vegetation in relation to the tent platforms.

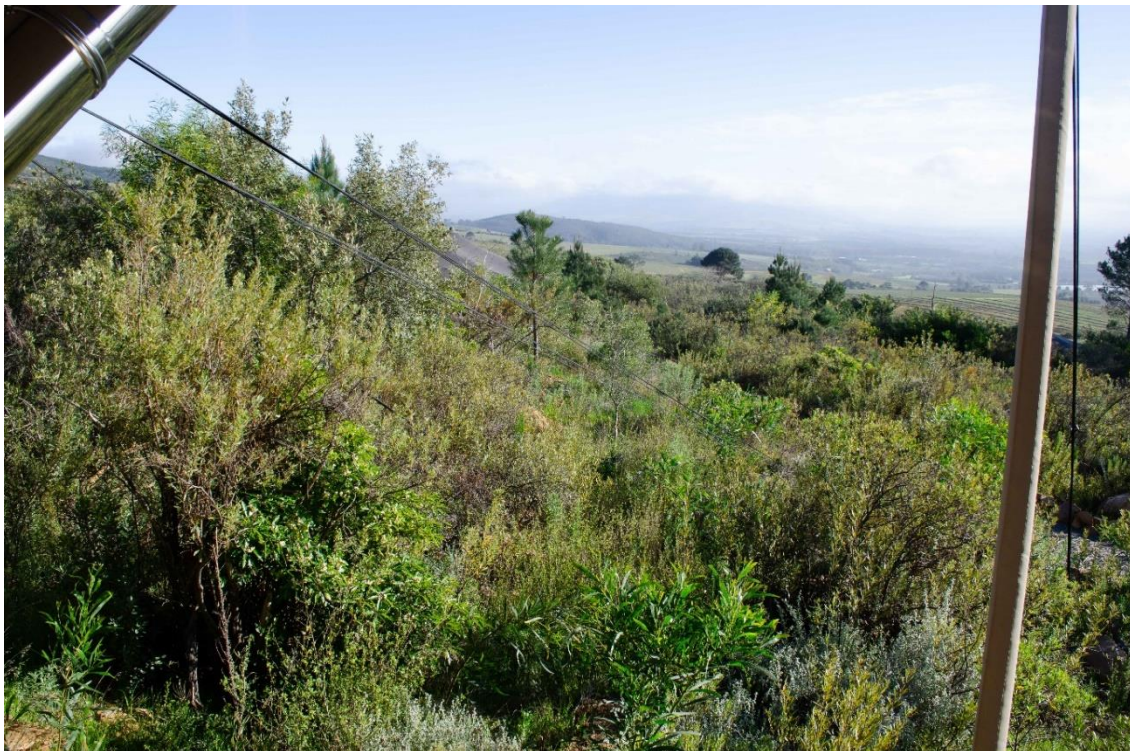
**Figure 4.4: Degraded Boland Granite Fynbos**

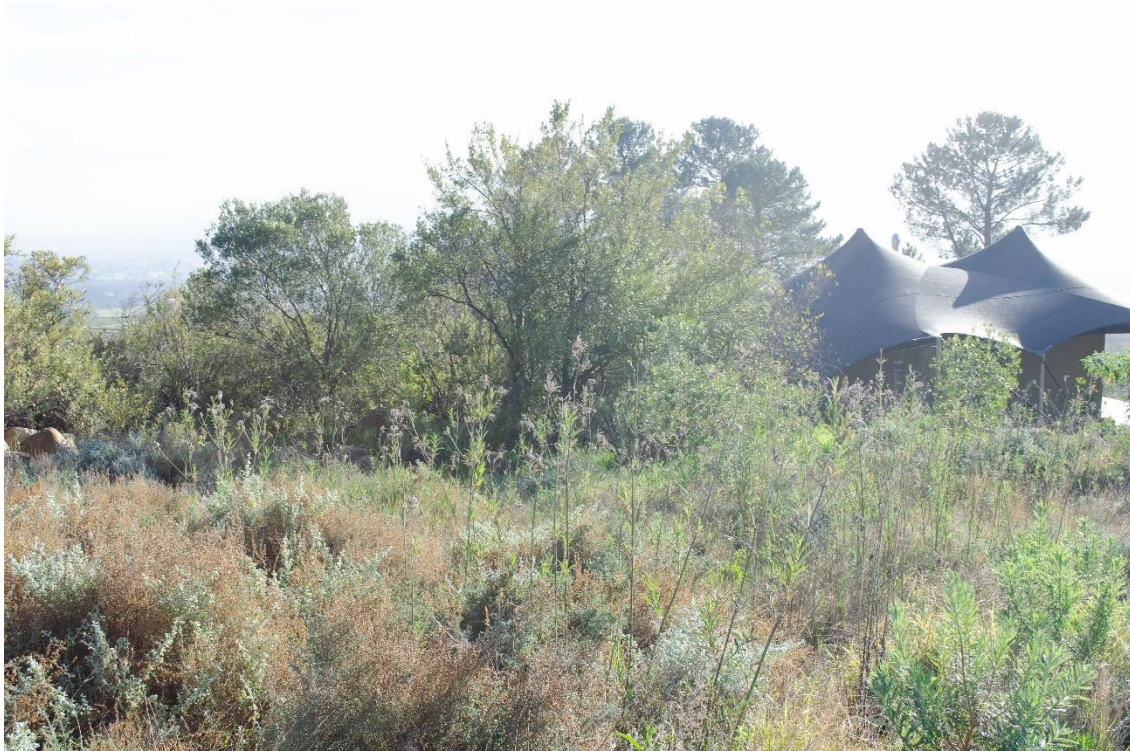
**Figure 4.5: Degraded Boland Granite Fynbos**

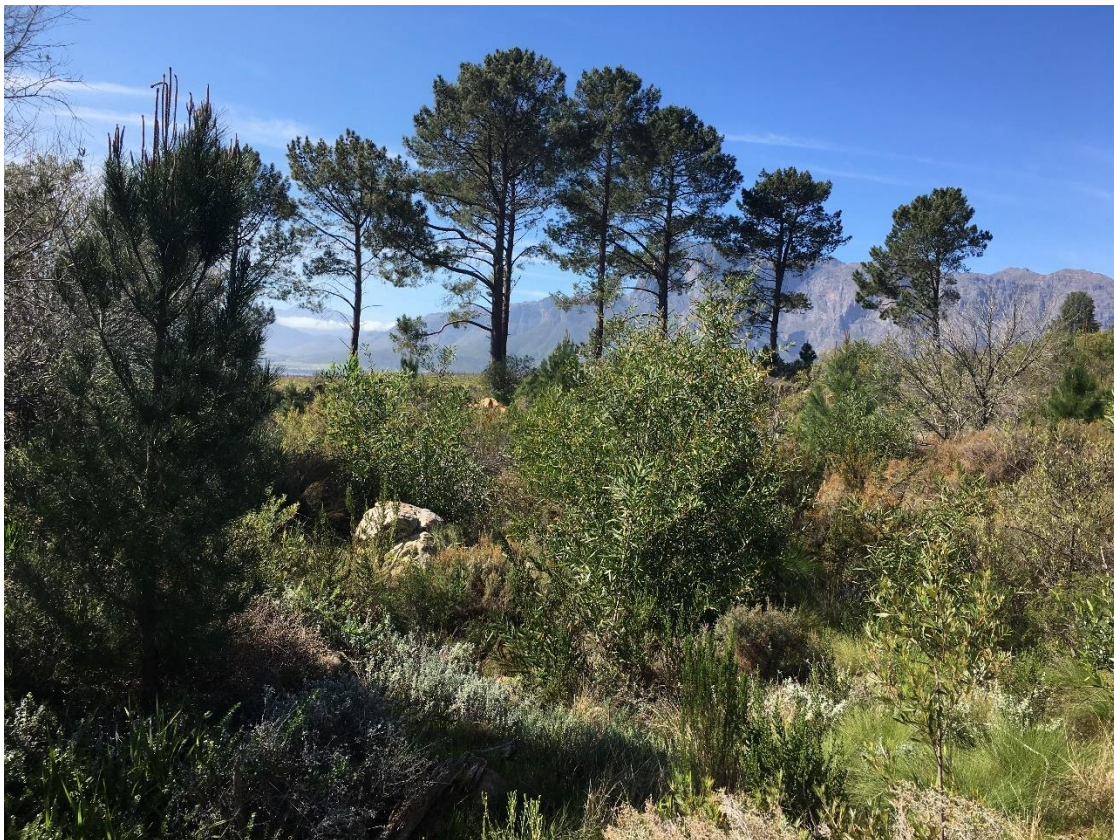
**Figure 4.6: Degraded Boland Granite Fynbos in the foreground with the stand of pine trees in the background. The foreground is infested with alien species such as *Acacia longifolia* and *Pinus sp.***

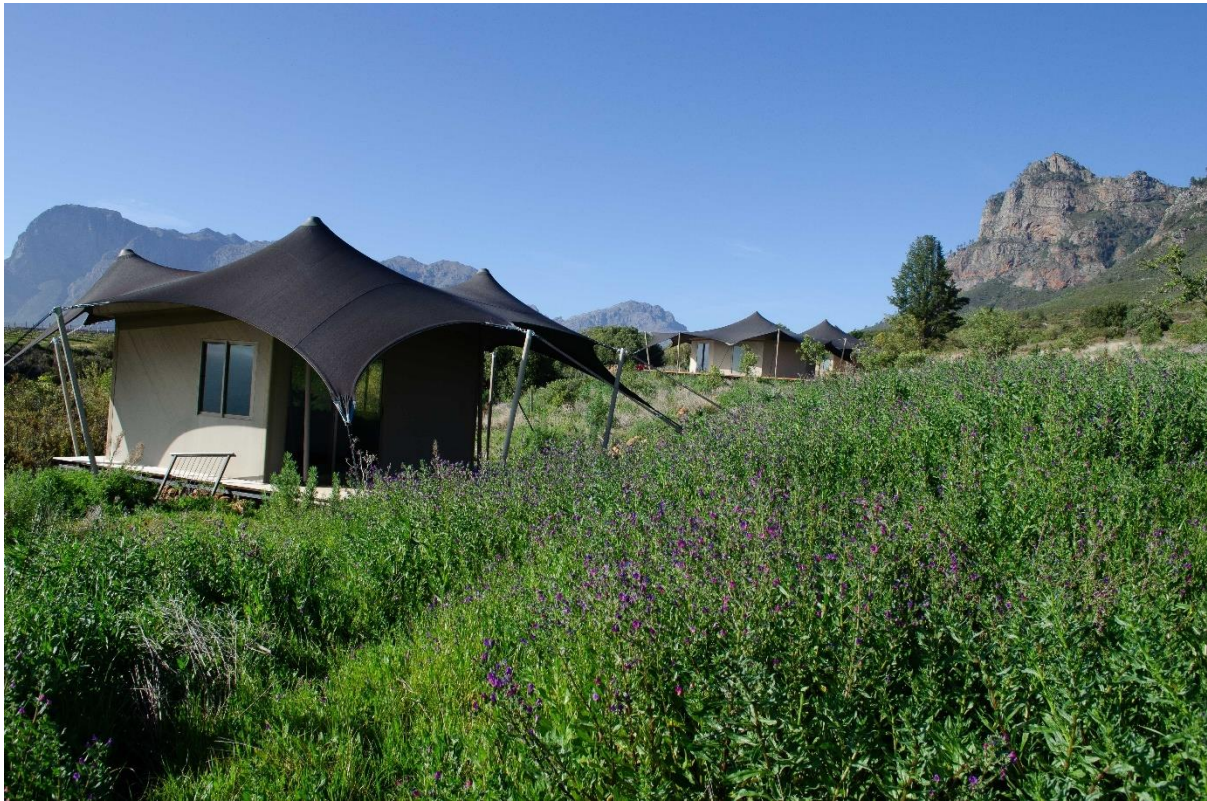
**Figure 4.7: Transformed area where the Mess Tent (platform 8), Guest Support Tent (platform 9) and Staff Office Tent (platform 10) are located**

The Mess Tent (platform 8), Guest Support Tent (platform 9), Staff Office Tent (platform 10) and power boxes are all located in an area that was previously transformed. Based on historical imagery, this area was once an agricultural field used for crops. These areas are now covered in lupins, grasses and species such as *Echium plantagineum*, *Verbena bonariensis* and *Acacia longifolia*.

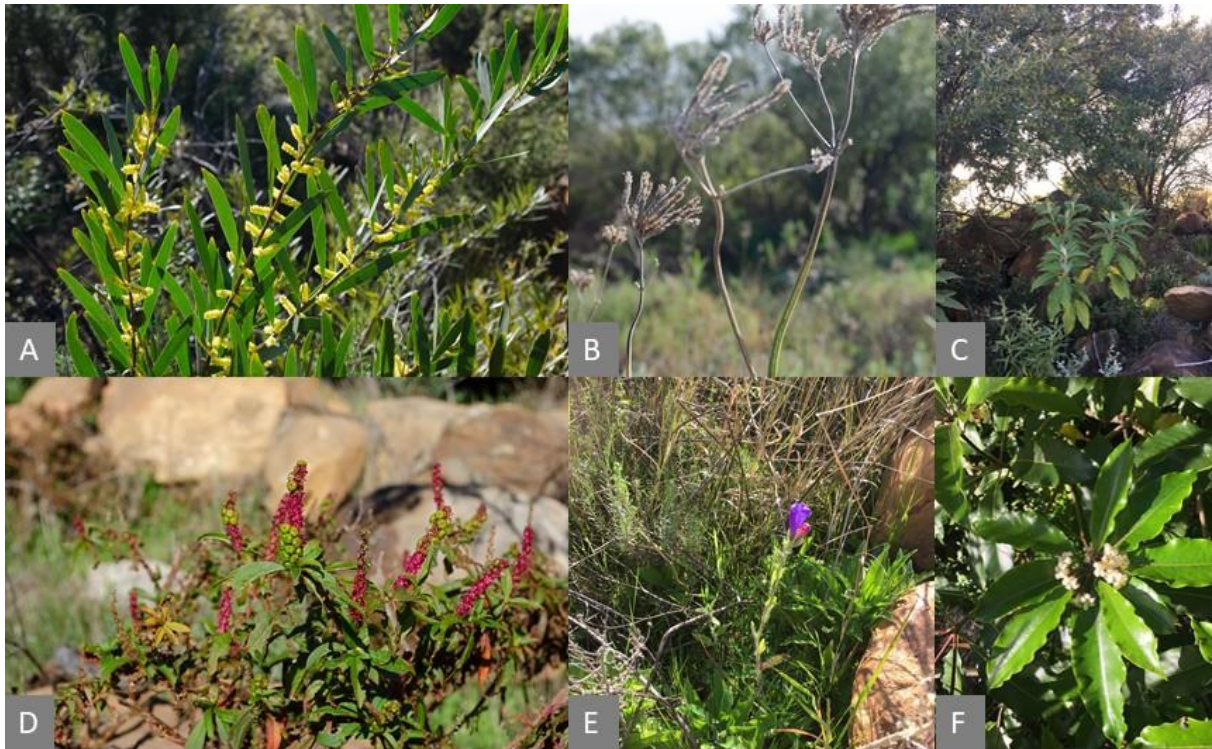
**Figure 4.9: Alien invasive species recorded within the project area. A) *Acacia longifolia*, B) *Verbena bonariensis*, C) *Solanum mauritianum*, D) *Phytolacca octandra*, E) *Echium plantagineum* and F) *Pittosporum undulatum***

Seven alien invasive species classified as Category 1b on the National Environmental Management: Biodiversity Act (2004) Alien Invasive Species Lists, 2020 were recorded within the project area (refer to Table 4.3 for a list of species and Figure 4.9 for images of six of the seven species). Of relevance to this site is that allowing the spread of a category 1b species is prohibited. An alien invasive management plan for the removal of this species will thus be required as part of the EMPr.

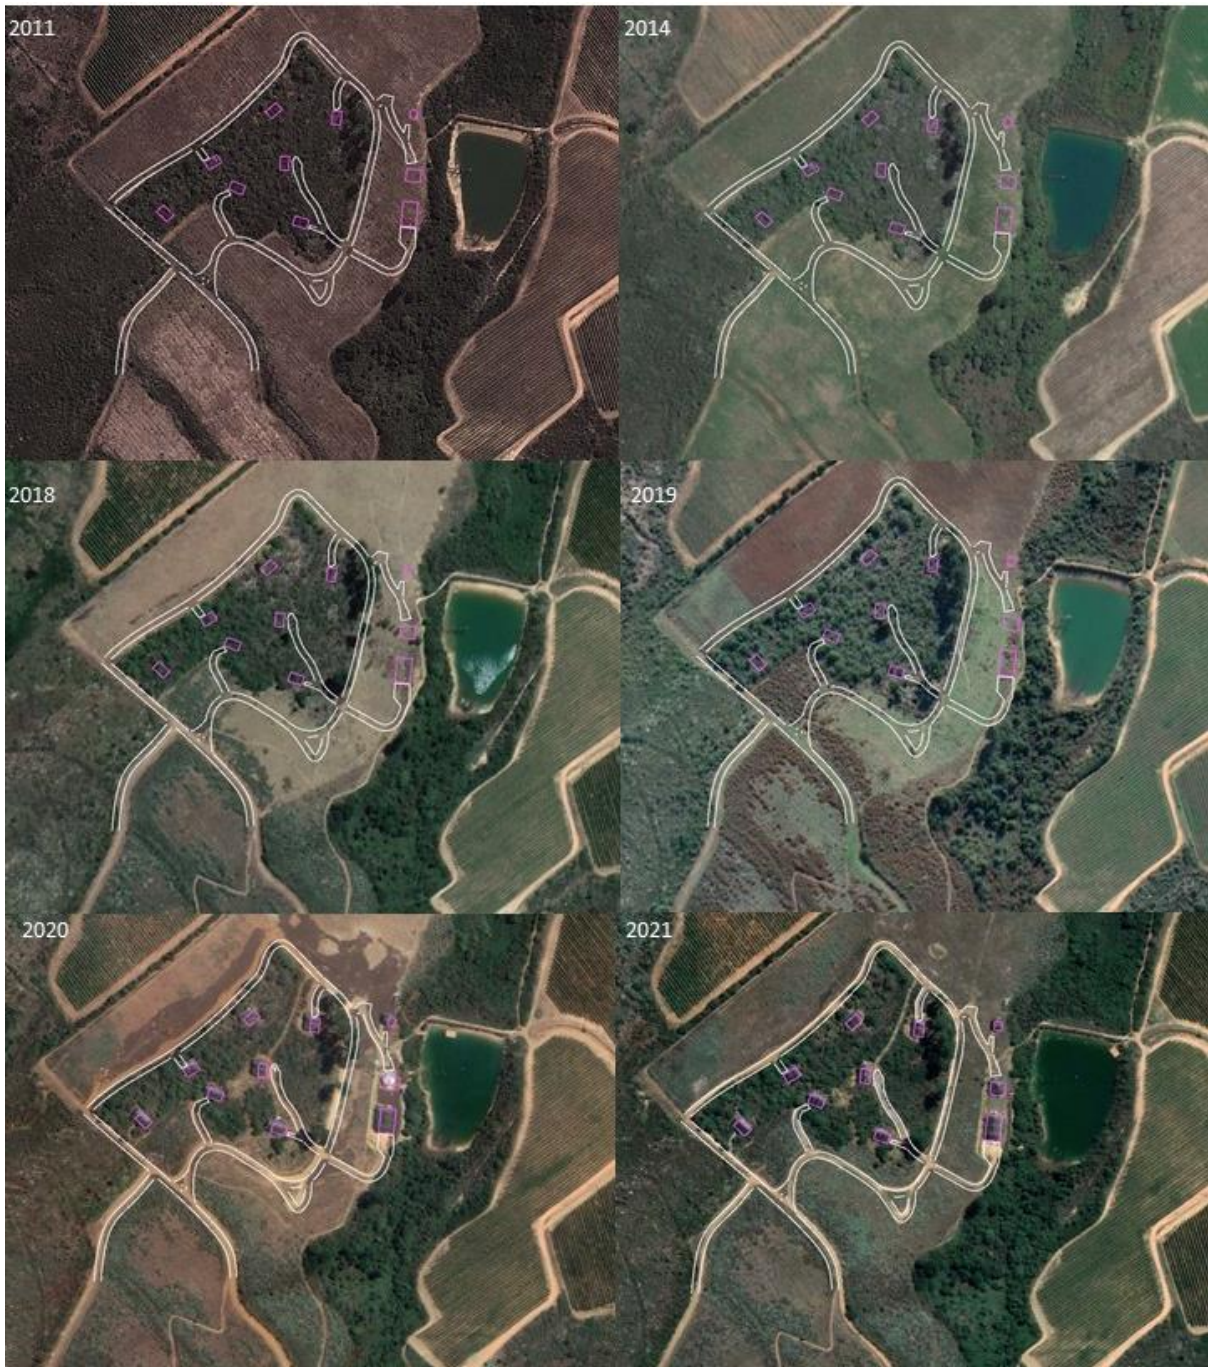
**Figure 7.1: Historical satellite imagery of the project site for 2011, 2014, 2018, 2019 (construction), 2020 and 2021.**

Since construction of the site started without Environmental Authorisation and this ecological assessment was undertaken once clearing and construction had commenced, historic satellite imagery was consulted to assist with determining potential impacts (Figure 7.1). The imagery shows that the impacted patch of Boland Granite Fynbos has remained almost static since at least 2011 and the area to the immediate north, east and south has been used for agriculture for just as long. Edge effects on this patch of fynbos, which are likely to have contributed to the introduction of alien invasive species, have been present since before the development of the site in 2019.

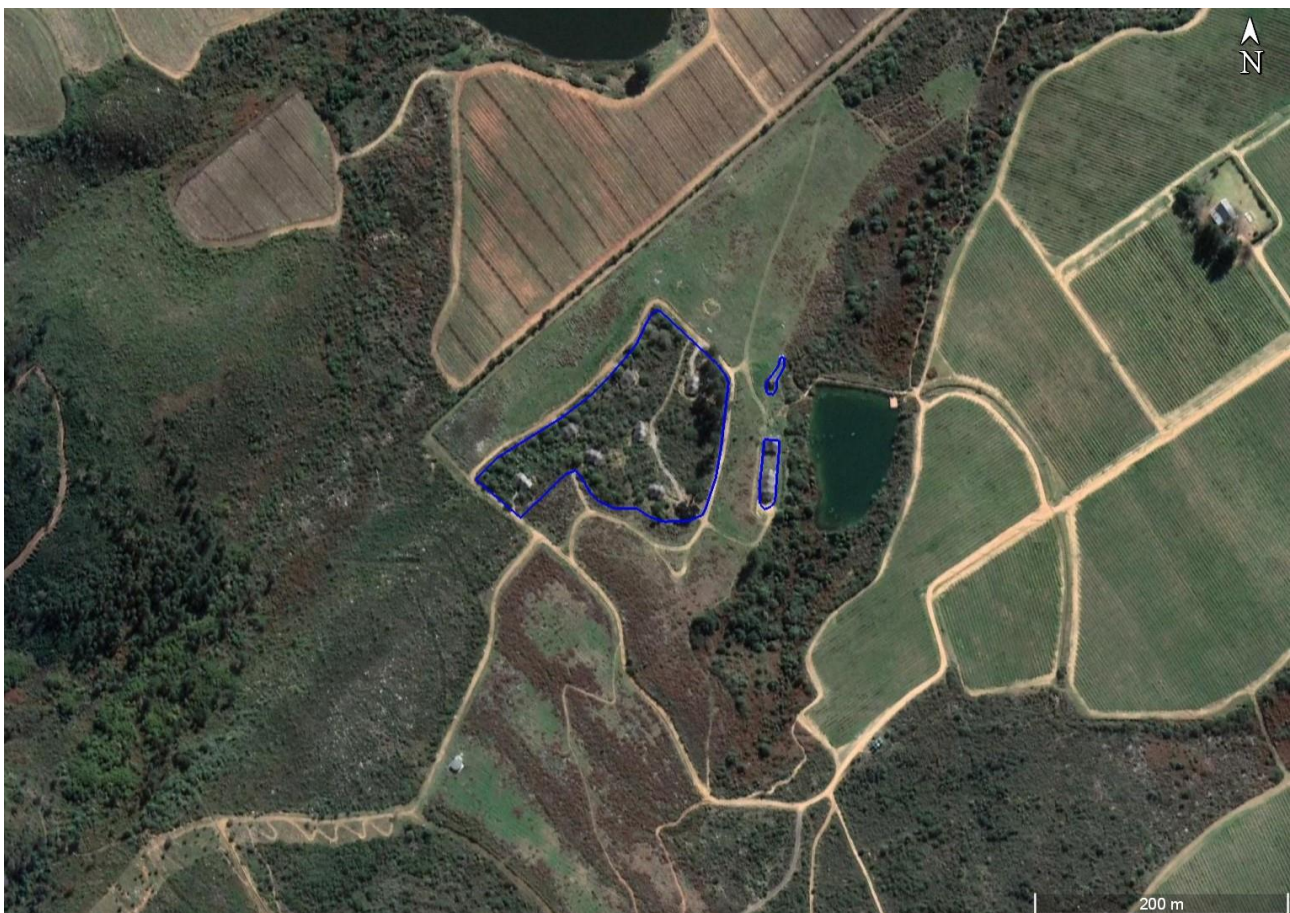
**Figure 1.** The footprint of the camp development (blue outline) on Boschendal Wine Estate.

A map of the proposed development overlaid on the screening tool sensitivity is given in Figure 2. The depicted footprint of the camp in Figures 1 and 2 comprises the main body of the camp which is located in land that has never been utilised for agricultural production because of the limitations imposed by large boulders and very rocky soils. Two tents to the east are located in ex vineyard land. Vines were removed from all of the surrounding lands at this altitude before 2009 because these lands were not considered to be sufficiently suitable for quality wine production. This land is rated as high agricultural sensitivity by the screening tool because it is classified as cultivated land. It has not however been cultivated since 2014, and so should no longer be classified as cultivated.

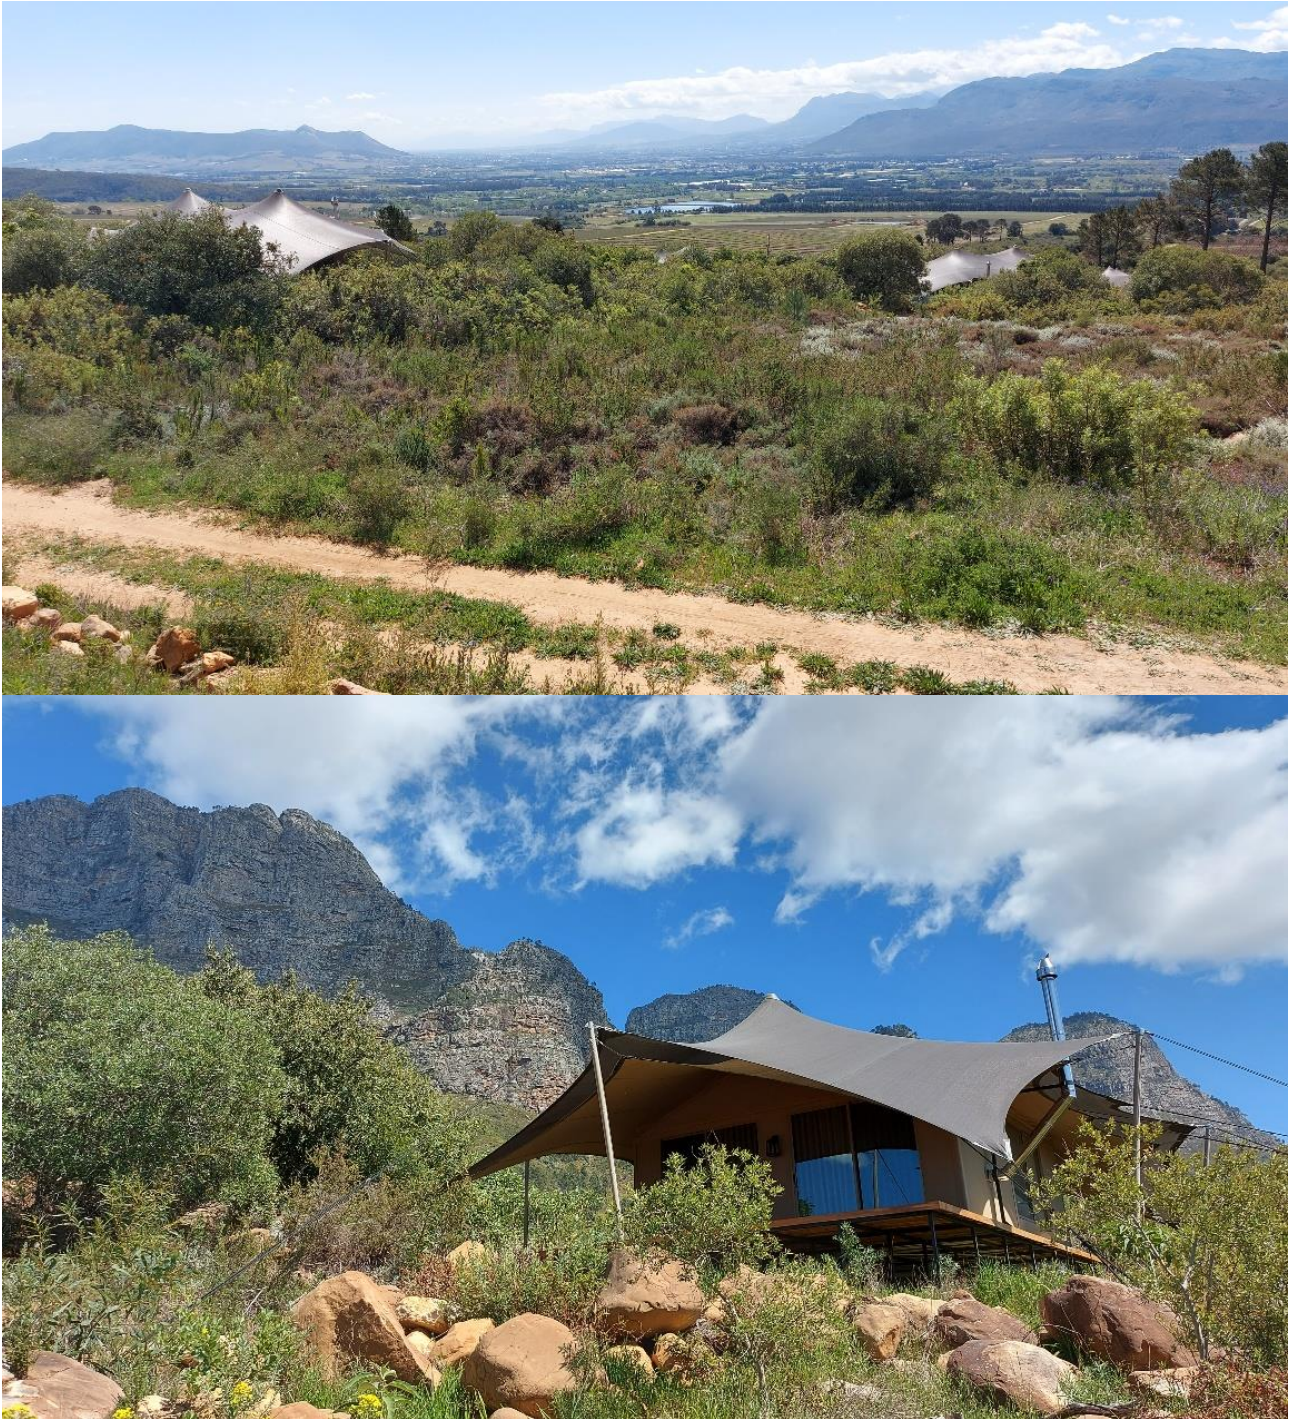
**Figure 3.** Photographs showing the bouldery land on which the camp is located.

extremely limited by large boulders and very rocky soils (see Figure 3). Such soils do not justify a land capability rating of more than 7, which would translate to an agricultural sensitivity of medium.

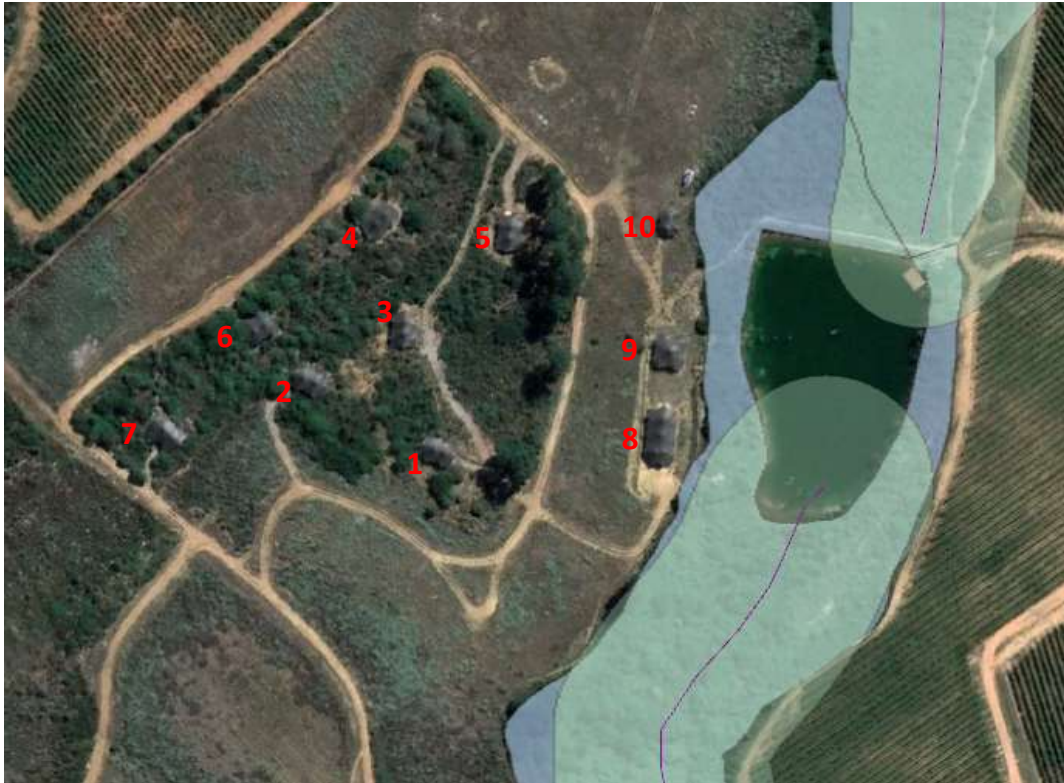
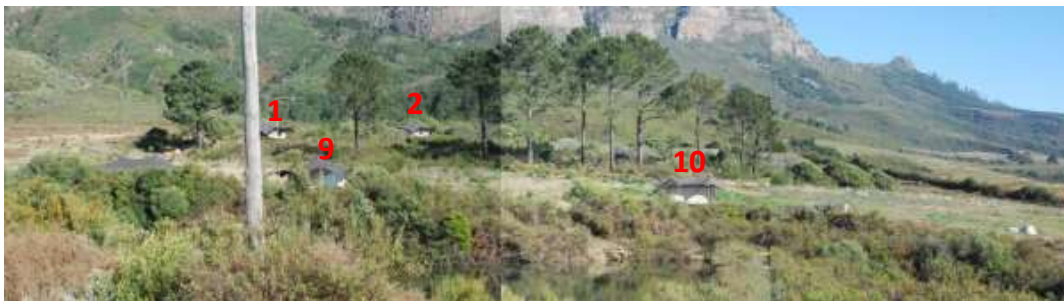
View from across the dam showing visibility of Tent Structure 1 and 2, 9 and 10.

Figure 21: *Visible tent locations to be considered for planting mitigation (NMA, 2021)*

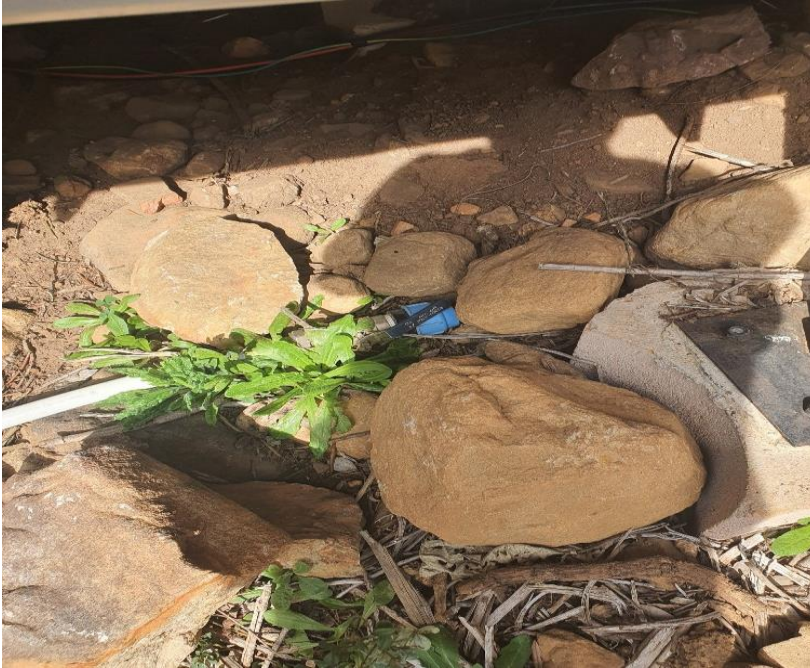
Each accommodation unit is then connected to the ringmain with a 32mm diam PVC unit connection.

32mm PVC water connection to each unit with lever action isolating valve

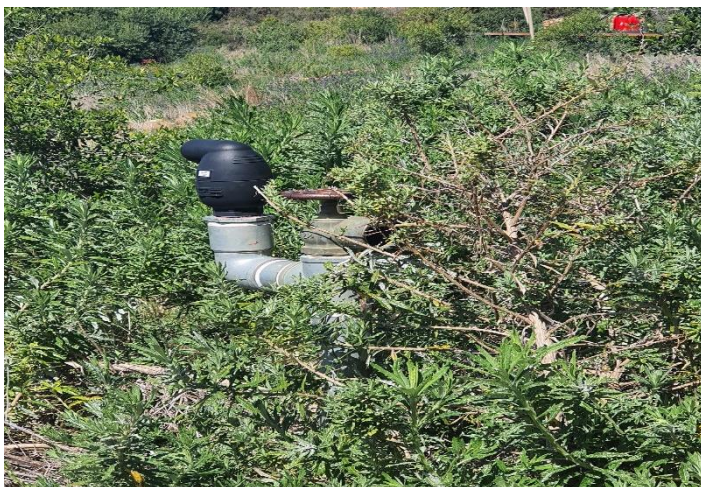
The water pressure is unknown at this stage. The system will be checked to ensure that at least a constant 4 Bar pressure and the required flow is achieved at each fire hydrant standpipe.

Typical hydrant standpipe .  
There are 4 strategically placed around the units

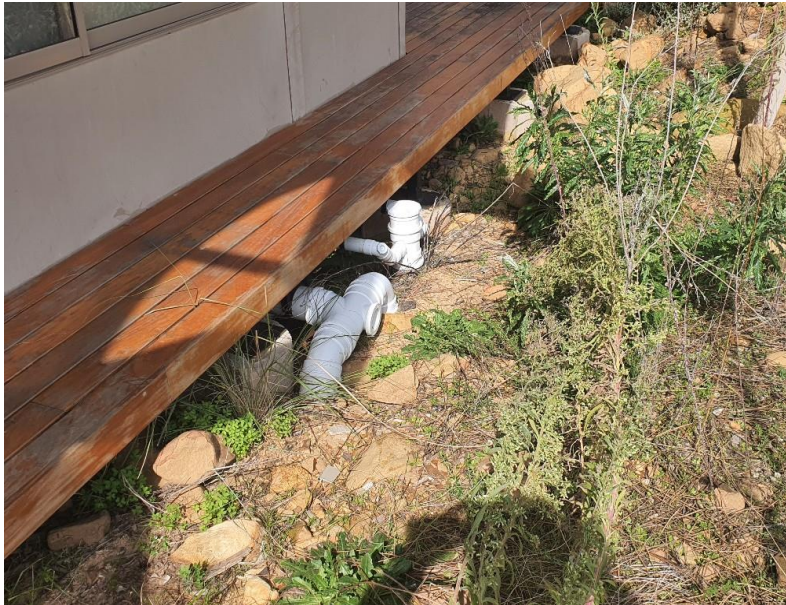
Each unit is connected to a 110mm diam uPVC sewer main that flows under gravity flow to the Kingspan Bio-disk unit.

Individual units connected to sewer mains

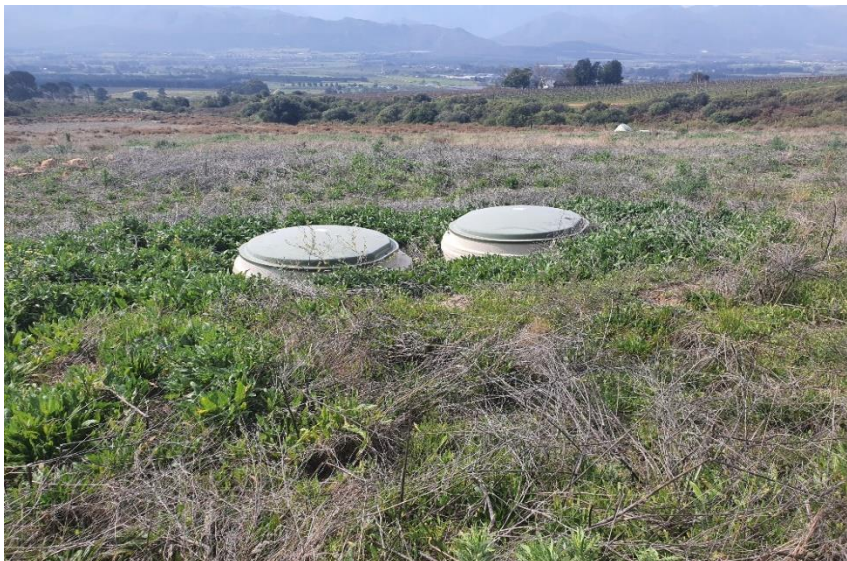
The Kingspan Bio-disk system is an Internationally accepted sewerage treatment system. The system used for the tented camp treats the raw effluent via its patented system to liquid discharge quality of “General Limits”.

Current bio-disc system in the landscape

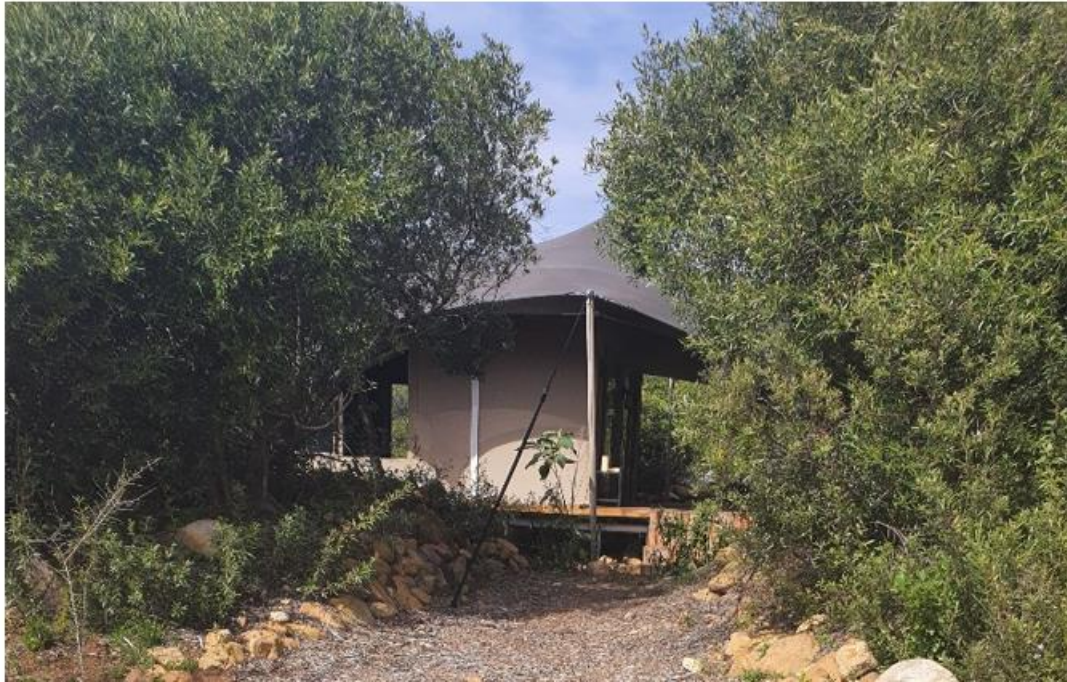
The free-form tented structures discharge stormwater onto the ground and this flows naturally into the landscape.

General rainfall flows naturally into the landscape.

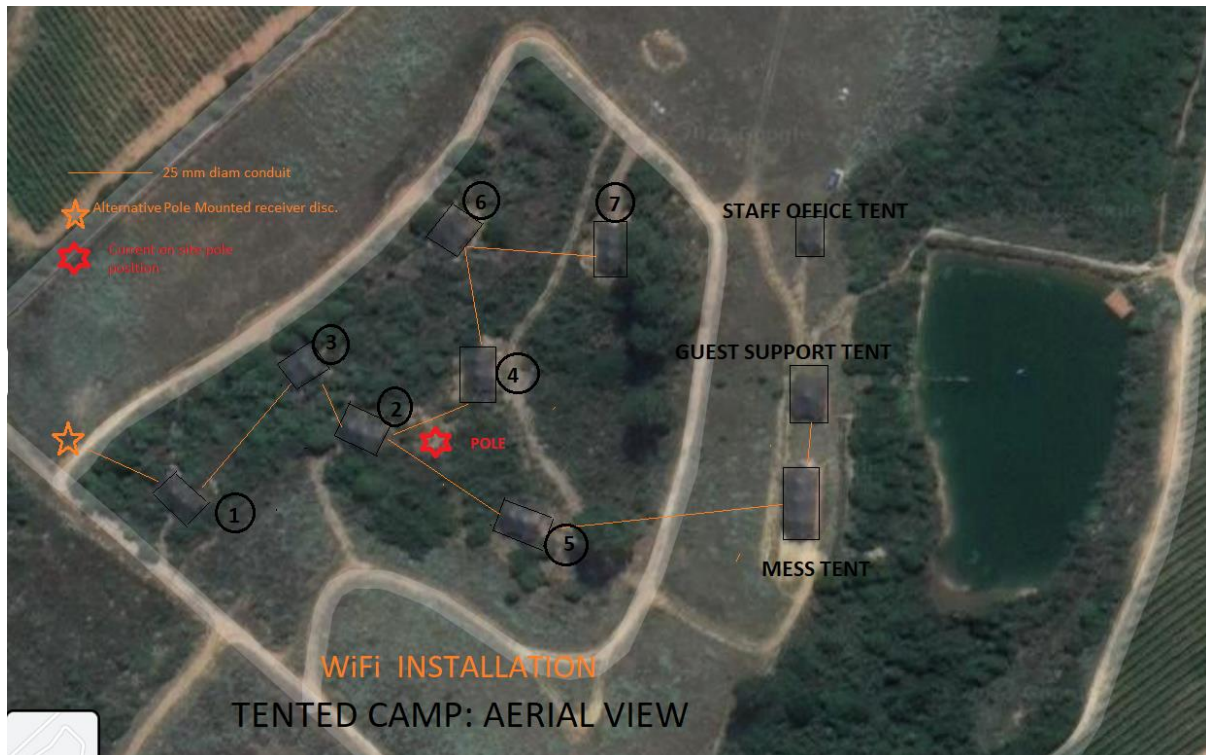
WiFi has been provided as per the attached image above.

- Reticulated 25mm black conduit as shown above. This conduit will be buried at the “road” crossings at a shallow depth of 500mm and will be loose laid through the vegetation connecting the various tents.
- The conduit will contain the ethernet cables. There are no power cables in these conduits.
