## **APPENDIX H**

Freshwater Impact Assessment

## **Environmental Impact Assessment of Founders Estate 5 Tented Camp, Boschendal Estate**

### **Freshwater ecosystems**

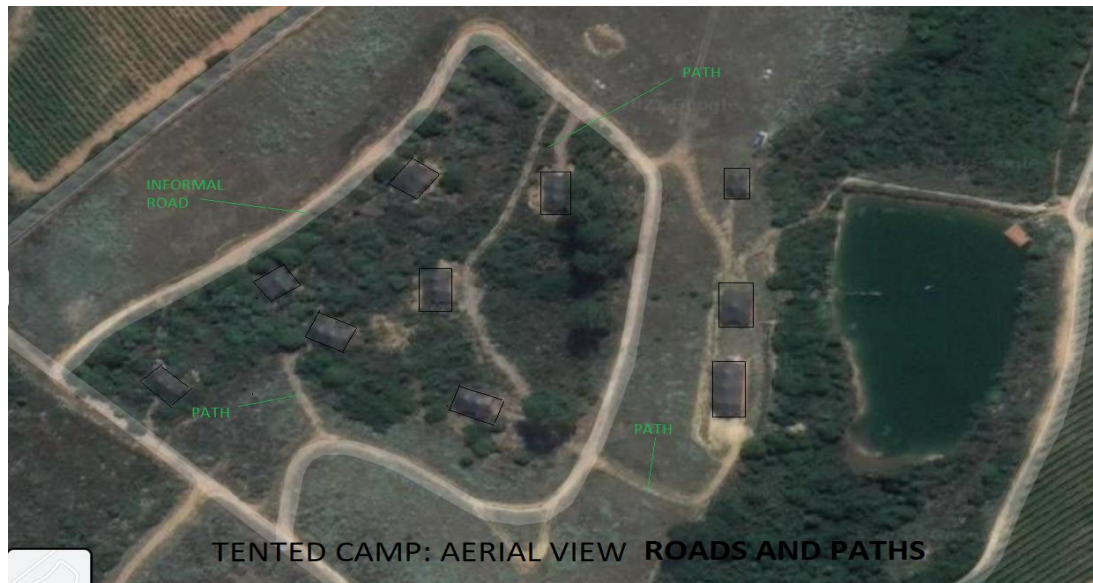
The road network is informal and as shown on the image above.

There has only been vegetation removal in the road reserve areas and the roads follow the natural terrain and contours.

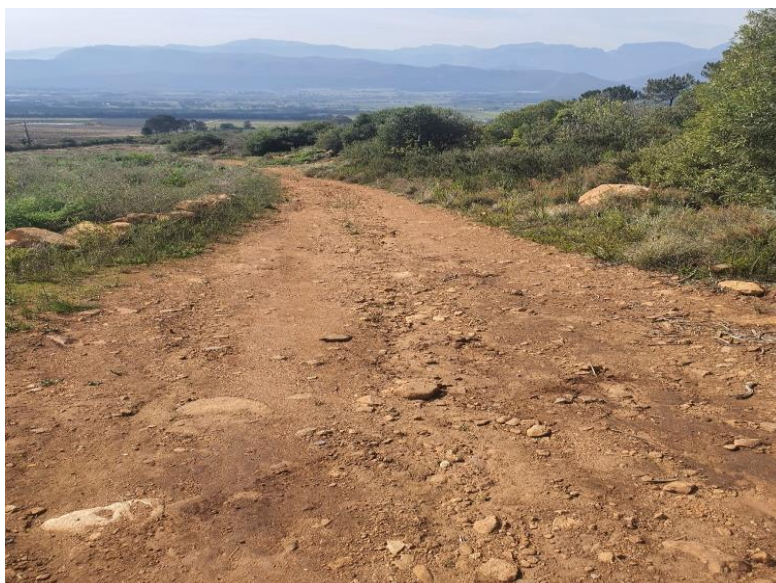
Typical ring road
