## Ngwenya Lodge Extention: Wetland and Riparian Zone Identification and Description

November 2017

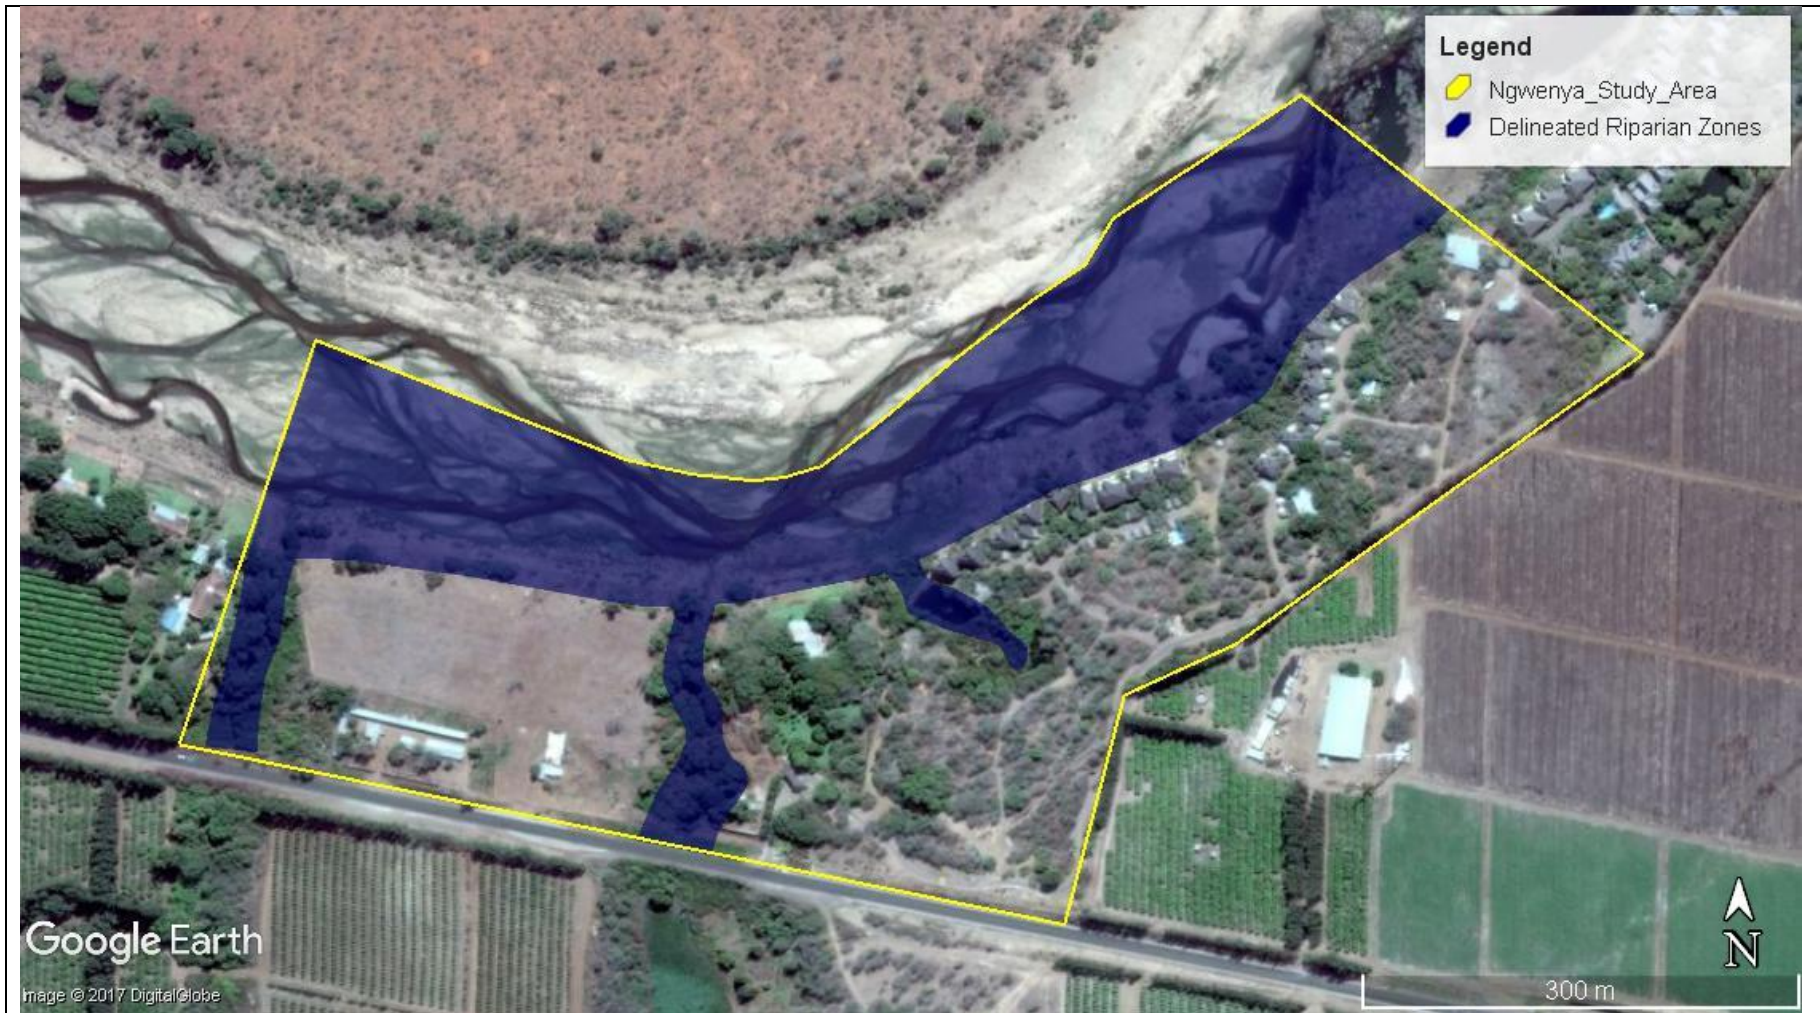
Figure 8: Delineated riparian areas within the Ngwenya study area

The riparian areas identified in the study area were delineated in accordance with the guidelines for delineating the boundaries of a wetland, set out by the Department of Water Affairs and Forestry (DWAFF) (DWAFF, 2005). These delineated riparian areas are demarcated and indicated as per the map shown in Figure 8.

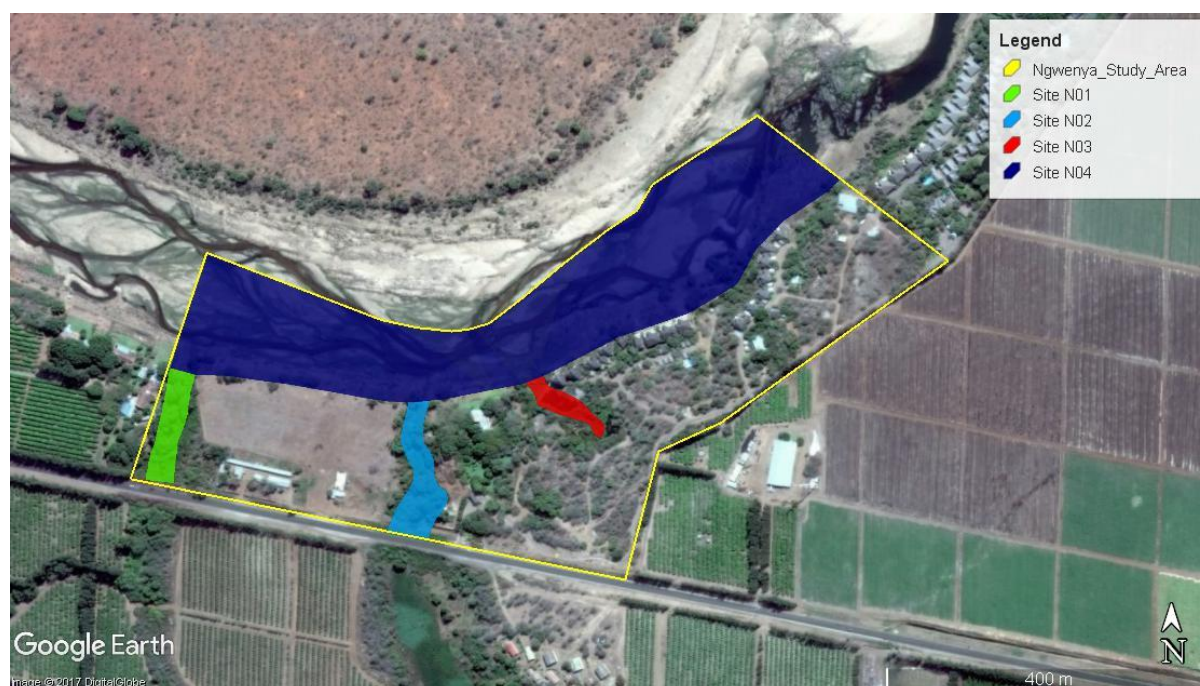
Figure 9: Identified watercourses denominated for the purpose of this study

Four watercourses were identified in the study area and can be described as riverine areas. The delineated riparian areas are demarcated and indicated as N01, N02, N03 and N04 for the purpose of this study. These areas are denominated and indicated as per the map in Figure 9. Please take note that site N03 is an artificial dam and receives its water from the Crocodile River (Herholdt, pers. comm.)

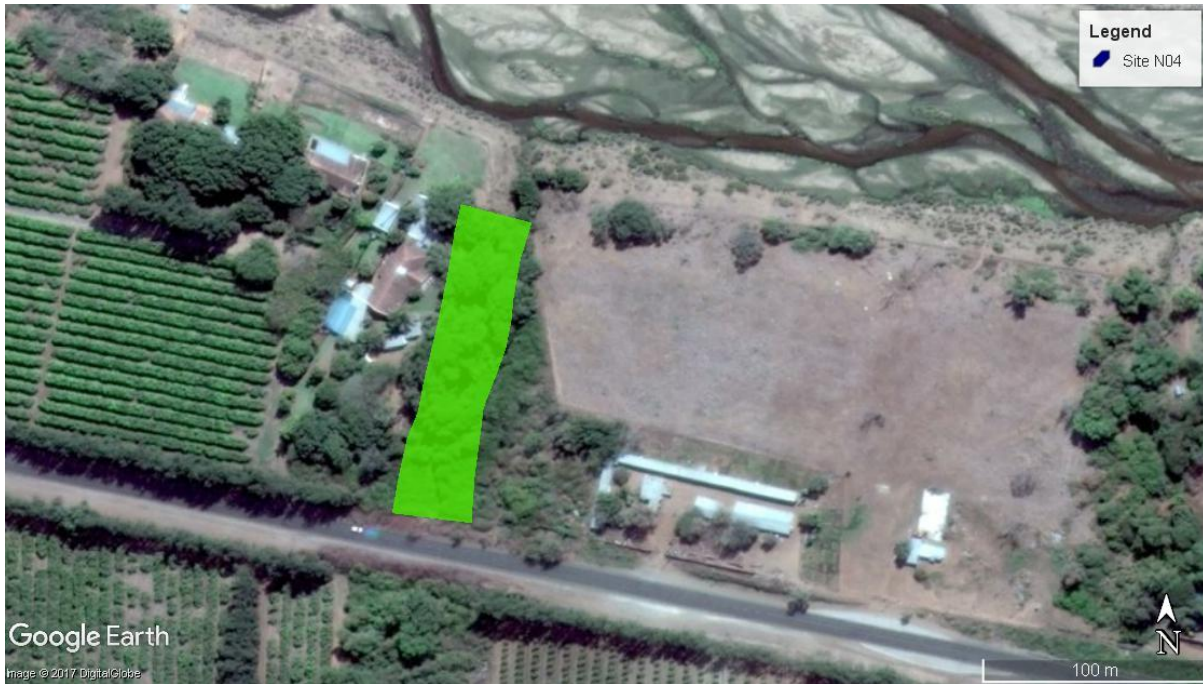
**Figure 10: Google image of the delineated N01 Riparian Area**

This site is located at 25°22'49.74 S, 31°50'55.93 E. The riparian zone extends upstream from the edge of the Crocodile River to the tar road between the R571 and the Tenbosch road. Features of this riparian area can be viewed in Figure 10 and Figure 11.

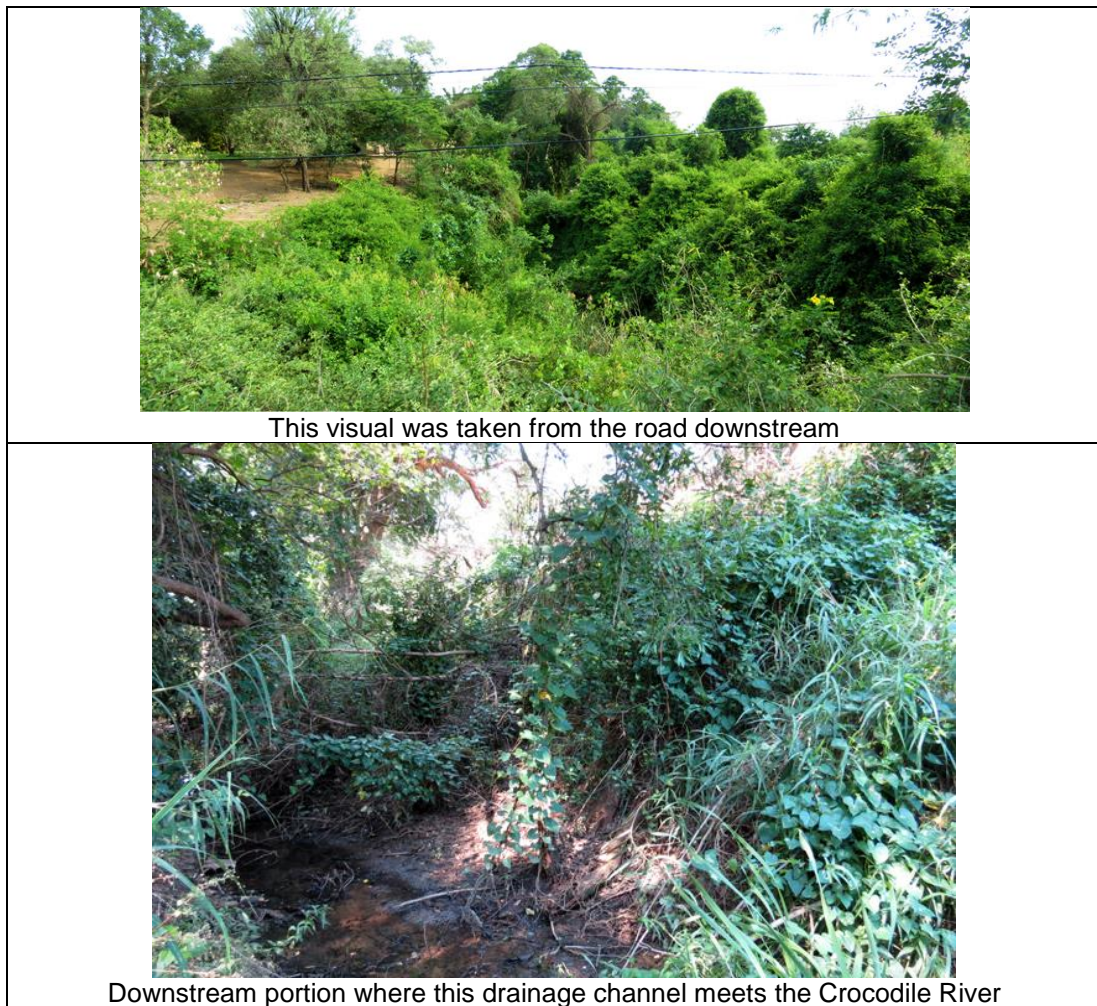
This visual was taken from the road downstream

Downstream portion where this drainage channel meets the Crocodile River

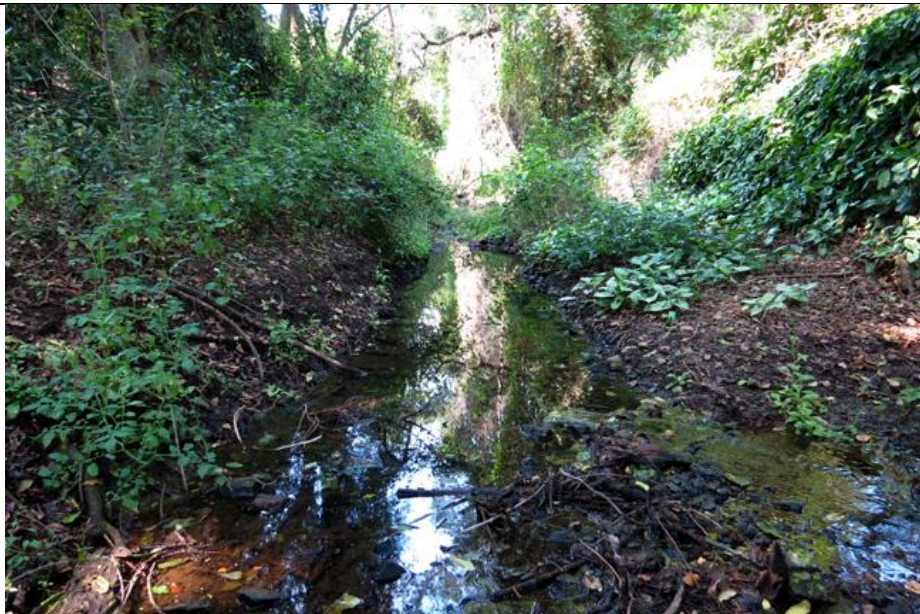
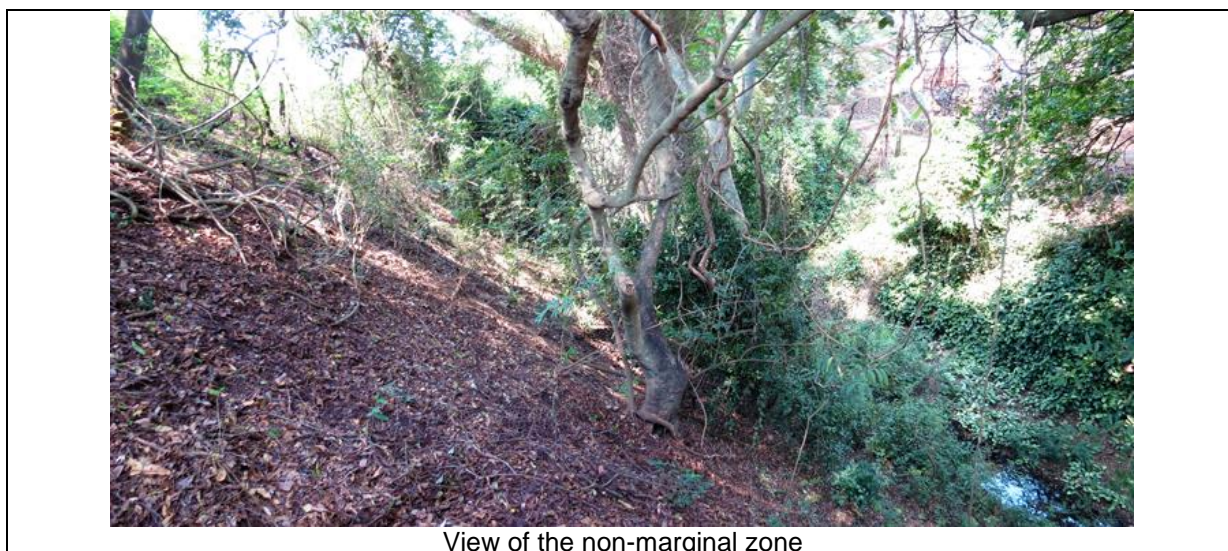
**Figure 12: Photos of selected VEGRAI at site N01**

In this area, trees are the dominant vegetation component with shrubs which occur in vast numbers. Due to the road crossing and lateral bank erosion, little cover occurs in places. The substrate consists mainly of high organic soil with a heavy leaf layer. The following woody species occur: *Phyllanthus reticulatus*, *Ficus sycomorus*, *Syzygium cordatum*, *Celtis africana*, *Ficus sycomorus*, *Syzygium cordatum*, etc. The cover and species composition appear to be good. Understory plants such as *Hypoestes forskoolii*, *Syngonium podophyllum*, *Jasminum fluminense*, *Setaria megaphylla*, *Panicum coloratum* and *Panicum maximum* occur. Some exotic vegetation such as *Achyranthes aspera* var. *aspera*, *Solanum mauritianum*, *Lantana camara*, *Tecoma stans*, etc. was also found. Exotic vegetation dominates the area just downstream of the road crossing and then occurs sporadically throughout the non-marginal zone.

View of the marginal zone

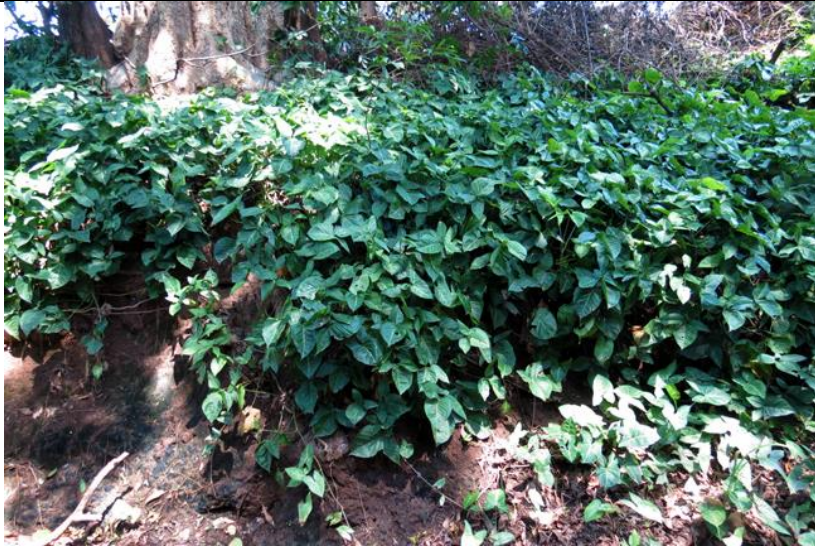
**Figure 13: Activities that contribute towards the degradation of the N01 riparian zone's integrity**

The Riparian Index of Habitat Integrity (RIHI) is a D/E (41.8%). The main impacts are the road crossing, historic cultivation and orchards in the catchment, exotic vegetation (*Tecoma stans* being the dominant species) and a housing development (Figure 13). Due to orchards in the catchment it is expected that the water will be enriched with nutrients (nitrates and

Channel bank is infested with exotic vegetation such as this *Syngonium podophyllum* (arrow-head vine)

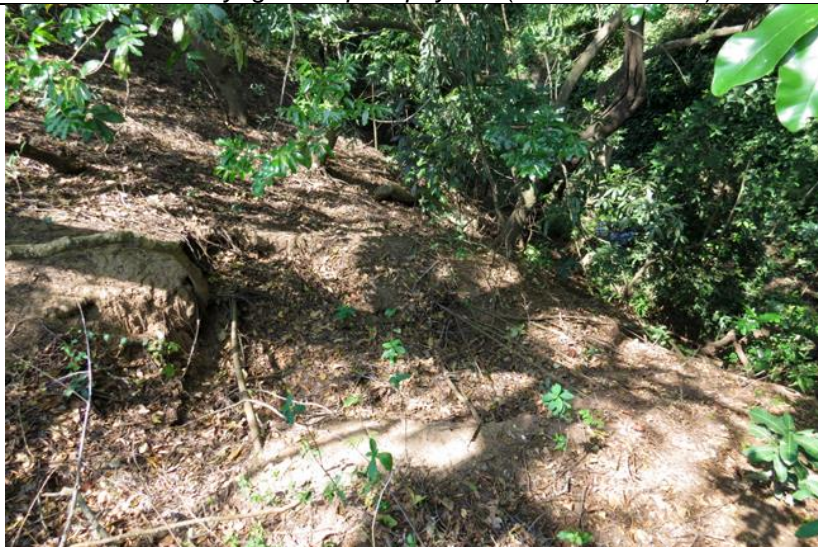
Eroded banks

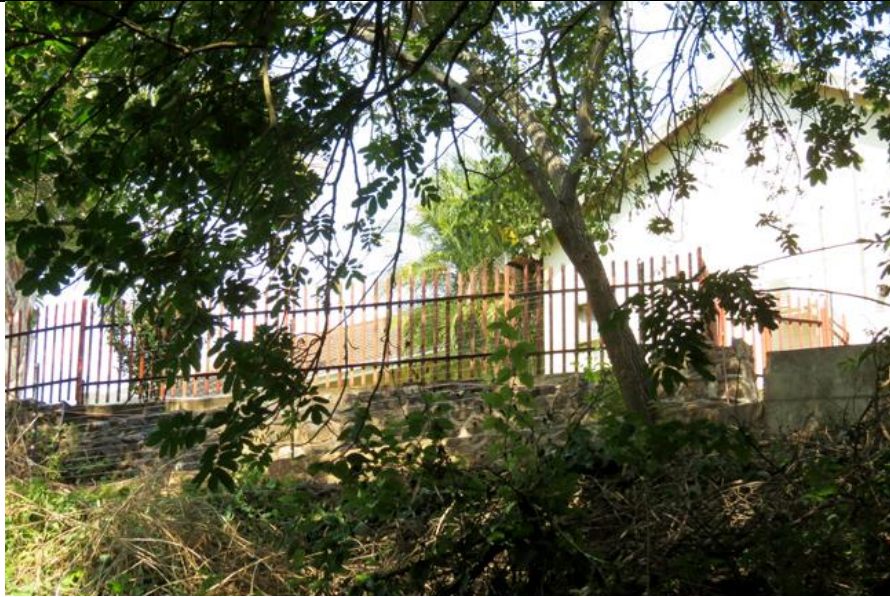
Infrastructure along the edge of the riparian zone

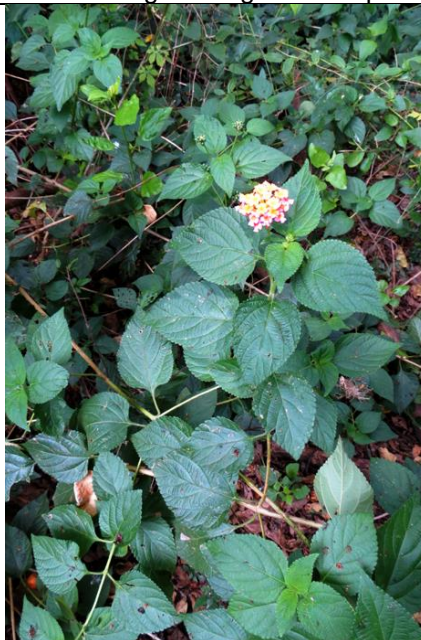
Exotic vegetation  
(*Lantana camara*)

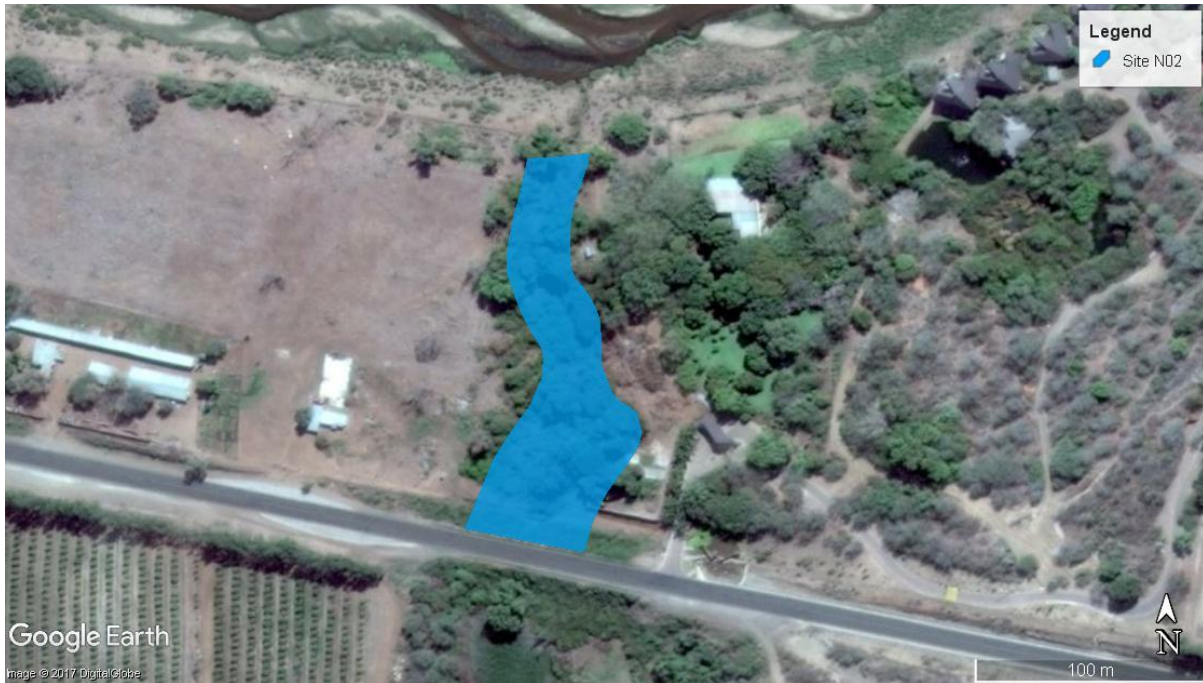
**Figure 14: Google image of the delineated N02**

This site is located at 25°22'51.18 S, 31°51'06.94 E. The riparian zone extends from the riparian edge of the Crocodile River upstream to the road between the R571 and the Tenbosch road. Visuals of this site can be seen in Figure 14 and Figure 15.

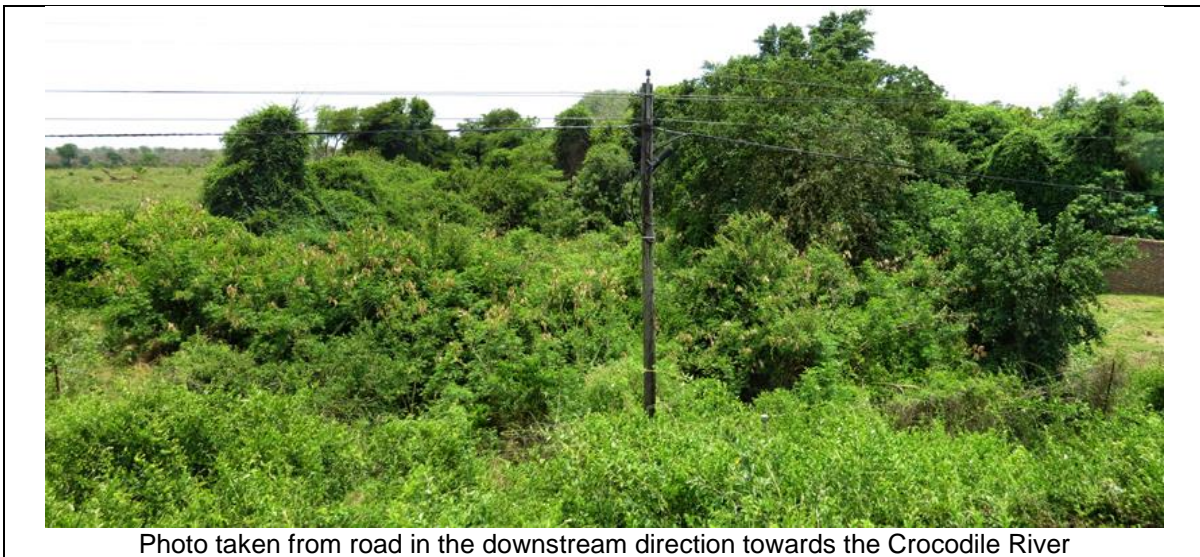
**Figure 15: Images indicating the nature of ephemeral Site N02**

Photo taken from road in the downstream direction towards the Crocodile River

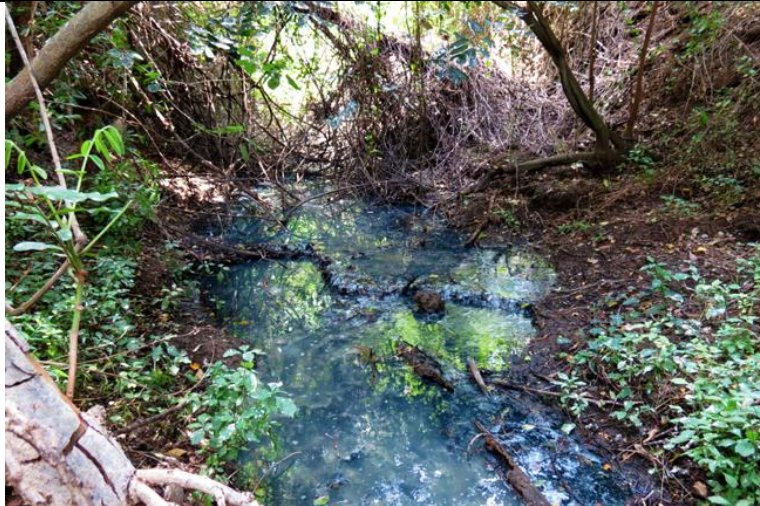
Visual of the active channel environment (note the greywater)

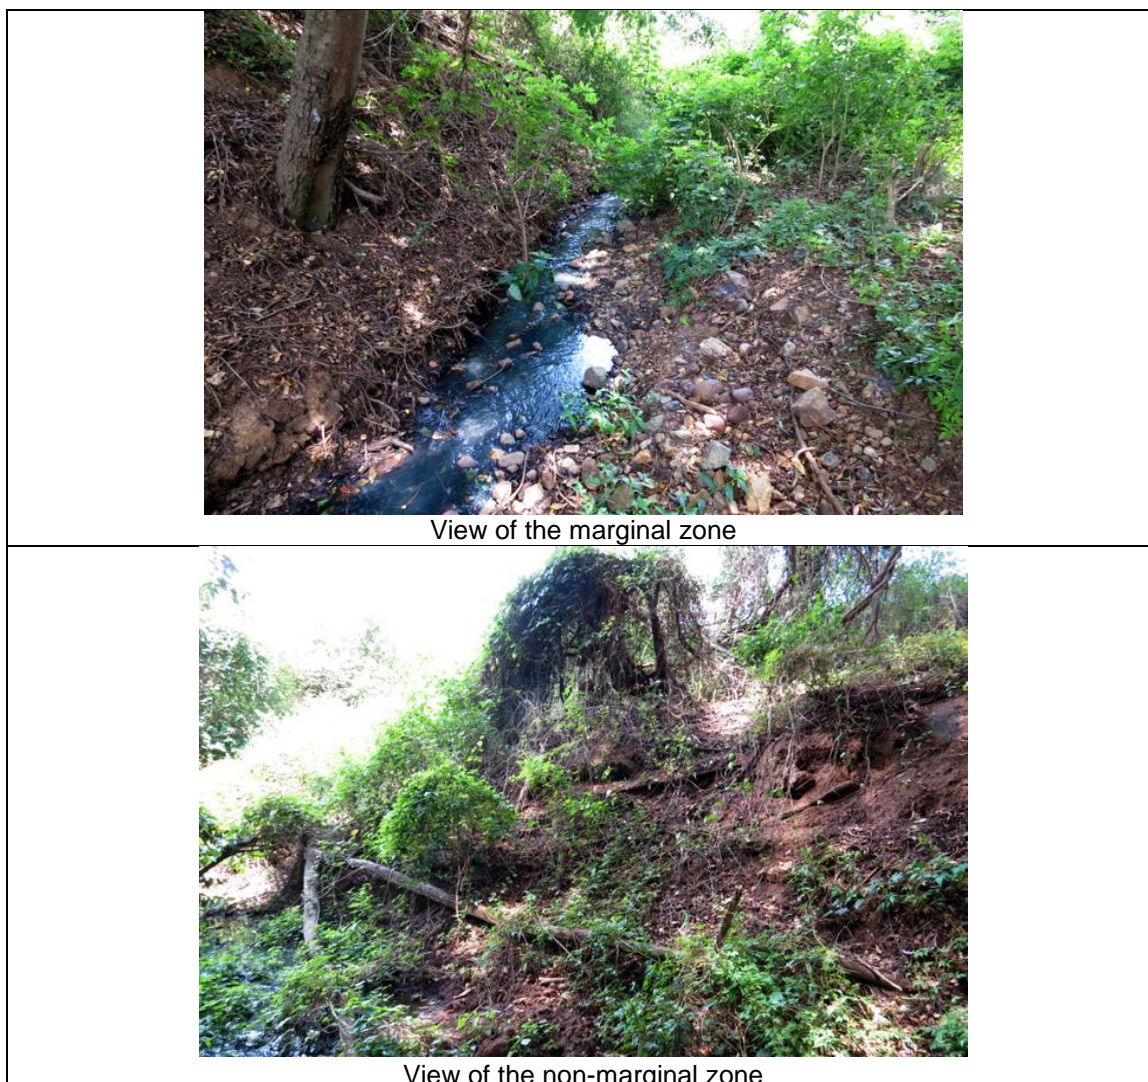
Figure 16: Photos of selected VEGRAI site

In this area trees are the dominant vegetation component with shrubs and forbs. Due to road crossings, a water treatment facility and eroded areas, sparse cover occurs in places. The substrate consists mainly of soils and rocky material. The following woody species occur: *Acacia xanthophloea*, *Phyllanthus reticulatus*, *Ficus sycomorus*, *Ziziphus mucronata*, *Syzygium cordatum*, *Grewia monticola*, *Pluchea dioscoridis*, etc. Understory plants such as *Setaria megaphylla*, *Panicum maximum*, *Hypoestes forskalii*, *Jasminum fluminense*, etc. occur. Exotic vegetation such as *Ricinus communis*, *Tecoma stans*, *Achyranthes aspera* var. *aspera*, *Solanum mauritianum*, *Lantana camara*, etc. was also found. *Lantana camara* is the most dominant of the exotic species.

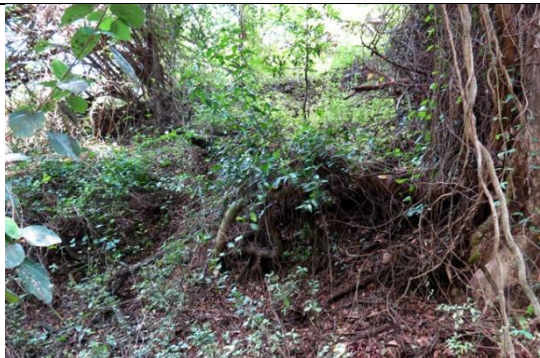
**Figure 17: Activities that contribute towards the degradation of the N02 riparian zone's integrity**

The Riparian Index of Habitat Integrity (RIHI) is a D/E (37.6%). The main impacts are the road crossing, historic cultivation and orchards in the catchment, exotic vegetation infestations (*Lantana camara* and *Tecoma stans* being the dominant species) and greywater being released into the system (Figure 13). Greywater can contain high levels of Chlorine, with additional pollutants in the form of sodium, phosphates, nitrates and other organic compounds. It is expected that this will have detrimental effects on the biota in this stream. Higher levels of flow occur which also contributes to an altered hydrology (Figure 13).

Surface area erosion

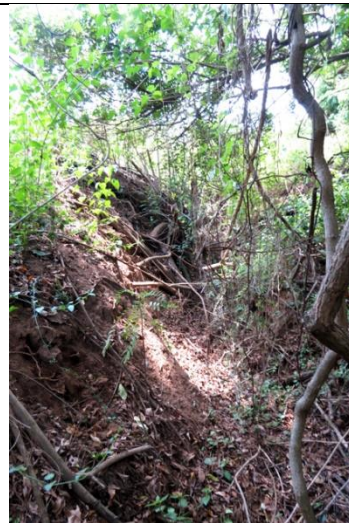
Donga erosion

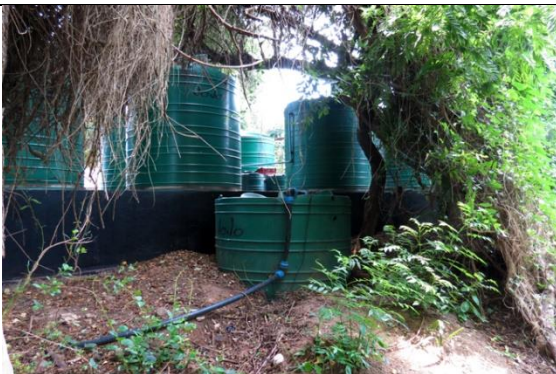
Water treatment facility

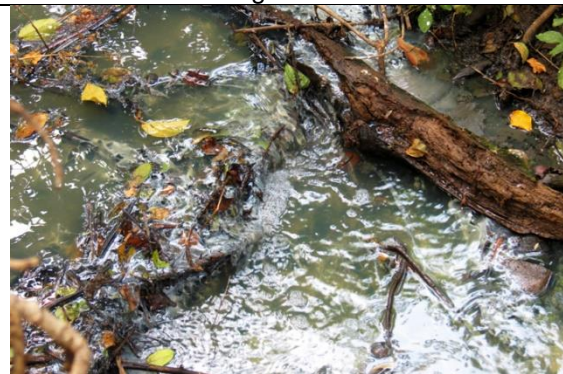
Greywater pollution

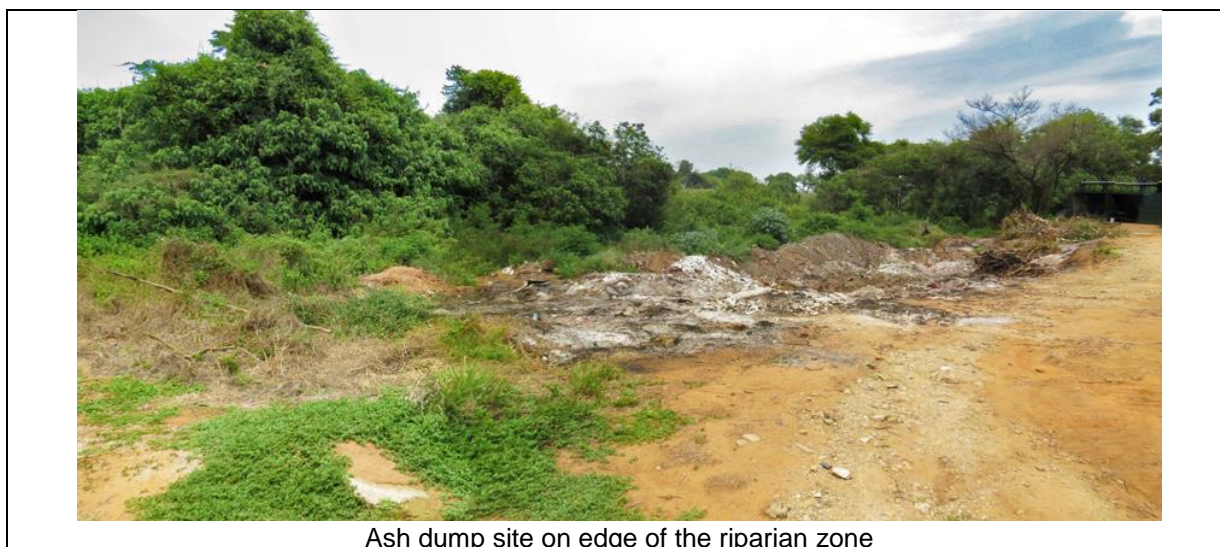
Ash dump site on edge of the riparian zone

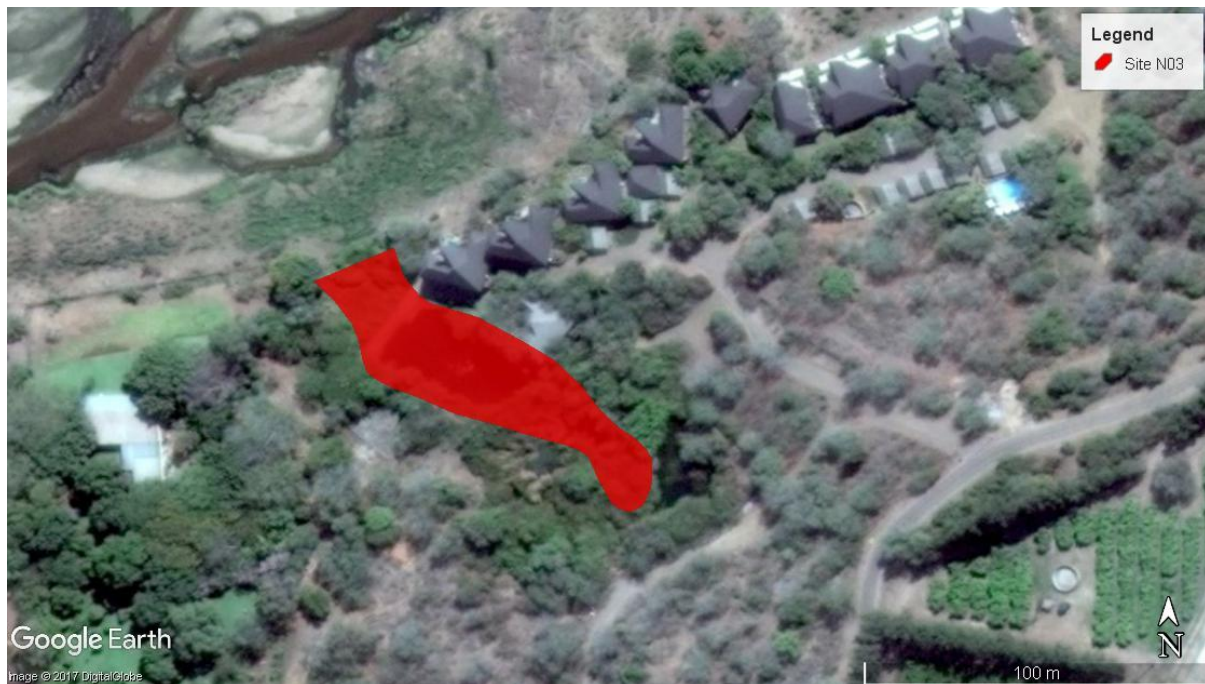
Figure 18: Google image of the delineated riparian area for Site N03

This site is located at 25°22'48.95 S, 31°51'12.68 E. This site is an artificially created dam into which water is pumped from the Crocodile River (Herholdt, pers. comm.) and visuals of this site can be seen in Figure 18 and Figure 19.

This site is not assessed due to its artificial nature.

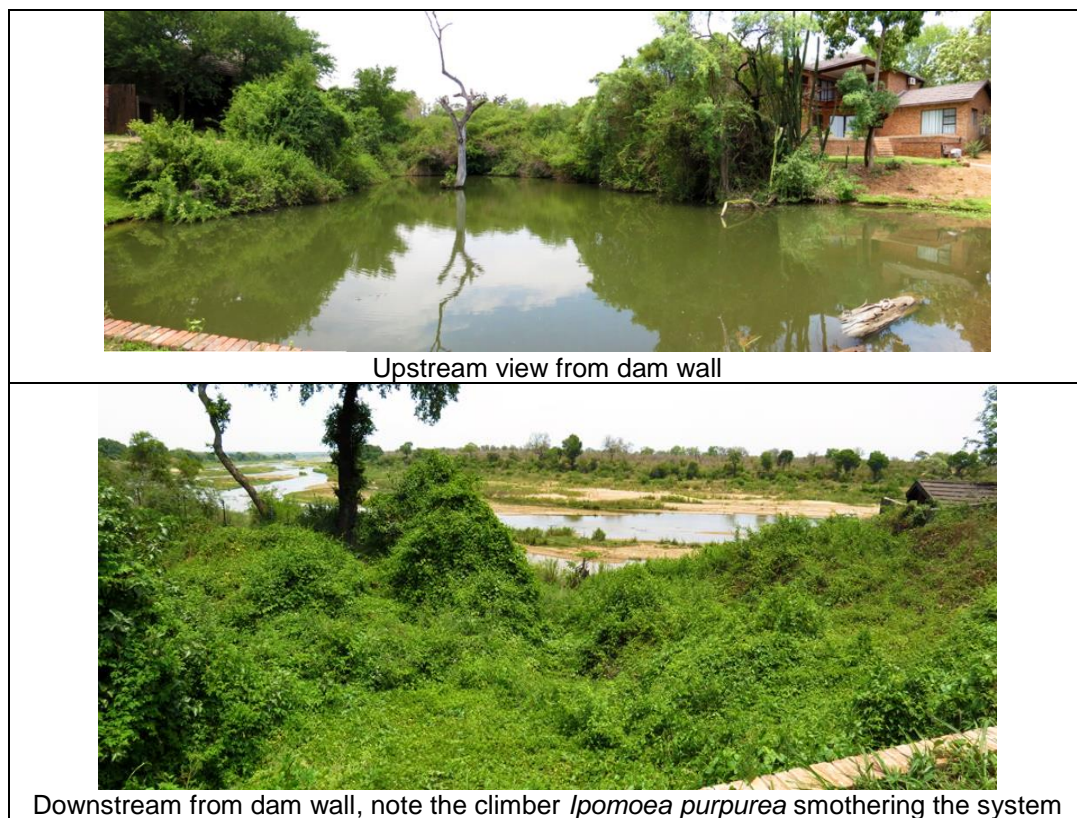
Figure 19: Images indicating the unnatural state of this Site N03

The dominant vegetation in this artificial environment is mostly exotic species, such as *Ipomoea purpurea*, *Lantana camara*, *Tecoma stans*, *Pennisetum clandestinum*, etc. Woody species present include: *Ficus sycomorus*, *Rauvolfia caffra*, *Syzygium cordatum*, *Celtis africana*, *Phyllanthus reticulatus*, *Acacia xanthophloea*, etc. *Ficus lutea*, a tree which is not indigenous in Mpumalanga, but has been cultivated widely also occurs in this artificial

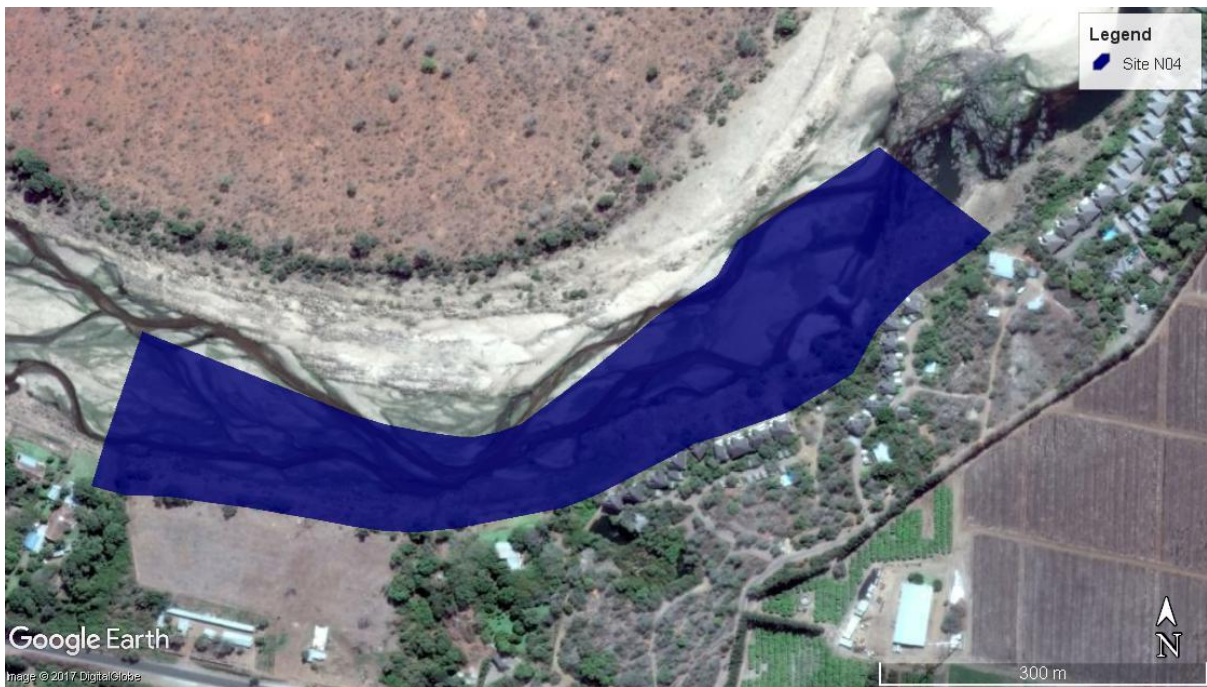
**Figure 21: Google image of the delineated riparian zone of the Crocodile River (Site N04)**

This site is located at 25°22'47.06 S, 31°51'06.30 E. The riparian zone of concern is demarcated within the area as provided by the client. The focus for this study will be on the right bank of the Crocodile River. In Figure 21 and Figure 22 a Google aerial photo indicates its location and other visuals indicate the current state of the site in question.

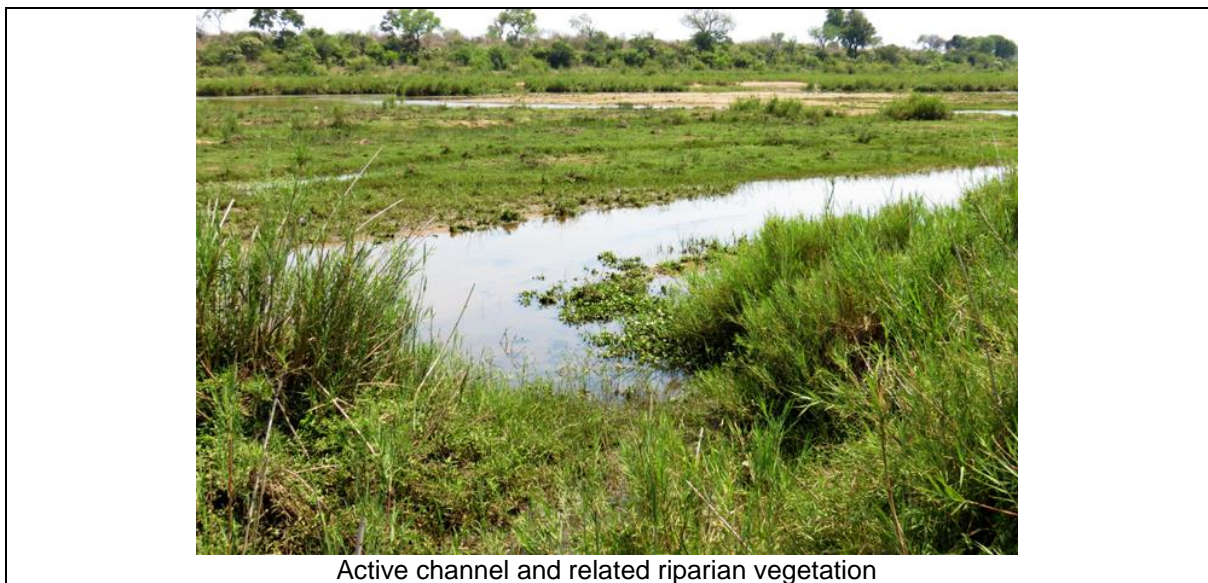
**Figure 22: Images indicating the current state of ephemeral Site N04**

Active channel and related riparian vegetation

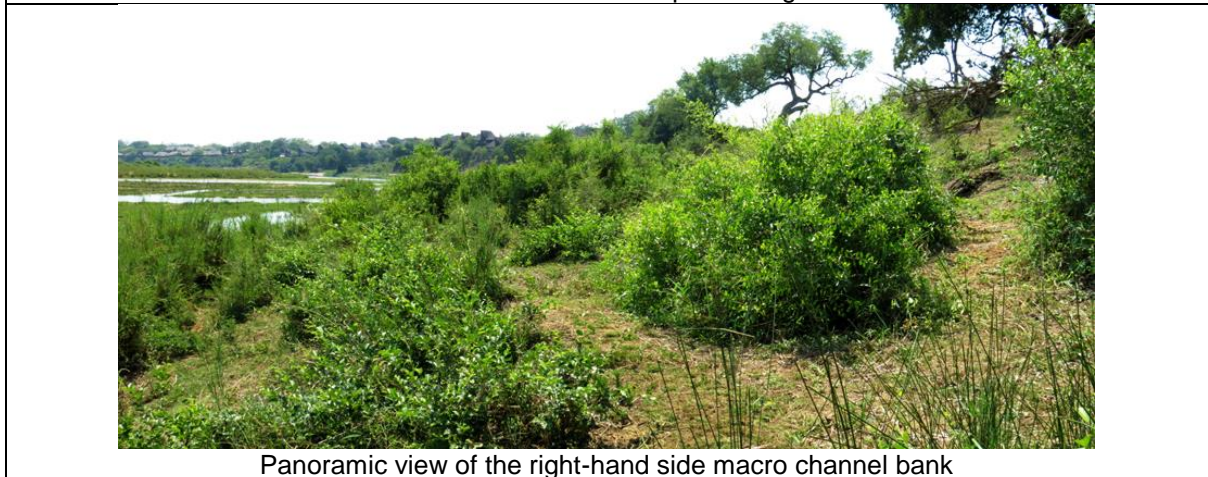
Panoramic view of the right-hand side macro channel bank

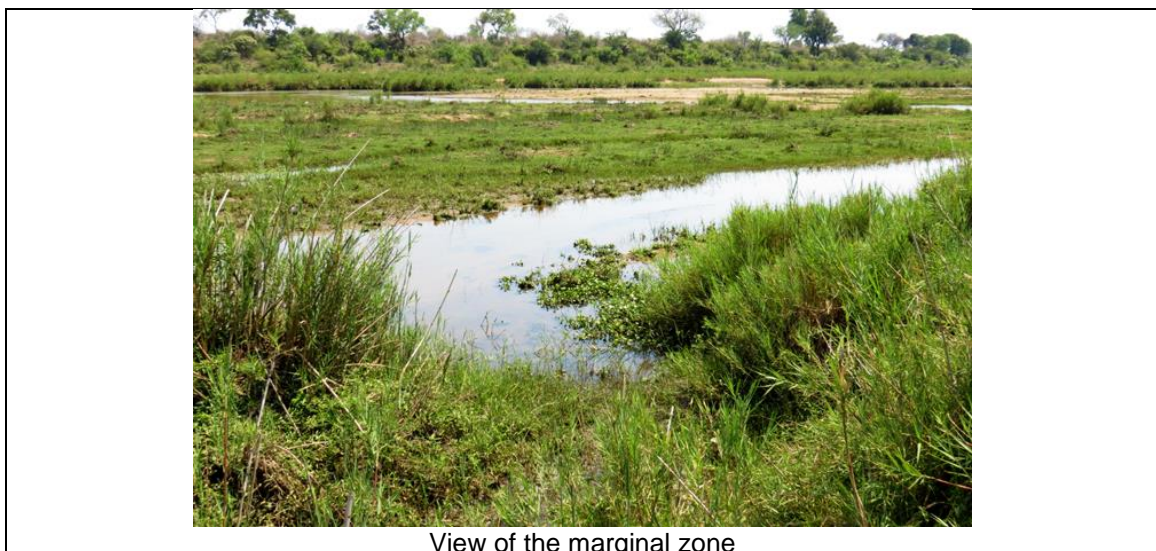
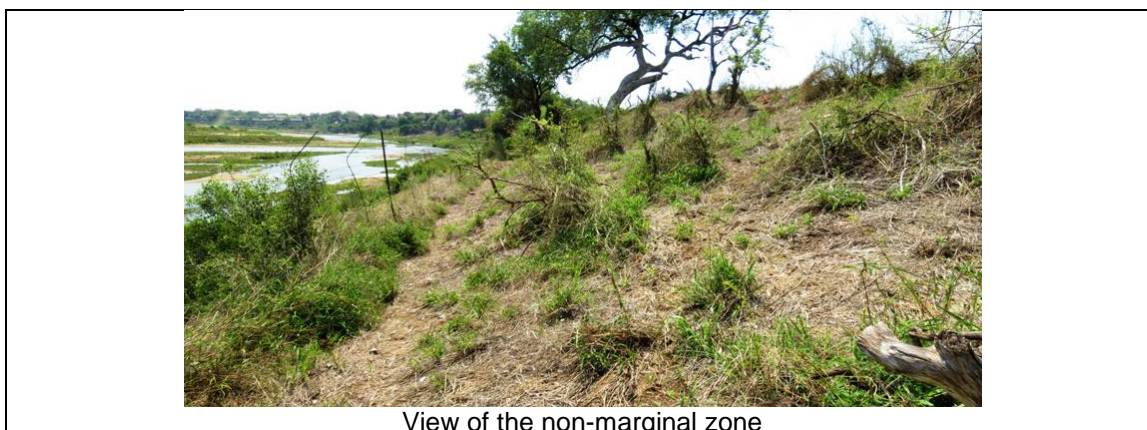
Figure 23: Photos of selected VEGRAI for Site N04

In this area tree and grasses are the dominant vegetation components with inhibited shrubs occurring sporadically in vast numbers. There are indicators that this zone is overgrazed and trampled. The substrate consists mainly of alluvial soils and some exposed rock dykes. The following woody species occur: *Acacia nigrescens*, *Acacia xanthophloea*, *Philenoptera violacea*, *Trichilia emetica*, *Diospyros mespiliformis*, *Phyllanthus reticulatus*, *Dichrostachys cinerea*, *Lippia javanica*, *Ficus sycomorus*, *Ziziphus mucronata*, *Syzygium cordatum*, *Sclerocarya birrea* subsp. *caffra*, *Grewia monticola*, *Grewia flavescens*, *Gomphocarpus fruticosus*, *Gymnosporia senegalensis*, *Pluchea dioscoridis*, *Asparagus cooperi*, *Vernonia colorata*, etc. The species composition appears to be good, however, the abundance and cover is lower than expected. Non-woody species such as *Cyperus sexangularis*, *Schoenoplectus brachyceras*, *Setaria sphacelata*, *Eragrostis rotifer*, *Melinis repens*, *Cynodon dactylon*, *Panicum coloratum* and *Panicum maximum* occur. Some exotic vegetation such as *Solanum mauritianum*, *Centella asiatica*, *Parthenium hysterophorus*, *Ricinus communis*, *Lantana camara*, etc. was also found. Exotic vegetation occurs sporadically throughout this non-marginal zone.

View of the non-marginal zone

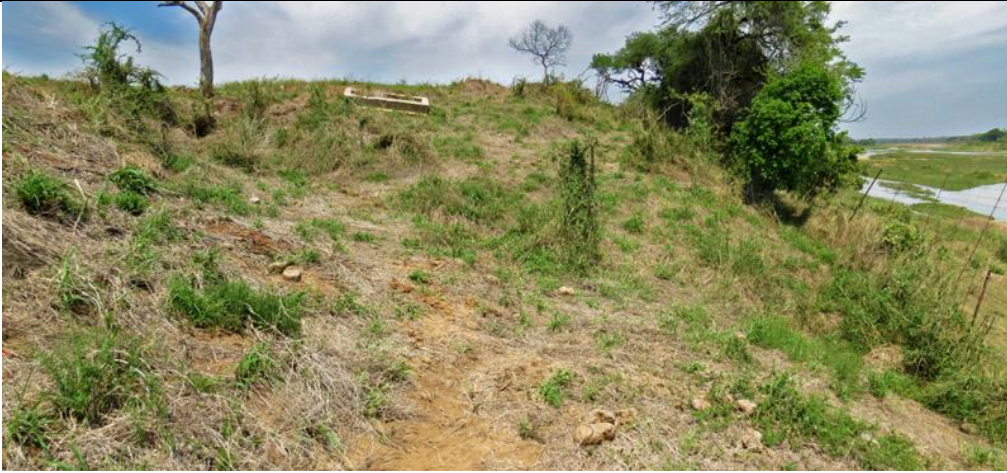
Figure 24: Activities that contribute towards the degradation of the N04 riparian zones integrity

The Riparian Index of Habitat Integrity (RIHI) is a C (63.1%). The main impacts are grazing and trampling, flood events, exotic species, dumped building material, historic cultivation and possible water abstraction (Figure 24).

Overgrazed and trampled macro-channel

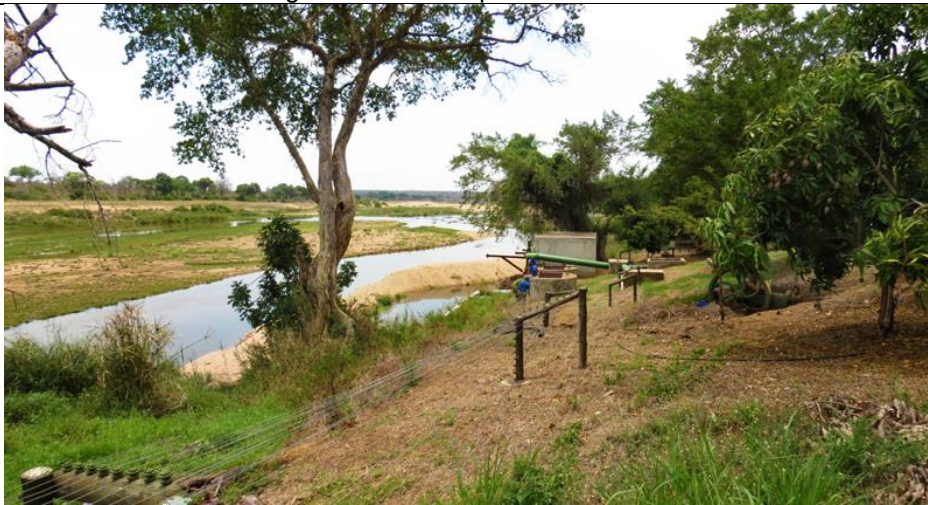
Water being pumped from the Crocodile River

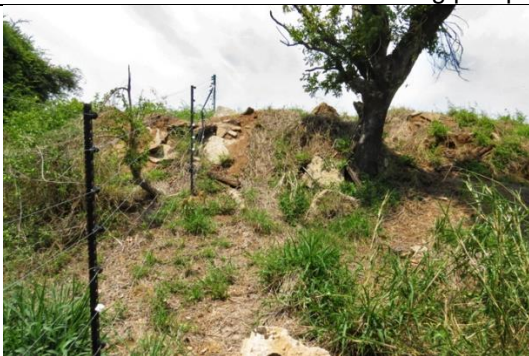
Building rubble dumped in the riparian zone

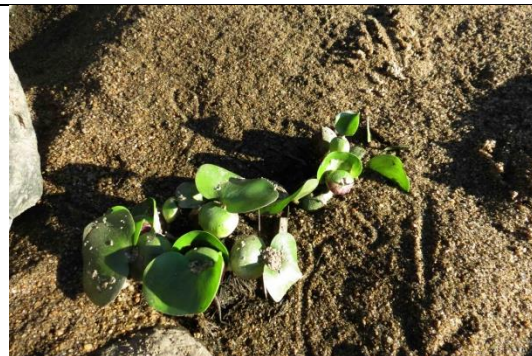
The exotic *Eichhornia crassipes*  
(Water hyacinth)

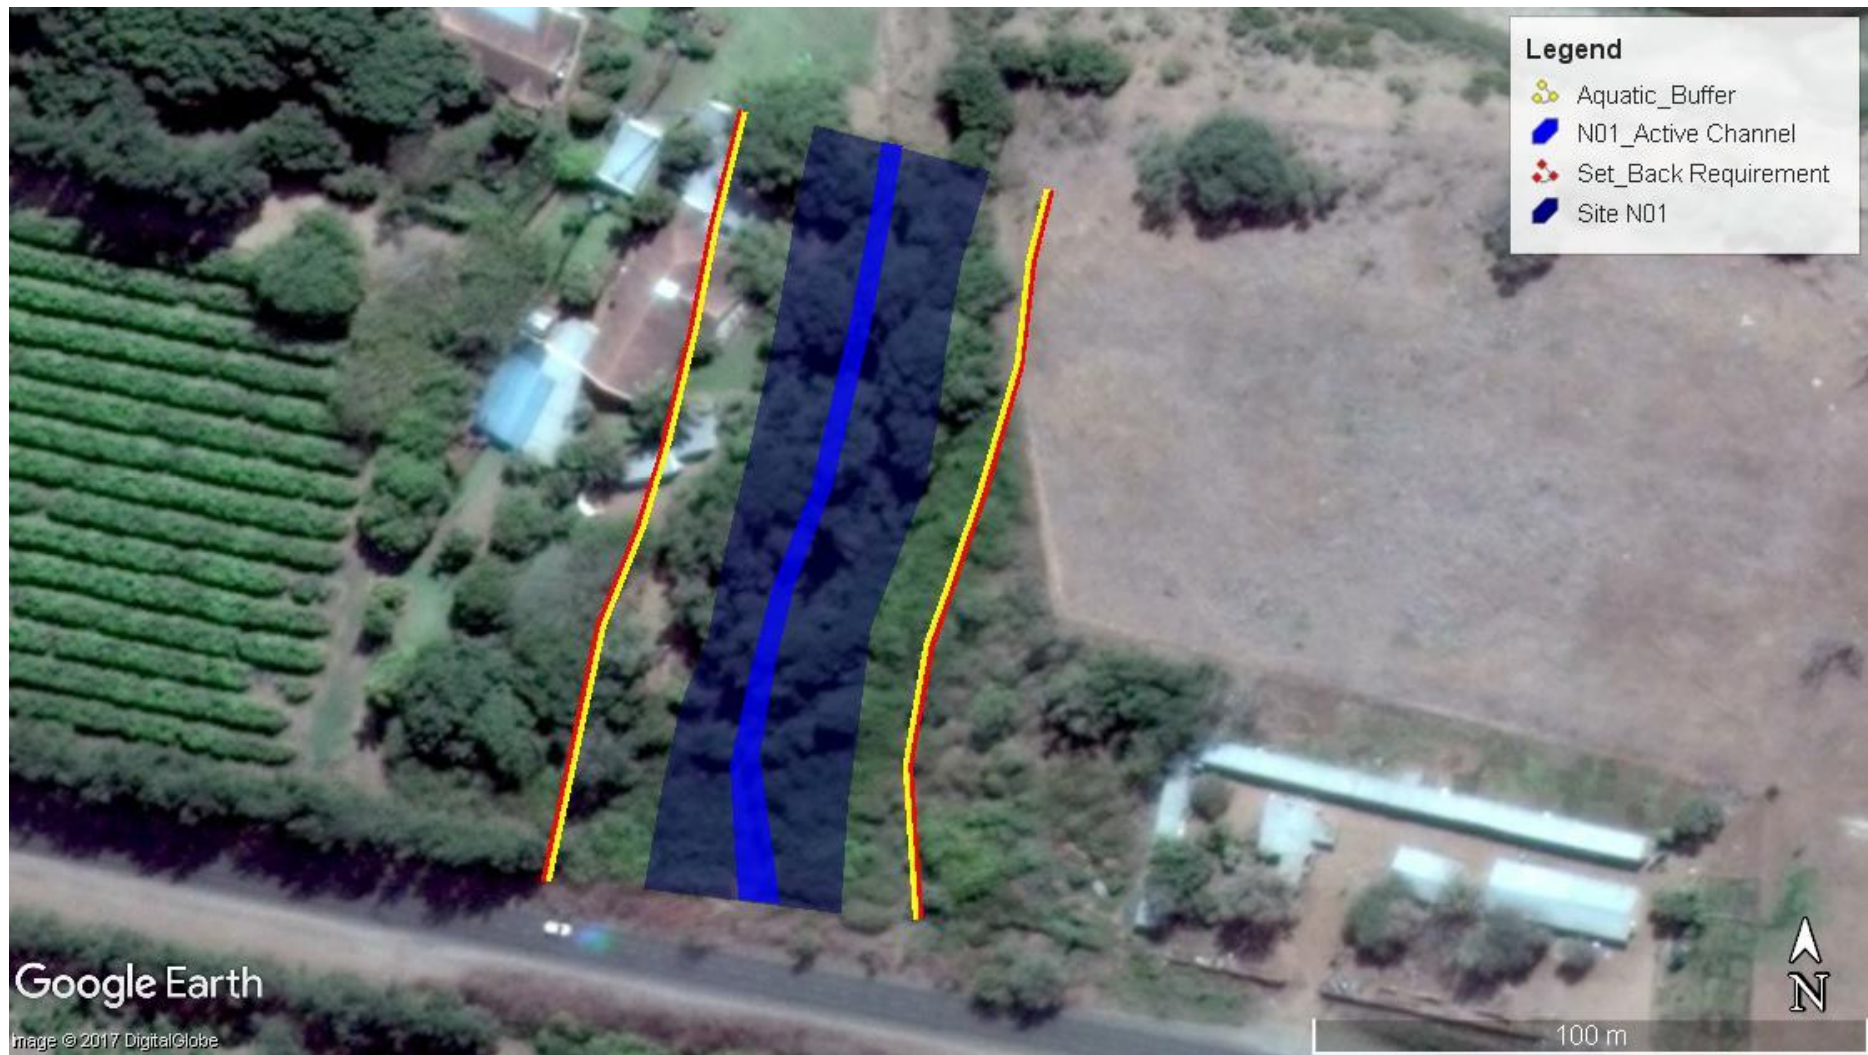
Figure 26: Delineation of the N01 Riparian site's active channel edge, aquatic requirement, riparian edge and then the final setback requirement
