## Ngwenya Lodge Extention: Wetland and Riparian Zone Identification and Description

November 2017

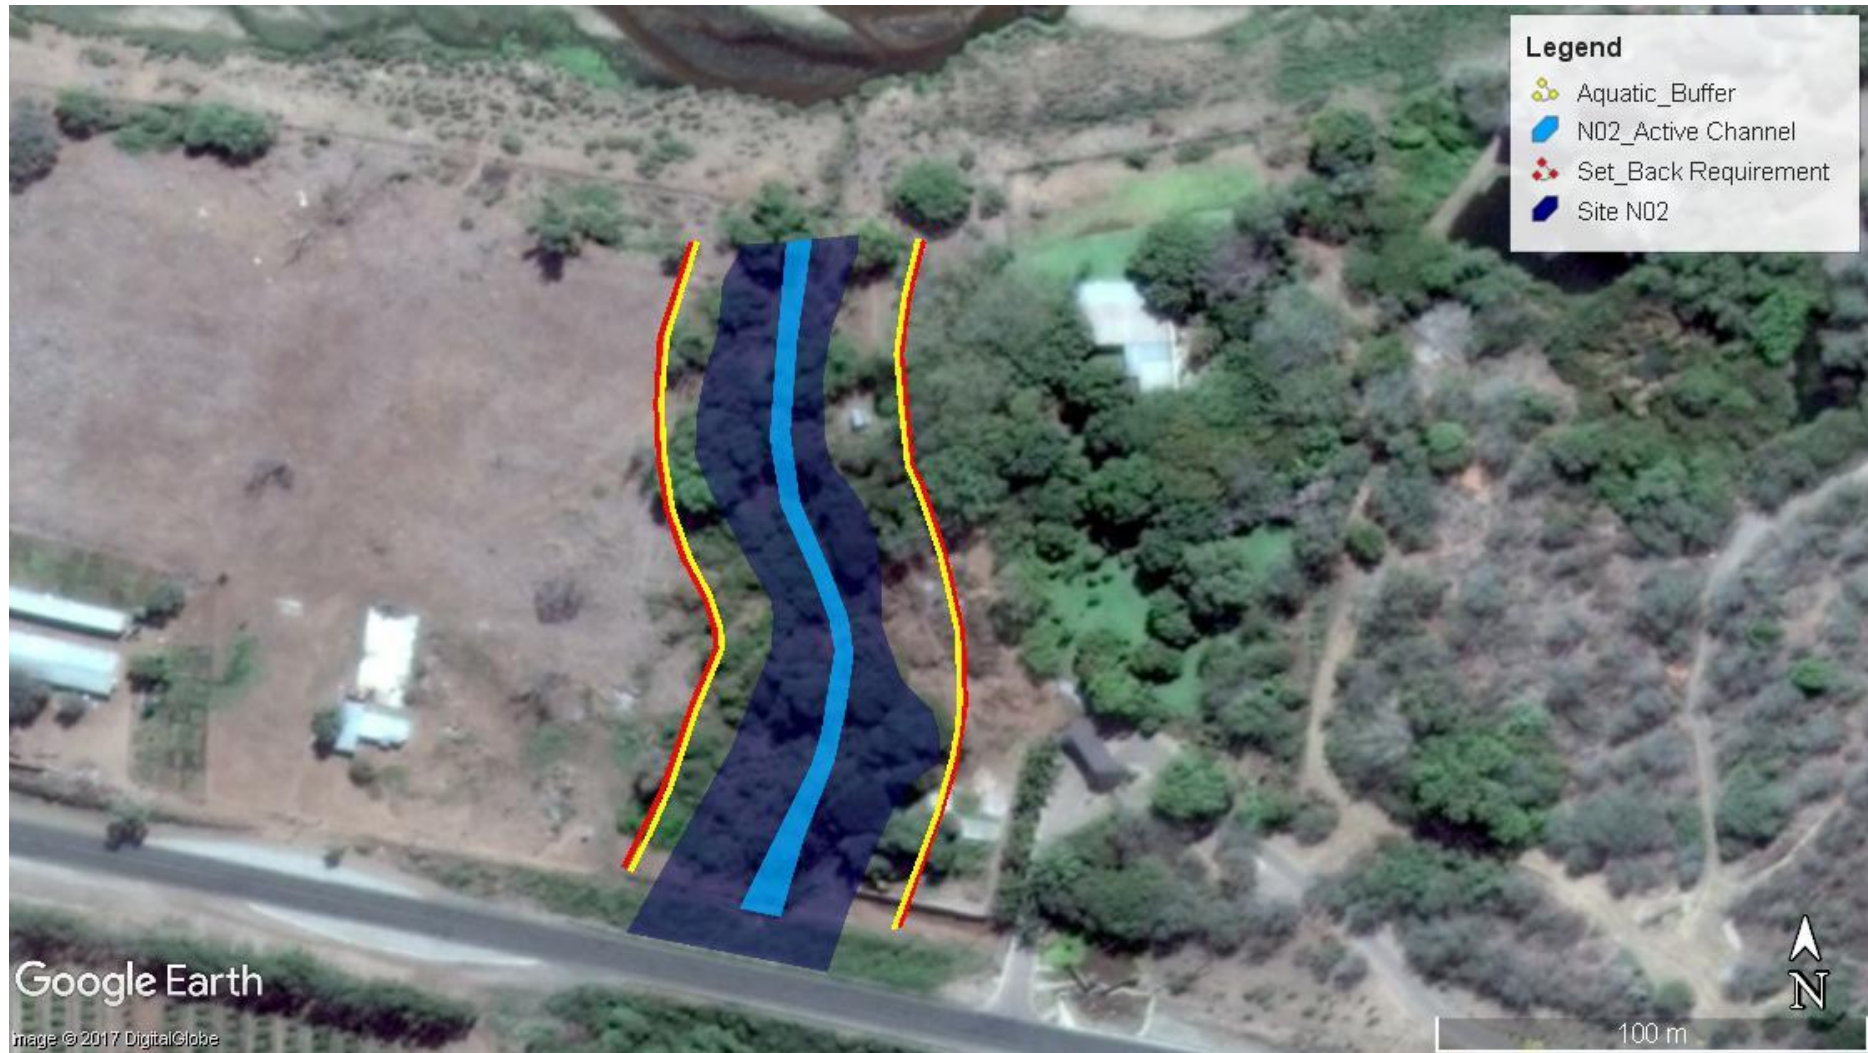
Figure 27: Delineation of the N02 Riparian site's active channel edge, aquatic requirement, riparian edge and then the final setback requirement
