MDARDLEA Ref:
1/3/1/16/1E-11

# BASIC ASSESSMENT REPORT

NSIKAZI NORTH BULK WATER SUPPLY
SCHEME UPGRADE
CONSTRUCTION & MAINTENANCE OF NEW
LINE & ASSOCIATED INFRASTRUCTURE

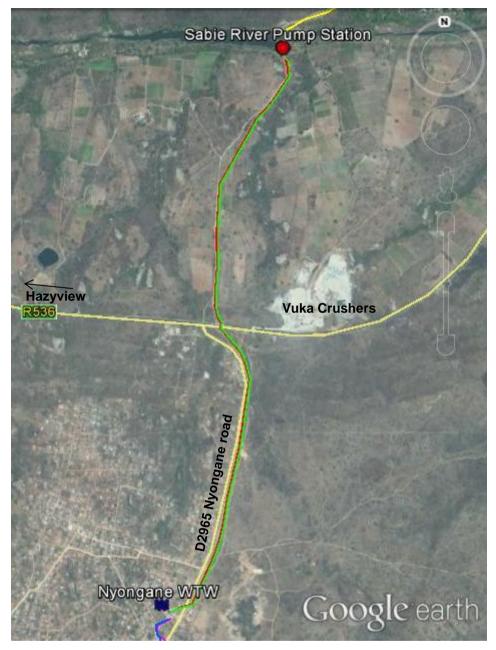
Figure 1: Google image of the alignment of the first section of proposed pipeline

The line will be 11 km in total and will be constructed and installed just east of and alongside the existing pipeline for the entire route with associated infrastructure such as scour valves

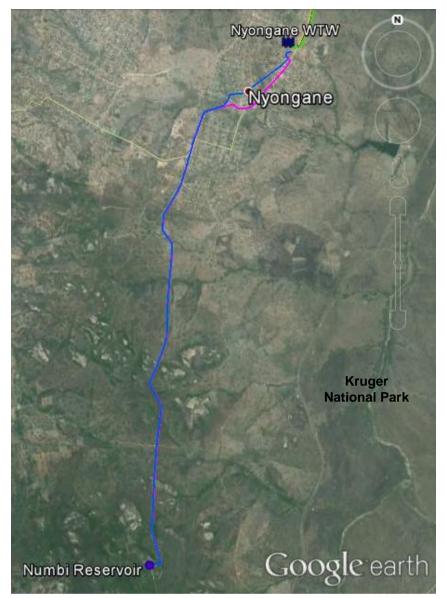
Figure 2: Google image of the alignment of the second section of the proposed pipeline

A 3km section pipeline will be constructed from the Sabie River Pump station to the Nyongane Water Treatment Works in the Nyongane Township. From there an 8km section will go up to the existing Numbi reservoir where the new reservoir will be constructed.

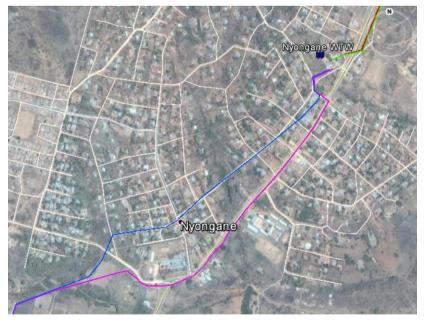
**Figure 4: Nyongane Water Treatment Works**

The preferred alternative is for the pipeline to be aligned from the treatment works back across to the east of the Nyongane road where there is more space. It will traverse the road again to join up with the existing pipeline's alignment further south.

Pink line = preferred alignment Blue line = initial alignment

Nyongane WTW through Nyongane Township: The section of the pipeline through the Nyongane township from the Nyongane Treatment Works to the Numbi reservoir was first proposed to be aligned west of the D2965 Nyongane tar road straight from the treatment works to where the track goes up to the Numbi reservoir. This would entail working in the very narrow dirt road that provides access to the residents and would entail the blocking of the road entirely. This would not be feasible and have a social impact. Refer to impact assessment.

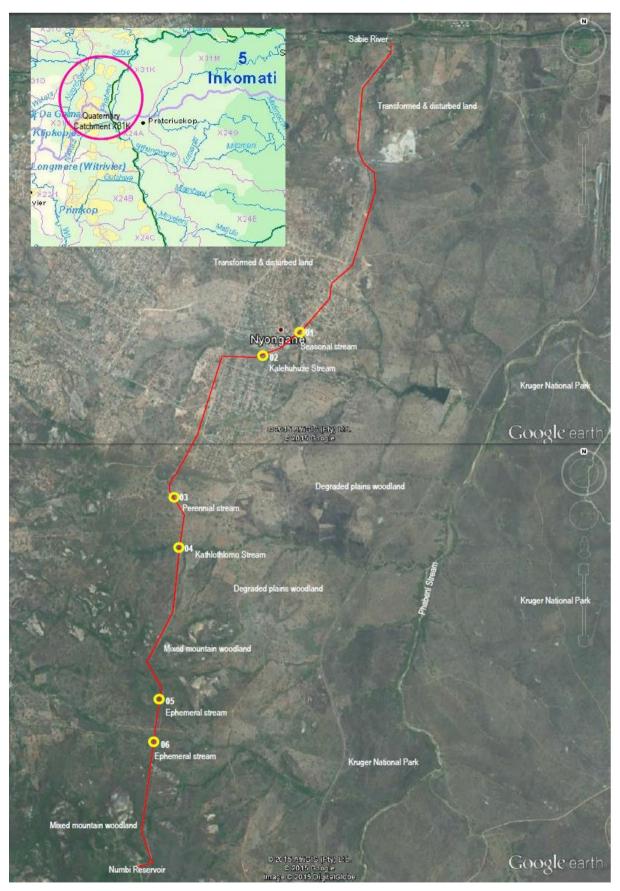
Figure 5: Vegetation communities identified within the study area

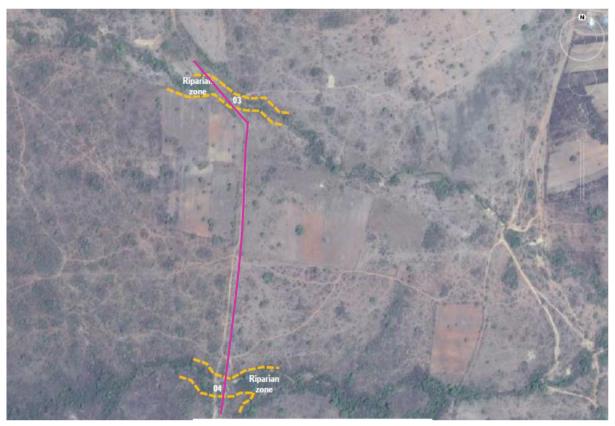
Figure 7: Riparian delineation of streams 03 and 04

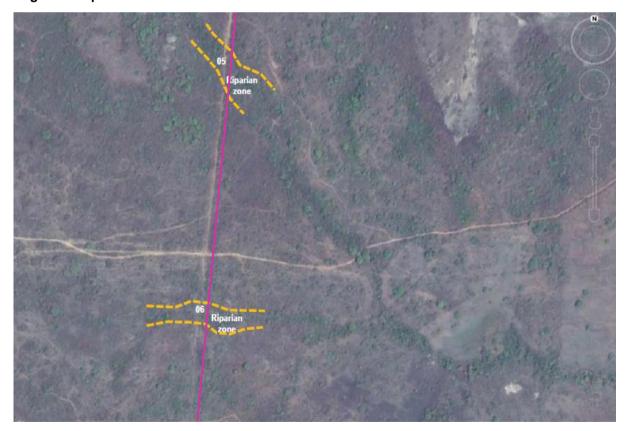
Figure 8: Riparian delineation of streams 05 and 06

Some of the existing pipeline crossings over streams/drainage lines are leaking at the specific localities. This causes some erosion and at one stream crossing (06) in particular the leak has resulted in a small donga on the downstream side of the pipe. The engineer indicated that these leaks will be fixed and where severe erosion has occurred, it will be addressed. The cleared track that follows the alignment of the existing line also shows signs of erosion in some sections.

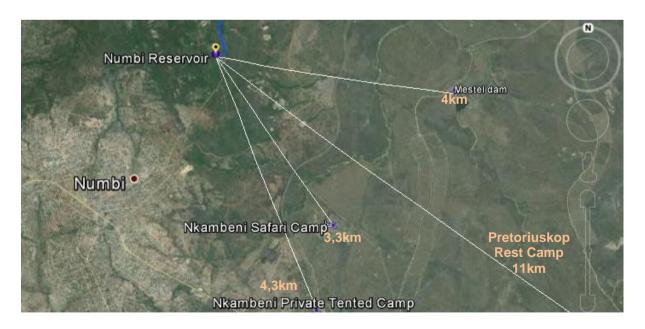
Four areas within the KNP were considered to form an idea of what the visual impact of the additional reservoir could be on these areas.

The existing reservoir and telecommunication mast already permanently changed the aesthetics of the area and is very likely visible from areas within the KNP. Numbi Townships,

specifically the outskirts is located on the eastern slope of the mountain and should be visible from most areas within the KNP if one faces westward.
