**PALAEONTOLOGICAL IMPACT ASSESSMENT (PHASE 1) FOR THE
PROPOSED ESTABLISHMENT OF A 2.3 MILLION m³ DAM AND CULTIVATION
OF 102 ha OF LAND LOCATED ON PORTION 1 OF MEERSIG No. 15550,
PORTION 1, 3 & 4 AND REM OF SMALDEEL No. 1390, AND PORTION 2, 3 & 10
OF LINDEQUES LAAGER No. 1039, LUSH VALLEY FARM AND PRAIRIE FARM,
WITHIN THE OKHAHLAMBA LOCAL AND uTHUKELA DISTRICT
MUNICIPALITY, WINTERTON, KWAZULU-NATAL**

1 November 2020

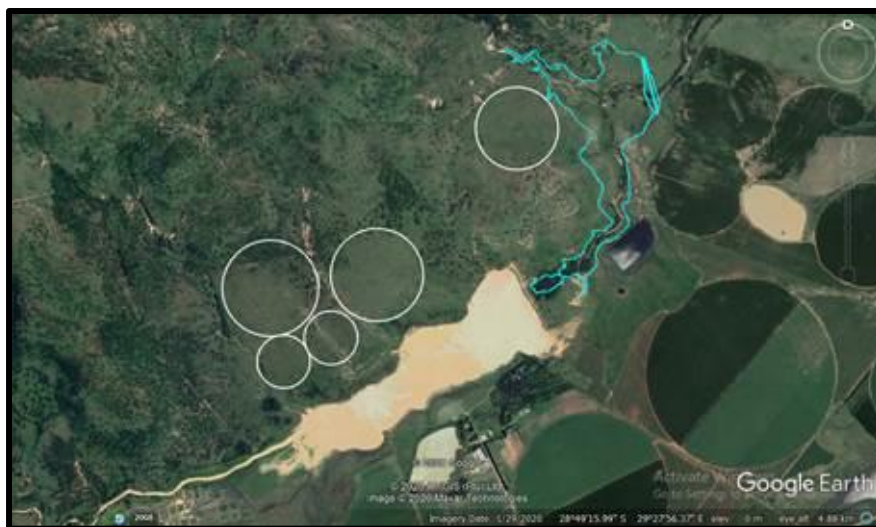
Figure 1: Satellite image showing the layout of the proposed project, with the blue outline showing the surface area of the dam and the five white circles showing the areas to be cultivated

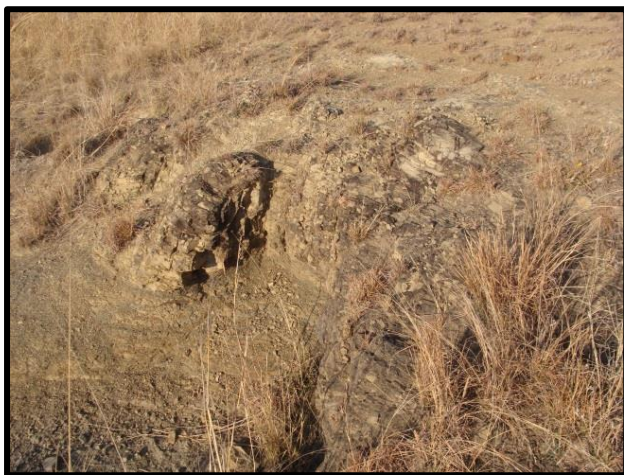
Only a few outcrops of rock were exposed at the surface at the proposed dam site, and within the buffer zone surrounding the dam site. Those that were visible looked promising (in terms of yielding fossiliferous material), but upon closer examination nothing palaeontological was observed (Figure 6). A low sandstone cliff was situated on the southern bank of the stream at the place where the proposed dam wall will be built and this outcrop of bedrock was surveyed but no visible fossils could be seen (Figure 7 & 9). As the rocks of this region are highly fossiliferous, it is probable that more fossil material is located within the broader landscape but was not observed due to its hidden or buried nature, or because they fell outside of the primary search area in the immediate vicinity of the dam.

Figure 6: Photograph showing some of the exposed mudstone located roughly 200m south west of the proposed dam wall. Although the rock type looked very promising for potential fossil occurrences, nothing could be seen within the small outcrops of exposed bedrock

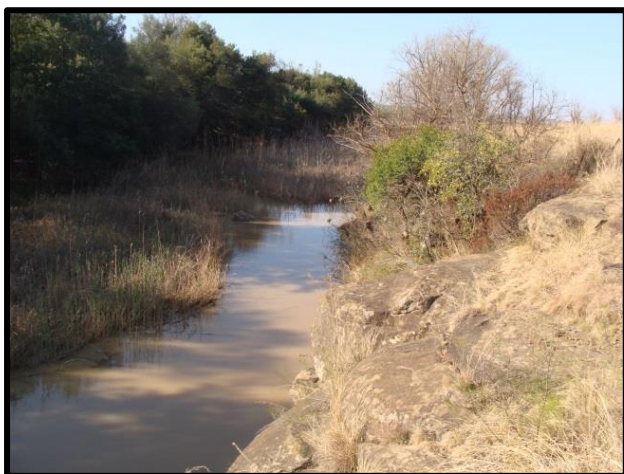
Figure 7: At the location of the proposed dam wall, a low cliff formed the southern bank of the stream. This outcrop of rock was carefully surveyed but no palaeontological material could be located

In conclusion, the survey of the site footprint at the location of the proposed dam revealed no palaeontological material exposed at the surface but due to the fact that the foundation of the dam wall will be excavated to bedrock, a Phase 2 palaeontological impact assessment is recommended for the construction phase of the dam so that the site monitoring can evaluate any possible fossil material which may be unearthed. In preparation for embankment construction, loose rocks will be removed and the cleaning of the surfaces of the sound bedrock foundation with air and water jets which will provide a good opportunity to view any fossils which may be preserved within the rock. In addition, a ground survey will need to be conducted to assess the extent of the archaeological village observed in some portions of the proposed cultivation area.

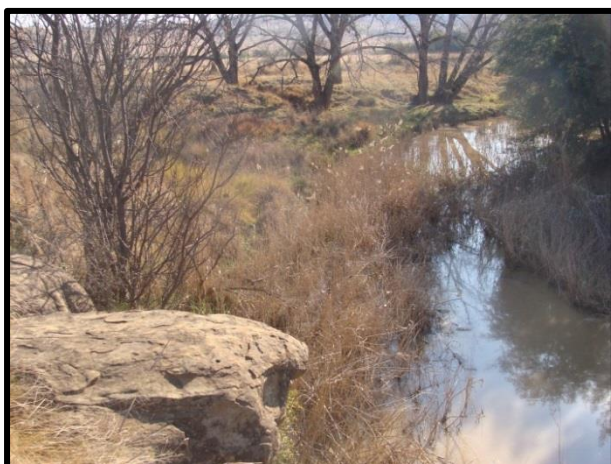
Figure 8: Looking upstream from the position of the proposed dam wall reveals how the banks are covered in abundant riparian vegetation, of which more than 50ha will unfortunately be cleared and/or flooded

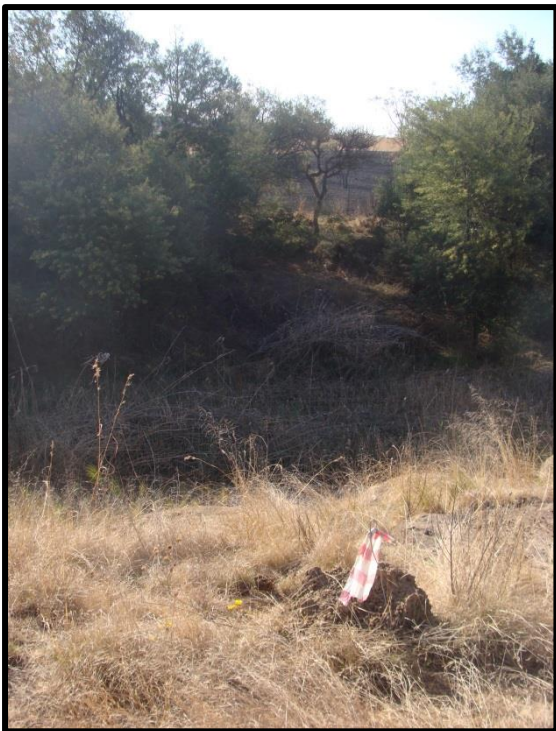
Figure 9: At the location of the proposed dam wall, a piece of red and white flagging tape had been stuck into an old termite mound just above the low cliff depicted in Fig.7 & 8

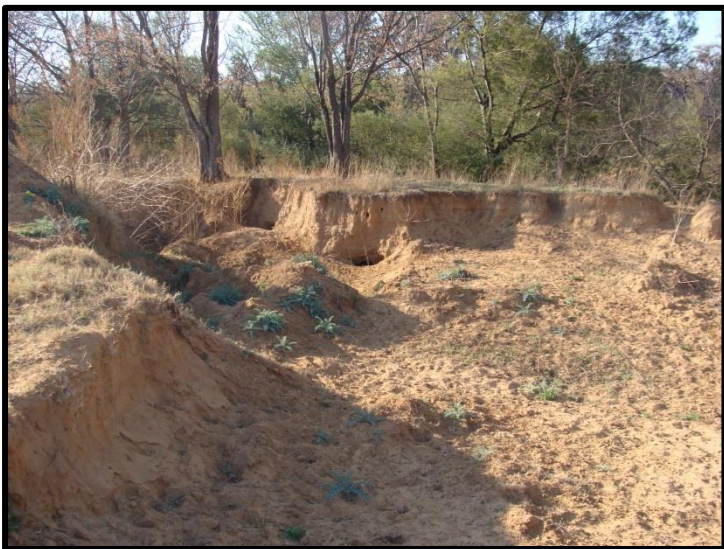
Down by the stream the overbank deposits looked very young and were not stratified. The sediment appeared to be reworked material that had washed down fairly recently when the stream was in flood (Figure 10). It is therefore unlikely that the Quaternary alluvial deposits in the vicinity of the proposed dam will be fossil-bearing. Porcupines had several dens in the banks of the stream and the sediment that had been ejected during the digging of these holes was examined for archaeological or palaeontological material, but nothing was recorded and the soil appeared to be sterile. Some antelope teeth were observed outside one of these burrows but these were modern and showed no evidence of mineralization (Figure 11 & 12). Porcupines are known to collect bones and bring them back to their burrows, and a game camp was located adjacent to the site footprint so it is likely that these teeth were brought in from the neighbouring camp. Whilst walking around on the site footprint the occasional small fragment of petrified wood was observed, but these were out of context surface finds. In addition the odd piece of coloured glass and European ceramic were also observed, but their origin was unknown as there were no farmhouses anywhere in the near vicinity.

Figure 10: Upstream from the proposed dam wall, and within the area that will be submerged by the water, the overbank deposits did not look very old and appeared to be fairly young reworked deposits. No archaeological or fossil material was visible within this sediment. Several porcupine burrows were noted within the bank of the stream and the sand excavated from their burrowing activities was also examined for lithics and fossils but nothing was observed

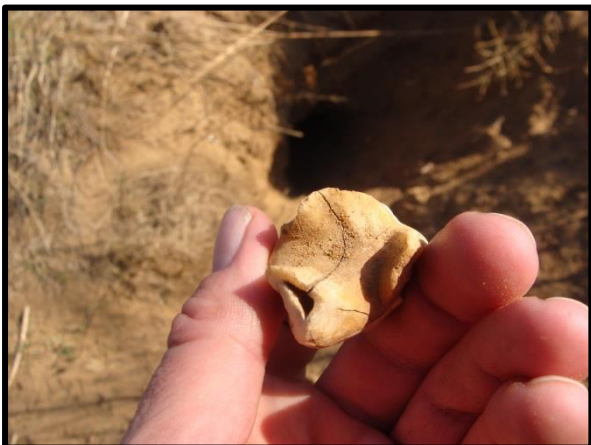
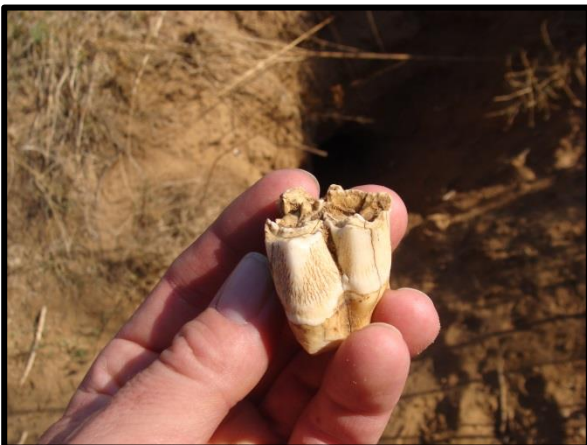
Figure 11 & 12: Photographs showing the modern bovid tooth that was lying outside of the entrance to the porcupine burrow, possibly belonging to a wildebeest or hartebeest. The tooth was not mineralized and was either carried to the den by the porcupine from the neighbouring game camp (as porcupines are known bone collectors), or it was trapped within the overbank deposits and dug up as a result of the burrowing activities of the animal

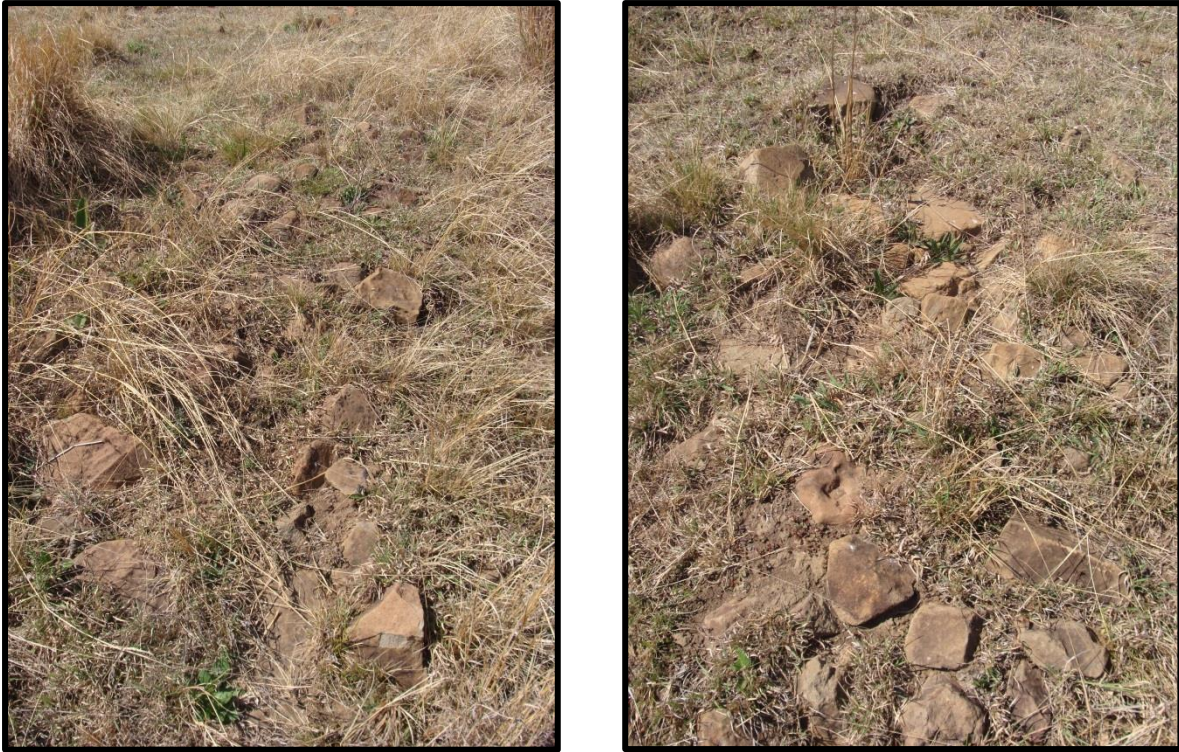
In the process of trying to reach the site some graves were located. They were semi-hidden amongst grass and were covered in rocks, and although located several kilometres from the site footprint they were documented and photographed to have on record (GPS coordinates 28 47 17.15 S 29 30 26.67 E, Figure 13 & 14). Whilst doing the initial satellite survey of the site footprint using Google Earth it was noted that some stone-walled features occur on a section of the land proposed for cultivation (Figure 18-23). Many of these features are overgrown with plants, making them difficult to see so their presence was revealed by sliding the time scale on Google Earth to previous years when the veld was drier and covered in less vegetation. They were predominantly circular in shape, although there were also linear features and some clustered features. Some of these were likely kraals whereas others likely represent the remnants of houses. These features are spread over quite a wide area and

Figure 13 & 14: In the process of trying to reach the proposed dam site, some graves were located. They were semi-hidden amongst the grass and were covered in rocks. However they were several kilometres from the proposed dam site and will not be affected by the project (GPS coordinates 28 47 17.15 S 29 30 26.67 E)

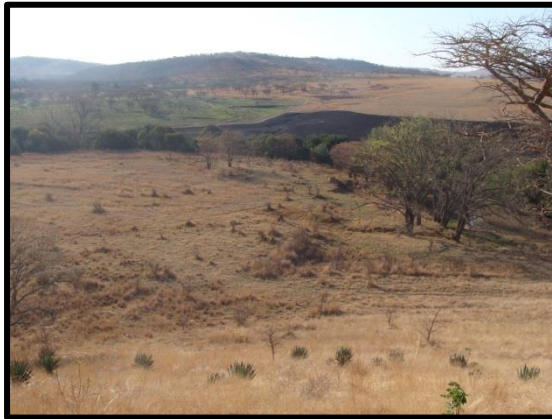
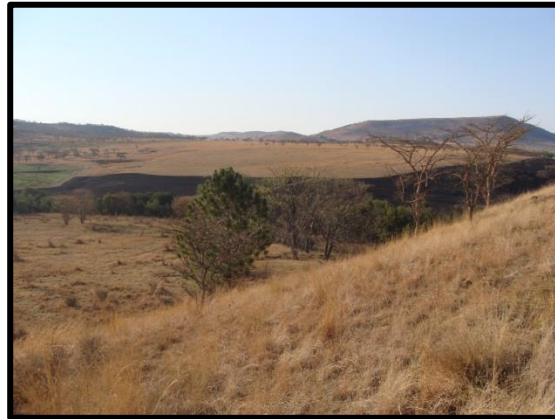
Figure 15 & 16: Standing on the hill located to the south of the proposed site footprint, looking north (left) and north east (right). The area between the base of the hill and the patch of burnt veld in the distance will all be submerged

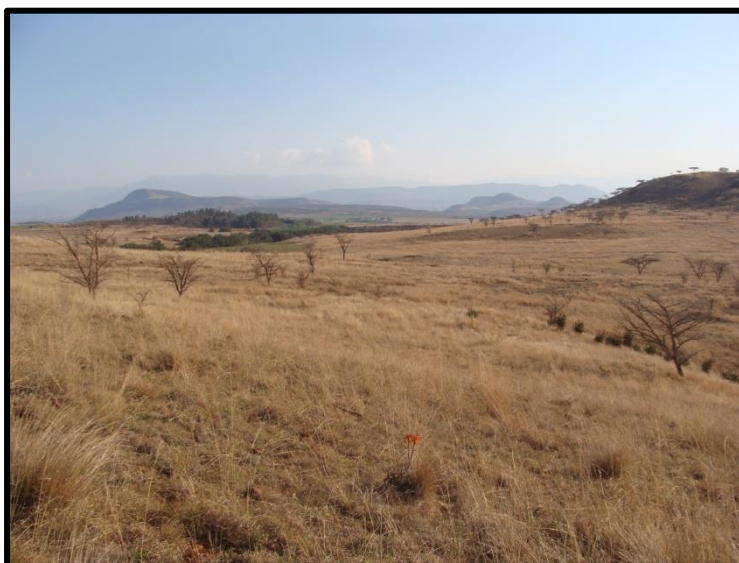
Figure 17: Standing on the hill located to the south of the site footprint, looking south west towards the area of the proposed cultivated fields where the stone-walled features were preserved

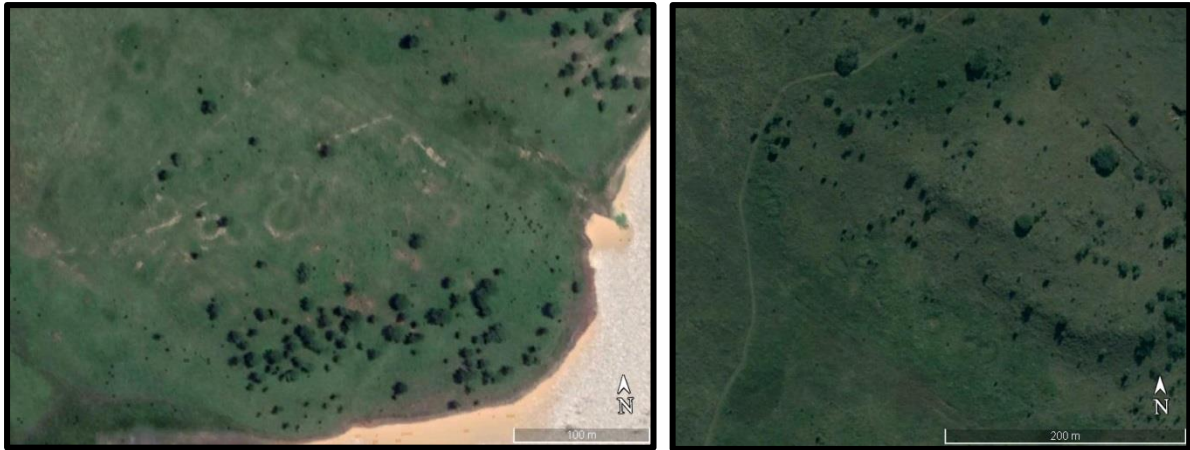
probably represent a Late Iron Age settlement or historical Bantu village. Graves are likely to be present within these ruins so a thorough ground survey by a suitably qualified archaeologist will be necessary to assess the full extent of the occurrence if the plans to cultivate this area are to proceed.

Figure 18 & 19: Satellite images showing some of the circular and linear stone-walled features situated very close to the location of the proposed cultivated fields. These features likely represent houses and kraals from a Late Iron Age or historical Bantu village (GPS coordinates 28° 49' 15.27" S 29° 27' 47.91" E, Fig.18 & 28° 49' 09" S 29° 27' 48.60" E, Fig.19)

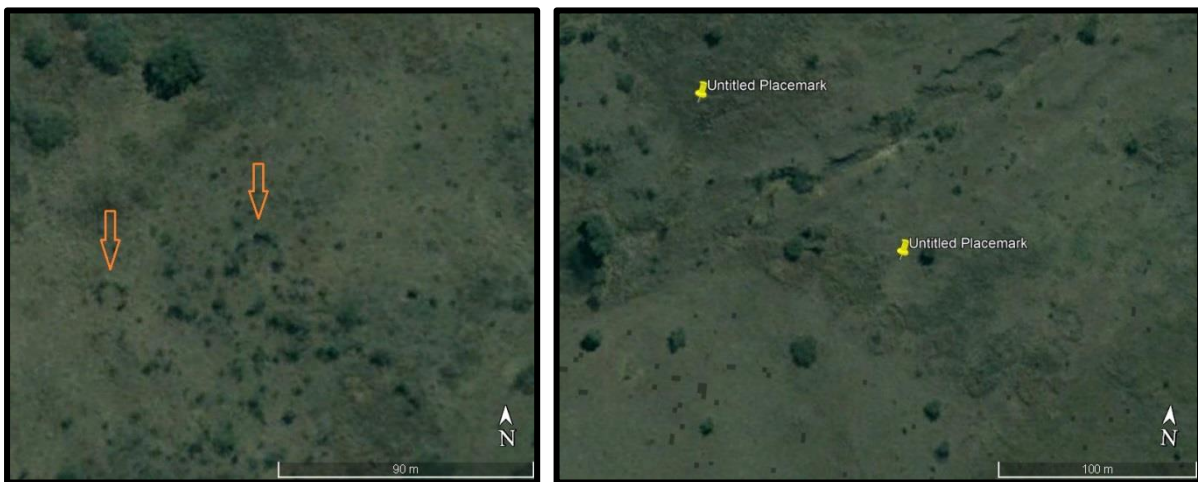
Figure 20 & 21: Satellite images showing additional circular stone-walled features situated very close to the location of the proposed cultivated fields. On the left two circular structures are indicated with orange arrows and on the right a more complex layout is visible comprising of multiple units (GPS coordinates 28° 48' 29.34" S 29° 27' 01.16" E, Fig.20)

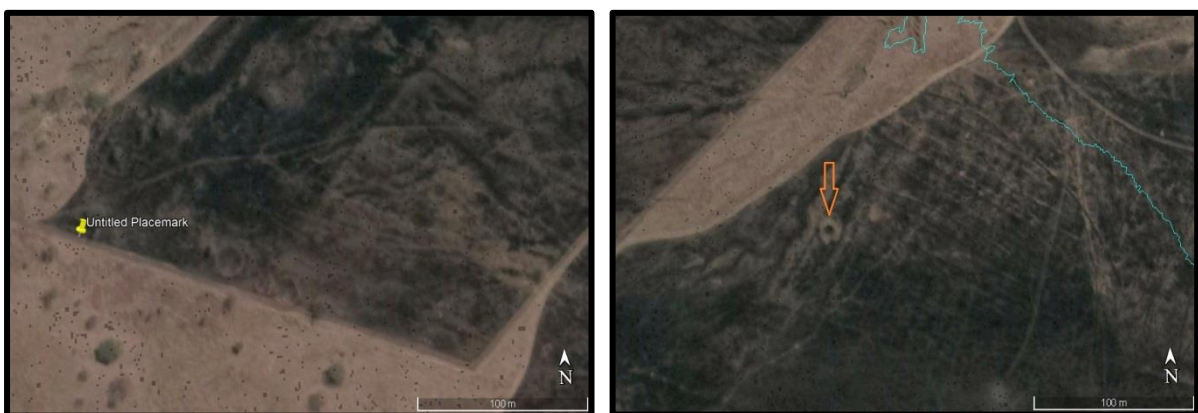
Figure 22 & 23: Satellite images showing more circular stone-walled features situated very close to the location of the proposed cultivated fields. There were several such occurrences, of which only a select few are depicted here (GPS coordinates 28° 48' 37.36" S 29° 28' 16.07" E, orange arrow in Fig.23)
