Old Bethlehem – Homestead

RESTORATION –
MOTIVATION FOR
HWC REV 1

Elisabeth Davies Architect

25 April 2013

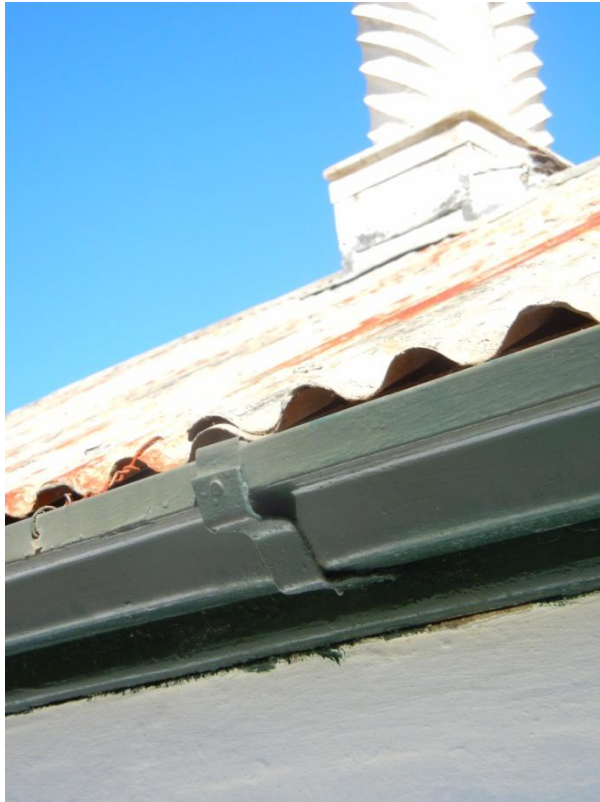
Existing Gutters to be retained

- 4.1.1 **Roof Sheeting:** 0.8mm galvanized corrugated iron in single lengths. Fixed to existing roof structure with 'Leak King' roofing screws. Painted light grey to match wine cellar.
- 4.1.2 **Gutters and fascias:** Rotten fascias to be replaced with same matching profile 32mm thick SA Pine fascias. Retain existing galvanized gutters. Replace perished or missing pieces with custom bent matching lengths, as previously done on Wine Cellar. Custom made 80mm dia galvanized downpipes. Brackets made up to match existing. All painted dark grey.
- 4.1.3 **Hurricane clips:** Fit hurricane clips to secure all purlins to rafters to protect rooves from strong winds in the area.

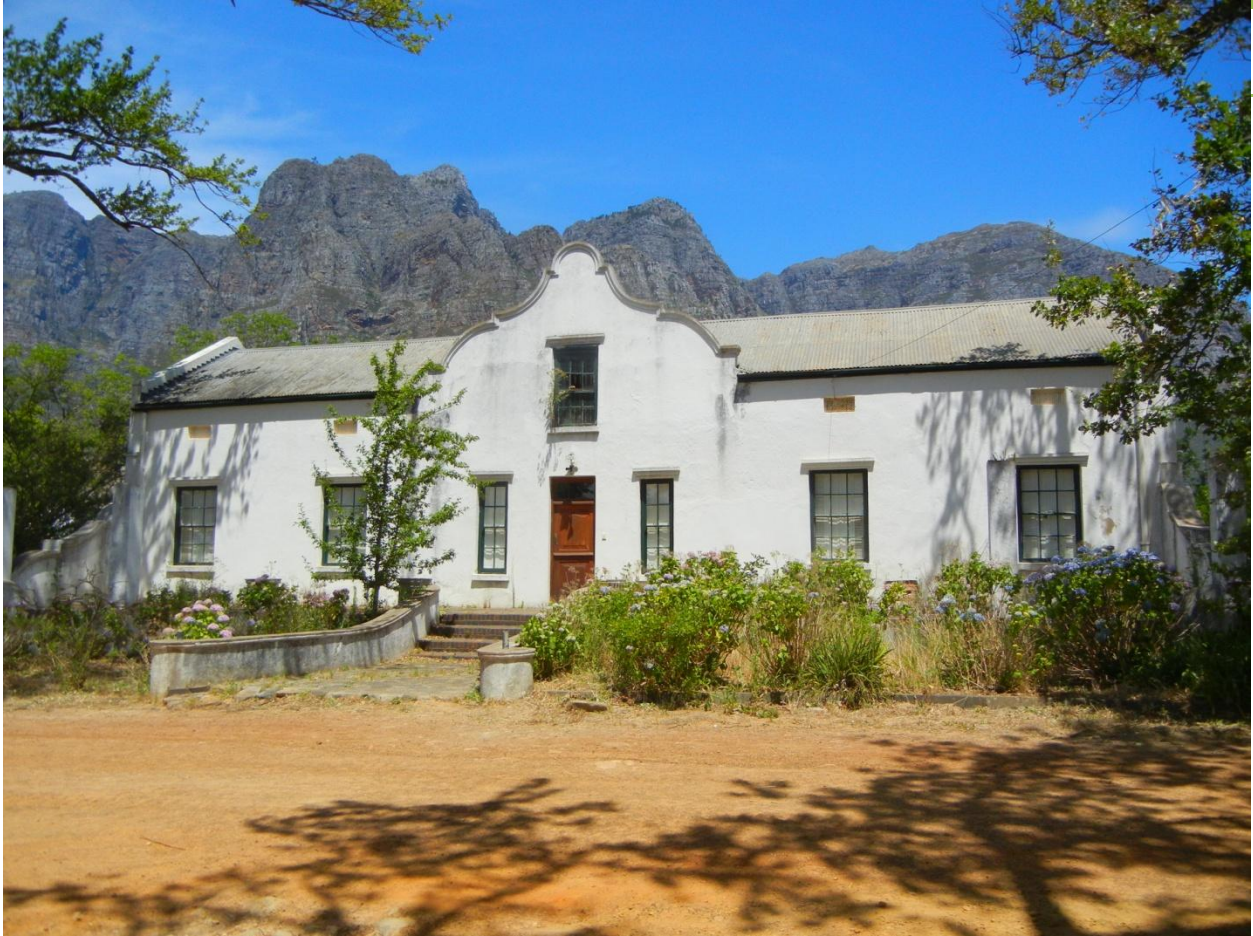
Existing Front Facade

- 5.6 The front facade will remain as is with all its mouldings etc. Replacing the front door is proposed. Evidence of a previous wider door was found on the existing lintol.

- 5.7 The wide stoep will be retained but the badly spaced late 20th century columns will be removed and the front steps reconfigured to later detail.
- 5.8 Electrics and plumbing will have to be updated. Chasing of walls to be kept to a minimum.

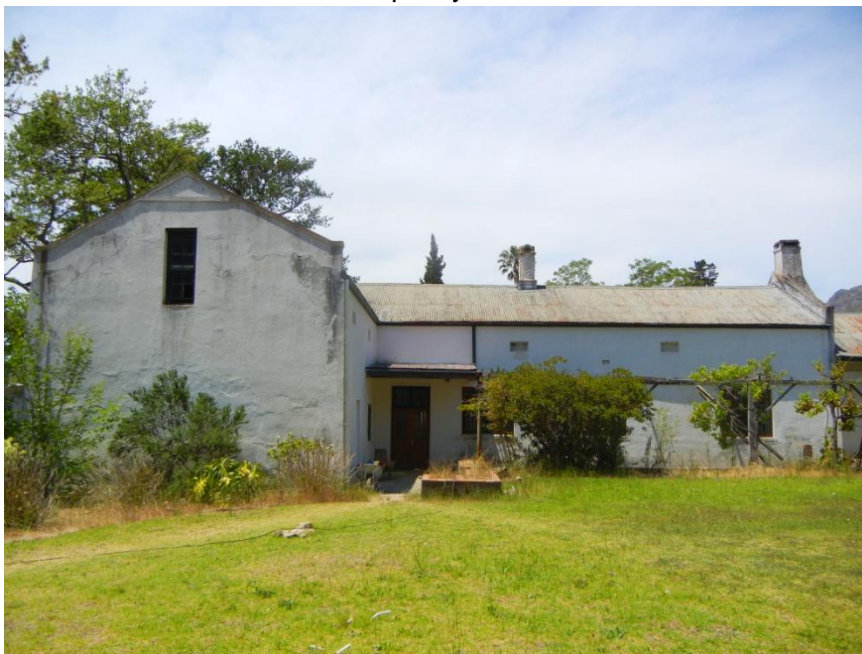
Garden Side View

- 5.5 The existing low grade meranti pergola and afdak, on the garden side, will be removed. A covered stoep in keeping with the later Victorian 'layer' of the homestead is proposed instead.

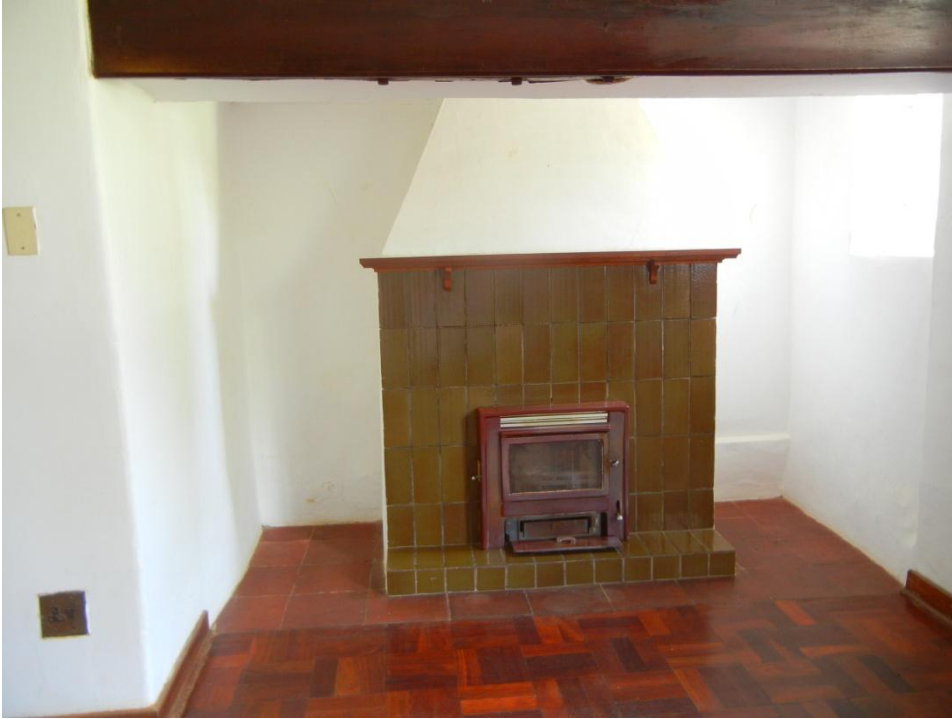
View of Hearth to be reinstated as open Fireplace

- 5.2 The kitchen will be moved to its original position and the hearth restored as a fireplace. Original beam and chimney remain. Bakoond was destroyed late 1800s when the leg of the 'T' was extended and now serves as a lobby link.

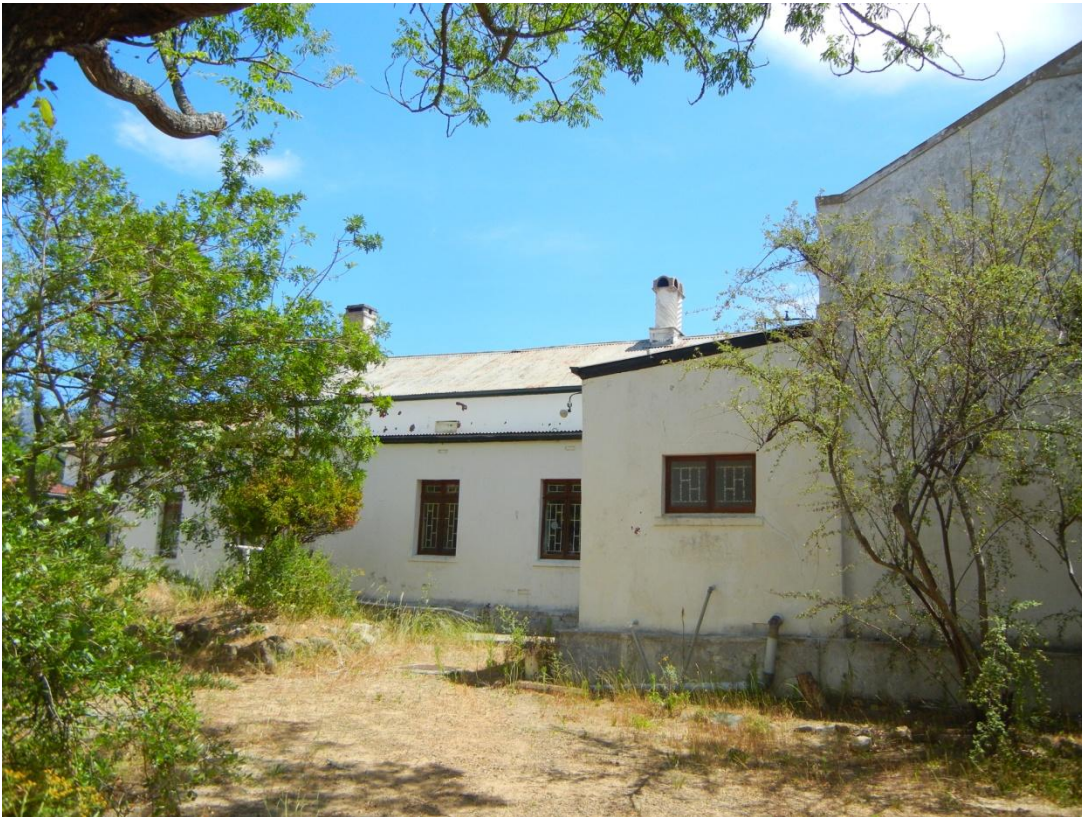
View of Lean To service structure on Kitchen Werf side

- 5.3 The late 19th century lean to service spaces will be reorganised to accommodate bathrooms and a scullery.
- 5.4 Inappropriate, large, late 20th century windows will be removed and replaced by sash windows to relate to the spectacular mountain view in the new bedroom position. The ones on the side will be replaced by Sash Windows and simple French doors to open out onto the outdoor living area and the garden.

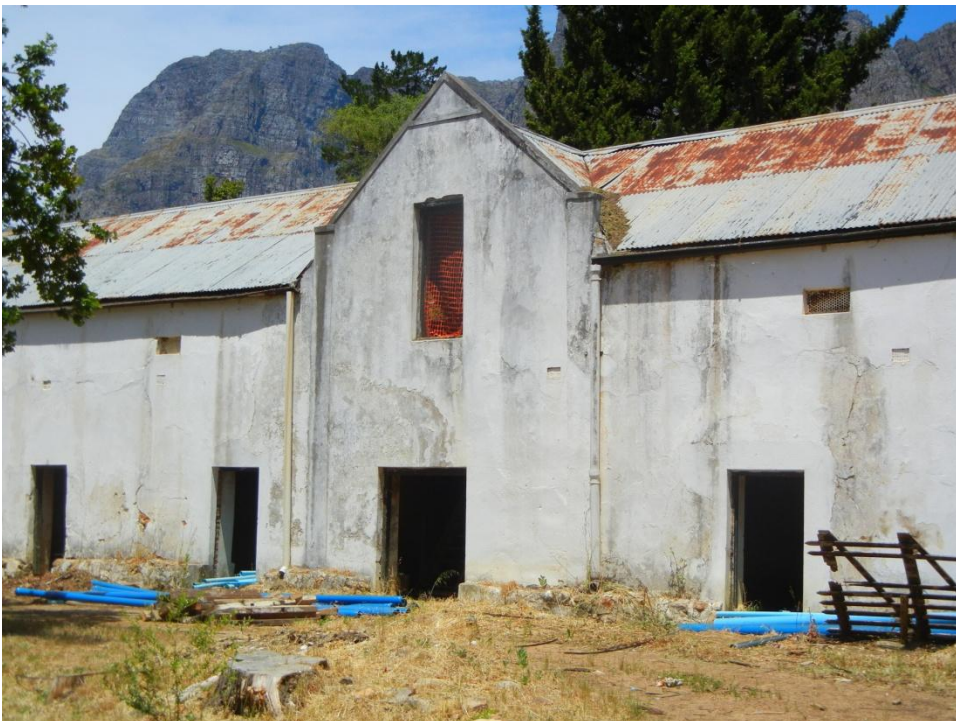
View of Stable Building – Roof sheeting to be replaced

Replace the corrugated roof sheeting of the Homestead, Stables and lesser outbuildings in the complex. This needs to be done urgently before the winter rains, independently of any other works. Gutters and fascias will also be replaced.

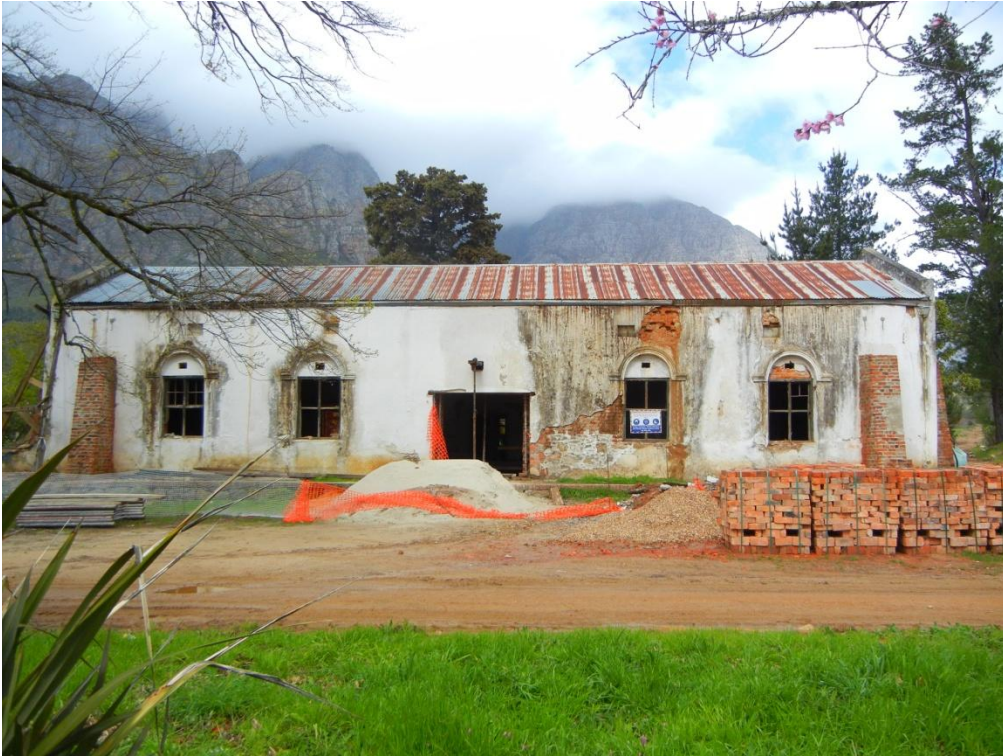
Wine Cellar Before Restoration

This process began in 2012 with the repair of the wine cellar, which is now complete. Approval was obtained from HWC for these restorations and they were overseen by Elisabeth Davies Architect, with the conservation architect Graham Jacobs as an occasional consultant.

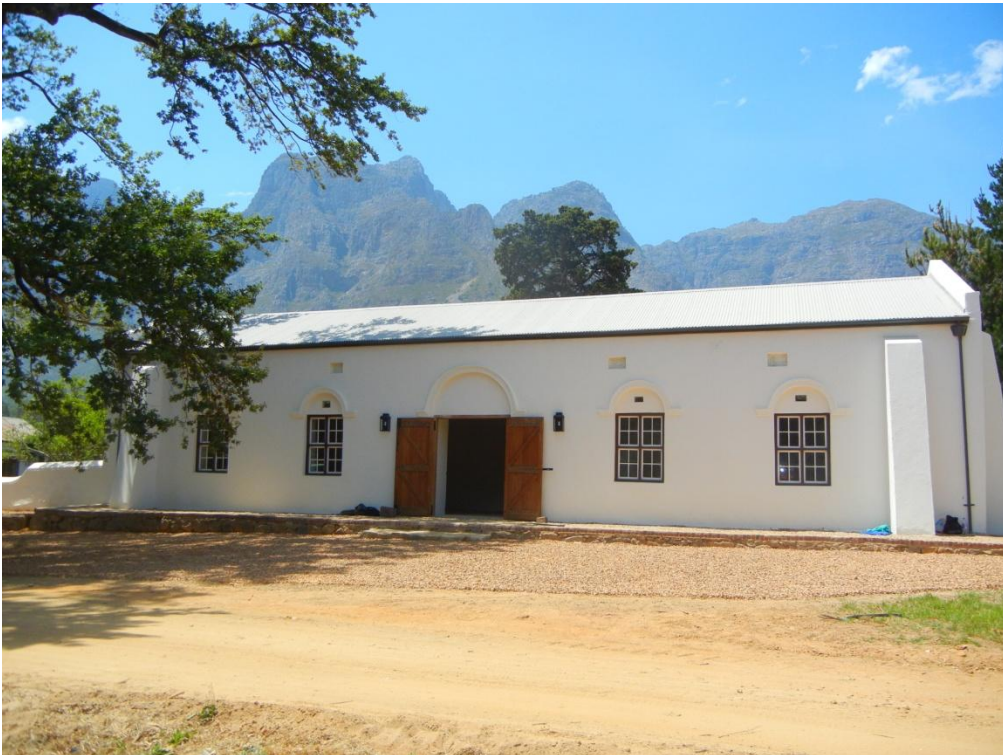
Wine Cellar after Restoration (First Application made to HWC in 2012)
