DRAFT BASIC ASSESSMENT REPORT

**CONSTRUCTION OF THE P303 PIPE CULVERTS AND BRIDGE
EDUMBE LOCAL MUNICIPALITY**

THE KWAZULU-NATAL DEPARTMENT OF TRANSPORT

EIA REF NO: DC26/0006/2019

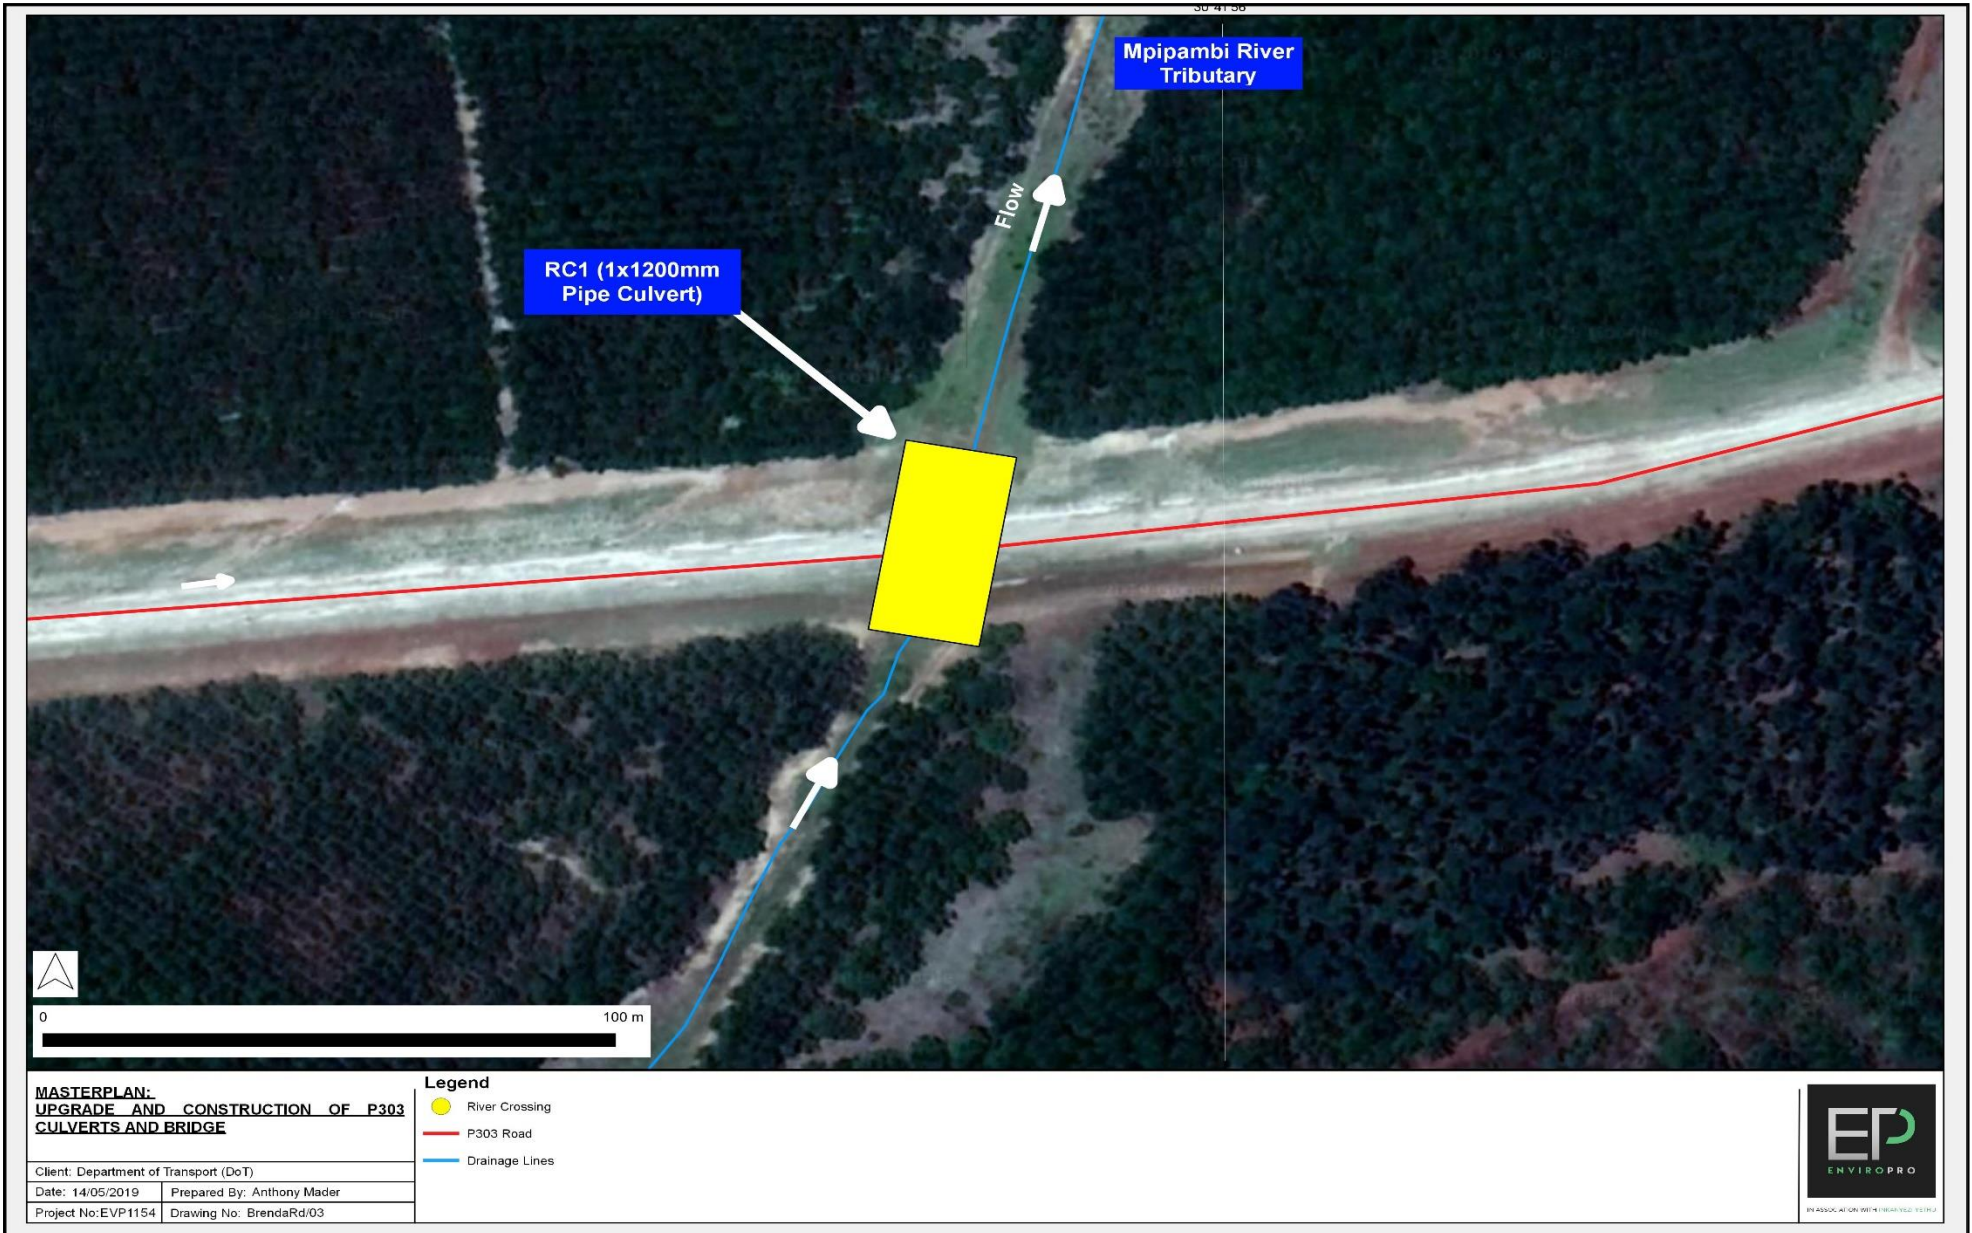
Figure 4: Aerial photograph showing RC1 located at 27°24'43.15"S; 30°41'54.68"E. QGIS, ver. 3.2.2.

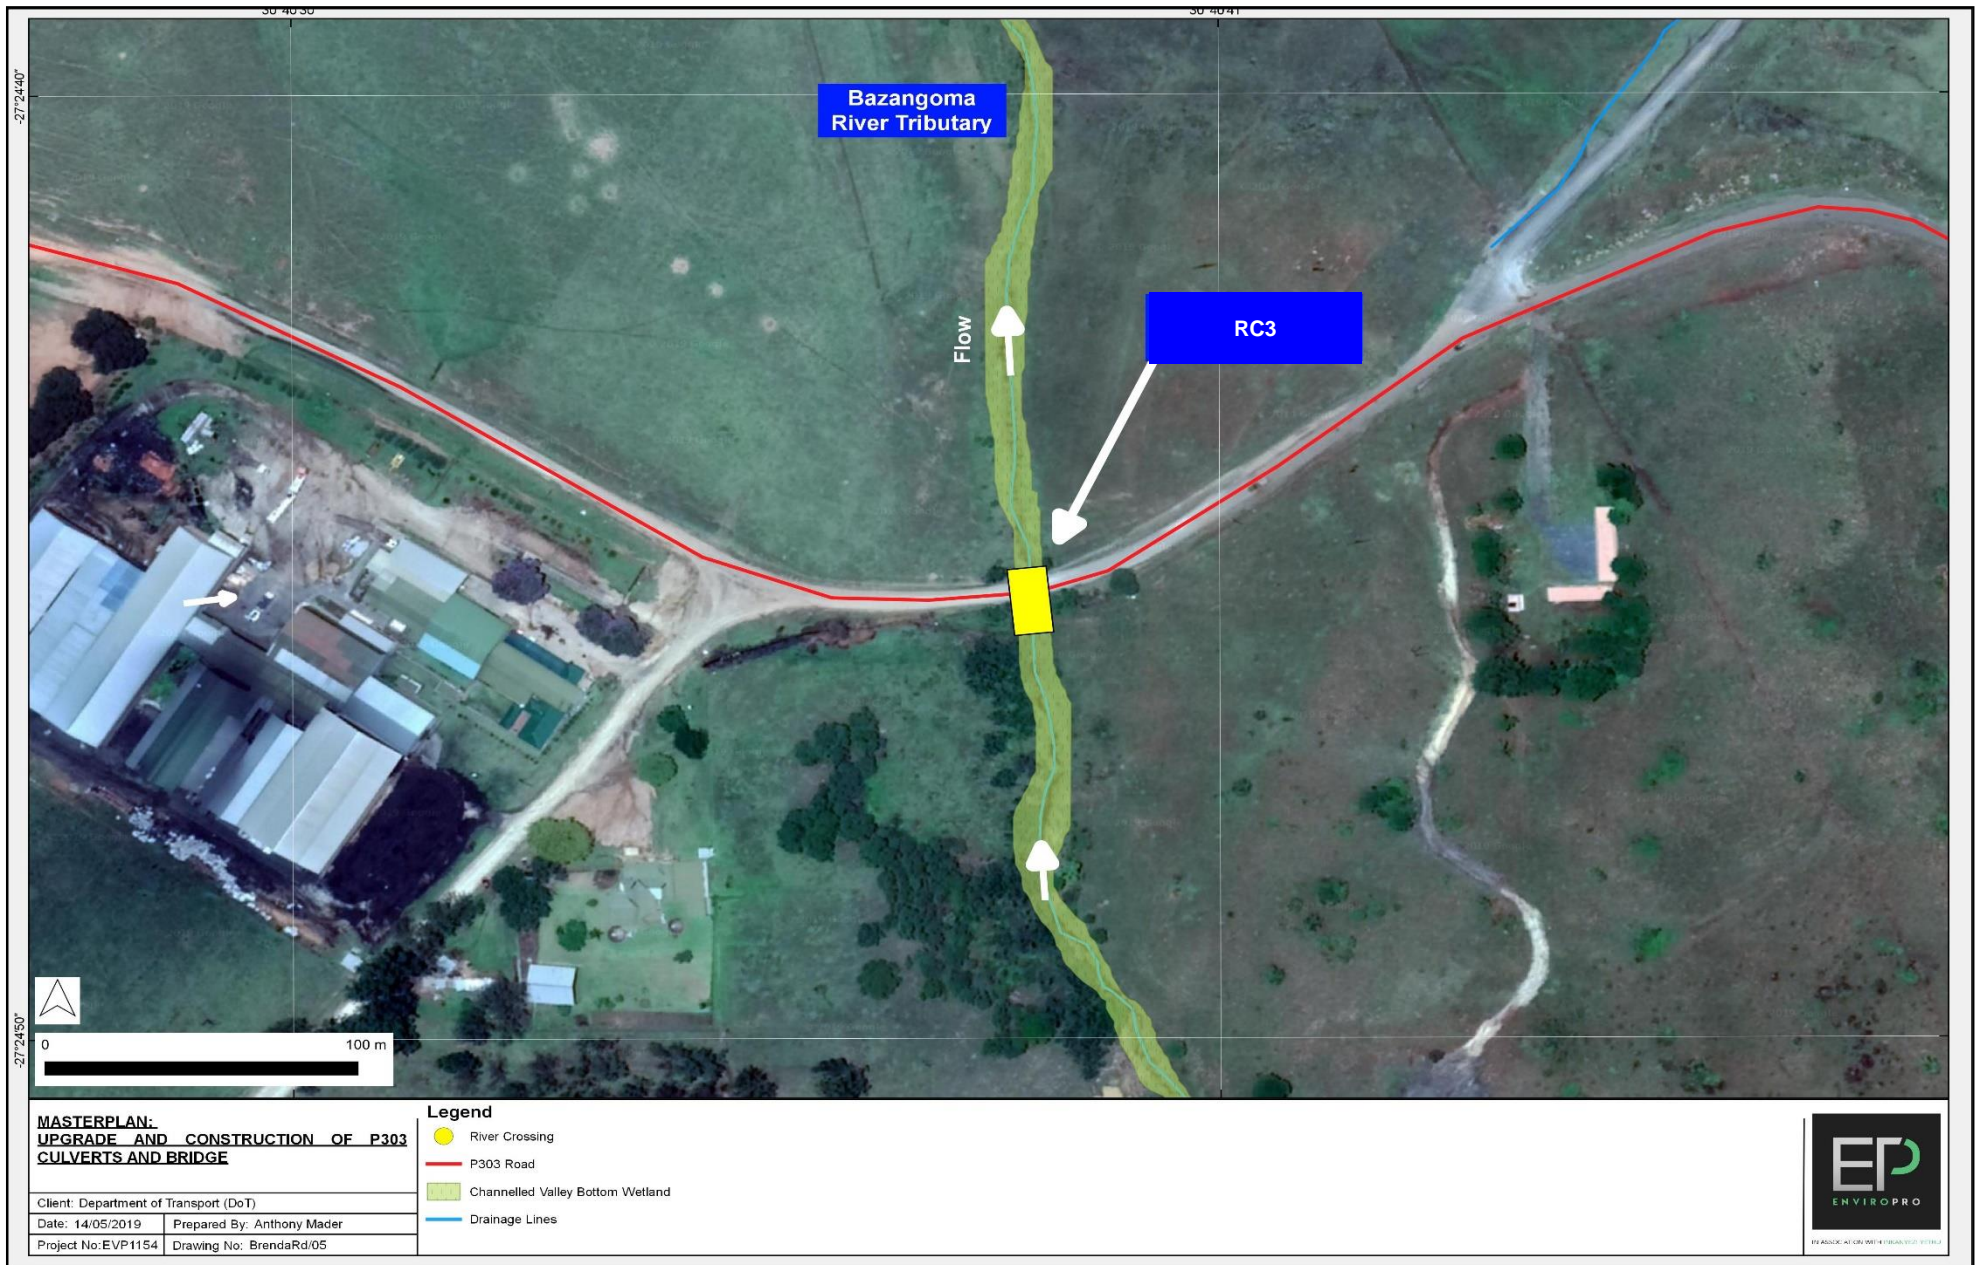
Figure 6: Aerial photograph showing RC3, located at 27°24'45.30"S; 30°40'38.64"E, to be repaired. QGIS, ver. 3.2.2.

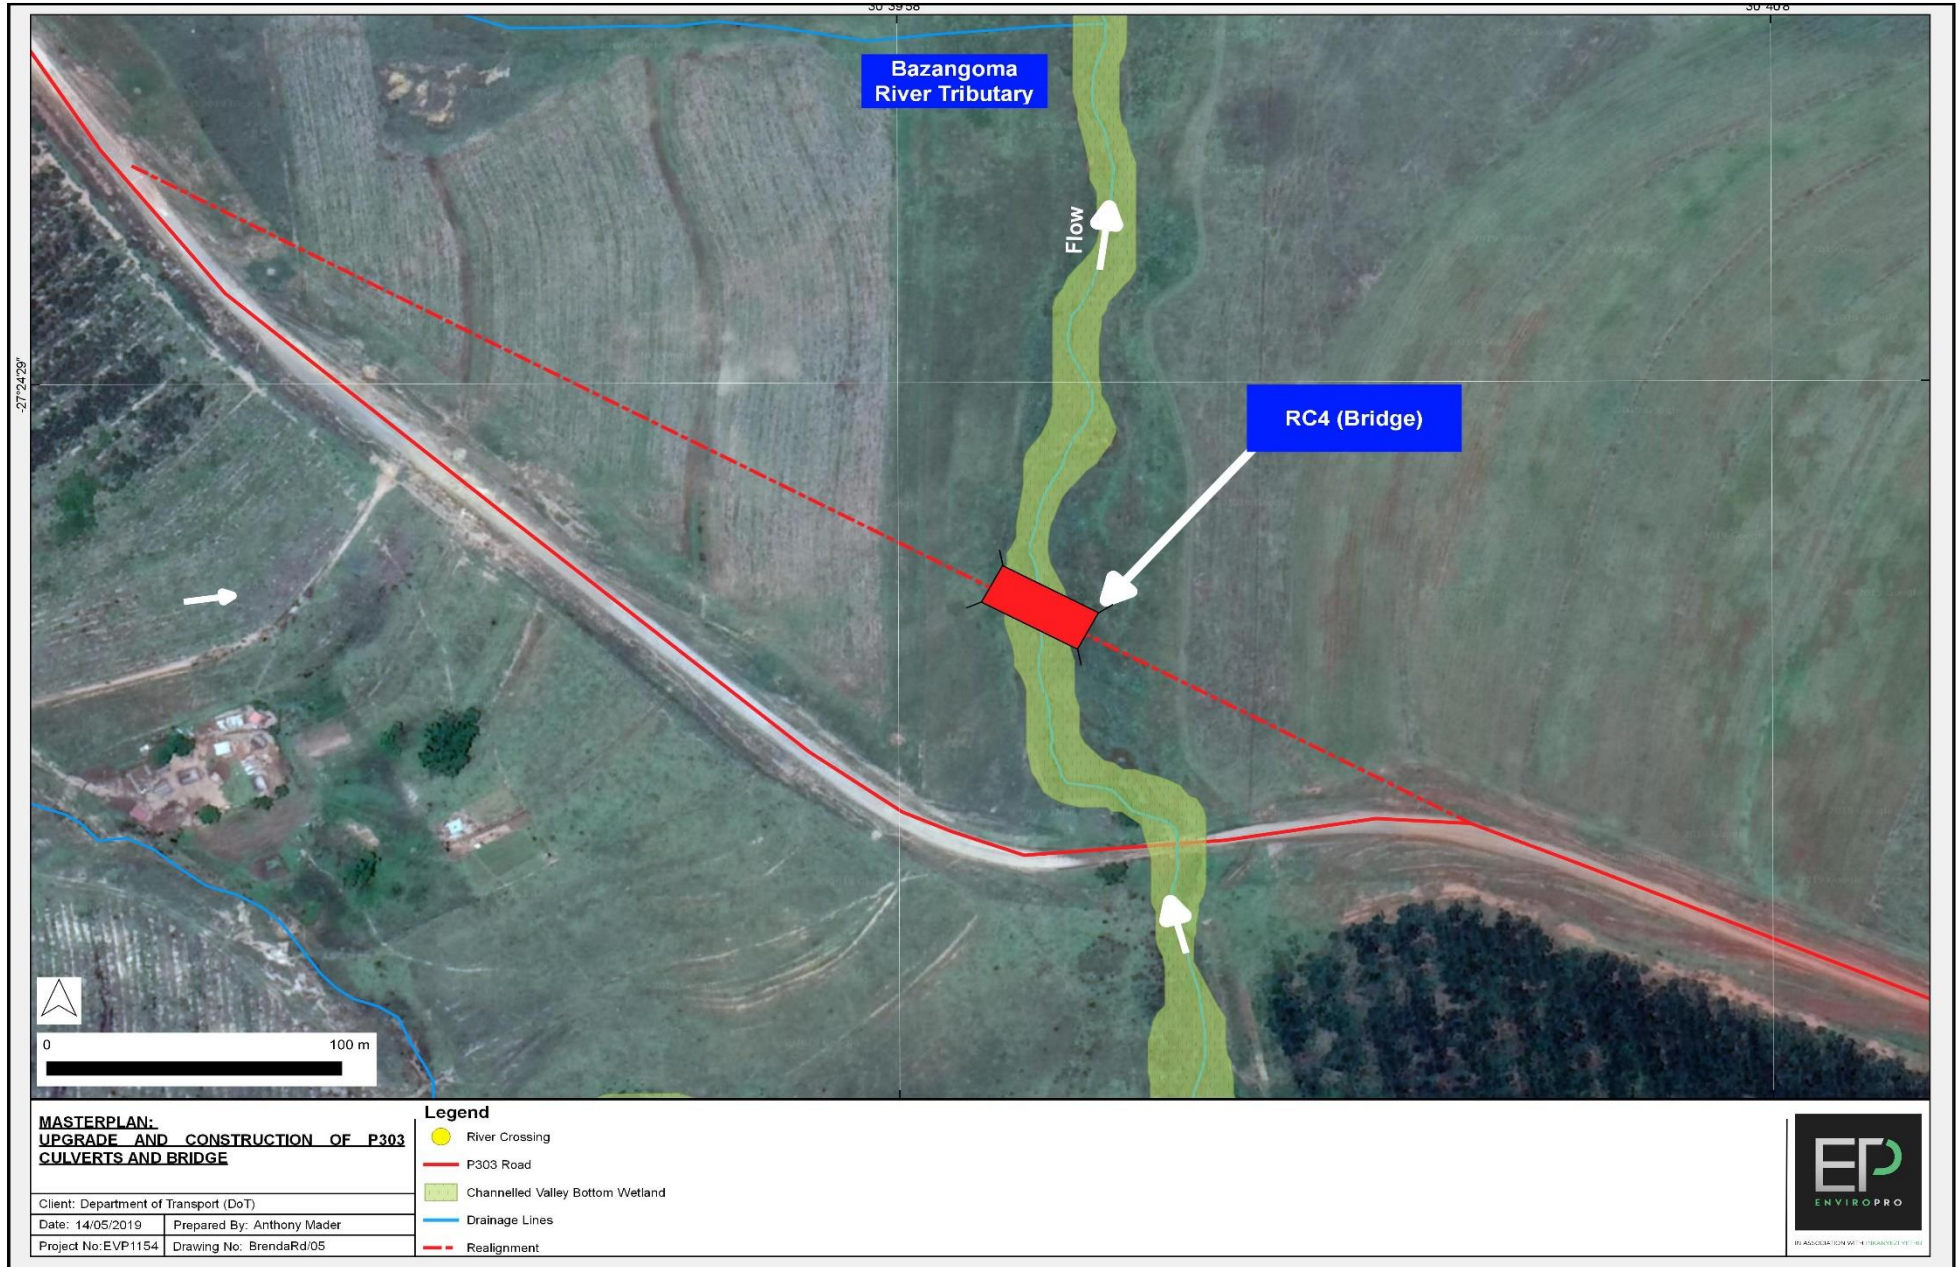
Figure 7: Aerial photograph showing RC4 located at 27°24'33.93"S; 30°40'0.48"E. QGIS, ver. 3.2.2

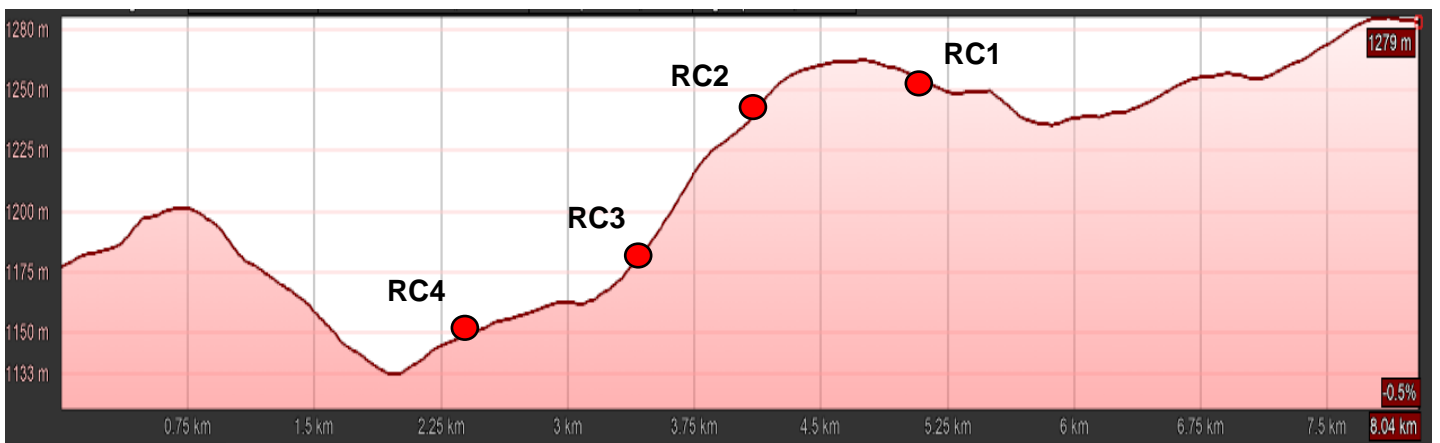
Figure 8: Elevation profile for the two pipe culverts (RC1 and RC2) and proposed Bridge (RC4) (red dots). Google Earth, 2019.

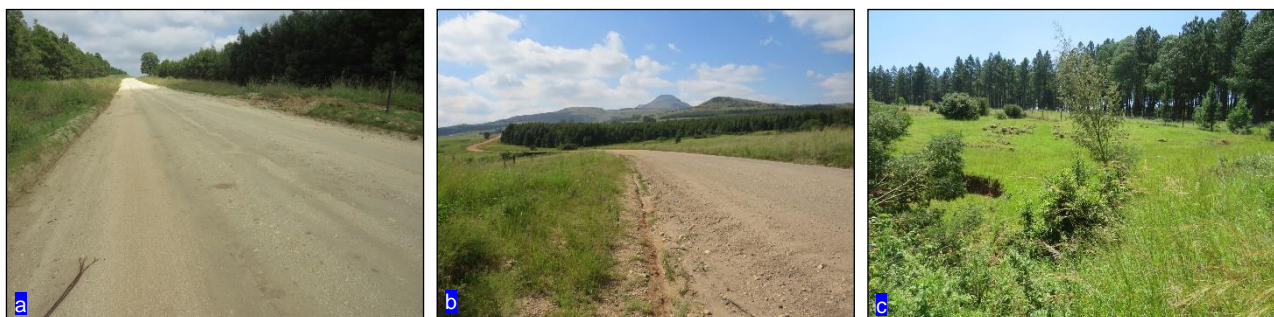
Figure 9: (a): Photographer facing west looking towards RC1 showing the status of the P303 road (b): Image showing surrounding land uses (namely plantations and open grasslands). (c): Additional image showing surrounding land uses.

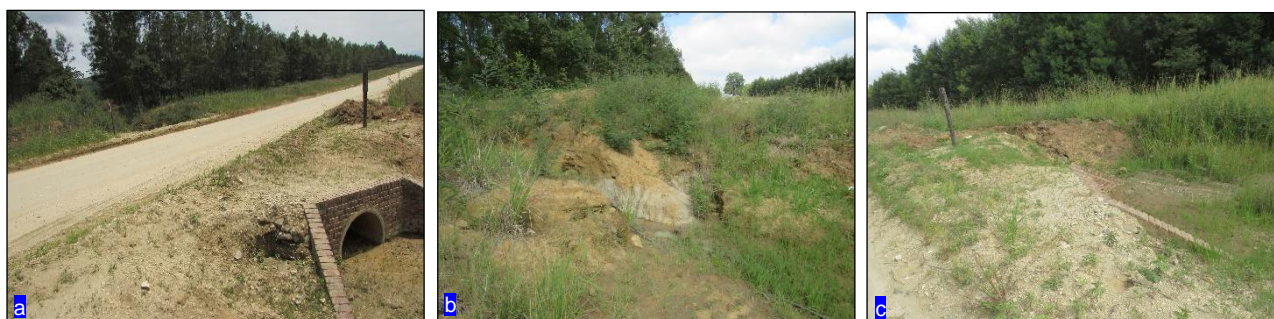
Figure 10: (a): Image showing existing structure at RC1 and P303 road. Note sedimentation of pipe; (b): Image showing upstream characteristics of the existing P303 structure (c): Additional image showing downstream of RC1.

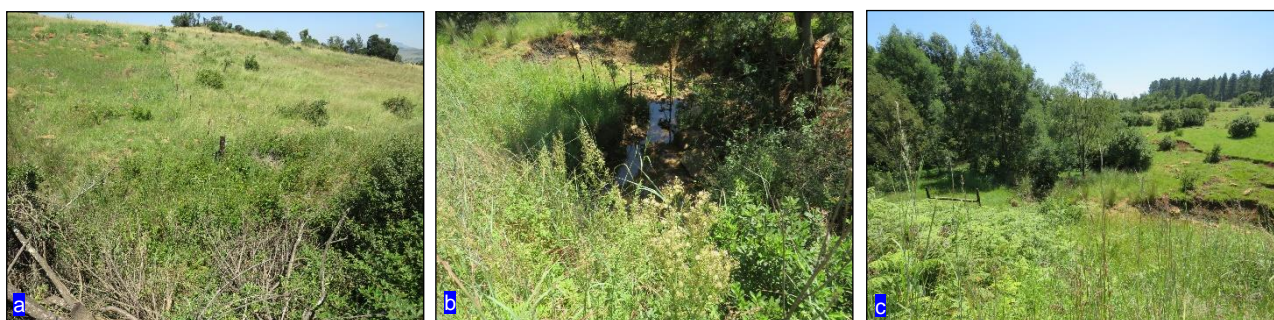
Figure 11: (a): Image showing upstream characteristics of RC2; **(b):** Image showing downstream characteristics at RC2 **(c):** Additional image showing surrounding land use at RC2.

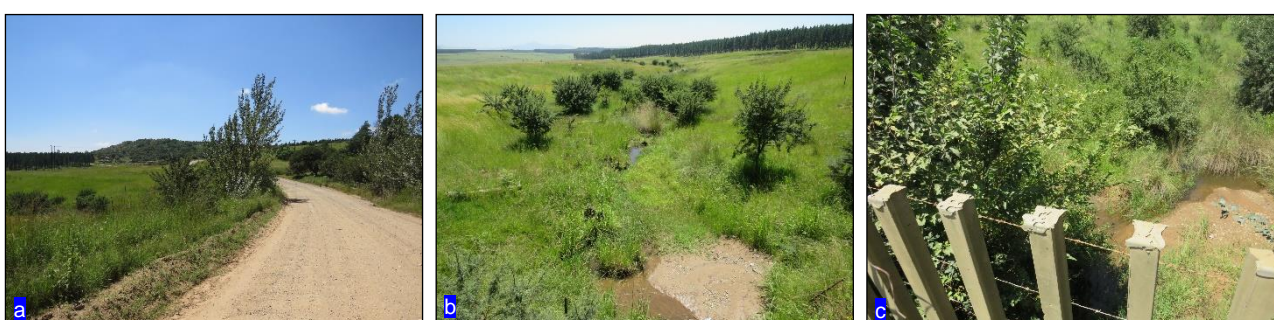
Figure 12: (a): Image showing P303 approaching RC3. **(b):** Photograph showing downstream characteristics at RC3 **(c):** Image showing upstream characteristics at RC3 and associated deteriorated infrastructure to be repaired. **Note, this existing structure, at RC3, will only be repaired and not upgraded.**

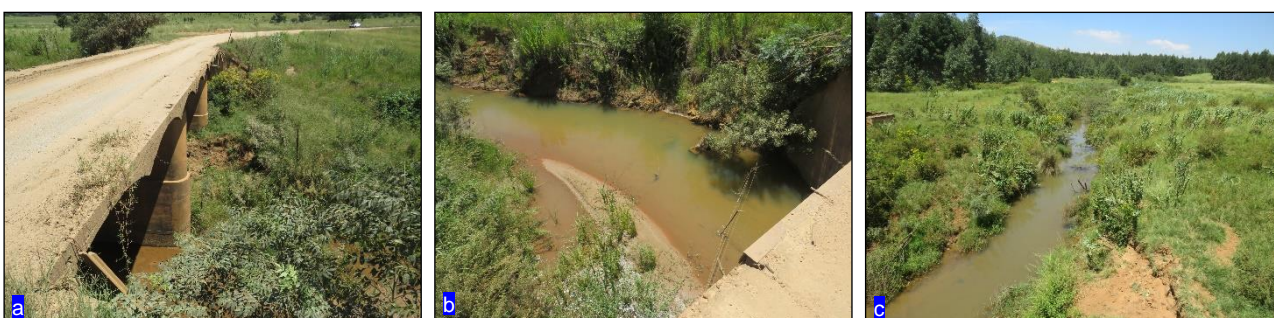
Figure 13: (a): Image showing existing infrastructure at RC4 **(b):** Image showing downstream characteristics at RC4 **(c):** Image showing upstream characteristics at RC4.
