Draft Basic Assessment Report for:

BASIC ENVIRONMENTAL IMPACT ASSESSMENT APPLICATION FOR THE PROPOSED RE-ALIGNMENT OF ROAD P75/2 WITHIN UMDONI, AND UMZUMBE LOCAL MUNICIPALITIES, UGU DISTRICT MUNICIPALITY, KWAZULU-NATAL

Name of Applicant: The Department of Transport

Title	Re-alignment of Road P75/2
Project Manager	Samani Consulting (Pty) Ltd
Author	Mrs Joleen Wilson
Reviewer	Ms Adrienne Edgson
Client	The Department of Transport
Project Reference Number	To Be Confirmed
Issue Date	17 th August 2017

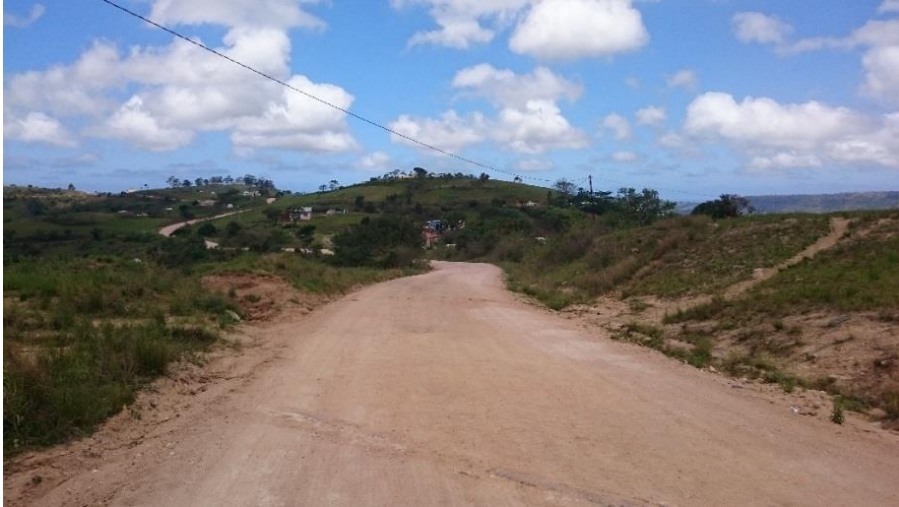
Photograph 1: Shows the existing condition of road P75-2

The existing road is a Type 6 District Gravel Road and is in a moderate to poor condition. For most parts of the road, the gravel wearing course is well compacted and intact, however erosion ruts have been created due to heavy rainfall events that have occurred between the months of June and August 2016. Due to the gravel nature of the road, it is subject to wear resulting in ruts and slippery conditions especially in wet weather. Sections of the road which have steep gradients and sharp bends are prone to easier wear and degradation. Due to the loose nature of the gravel wearing course, driving conditions at various points of the road (steep declines and sharp bends) becomes dangerous. Refer to the photos below showing existing conditions of the road.

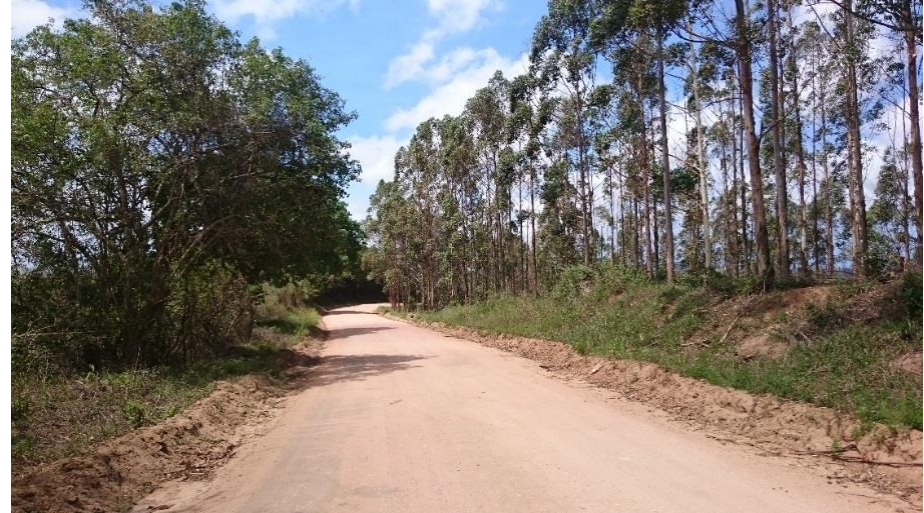
Photograph 2: Shows the existing condition of road P75-2. Note, no storm water management system has been provided.

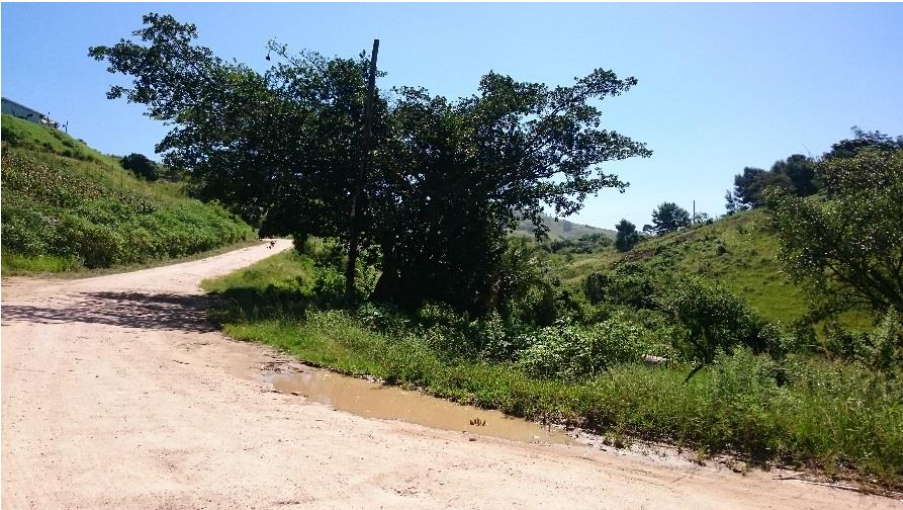
Photograph 3: Shows the existing condition of road P75-2. Note, no storm water management system has been provided, resulting in pooling of water.

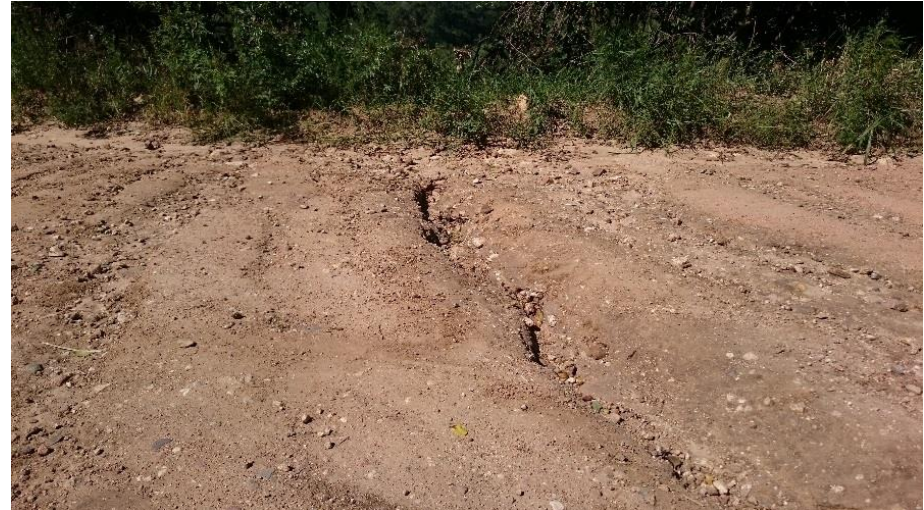
Photograph 4: Shows the existing condition of road P75-2 and the erosion that is currently occurring. This clearly shows rutting of the road.

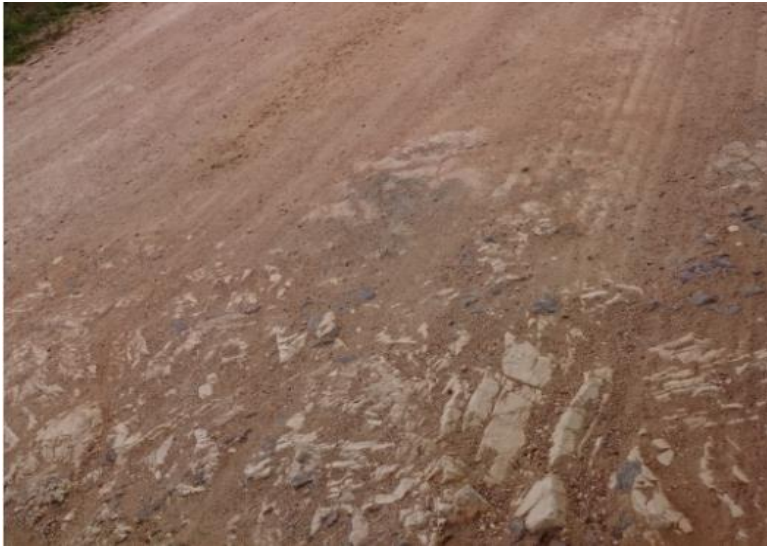
Photograph 5: Shows the condition of the road and erosion exposing rock.

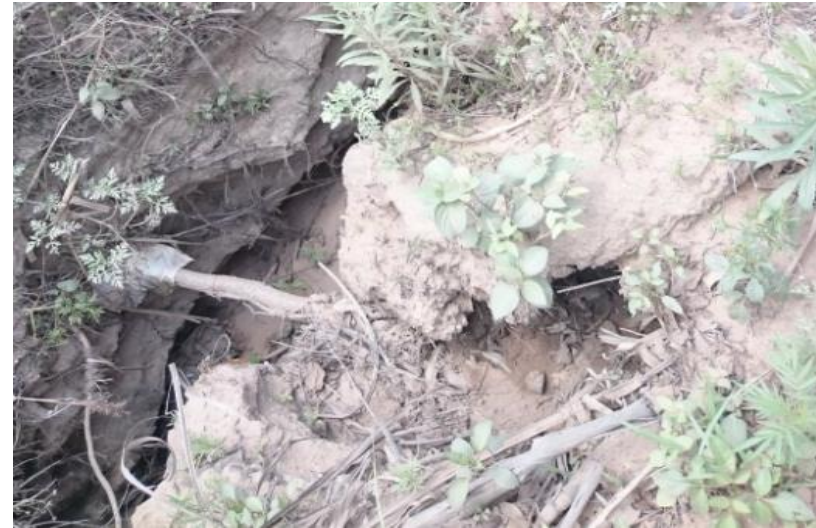
Photograph 6: Shows erosion found alongside road P75-2 due to the lack of storm water control.

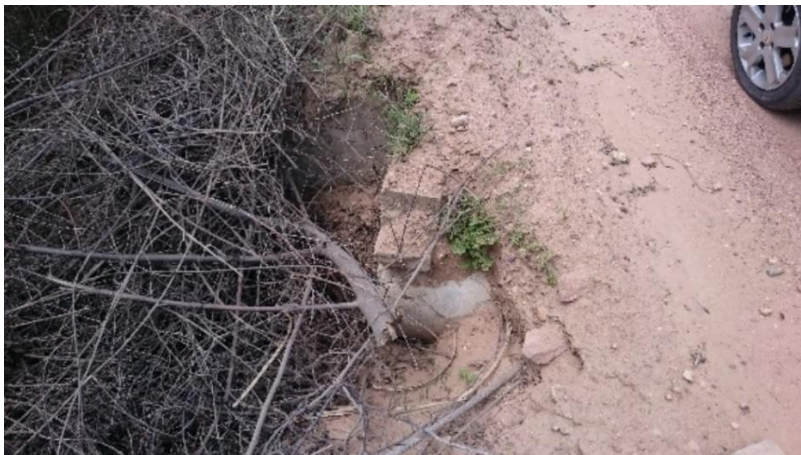
Photograph 7: Shows one of the culvers along road P75-2, which is seen to be blocked and eroded.

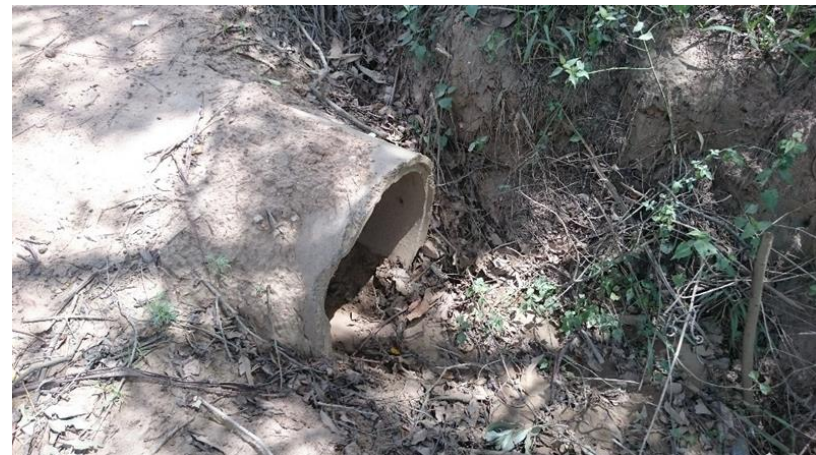
Photograph 8: Shows a stormwater surrounded by sediment which will either build up overtime and block the pipe or in heavy rainfall, be washed down the steep banks and cause erosion.

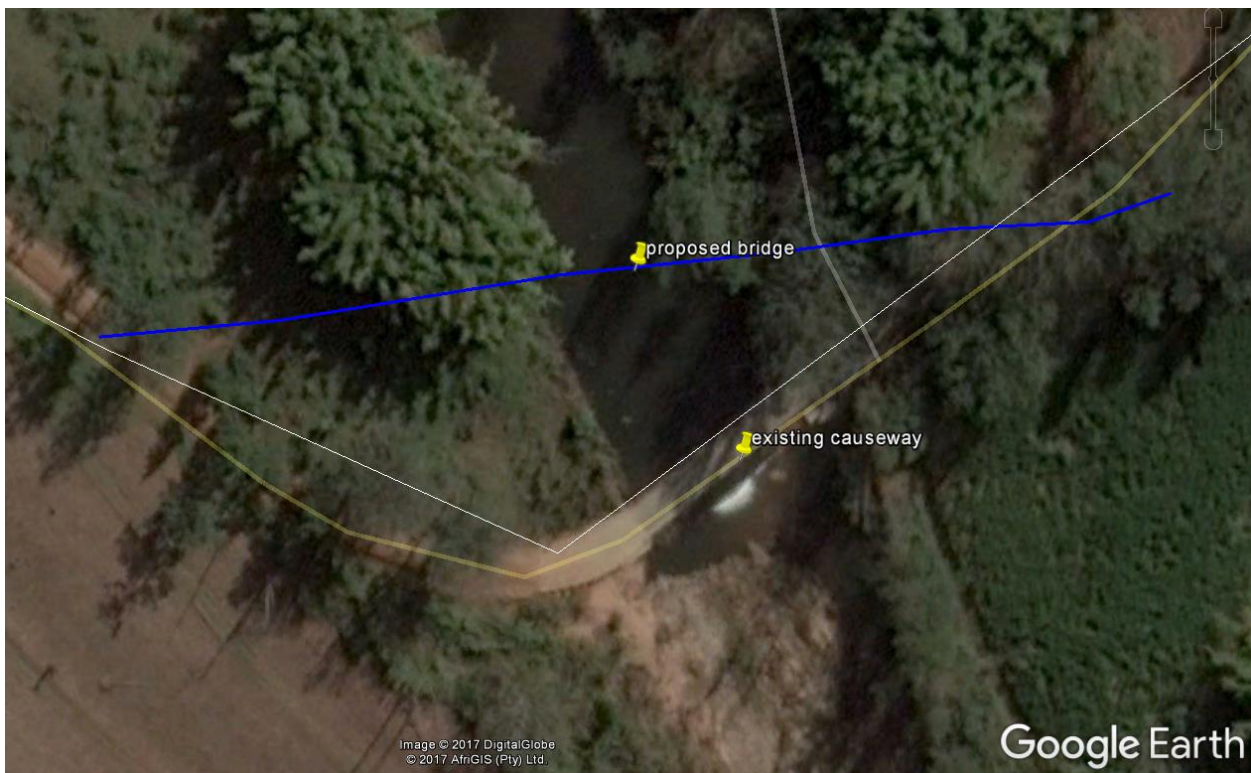
Figure 4: Google Earth Imagery showing the location of the existing causeway and proposed bridge.

A new river bridge is planned for this project, which will provide a crossing of the river for vehicles and pedestrians. The existing river crossing is a causeway. The new bridge is positioned approximately 41 metres north (upstream) of the existing causeway. The bridge is designed to accommodate a 1:20 year flood.

The image below shows the existing causeway and the location of the proposed bridge.

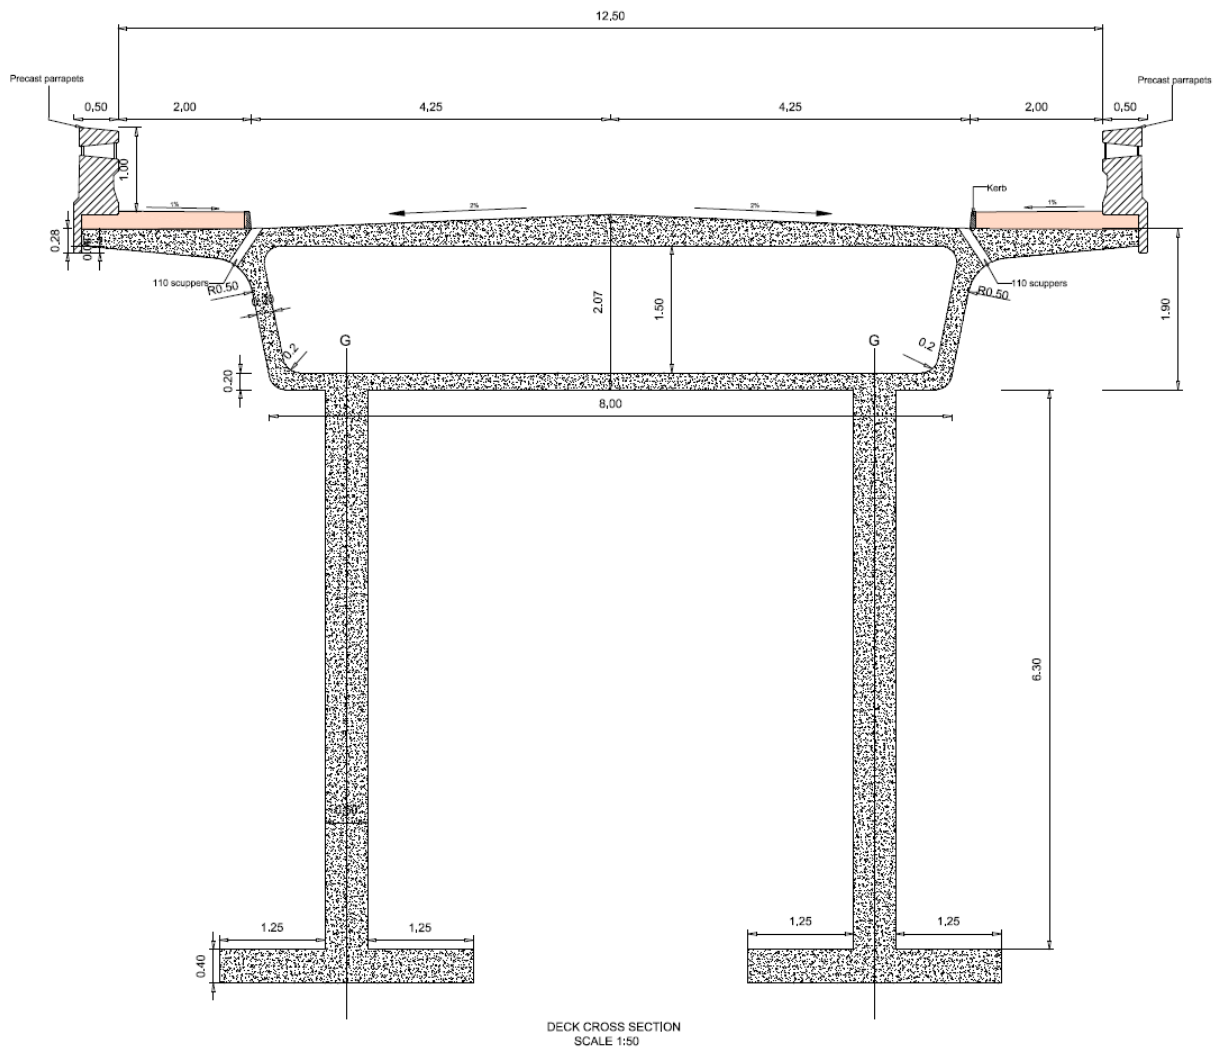
Figure 5: Design of the proposed bridge (Refer to Appendix B6 for the full design drawing)

Scupper pipes are proposed in the design to allow stormwater to flow from the bridge directly into the river below. **The use of scupper pipes is not supported** by the environmental assessment practitioner. **It is suggested that an alternative design is used to capture and remove water such that it is directed from the kerb into a box gutter which is attached to the bridge parapet / deck along the full length of the bridge. The water is then directed into a downpipe at the end of the bridge and then into an attenuation pond which allows the water to be discharged through groundwater seepage at a normal rate into the river. Groundwater seepage will also allow filtration of the water before entering the river.**

The main bridge structure will be constructed from concrete in situ. Precast concrete will be used for pavements and parapets.

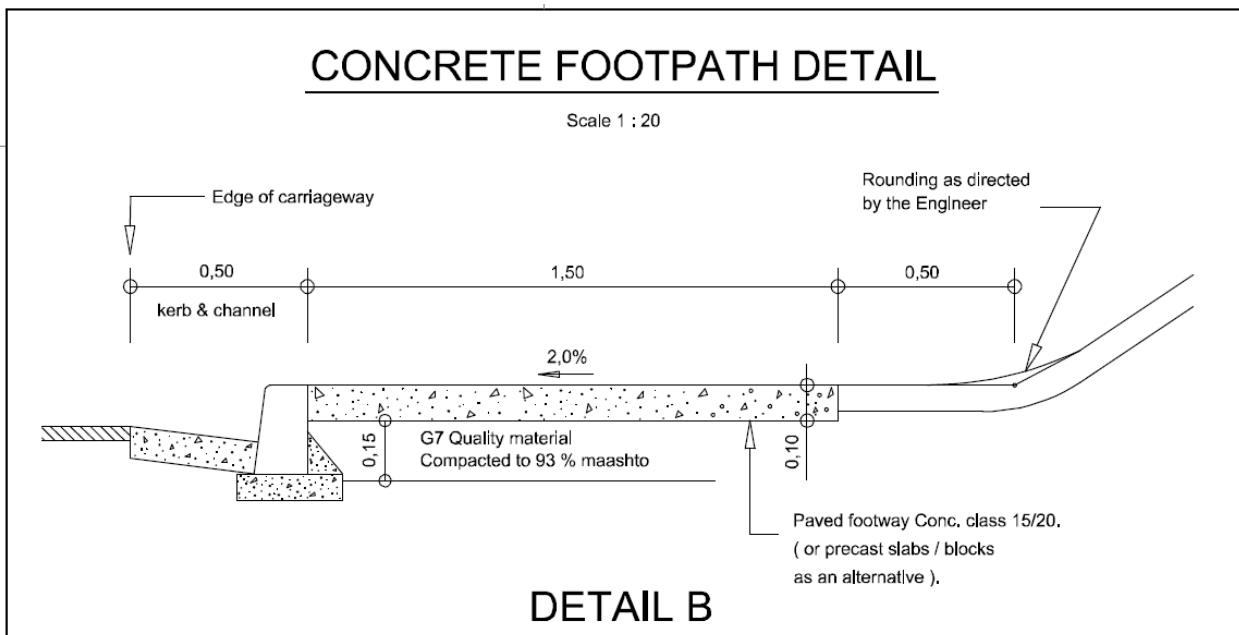
Figure 6: Concrete Footpath Detail (Refer to Appendix B1 for the full design drawing)

The footpath will be 1.5metres wide, at the toe of the footpath, a kerb and channel will be provided. Beneath the paved surface of the footpath, G7 quality material will be used and compacted to 93% maashto.

Refer to figure 5 and 6 below which shows the detail of a footpath in a cut condition as well as the footpath detail.

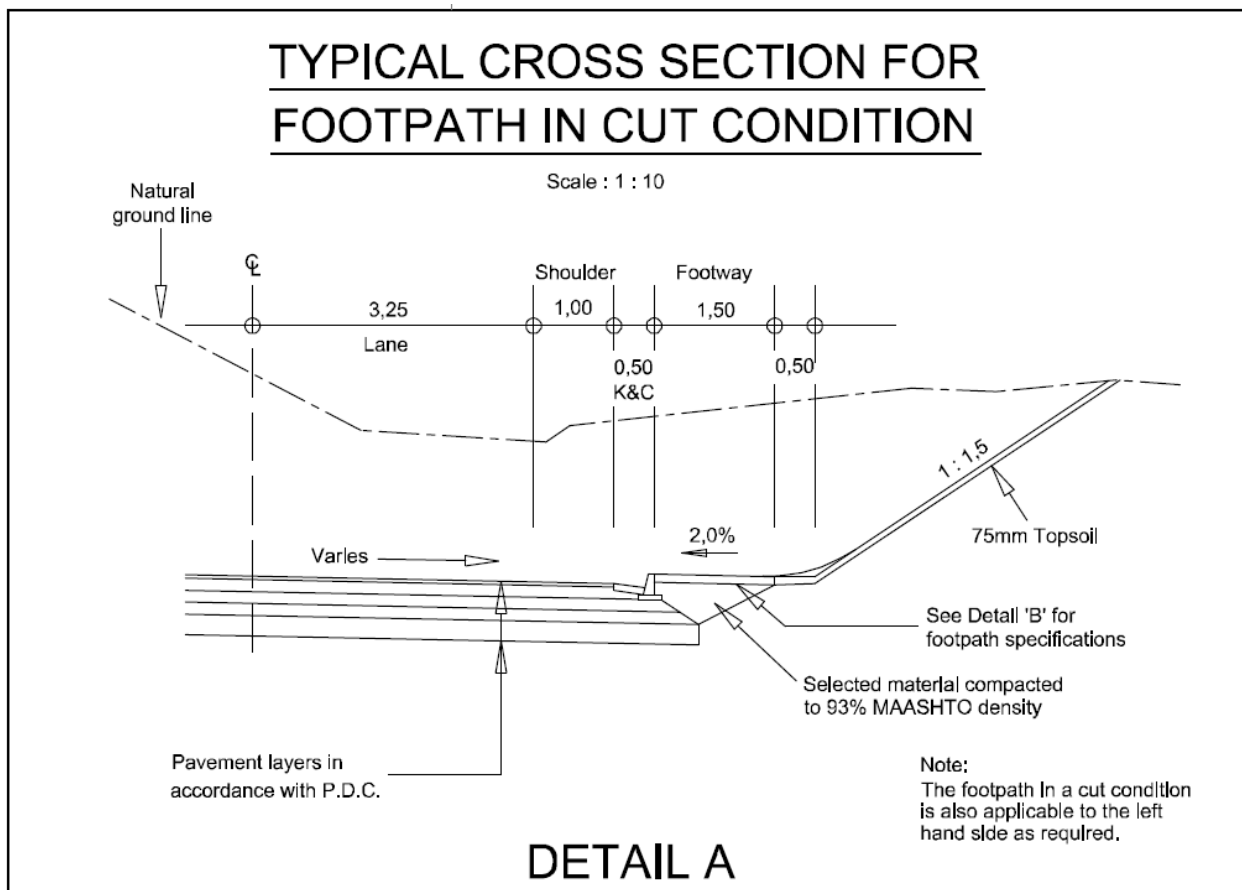
Figure 7: Typical cross section for footpath in a cut condition (Refer to Appendix B1 for the full design drawing).

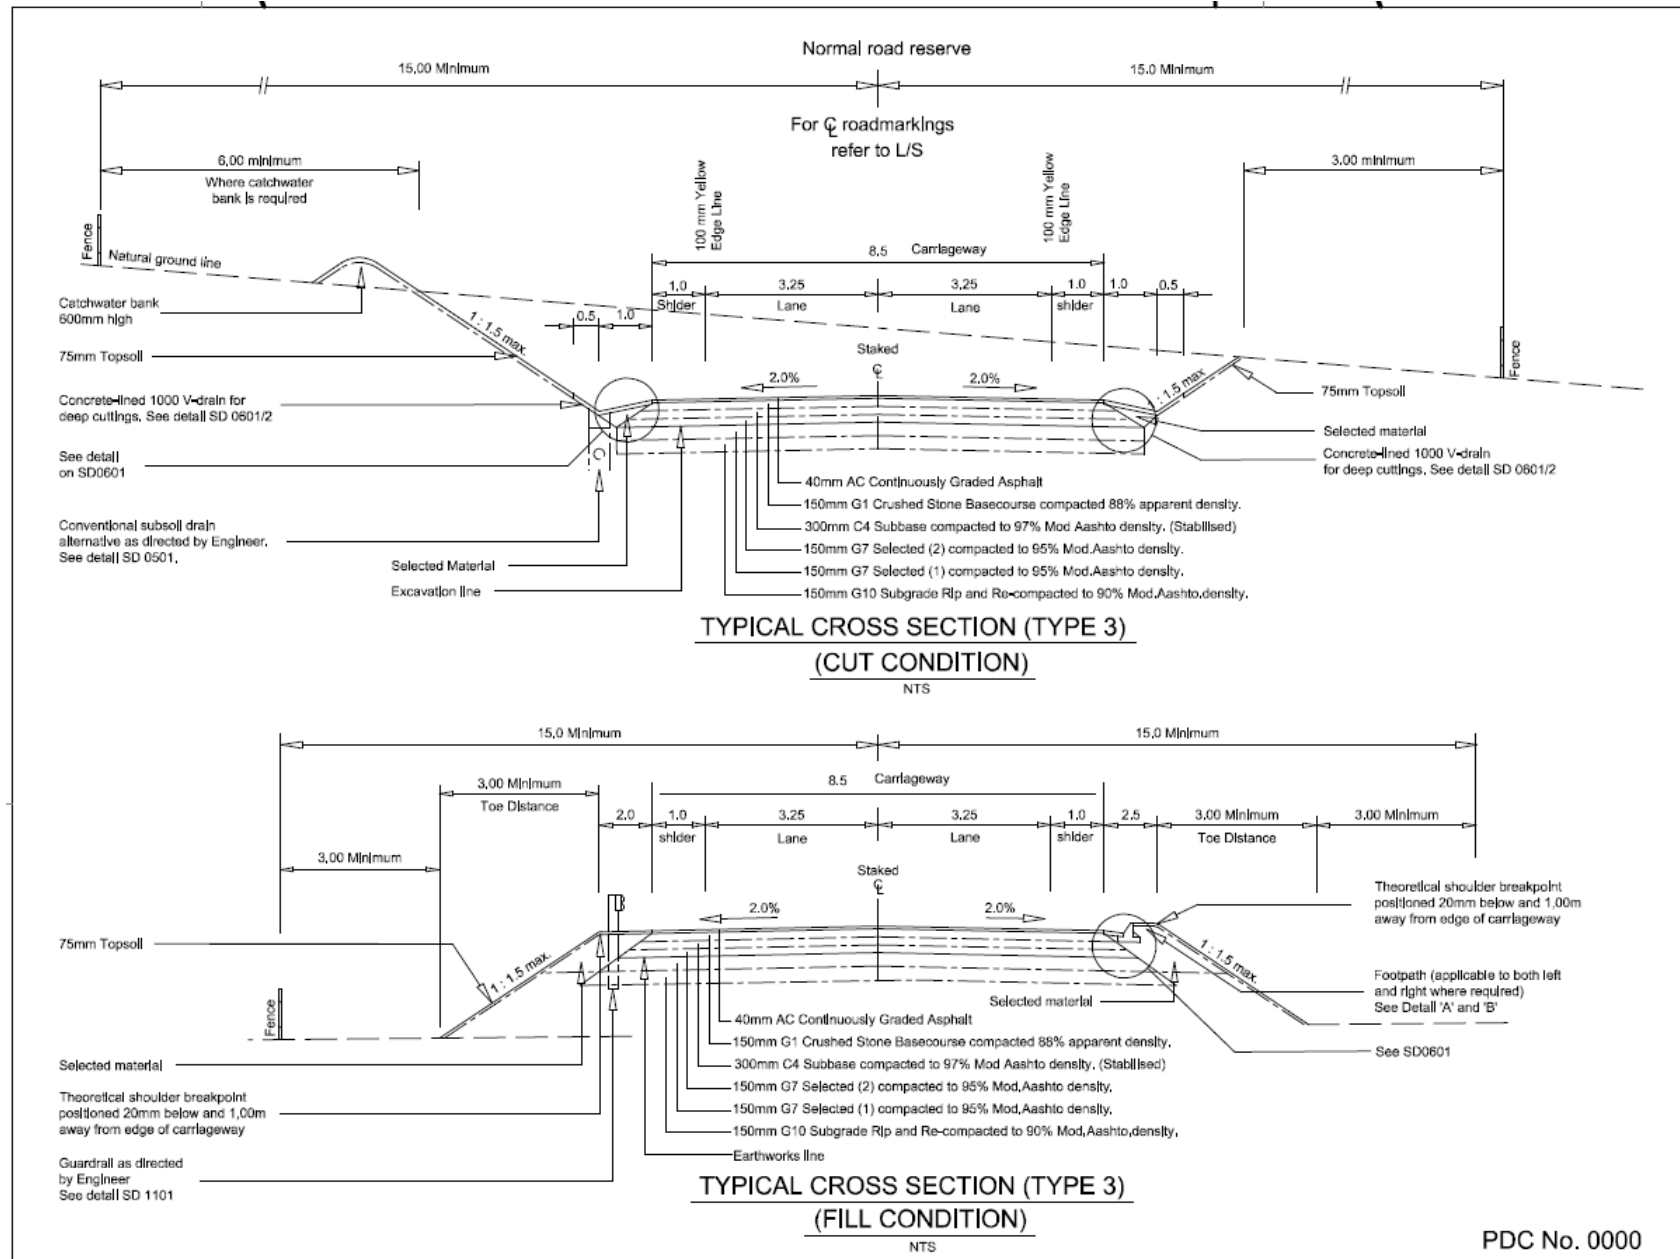
Figure 8: Typical cross section of the road upgrade in a cut and fill condition. (Refer to Appendix B1 for the full design drawing)

- 40mm AC Continuously Graded Asphalt;
- 150mm G1 Crushed Stone Basecourse compacted 88% apparent density;
- 300mm C4 Subbase compacted to 97% Mod Aashto density (stabilised);
- 150mm G7 Selected (2) compacted to 95% Mod.Aashto density;
- 150mm G7 Selected (1) compacted to 95% Mod.Aashto density; and
- 150mm G10 Subgrade Rip and Recompacted to 90% Mod.Aashto density.

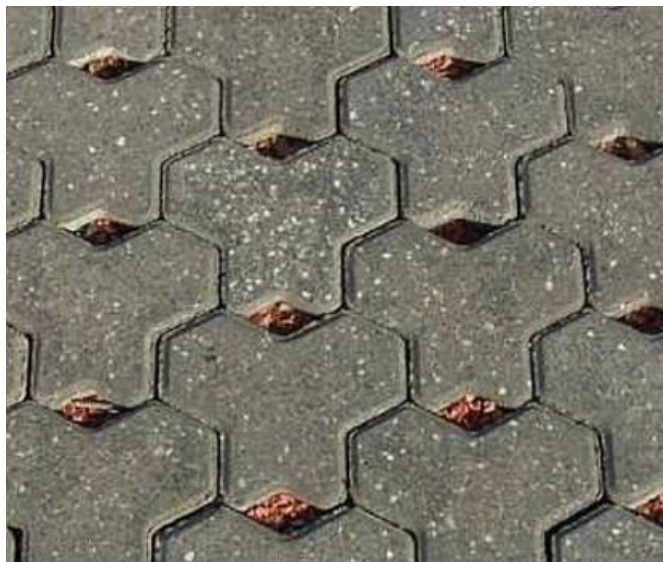
Example of permeable paving

Permeable Paving – allows rain and storm water to be absorbed by filtration into ground water systems as it would happen naturally. This system allows natural biological processes to continue as the soil will filter and break down runoff pollutants in the water. Permeable pavements promote water infiltration which reduces flooding and non-point source pollution, minimises storm water infrastructure costs and maximises groundwater recharge improving ecological functions of nearby drainage channels and wetlands. This has a positive effect on the surrounding biodiversity.

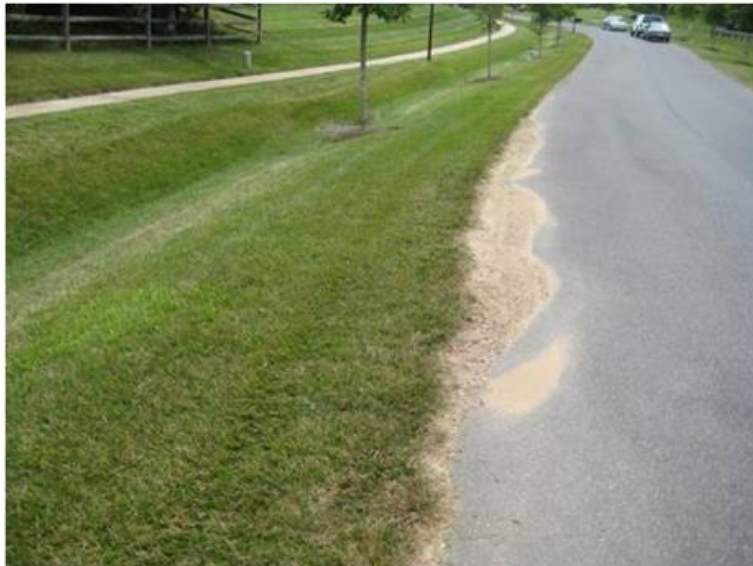
Example of a filter strip adjacent to a road

Filter strips – Filter strips are maintained grassed areas of land that are used to manage *shallow* overland storm water runoff through several filtration processes in a similar manner to buffer strips. They are most effective as pre-treatment options to aid the storm water management processes of bio-retention areas, infiltration trenches and swales. They intercept and spread out storm water runoff resulting in the attenuation of flood peaks. Filter strips are commonly used along stream banks as vegetated buffer systems and used downstream of agricultural land to intercept and infiltrate storm water runoff. They are particularly useful for providing a first line of defence against sheet flows from large paved areas such as roads. Filter strips use vegetative filtering as a primary means of storm water runoff pollutant removal. Properly designed filter strips remove most sediment and pollutants such as hydrocarbons and nitrates. Furthermore, with the use of appropriate indigenous vegetation, filter strips have the potential to provide a habitat corridor for wildlife.

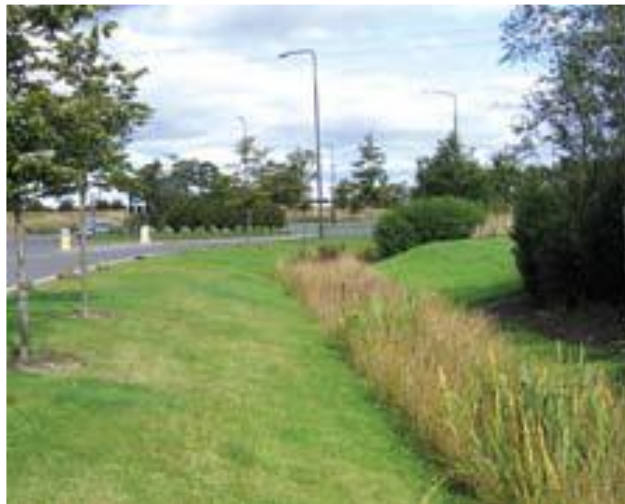
Example of a swale alongside a road.

Swales - linear grass covered depressions that typically remain dry between rainfall events. Swales lead surface water overland from the drained surface to a storage or discharge system, typically using road verges. It provides temporary storage for storm water and reduces peak flows. Furthermore, they use partial infiltration and bio-infiltration to remove pollutants from storm water runoff. Swales avoid the need for expensive roadside kerbs and related maintenance.

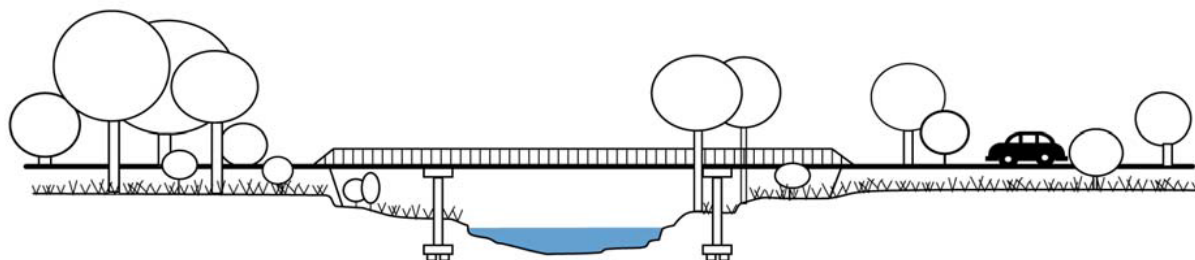
- Bed level crossings or bridges which fully span the watercourse channel provide the best opportunities for maintaining channel functions, as illustrated below:
